# National Transportation Safety Board

## Highway Accident Brief

**Accident No.:** HWY-00-FH011  
**Accident Type:** Motorcoach run-off-the-road  
**Location:** Eastbound State Highway 50 near milepost 273,  
Canon City, Colorado  
**Date and Time:** December 21, 1999, about 9:05 p.m.  
**Vehicle:** 1999 Setra 59-passenger motorcoach  
**Owner/Operator:** Sierra Trailways, Inc.  
**Vehicle Damage:** Motorcoach destroyed  
**People on Board:** Sixty—driver and 59 passengers  
**Injuries:** Three fatalities  
Thirty-three serious and 24 minor

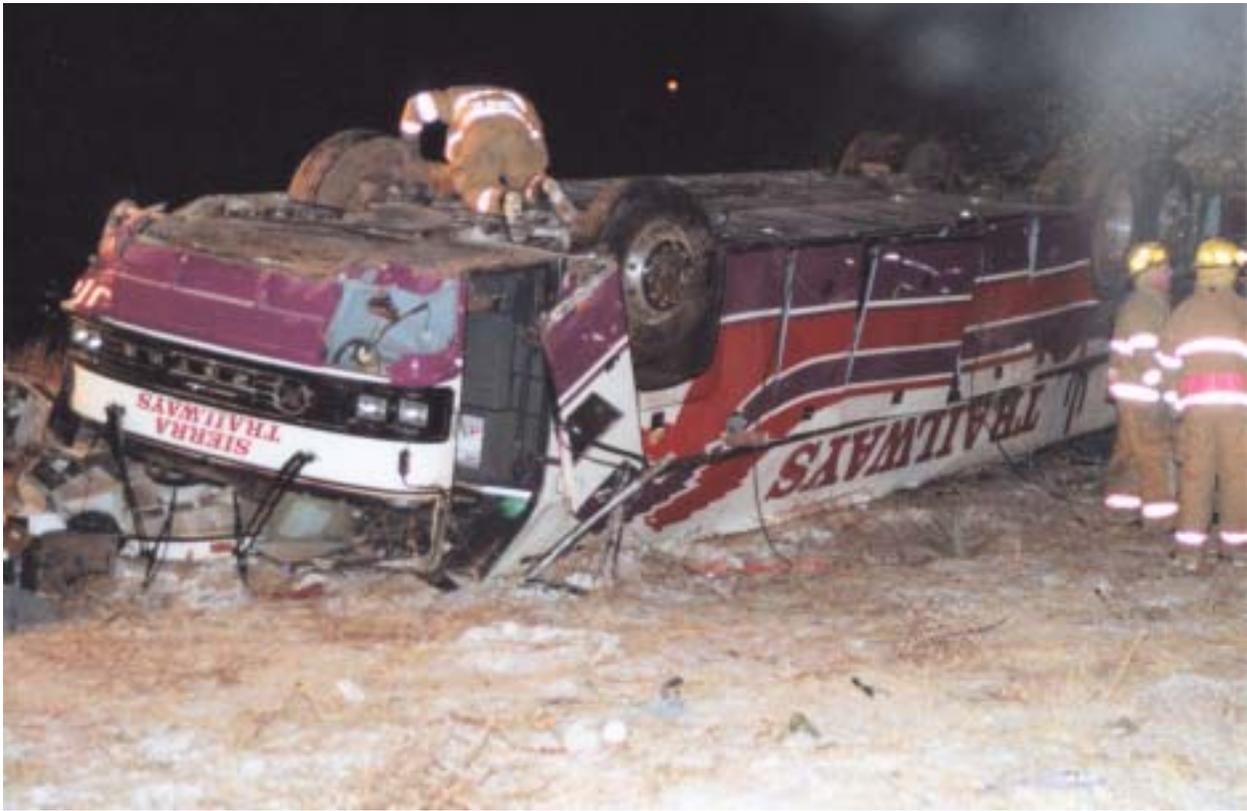
Figure 1. Photograph of motorcoach at final rest position.

toward the north embankment on the opposite side of the roadway. The busdriver subsequently steered to the right, initiating a 180-degree-clockwise rotation of the motorcoach, and the vehicle traveled backward down the opposite lane. Evidence indicated that the motorcoach's left-rear bumper struck another delineator on the left side of the road, and the bus proceeded backward down the north embankment, rolling at least 1.5 times on its side before coming to rest on its roof.

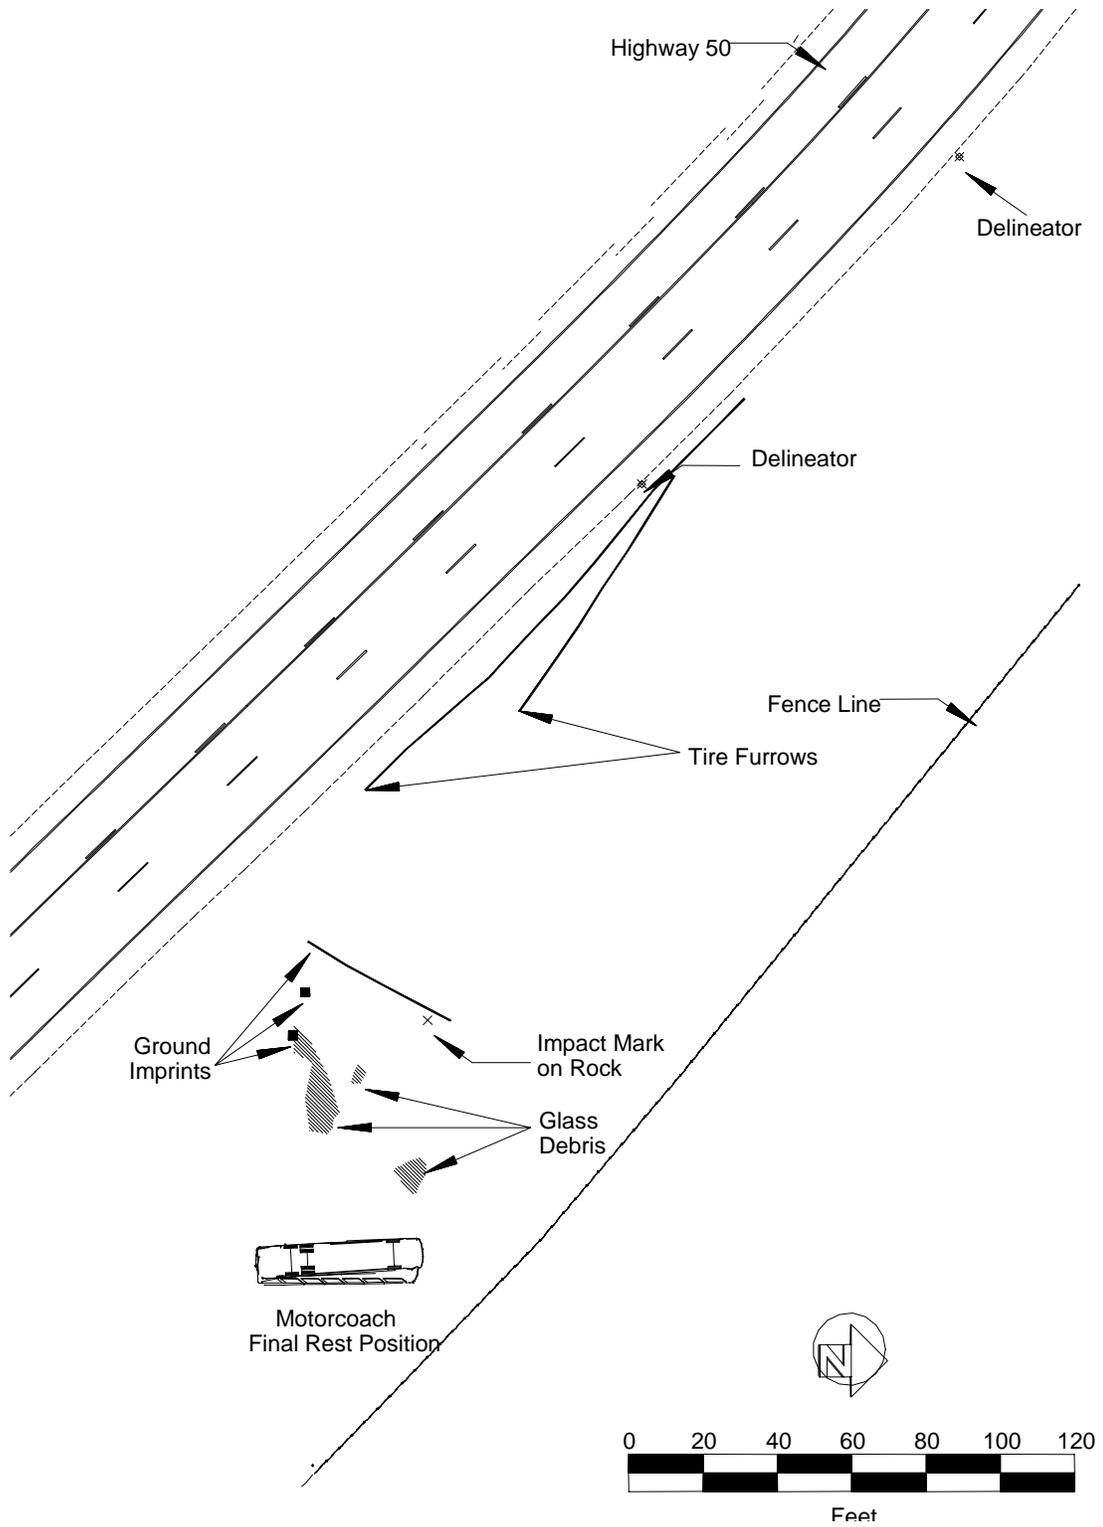
**Figure 2.** Diagram of accident

As the motorcoach approached MP 273, it yawed<sup>12</sup> to the right, departed the roadway shoulder, and went onto the dirt. Physical evidence indicated that the bus struck MP 273 and a delineator before the busdriver was able to steer the motorcoach back onto the pavement. The simulation suggested that the busdriver's steering input was such that it probably angled the bus
