National Transportation Safety Board

Highway Accident Brief

Accident Number: HWY14FH013
Accident Type: Motorcoach run-off-road and overturn
Location: State Route 1 ramp to US Route 13 north, Red Lion, New Castle County, Delaware
Date and Time: September 21, 2014, 4:15 p.m.
Vehicle: 1996 Setra S215 HDH
Fatalities: 3
Injuries: 48

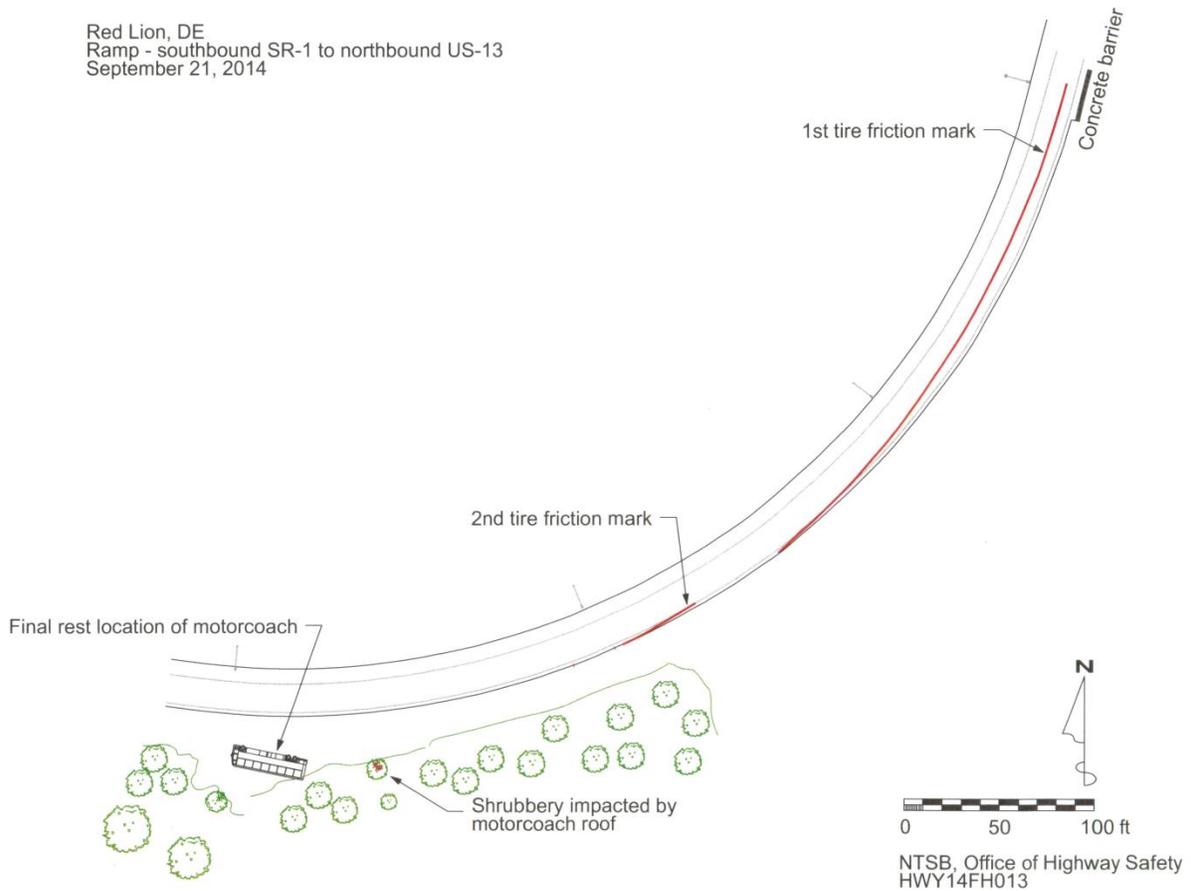
At the point where the SR-1 access ramp curves sharply to the right, the driver failed to negotiate the curve, and the motorcoach departed the left edge of the roadway. The motorcoach entered an earthen area, rotated clockwise, and overturned onto its left (driver) side and partially onto its roof, coming to rest about 25 feet off the roadway (figure 2).

Figure 2. Crash scene diagram.

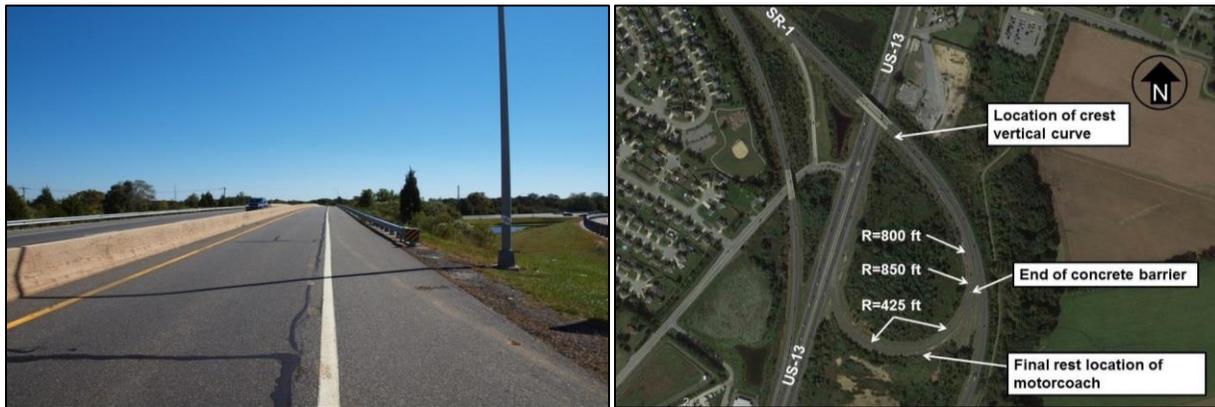
The crash occurred on the access ramp from southbound SR-1 to US-13 north near Red Lion, Delaware. The crash site is located about 7 miles southeast of Newark, Delaware. At the entrance to the access ramp, a crest vertical curve limits the visibility of the ramp ahead (figure 3, left).¹ The 1,600-foot vertical curve provides a transition between a 2 percent upgrade slope and a 3 percent downgrade slope. Beyond this point, the ramp is a horizontal curve with varying radii as it turns to the right in the direction of travel.² The radii transition from 800 to 850 feet before the end of the concrete barrier and toward the northern end of the ramp. Beyond the barrier, the ramp transitions to a 425-foot radius (figure 3, right).

Figure 3. At left, crest vertical curve at entrance to access ramp to US-13 north. At right, access ramp and relative locations of key roadway elements (adapted from figure 1).

At the time of the crash, no traffic signs were in place to warn motorists of the change in roadway curvature, or to reduce vehicle speed from 55 mph on the curved access ramp from southbound SR-1 to US-13 north.

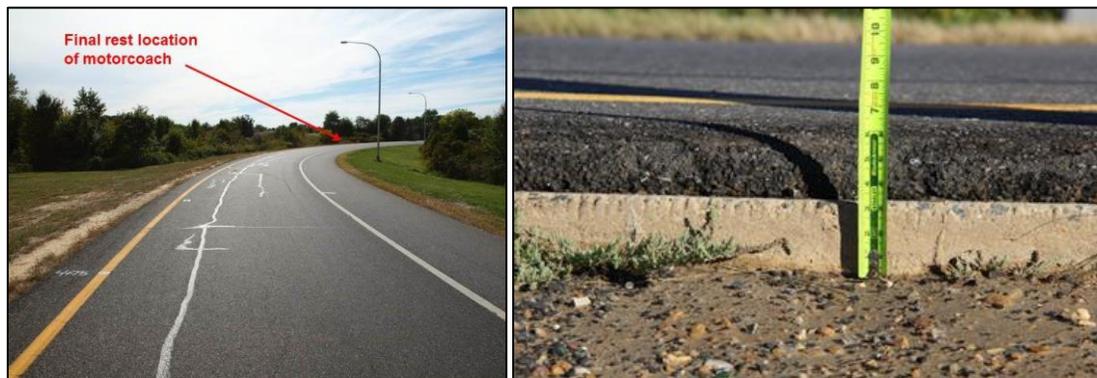
The access ramp consists of a single 14-foot-wide travel lane with a 2-foot-wide shoulder to the left and an 8-foot-wide shoulder to the right (figure 4, left). An earthen negative slope borders the left and right shoulders. Super-elevation values along the access ramp range from 4.6 to 5.5 percent.³ Values for the pavement edge drop-off along the access ramp ranged from 0.8 to 6.0 inches (figure 4, right).⁴ At the point where the motorcoach departed the roadway, the pavement edge drop-off was about 2.5 inches. This drop-off as observed along the ramp was not

a factor in the crash, but was identified as an issue to be addressed by the Delaware Department of Transportation (DelDOT) because of potential hazards to “errant vehicles.”⁵

Figure 4. At left, view of 425-foot-radius curve on SR-1 ramp, turning to right in direction of travel, and showing final rest location of motorcoach. At right, view of most prominent edge-of-pavement drop-off along access ramp.

With the assistance of DeIDOT staff, NTSB investigators determined that the shoulder required regrading to eliminate the edge-of-pavement drop-off. In summer 2015, DeIDOT regraded the shoulder to meet the elevation of the asphalt surface on the loop ramp.

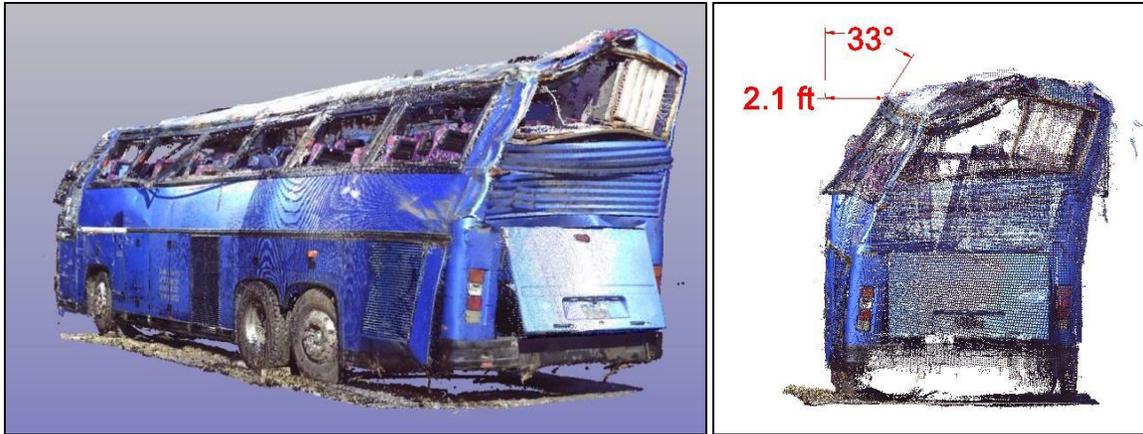
The 1996 Setra model S215 HDH motorcoach sustained extensive damage to the left side, rear, roof, and related support structures (figure 5, left). Some passenger seatbacks on the left side of the motorcoach became exposed through the window openings due to the lateral displacement of the roof (figure 5, right).

Figure 5. At left, three-dimensional scan of motorcoach showing damage to left side, rear, and roof. At right, three-dimensional scan of rear of motorcoach showing lateral displacement of roof.

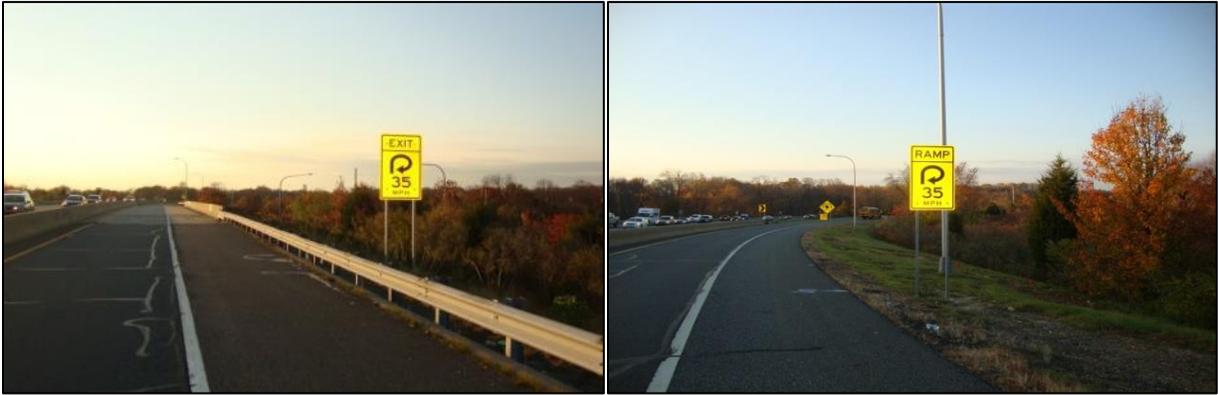
Figure 6. At left, new 35-mph combination horizontal alignment/advisory exit sign located in advance of crest vertical curve. At right, new 35-mph combination horizontal alignment/ramp speed sign located near 800-foot radius. (Source: DeIDOT)

On October 9–10, 2014, DeIDOT installed new traffic signs on the access ramp that meet the requirements of the 2009 MUTCD. These signs include the following:

- A 35-mph combination horizontal alignment/advisory exit sign (W13-6) located before the crest vertical curve (figure 6, left).
- A horizontal alignment sign (W1-15) with a 35-mph advisory speed plaque sign (W13-1P) located beyond the crest vertical curve.
- A 35-mph combination horizontal alignment/ramp speed sign (W13-7) located near the 800-foot radius (figure 6, right).
- A truck rollover warning sign (W1-13) with a 35-mph advisory speed plaque sign (W13-1P) located near the 850-foot radius (figure 7, left).

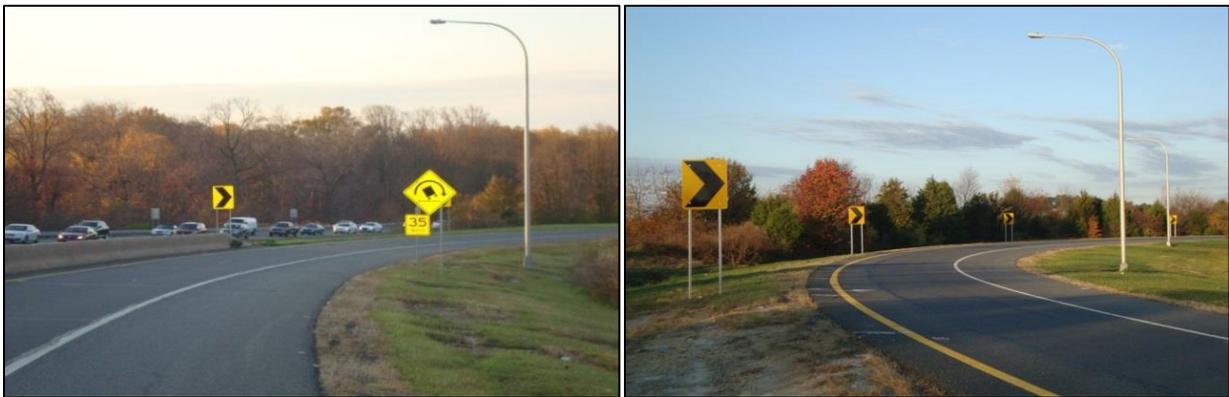
Figure 7. At left, new truck rollover warning sign with 35-mph advisory speed plaque sign located near 850-foot radius. At right, new chevron signs spaced at 120-foot intervals along loop ramp. (Source: DeIDOT)

- Thirteen high post-mounted chevron signs (W1-8) spaced at 120-foot intervals along the loop ramp (figure 7, right).²³
