National Transportation Safety Board

Highway Accident Brief

Passenger Vehicle/School Bus Collision and Roadway Departure

Accident Number:	HWY15FH010
Accident Type:	Passenger vehicle/school bus collision and roadway departure
Location:	Eastbound Interstate 610 (I-610) overpass above Telephone Road, Houston, Harris County, Texas
Date and Time:	September 15, 2015; about 7:03 a.m.
Vehicles:	47-passenger 2009 International school bus 2004 Buick LeSabre passenger vehicle
Fatalities:	2
Injuries:	3

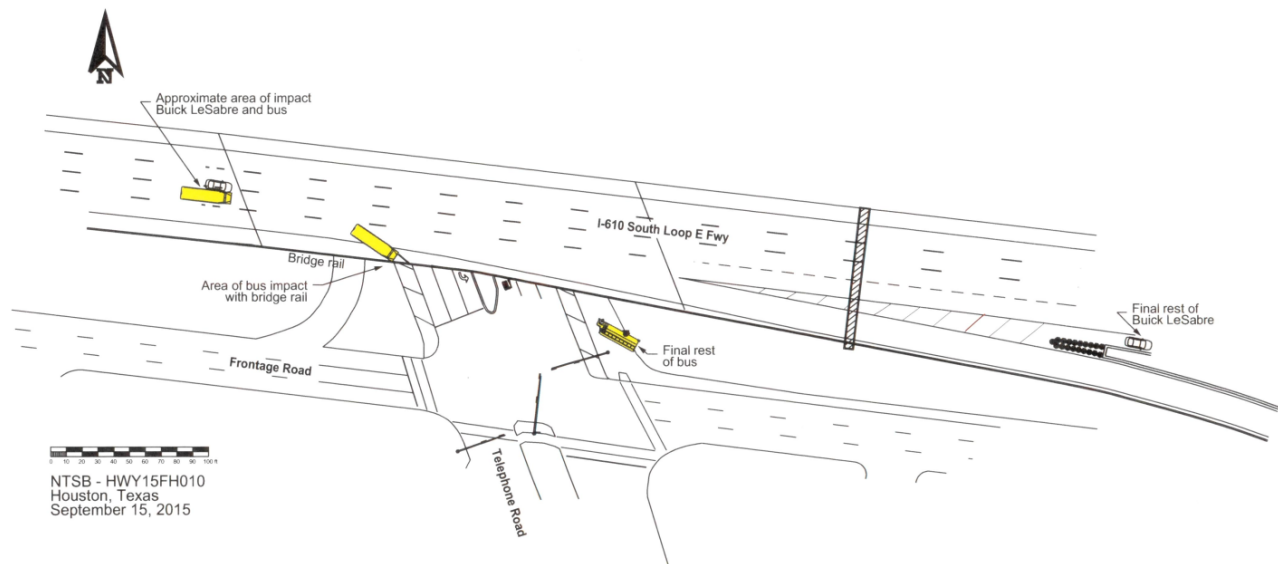
Figure 2 is a crash scene diagram showing the following features of this crash: approximate area of impact between the Buick LeSabre and the HISD school bus; approximate point of the school bus's impact with the bridge rail; and final rest positions of the school bus and the Buick.

Figure 2. Diagram showing the crash events that involved the school bus (in yellow) and Buick LeSabre.

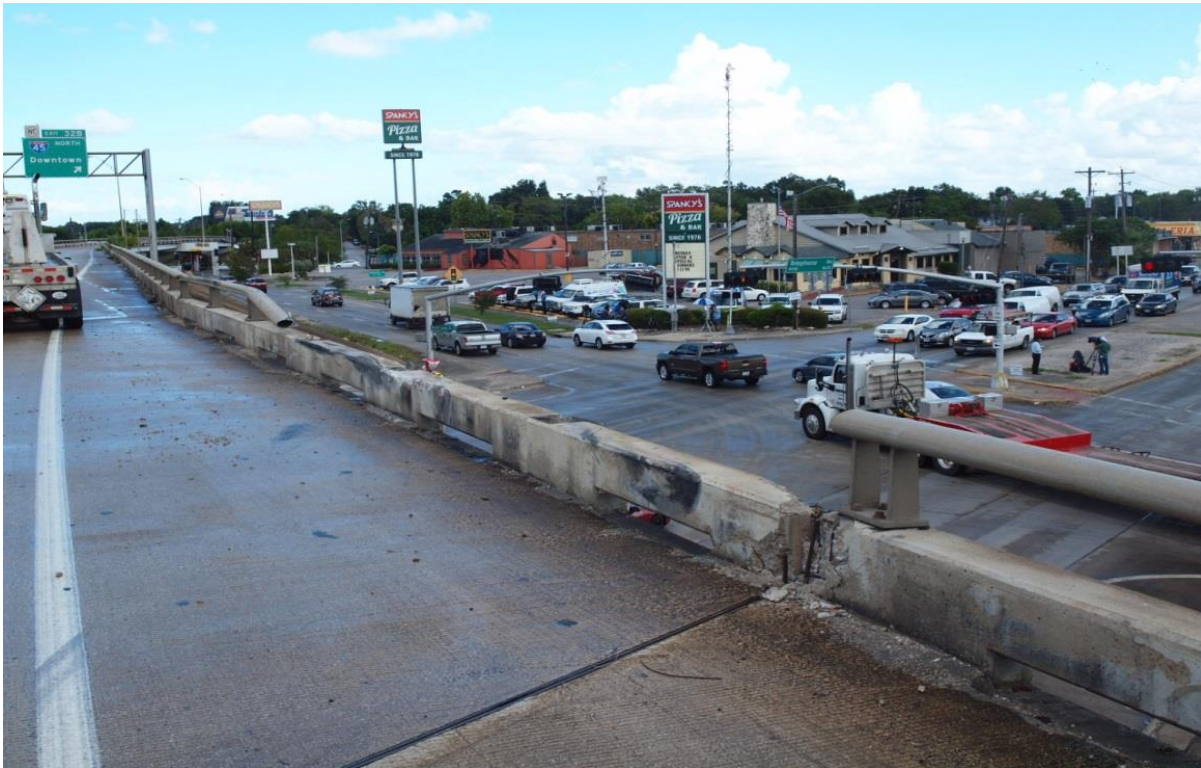
The total weight of the HISD school bus in the crash was approximately 16,300 pounds.⁹ In addition to the bus's weight being almost 12,000 pounds above the TL-3 test protocol, the angle of impact with the barrier was slightly above the thresholds for the TL-3 test criteria. Given these factors, the Type C4 (modified) bridge railing, in its designed condition, would not have been expected to redirect a collision by a school bus. (Figure 3 provides a view of the bridge rail after being struck by the HISD school bus.)

Figure 3. Bridge rail after being struck by the HISD school bus (view is to the southeast).

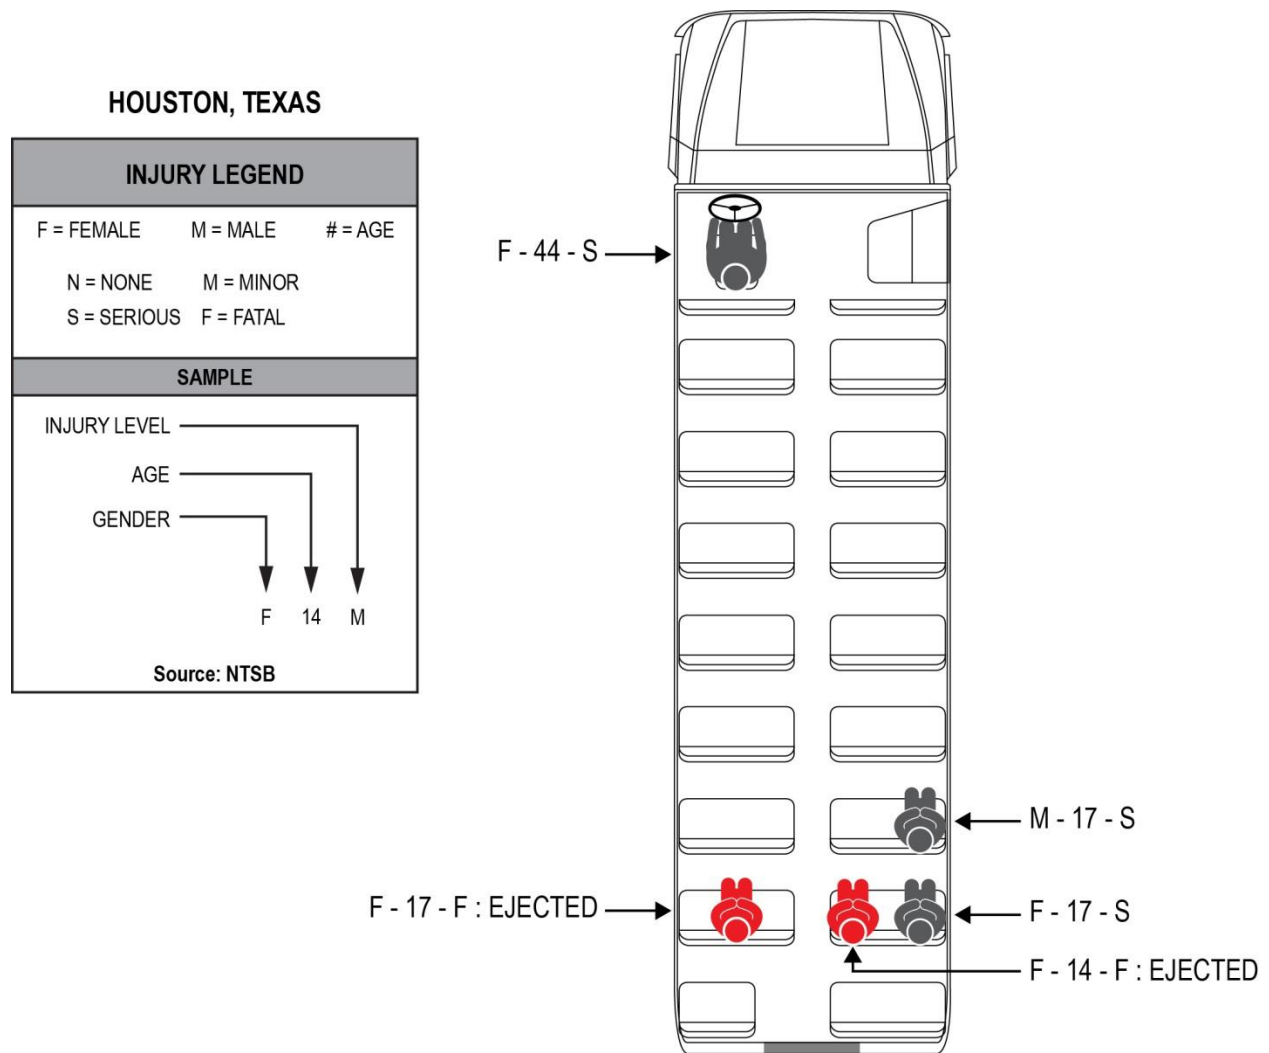
Figure 4 is a seating chart of the school bus that provides the gender, age, and injury level of the bus occupants. It also indicates the seating locations of the two student passengers who were ejected from the bus; these two students were fatally injured in the crash.

Figure 4. Seating positions, demographic information, and injury and ejection outcomes for school bus occupants. (Persons who received fatal injuries are indicated in red.)

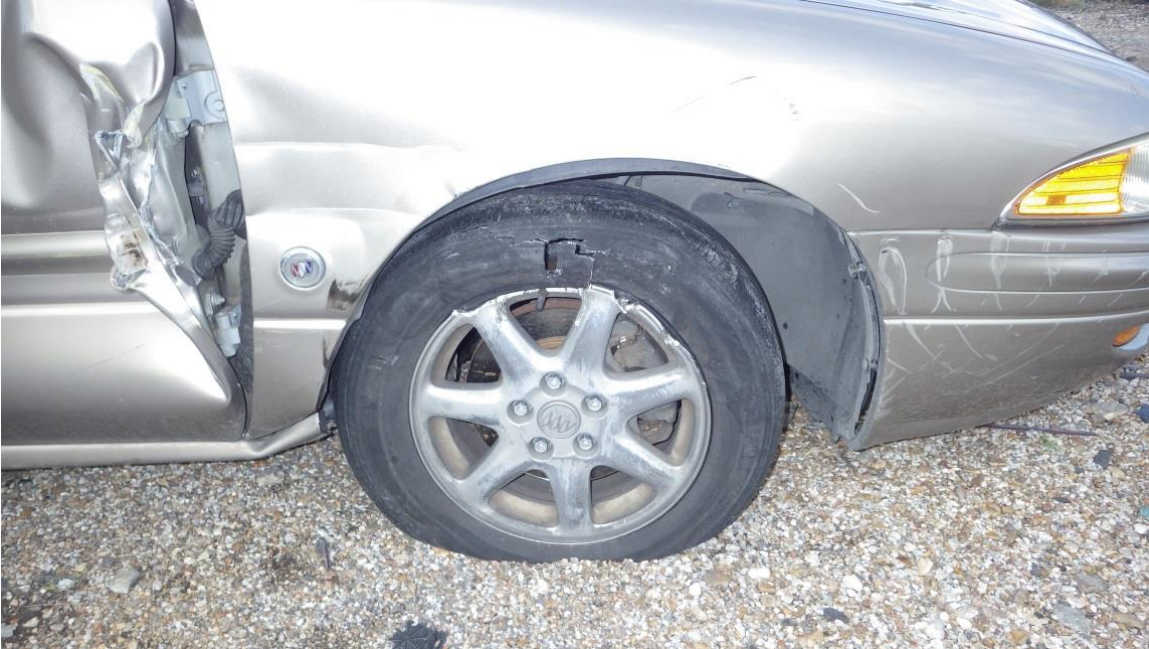
Buick LeSabre. The damage to the Buick LeSabre was limited to the right side of the vehicle. There were pattern scratches in the paint on the right front fender near the wheel well. Portions of the outside flange of the right front wheel rim were broken away. There was a tear measuring approximately 3 x 3 inches in the right front sidewall near the valve stem, and the tire was deflated. The pattern scratches and the tear were caused by contact with the wheel studs on the rotating left front wheel of the bus. Figure 6 shows the damage to the Buick LeSabre caused

by the wheel studs. A portion of the steering system's right side control arm was fractured through at a fitting near the frame.

Figure 6. Pattern scratches and damage to the front right tire on the Buick LeSabre from contact with the HISD bus.
