National Transportation Safety Board

Highway Accident Brief

Train and Truck Crash on Railroad Right-of-Way and Subsequent Fire

Accident Number:	HWY15MH006
Accident Type:	Train and truck crash on railroad right-of-way and subsequent fire
Location:	Near intersection of East Fifth Street and South Rice Avenue, Oxnard, California
Date and Time:	February 24, 2015, 5:44 a.m. Pacific standard time
Vehicle 1:	Commuter train 102
Operator:	Metrolink/Amtrak
Vehicle 2:	2005 Ford F450 service truck, with two-axle utility trailer
Operator:	Harvest Management, LLC
Vehicle 3:	1998 Toyota Camry
Fatalities:	1
Injuries:	33

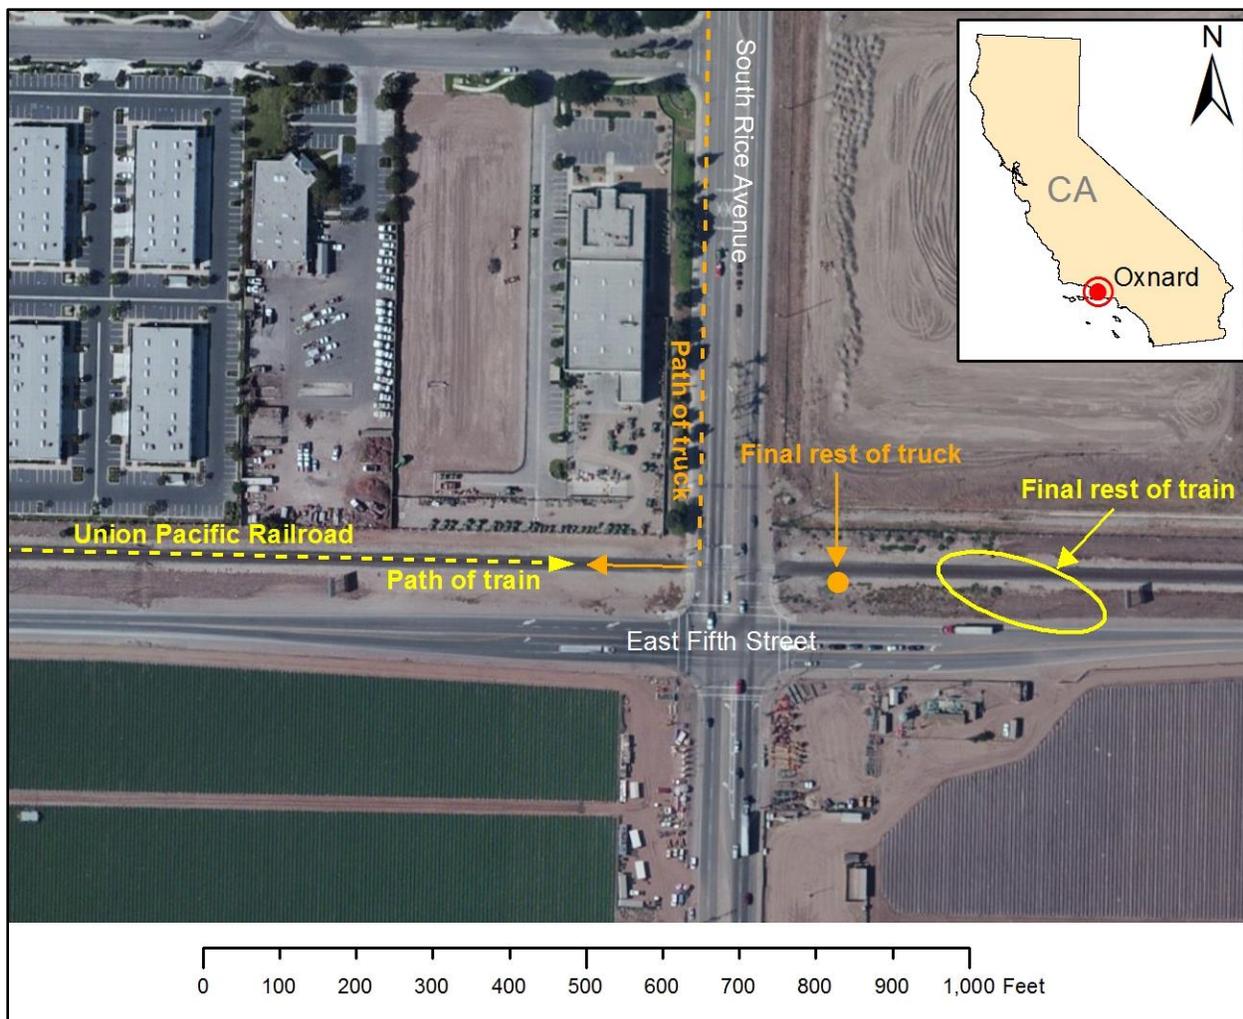
Figure 1. Aerial view of crash location showing (a) truck's path onto railroad track 80 feet west of South Rice Avenue; and (b) East Fifth Street, where truck driver had intended to turn. (Source: Google Maps)

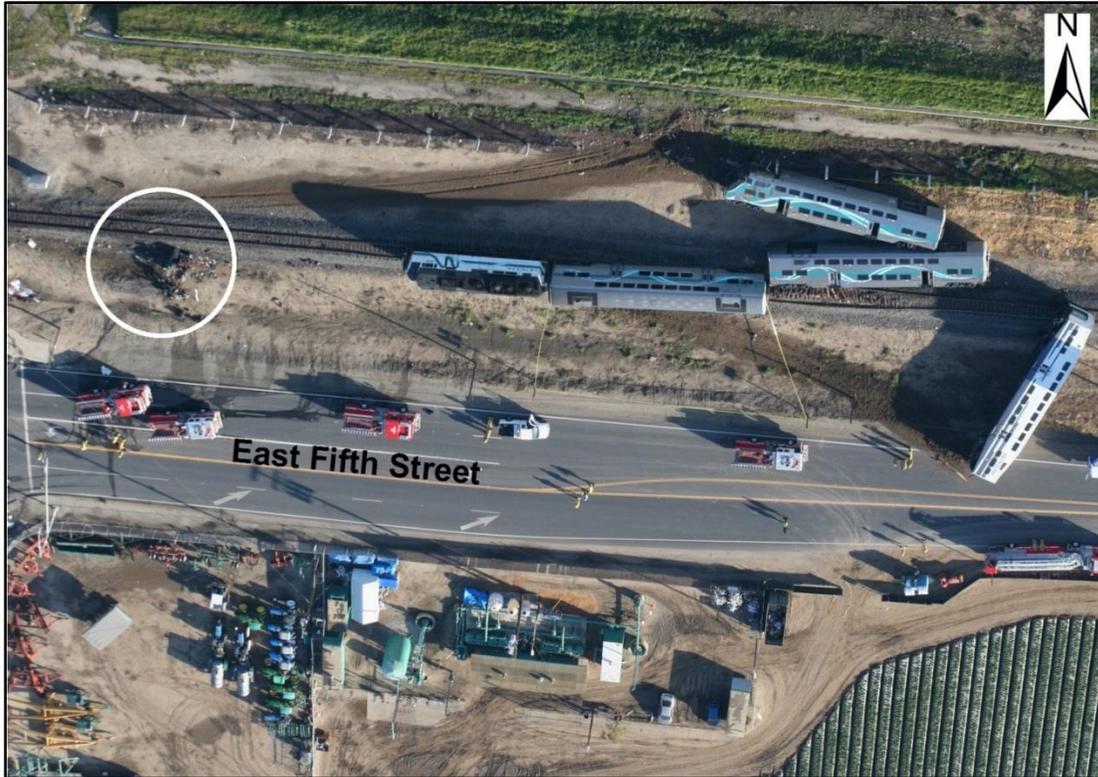
After striking the truck and trailer, the train continued through the grade crossing, where all four coach cars subsequently derailed, and three rolled over on their sides (figure 2). The locomotive did not derail. The truck was pushed along the track and came to rest about 130 feet east of the grade crossing on the south side of the track bed (figure 3). The trailer detached from the truck and came to rest on the grade crossing, where it was consumed by a postcrash fire. Debris from the collision caused minor damage to a 1998 Toyota Camry, which was stopped at the grade crossing, facing north, at the time of the crash.

Figure 2. Northward-facing aerial view of train at final rest, showing (a) rear locomotive; (b) three overturned railcars and one derailed but upright railcar, with railcar at far right blocking part of East Fifth Street; and (c) remains of truck circled at left.

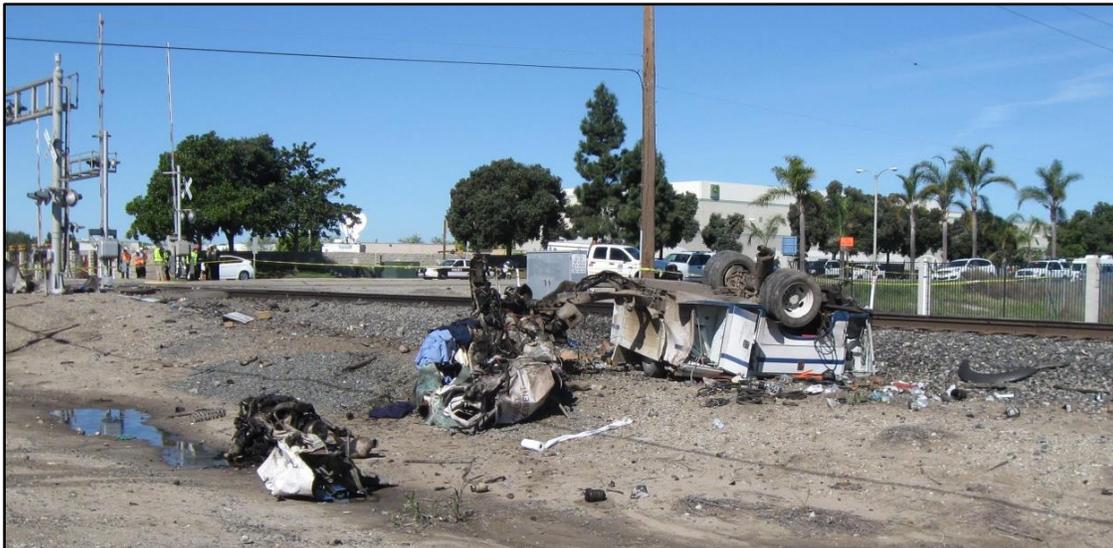
Figure 3. Remains of truck at final rest, with grade crossing at left.

The truck sustained severe collision damage to all areas, and the front of the utility trailer was similarly damaged. The postcrash fire consumed most of the trailer. NTSB investigators were unable to determine if the truck engine was running at the time of the collision; however, a comprehensive examination of the vehicle indicated no mechanical failures that would have prevented the engine from running. Functional checks of the truck's brakes were completed by supplying compressed air directly to each of the hydraulic brake lines. All of the brakes were found to be functional, and any observed damage to the system was consistent with involvement in a collision or postcrash fire. The extent of postcrash damage prevented examination of the vehicle's steering system.

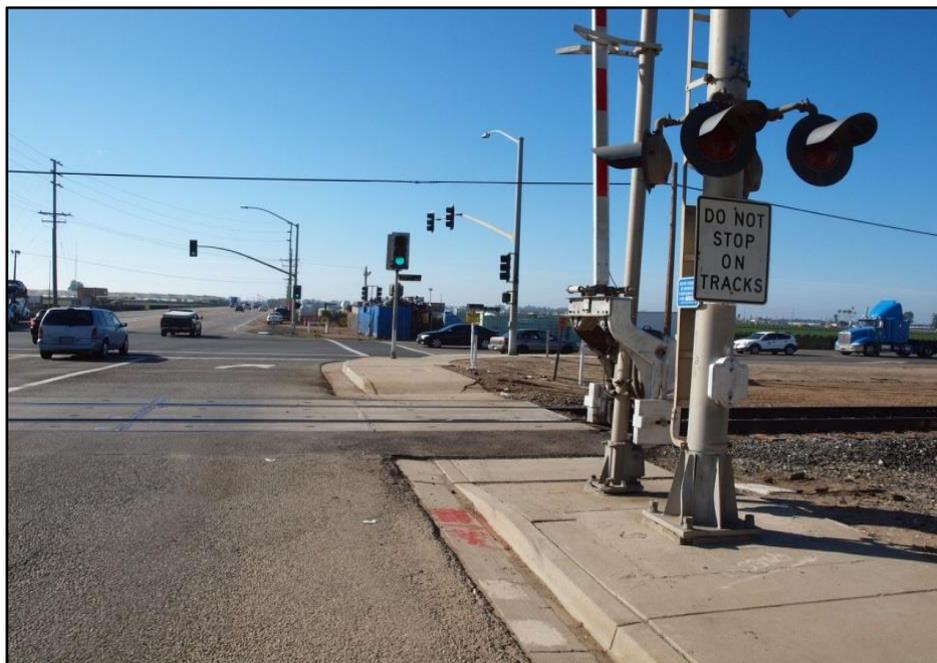
In Oxnard, the truck driver traveled south on South Rice Avenue on approach to the intersection with East Fifth Street, which is located just 57 feet beyond the railroad grade crossing (745855H). This protected highway–railroad at-grade crossing is marked by a combination of warning lights, gates, signs, and pavement markings (figure 4). According to the driver, he had intended to turn right at the intersection and to proceed west on East Fifth Street; however, he turned his vehicle too soon and entered the railroad right-of-way. The lights and gates at the grade crossing were not active because no train was approaching at that time.

Figure 4. View of southward approach to East Fifth Street from right lane of South Rice Avenue, with grade crossing in foreground, 57 feet from East Fifth Street.

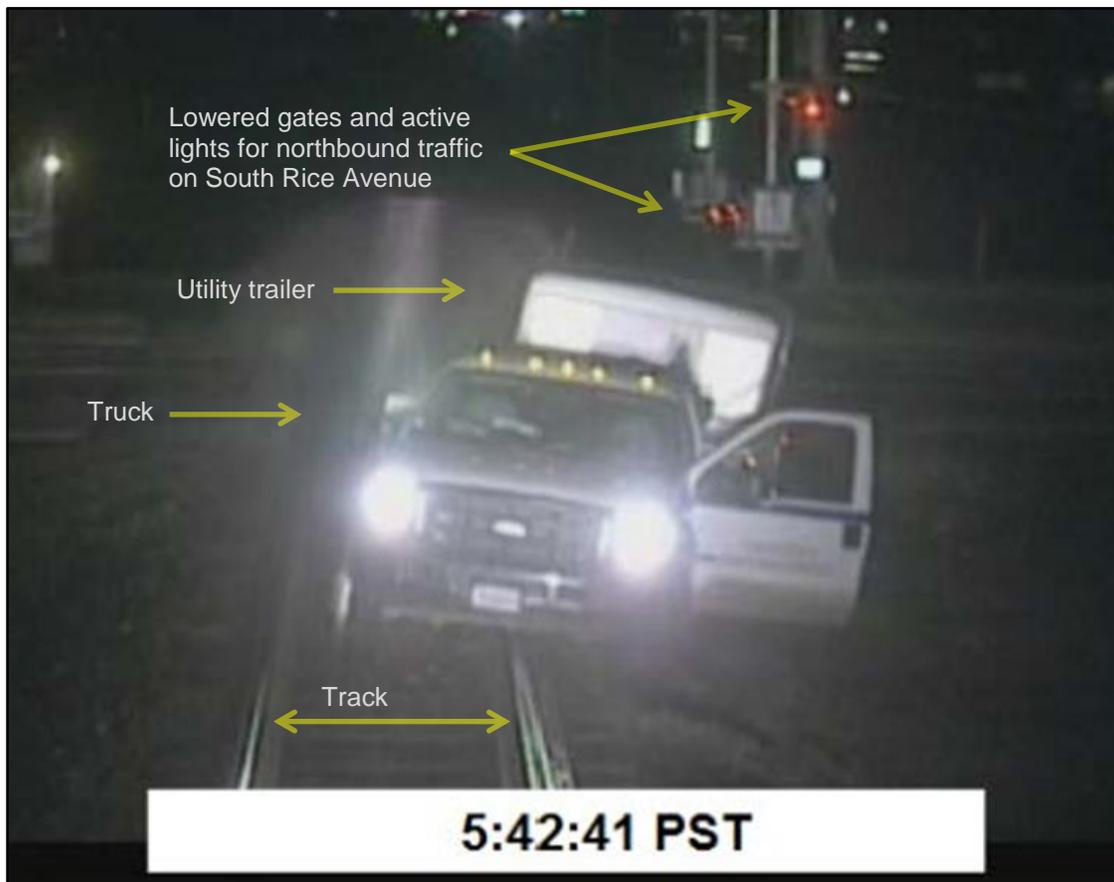
The train's forward-facing video camera showed the truck straddling the south rail, positioned to the right of center of the track bed, relative to the eastbound movement of the train (figure 5). NTSB investigators performed a postcrash sight-distance test to determine how soon the student engineer could have seen the truck.¹² The test showed that the truck was visible from a distance of more than 0.5 mile; however, at that distance, the headlights of approaching highway vehicles traveling west on East Fifth Street converged with the truck headlights. This masking of

the obstruction—and the unexpected condition of having a vehicle on the track in advance of the crossing—might have made it difficult for the student engineer to identify and comprehend the hazard.

Figure 5. Still image from train's forward video camera, showing disabled truck straddling south rail, with headlights on and driver door open; utility trailer behind the truck; and South Rice Avenue grade crossing in background, with its gates down and lights active.

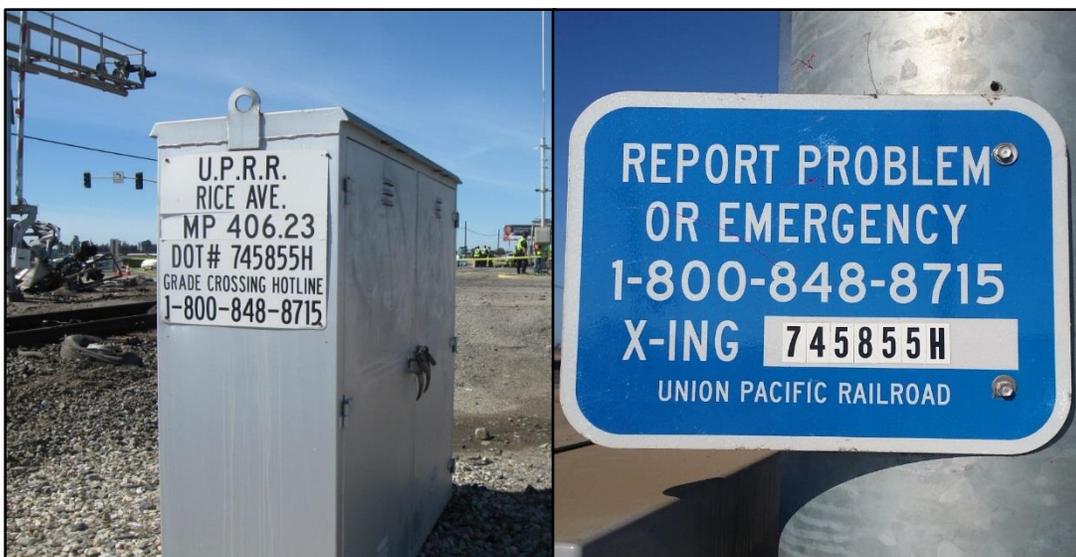
Figure 6. Signal bungalow near South Rice Avenue grade crossing, and one of two blue signs mounted on the cantilever signal masts, showing emergency telephone and grade crossing numbers.

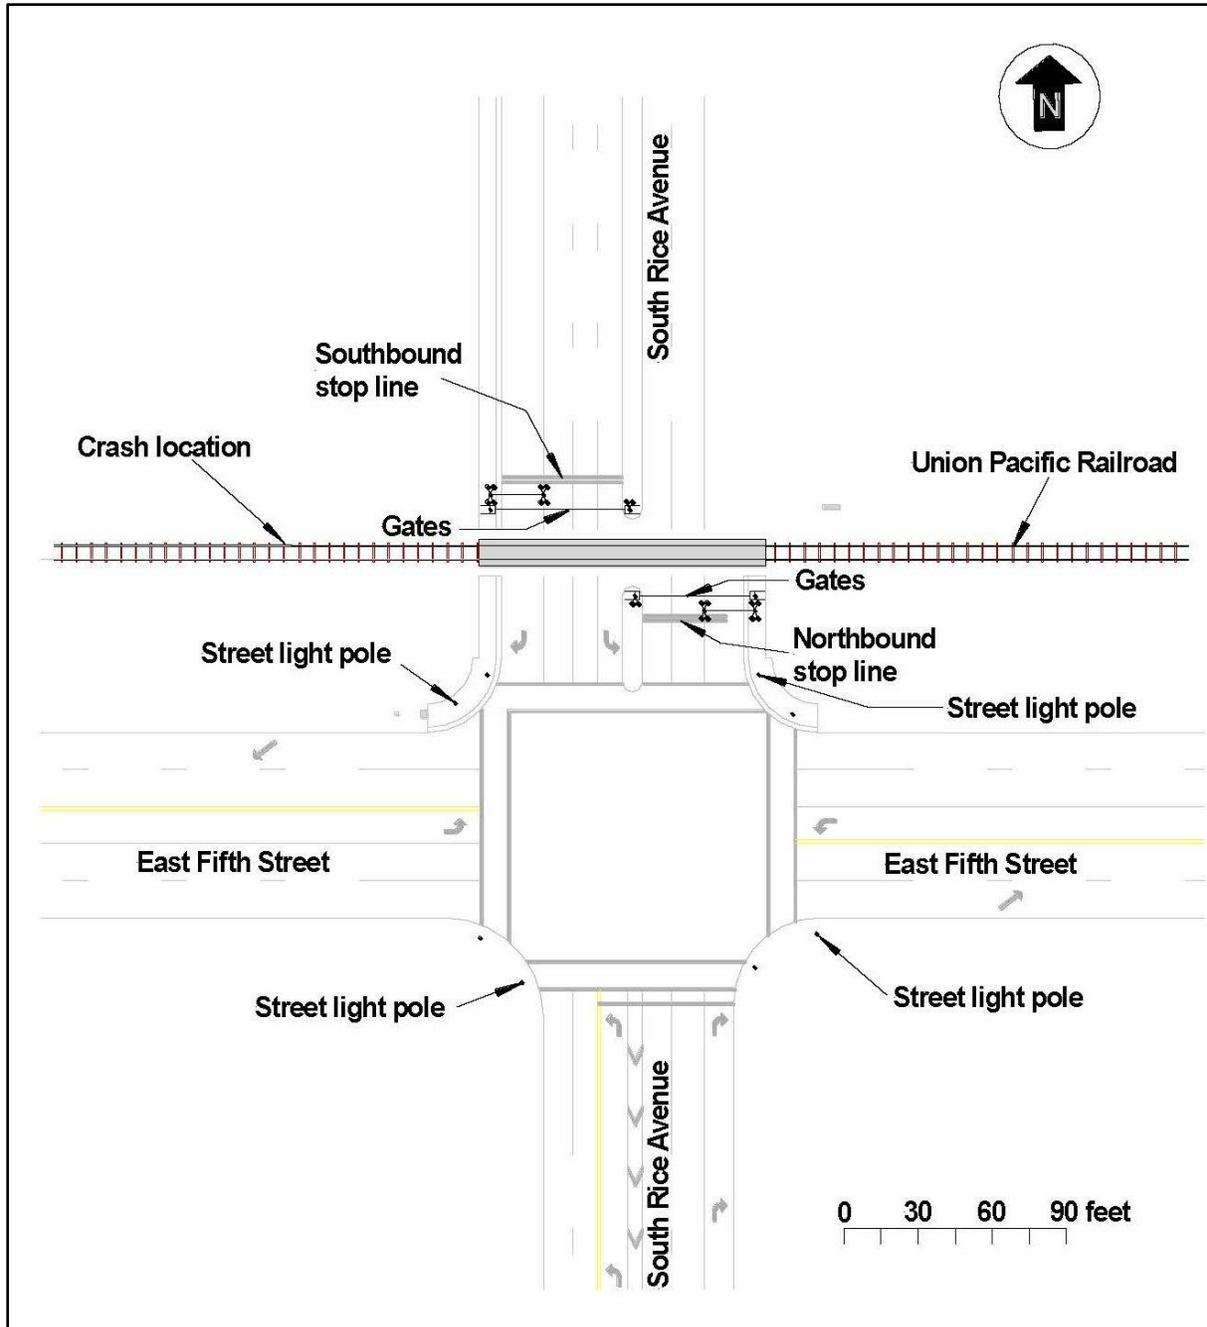
Figure 7. Crash scene diagram of grade crossing and East Fifth Street-South Rice Avenue intersection.

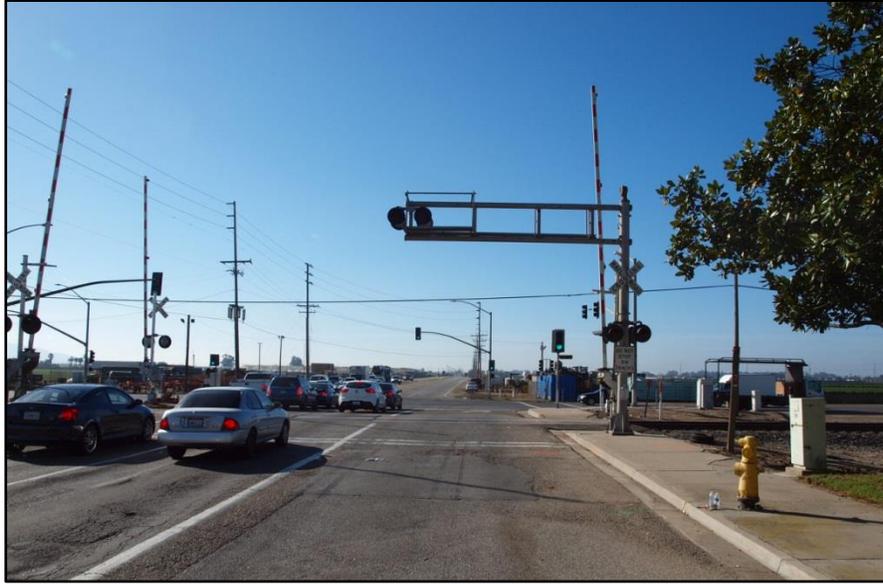
Figure 8. View of southbound approach to East Fifth Street intersection from right lane of South Rice Avenue.

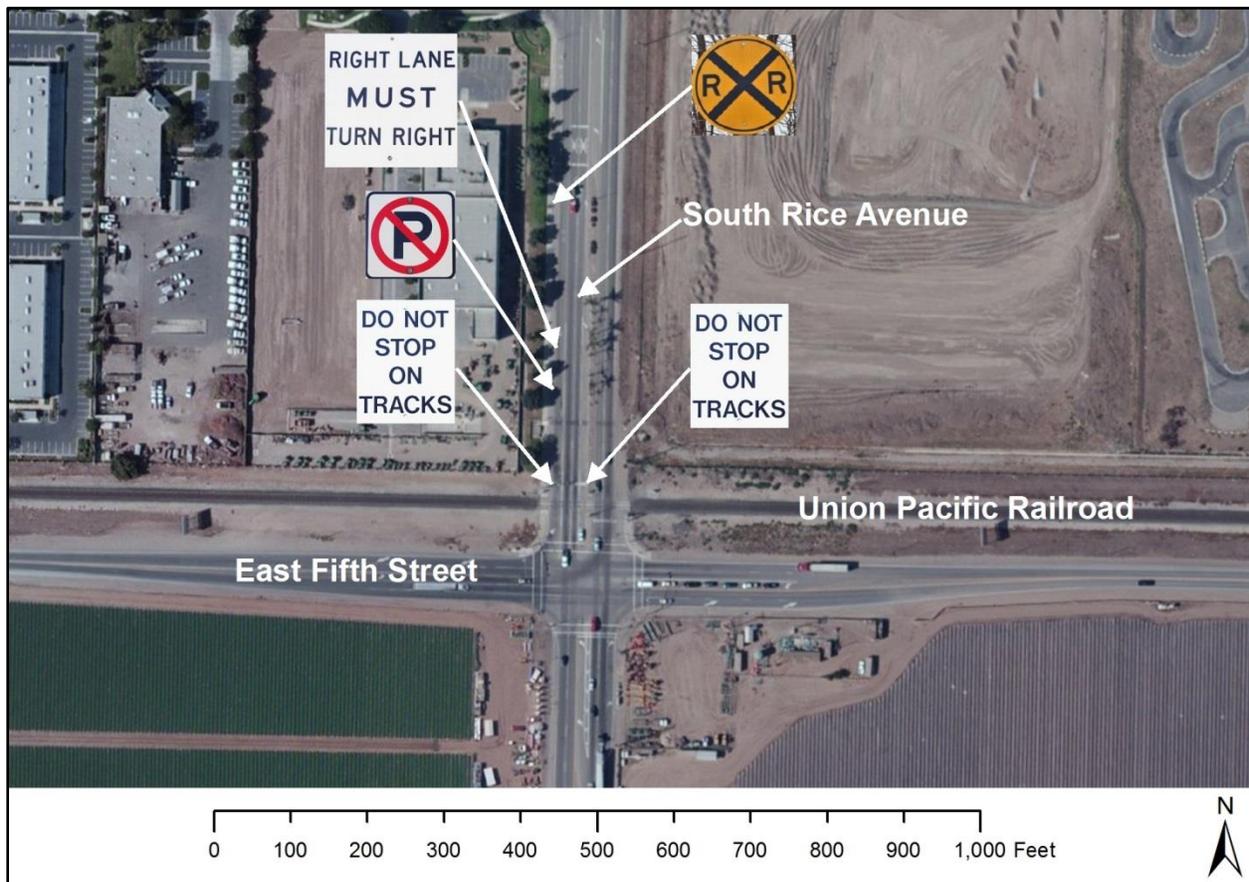
- Grade crossing advance warning symbol located 355 feet from the nearest rail.
- “RIGHT LANE MUST TURN RIGHT” sign located 208 feet from the nearest rail.
- No parking sign located 105 feet from the nearest rail.
- “DO NOT STOP ON TRACKS” sign located 18 feet from the nearest rail.

Figure 9. Signage in vicinity of southbound approach to grade crossing.

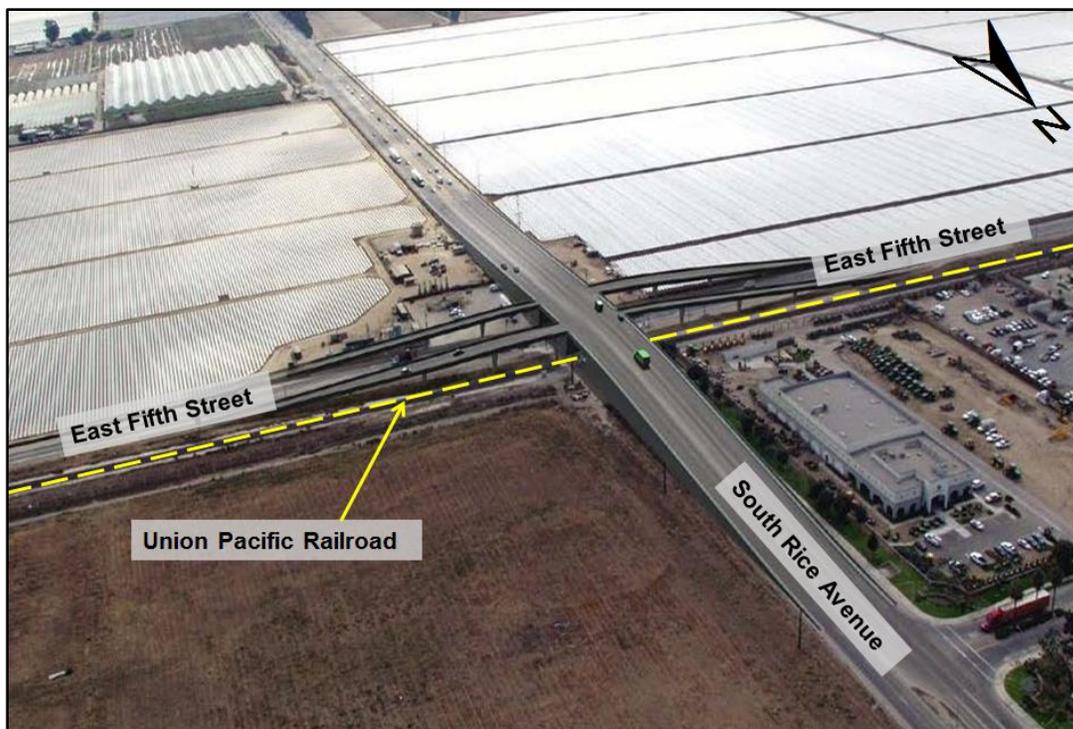
Figure 10. Conceptual representation of future grade separation of South Rice Avenue over UP track and East Fifth Street.

The city of Oxnard is planning to grade separate South Rice Avenue over the UP track and East Fifth Street. The grade separation will address the significant traffic delays that occur on South Rice Avenue and provide free flow movement of vehicles over the track and intersection. Figure 10 depicts the proposed conceptual grade separation. The environmental study phase is currently underway, with completion expected by March 2017. The city plans to select a construction contractor in 2019 and to complete the project in 2021.

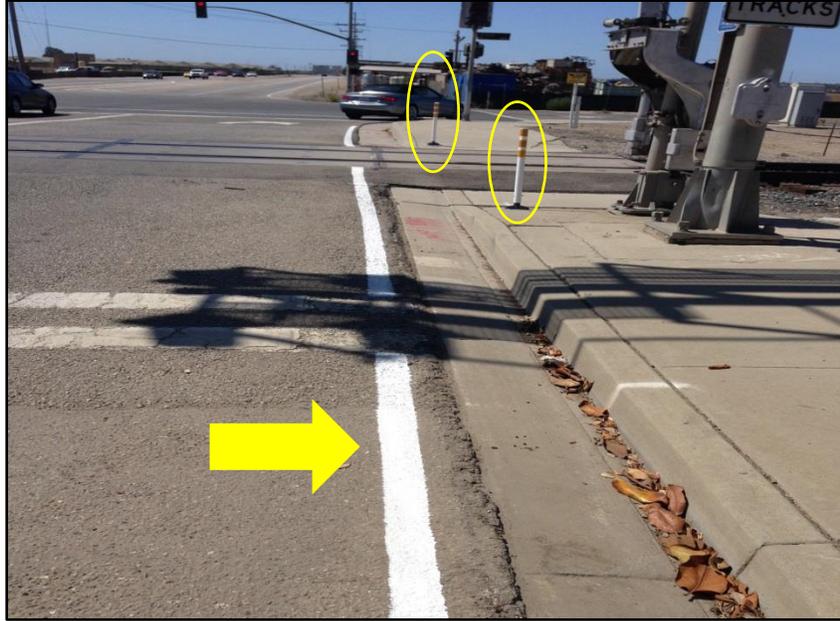
Figure 11. Interim improvements at grade crossing: 4-inch-wide solid white edge line and two white tubular markers installed postcrash.

In the interim, the city of Oxnard and the UP have worked together to make short-term improvements to the grade crossing, as noted below:
