# National Transportation Safety Board

## Highway Accident Brief

### Passenger Vehicle Median Crossover Crash, Robstown, Texas

<b>Accident Number:</b>	HWY16FH007
<b>Accident Type:</b>	Passenger vehicle median crossover crash
<b>Location:</b>	US Highway 77, Robstown, Texas
<b>Date and Time:</b>	Sunday, March 20, 2016, 1:57 p.m. central daylight time
<b>Vehicle 1:</b>	2013 Hyundai Elantra
<b>Fatalities:</b>	3
<b>Injuries:</b>	1
<b>Vehicle 2:</b>	2009 Freightliner truck-tractor in combination with a 2014 flatbed semitrailer
<b>Operator:</b>	Suarez Bros. Crane and Heavy Haul, LLC
<b>Injuries:</b>	0

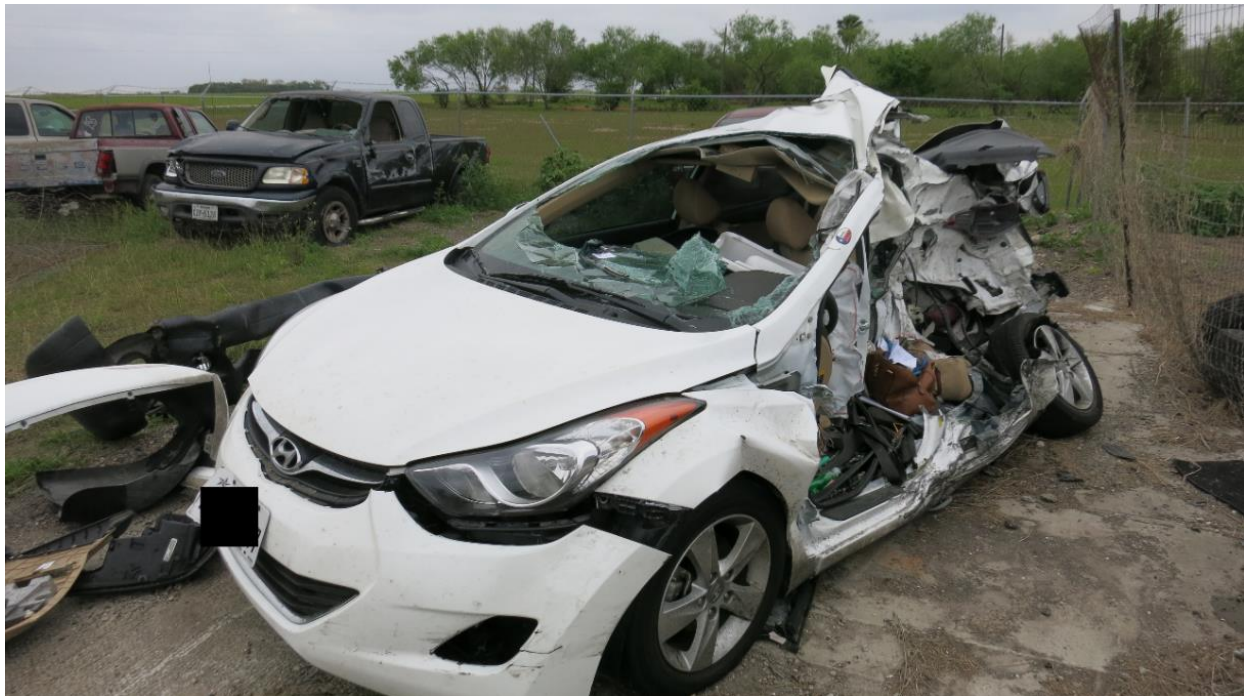
The Hyundai was inspected at a wreckage facility near the crash scene.<sup>10</sup> (See figure 2.) The point of impact with the Freightliner appeared to be behind the driver's-side B-pillar, with the truck frame intruding 36 inches inward to the middle-rear seating position of the Hyundai.<sup>11</sup> The driver's-side airbag had deployed from the seat. The driver's front airbag did not deploy. The side curtain and rear curtain airbags on the driver's side did not deploy and had fallen out of their destroyed compartments.

The steering wheel was deformed, and the driver's seat was deformed and pushed inward toward the center of the vehicle. The rear passenger seat on the driver's side was pushed inward into the other rear seating position, which compromised the survivable space of the rear passengers. Although there appeared to be survivable space at the front passenger seating position, the seat was deformed and displayed contact marks from other passengers inside the vehicle. Based on the crash report, all four passengers were wearing their seat belts at the time of the crash.

**Figure 2.** Wreckage of the 2013 Hyundai Elantra.

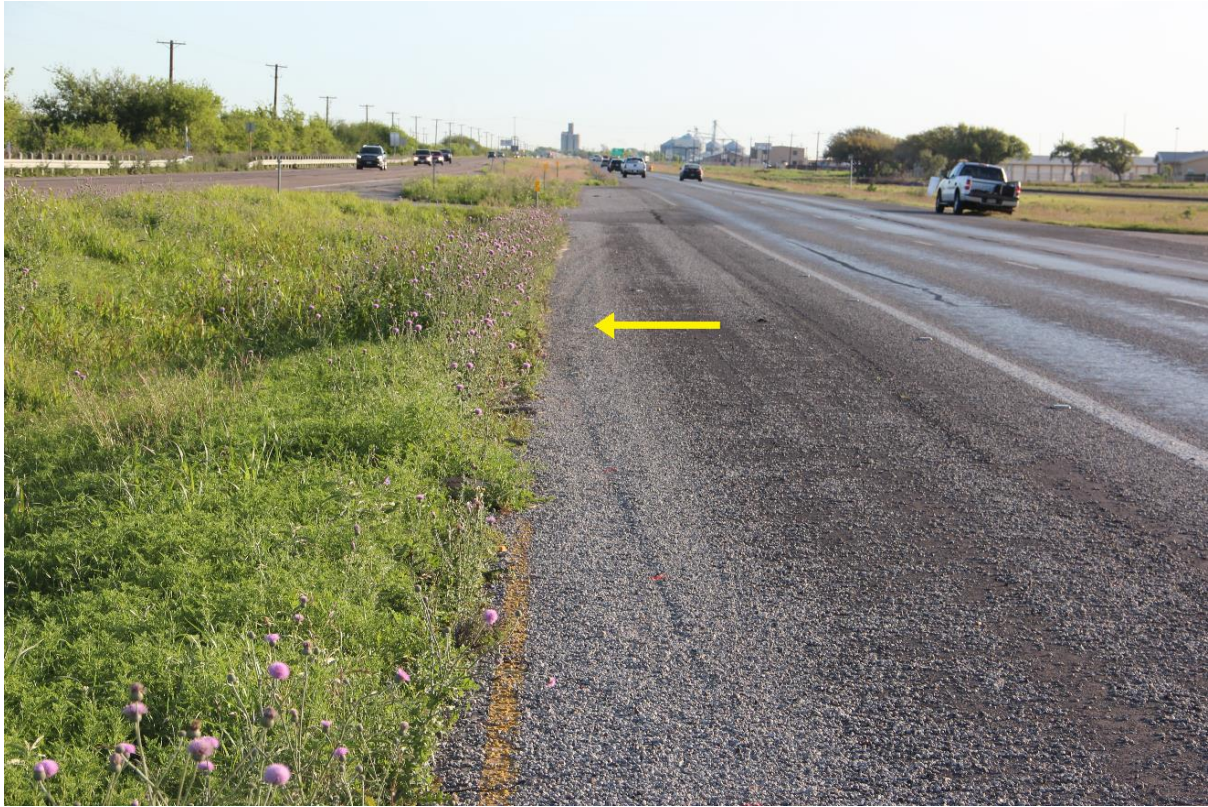
Tire friction marks at the scene showed that the Hyundai traveled into the left-turn lane for the crossover and departed into the median at about a 2° angle to the left.<sup>12</sup> (See figure 3.)

**Figure 3.** Northbound US-77. The arrow indicates the point at which the Hyundai initially drifted into the median. The vehicle drifted into the left-turn lane before reaching the median.

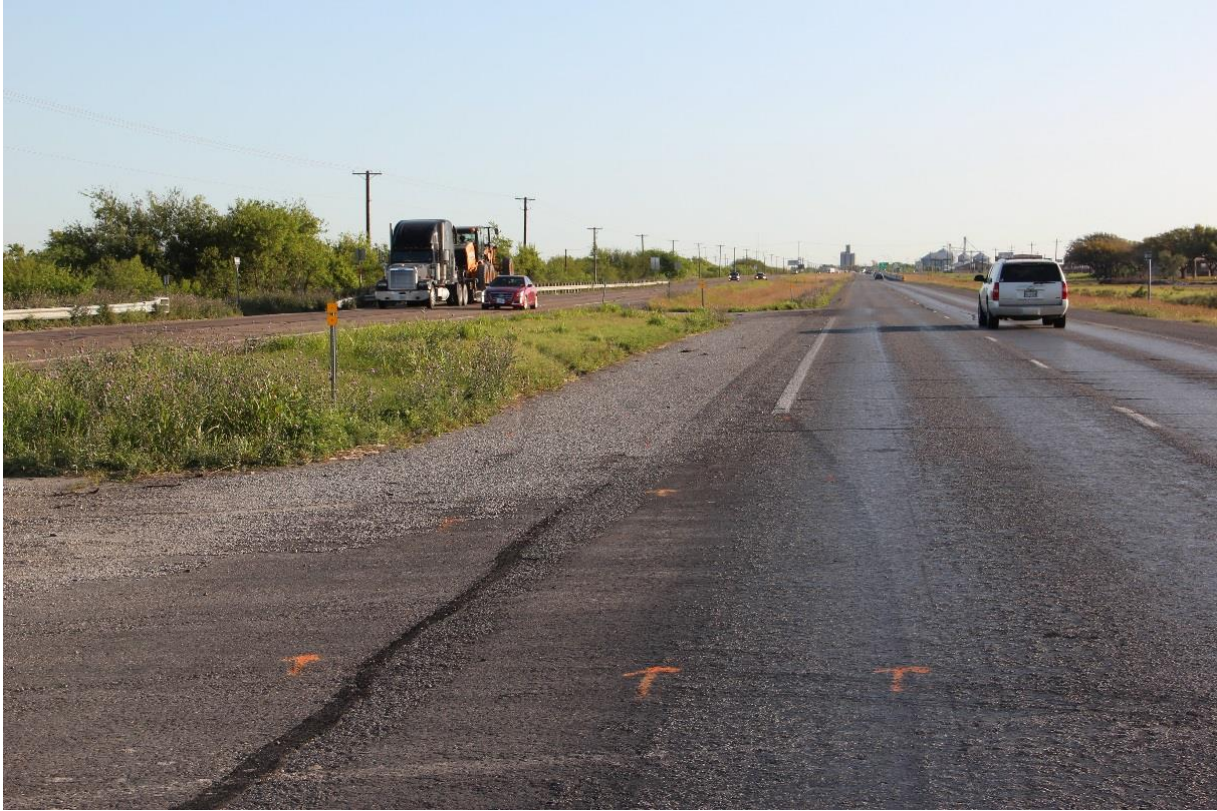
The tire marks showing the vehicle's path into and out of the median were about 207 feet long. There was a gap of about 36 feet, then the tire friction marks curved back to the left along a radius of about 168 feet. At first contact, the Freightliner struck the Hyundai on the driver's side in the vicinity of the B-pillar. The Hyundai was pushed backward about 117 feet before coming to final rest in the area of the median where it had initially crossed over. The Hyundai had traveled about 522 feet from where it initially departed the travel lane into the median where the impact with the Freightliner occurred. The Freightliner left preimpact tire friction marks, which were about 185 feet long, and traveled 144 feet after impact to where it came to a final rest in the southbound lanes. (See figure 4.)

**Figure 4.** Tire marks from the Hyundai as it was redirected toward the median. Furrows in the grass indicate travel through the median.
