National Transportation Safety Board

Highway Accident Brief

Intersection Collision Involving Motorcoach and Transit Bus, Flushing, New York, September 18, 2017

Accident Number:	HWY17MH015
Accident Type:	Intersection collision
Location:	Northern Boulevard (New York State Route 25A) and Main Street, Flushing, New York
Date and Time:	September 18, 2017, 6:16 a.m.
Vehicle 1:	2015 MCI motorcoach operated by Dahlia Group Inc.
Vehicle 2:	2015 New Flyer XD40 bus operated by New York City Transit Authority
Fatalities:	3
Injuries:	Multiple

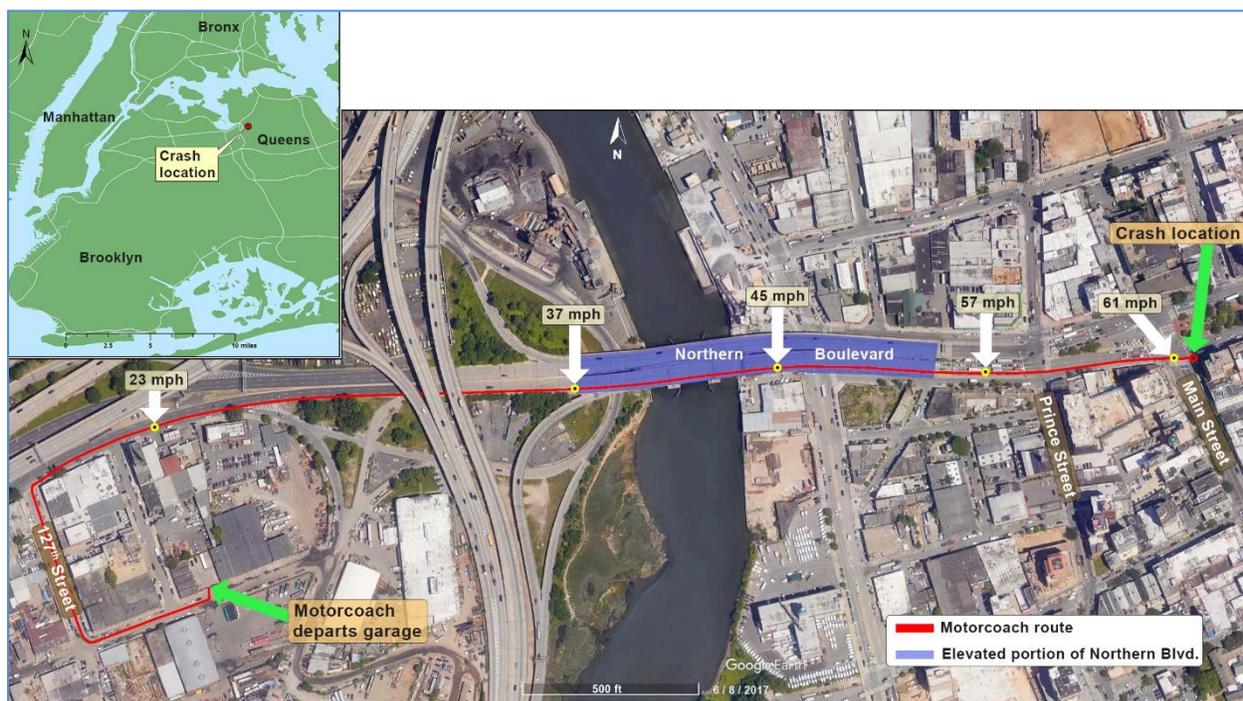
The motorcoach—occupied only by the driver—was traveling east on Northern Boulevard and failed to stop for a red traffic signal at the intersection with Main Street (figure 1). Meanwhile, the transit bus—occupied by the driver and 16 passengers—was executing a right turn on a green right-turn traffic signal from northbound Main Street onto eastbound Northern Boulevard. The motorcoach was traveling 60–61 mph when it struck the left rear side of the transit bus, causing the transit bus to rotate 120 degrees counterclockwise and then strike two cars parked along the right curb of Northern Boulevard.² One of the parked vehicles—a 2009 Honda—was unoccupied; the other—a 2002 Toyota—was occupied by a driver and a front passenger. The motorcoach then departed the south side of Northern Boulevard; crossed over the sidewalk; and struck a building

Figure 1. Path of motorcoach from beginning of trip to crash location, highlighting elevated portion of Northern Boulevard over Flushing River and motorcoach speeds increasing from 23 to 61 mph.

At 6:15:41 a.m.—3 seconds after the metal rattling sound—the driver utters a single-word remark and then the motorcoach increases its speed.⁶ At 6:15:49 a.m., the speed increases to 37 mph as the motorcoach passes a school bus and a car merging on the right from the Van Wyck Expressway ramp. The motorcoach maintains its position in lane 3 as the ramp transitions to becoming the fourth lane of Northern Boulevard. At 6:15:50 a.m., more audible metal rattling sounds are recorded from inside the cabin. At 6:15:54 a.m., at a speed of 40–42 mph, the motorcoach reaches the vertical crest of the bridge. Its speed continues to increase as it travels downhill. At 6:16:02 a.m., as the road grade levels, the motorcoach speed is recorded as 50 mph.

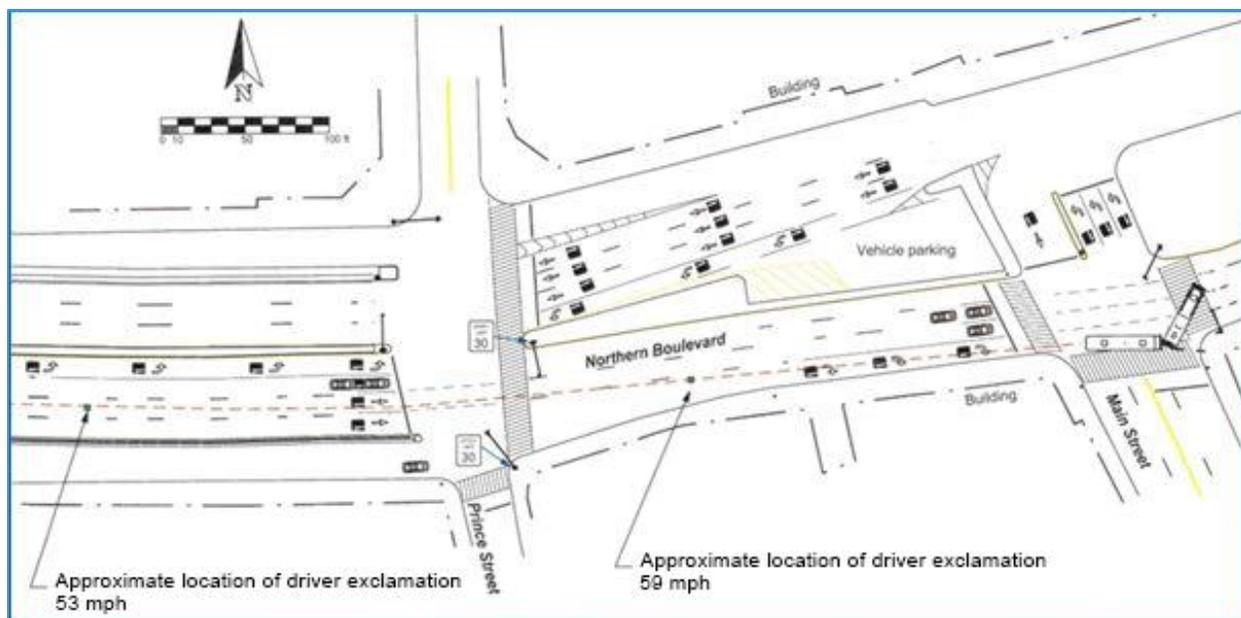
The Garmin video shows the traffic signal visible at the Prince Street intersection. At 6:16:03 a.m., a driver exclamation is recorded as the motorcoach is traveling 53 mph. The motorcoach continues travel in lane 3 and enters the Prince Street intersection at 57 mph through a red traffic signal; the signal turns green as the motorcoach is in the middle of the intersection (figure 2).

Figure 2. Depiction of motorcoach path of travel through Prince Street and Main Street intersections, with approximate location of driver exclamations noted.

At 6:16:06 a.m.—3 seconds after the first exclamation—the driver exclaims a second time as he approaches the Main Street intersection and moves to the right (from lane 3 to lane 4) in response to stopped vehicles in lanes 2 and 3. This steering maneuver is the only known action the driver takes after experiencing unintended vehicle acceleration. Vehicle data show no brake application. The motorcoach enters the Main Street intersection at 60 mph.

The Garmin video ends as the motorcoach enters the Main Street intersection, estimated to be about 0.6 second before the collision with the transit bus. As noted earlier, the transit bus had entered the intersection and was progressing through its right turn onto Northern Boulevard (figure 2). The video and onboard telematics system indicate a final vehicle speed of 60–61 mph. The motorcoach driver makes an unintelligible remark prior to the end of the video. Table 1 summarizes the motorcoach trip events.

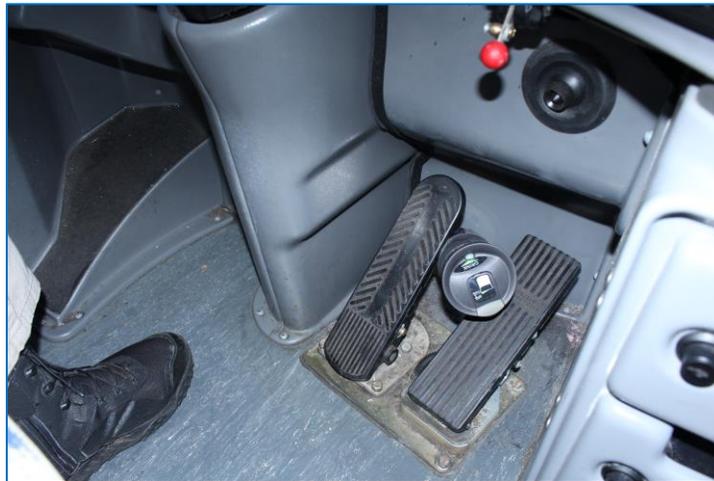
NTSB investigators considered the possibility that an object became lodged beneath or between both the brake and the accelerator pedals, resulting in uncontrolled acceleration and the inability to apply the brakes (figure 3). At the scene of the crash, investigators found a metal thermos near the control pedals. When interviewed, the driver's wife stated that he had taken his thermos for the trip. The thermos could potentially explain the metal rattling heard on the Garmin audio just before the driver's first remark.

Figure 3: Pedal obstruction test using exemplar motorcoach and metal thermos, showing one lodging position among several possible thermos and pedal combination scenarios.

Investigators examined the audio recording to determine if a dropped thermos could have created the sound, but the results were inconclusive. Metallurgists from the NTSB Office of Research and Engineering examined marks on the thermos to determine if they could have been caused by contact with the vehicle control pedals; no physical evidence was present to indicate this type of interference. Investigators also obtained a similar thermos and attempted to lodge it in the pedals of an exemplar motorcoach. They found that it was possible to position the thermos

beneath and between the pedal controls such that it prevented brake application while depressing the throttle.

The surveillance video that captured the motorcoach colliding with the bus does not show any brake lights from the motorcoach until it comes to rest.¹³ Likewise, the engine control module data provide no indication of a hard brake application. It is possible that an engine control module would not record a brake attempt if the pedal was obstructed, thus preventing the driver from fully depressing it. Results of exemplar brake testing indicate that only a small brake application is required to register on the brake application gauge (about 1 degree movement of the brake pedal to the floorboard). With less than 1 degree of pedal movement, the data might not indicate braking even if a driver attempted to apply the brakes. The NTSB concludes that though an obstructed brake pedal could not be discounted as a factor in the crash, it also could not be determined as causal to the crash.
