# National Transportation Safety Board

## Highway Accident Brief

### Intersection Collision and Rollover Involving School Bus and Pickup Truck, Helena, Montana, November 27, 2017

<b>Accident Number:</b>	HWY18FH002
<b>Accident Type:</b>	Intersection collision and rollover
<b>Location:</b>	Green Meadow Drive and John G. Mine Road, near Helena, Montana
<b>Date and Time:</b>	November 27, 2017, 7:13 a.m.
<b>Vehicle 1:</b>	2011 Chevrolet Express school bus operated by First Student, Inc.
<b>Vehicle 2:</b>	1998 Dodge Ram 1500 pickup truck
<b>Fatalities:</b>	0
<b>Injuries:</b>	6 (minor)

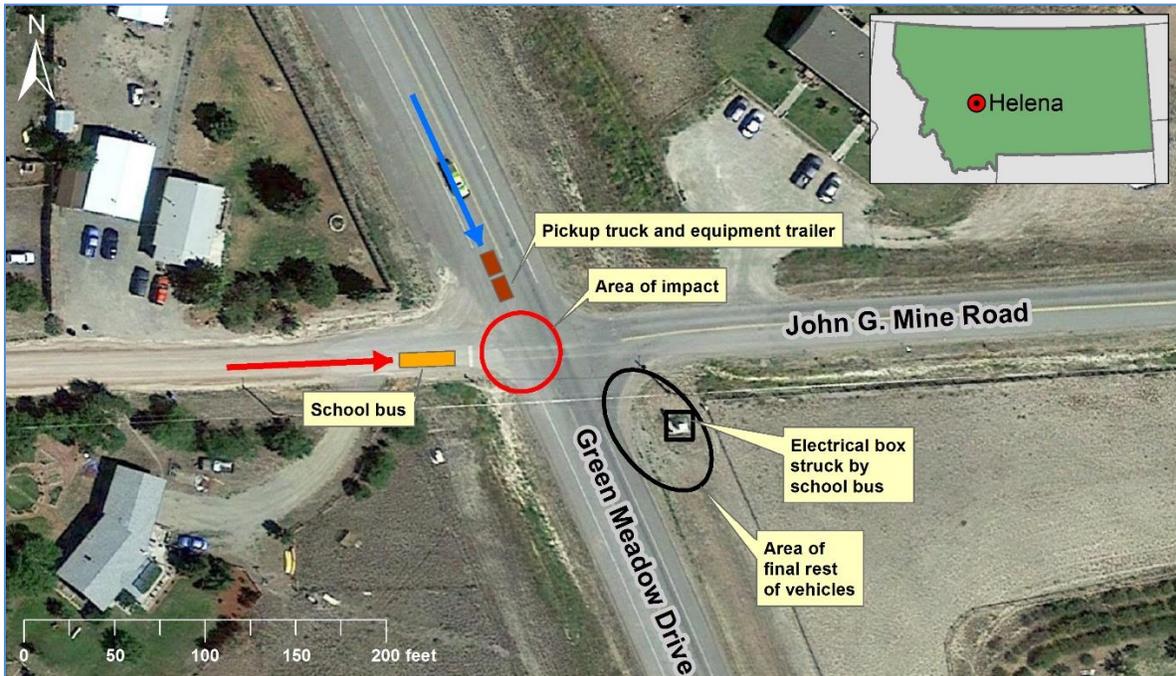
**Figure 1.** Intersection of John G. Mine Road and Green Meadow Drive, Helena, Montana.

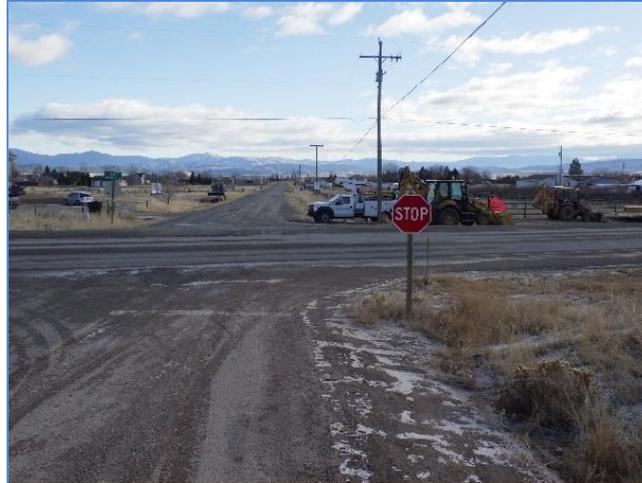
**Figure 2.** View from John G. Mine Road looking east on approach to intersection.

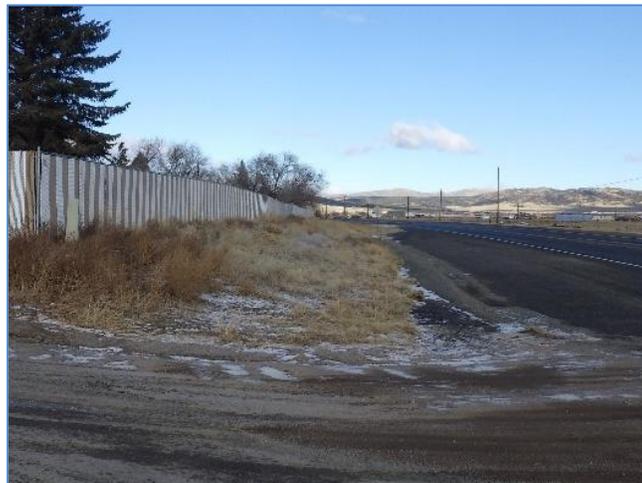
**Figure 3.** View from John G. Mine Road looking north onto Green Mountain Drive.

The Montana Highway Patrol (MHP) trooper who investigated the crash told National Transportation Safety Board (NTSB) investigators that tire marks were visible on Green Mountain Drive, indicating that the pickup truck driver had made some effort to avoid the collision by swerving to the left, but there was no substantial evidence of braking. The trooper stated that the roadway on the morning of the crash was damp from the morning dew, but it was not icy.

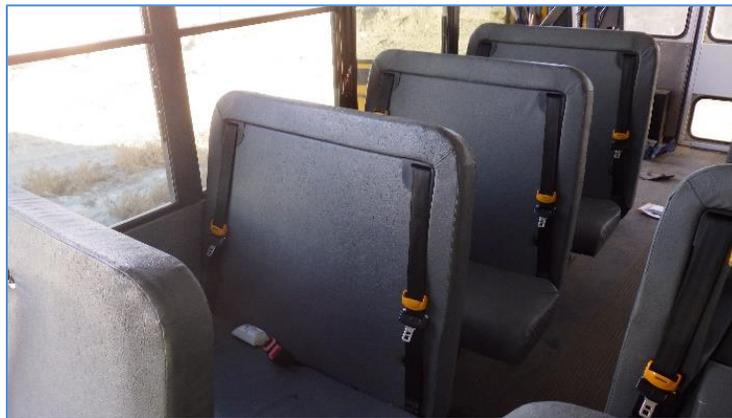
**Figure 4.** Right-side passenger seats equipped with lap/shoulder belts.

The occupied passenger seats were inspected postcrash, and the lap/shoulder belts were functional. Postcrash interviews with the bus driver and the adult aide indicated that the driver assisted the aide in releasing her seat belt buckle. Her lap/shoulder belt, as well as another lap/shoulder belt that was not in use during the crash, were removed from the bus for inspection and testing at the manufacturer's facility. NTSB investigators worked with IMMI in determining any anomalies or deficiencies with the aide's lap/shoulder belt and in comparing the buckle release characteristics with the noncrash buckle.

These inspections of the seat belt, including its latching mechanism, revealed no anomalies or performance issues. Test data were compared with the original manufacturing lot inspection data. The physical tests included release force testing with the buckles both static and under load, according to the requirements of Federal Motor Vehicle Safety Standard (FMVSS) 209 contained in 49 CFR 571.209.<sup>5</sup> The results indicated that both buckles were within production specifications, exhibited similar release characteristics, and performed as designed.

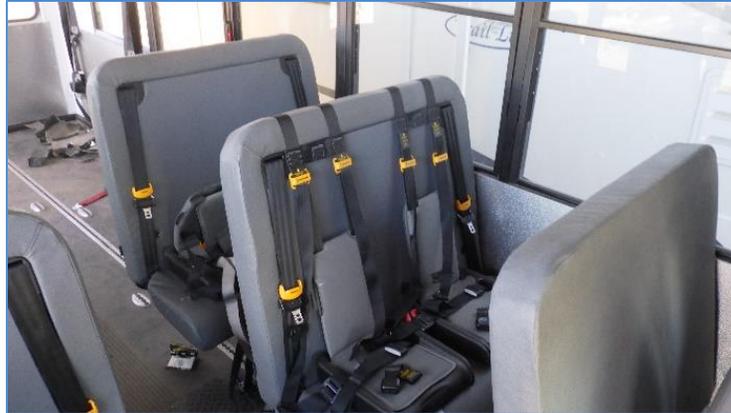
**Figure 5.** Left-side passenger seats equipped with lap/shoulder belts and STAR system.

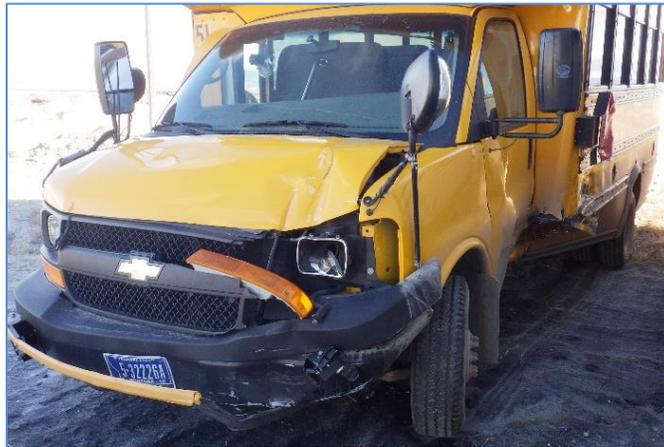
- ***Along the left side of the bus:*** contact damage from colliding with the pickup truck. This damage was most severe along the lower portion of the bus body, between the driver door and the front portion of the passenger compartment.
- ***At the left front of the bus:*** damage due to striking the electrical box. The left front bumper was displaced upward and to the rear. The left side of the hood was crushed rearward and buckled at the middle.

**Figure 6.** Left-front and partial side view of school bus postcrash.

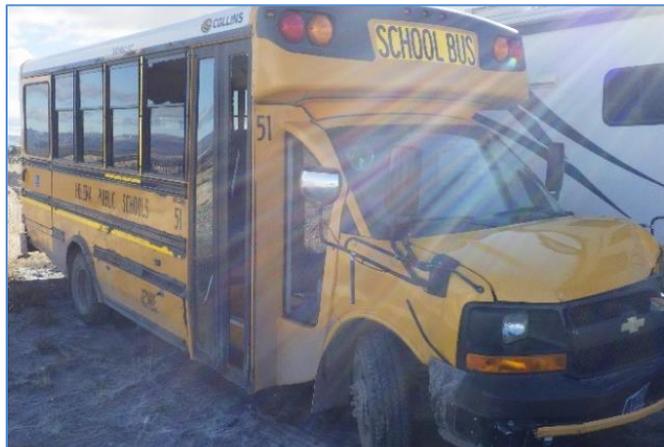
- *Along the right side of the bus:* damage from contact with the ground due to the rollover.
- *Other damage:* scratches to the bus body, and broken forward pane of the loading door glass and upper pane of the first passenger window.

**Figure 7.** Right-front and side view of school bus postcrash.

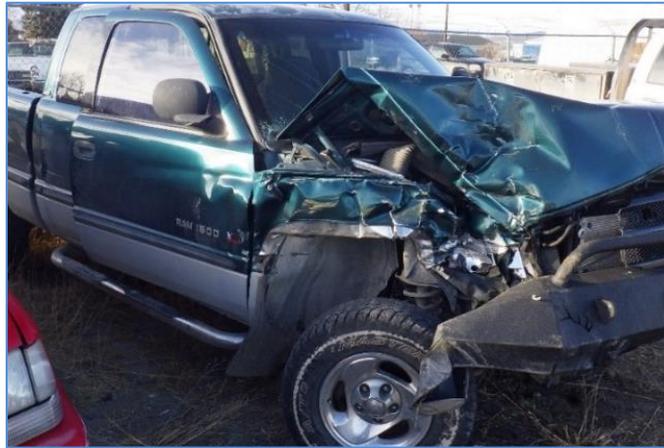
The 1998 Dodge Ram 1500 is an extended cab pickup truck. At the time of the crash, it was towing a 2005 MNDE model flatbed utility trailer. The pickup truck sustained impact damage to the right-front corner, as shown in figure 8.

**Figure 8.** Right-front view of pickup truck postcrash.
