# National Transportation Safety Board

## Highway Accident Brief

### Motorcycle and Pickup Truck Crash During “Toy Run” Group Ride, Augusta, Maine, September 10, 2017

<b>Accident Number:</b>	HWY17FH014
<b>Accident Type:</b>	Pickup truck collision with multiple motorcycles
<b>Location:</b>	Interstate 95 northbound, between exits 112B and 113, Augusta, Kennebec County, Maine
<b>Date and Time:</b>	Sunday, September 10, 2017, about noon, eastern daylight time
<b>Vehicle 1:</b>	2007 Harley-Davidson XL 1200 motorcycle
<b>Vehicle 2:</b>	2008 Ford F250 pickup truck
<b>Vehicle 3:</b>	2008 Harley-Davidson Dyna Low Rider motorcycle
<b>Vehicle 4:</b>	2003 Harley-Davidson Road King Classic motorcycle
<b>Vehicle 5:</b>	1992 Harley-Davidson XL 1200 motorcycle
<b>Vehicle 6:</b>	2003 Harley-Davidson Softail motorcycle
<b>Fatalities:</b>	2
<b>Injuries:</b>	7

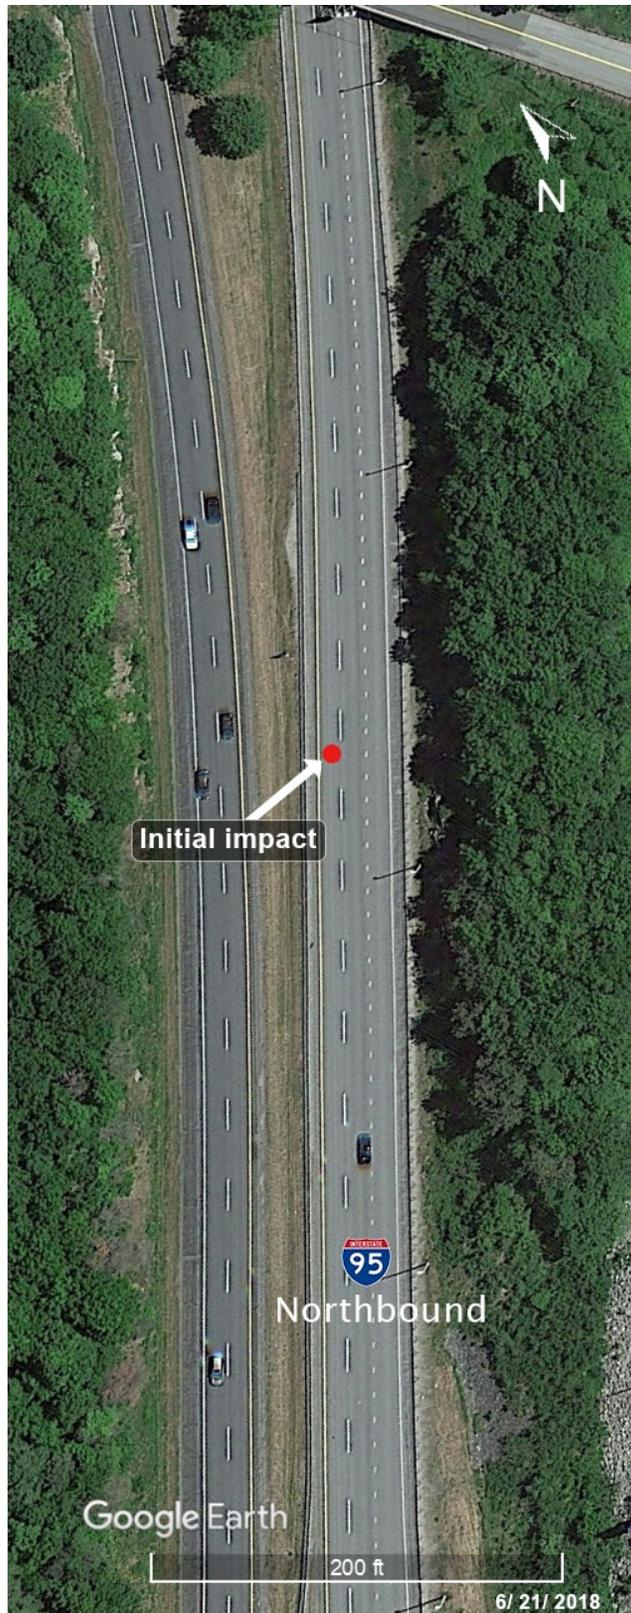
**Figure 2.** Overhead view of the crash site, showing the three northbound lanes of I-95 on the right. (Source: Google Earth modified)

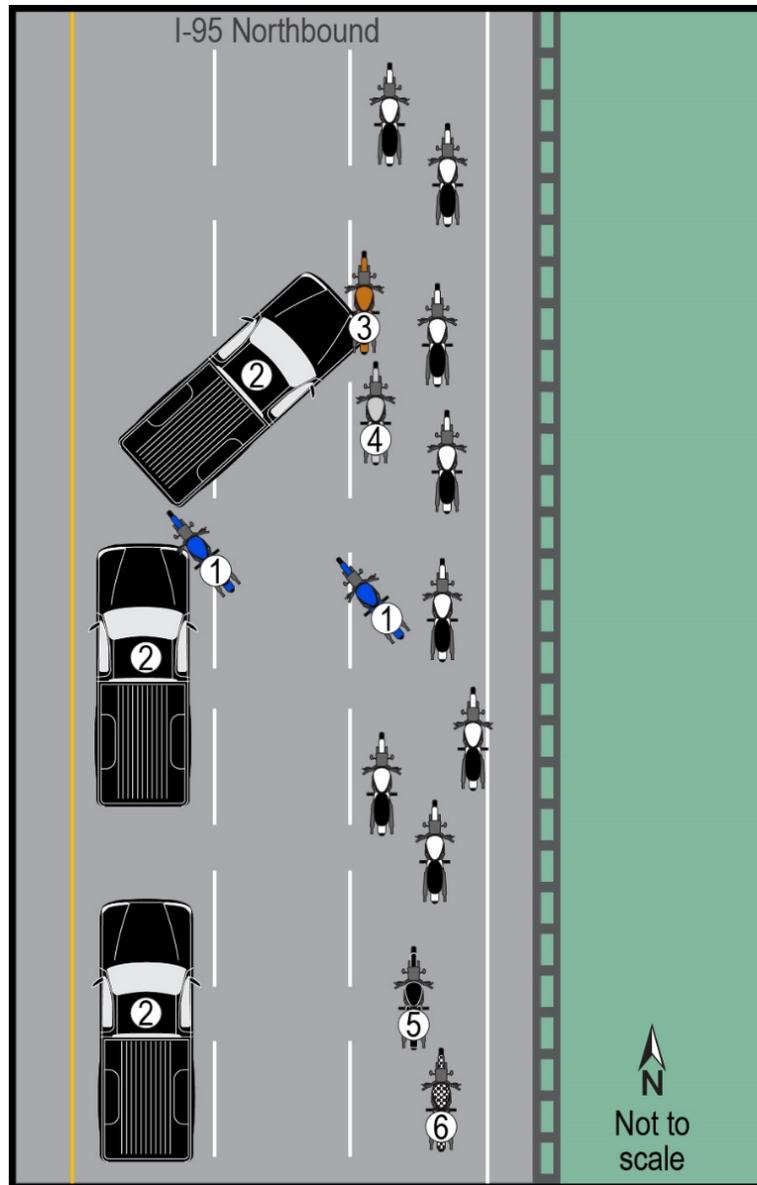
About 12:05 p.m., a 2007 Harley-Davidson XL 1200 motorcycle (vehicle 1), which was participating in the group ride, suddenly moved out of the right lane, traveled across the center lane, and entered the left lane in front of a 2008 Ford F250 pickup truck (vehicle 2), occupied by a 67-year-old male driver and a 99-year-old female passenger, which was traveling north on I-95. The motorcycle was carrying a 25-year-old male operator and a 26-year-old female passenger. Based on skid mark evidence, the pickup truck driver attempted an evasive maneuver but collided with the motorcycle at about mile marker 112.5, losing control of his vehicle, in part because the pickup truck had “collected” the Harley-Davidson XL 1200 motorcycle, causing the pickup truck to rotate clockwise. The pickup truck veered out of the left lane to the right and traveled across the center and right northbound lanes, striking four other motorcycles. (See figures 2 and 3 for an overhead view of the crash site and a diagram showing the initial stages of the crash.)

**Figure 3.** Initial stages of the crash sequence, with vehicle 1 (2007 Harley-Davidson XL 1200 motorcycle) moving westward on northbound I-95 across two lanes and into the path of vehicle 2 (2008 Ford F250 pickup truck). After these two vehicles collided, the pickup truck veered across the center lane into the right lane and struck vehicle 3 (2008 Harley-Davidson Dyna Low Rider motorcycle). Three other motorcycles (vehicles 4–6) that were subsequently involved in the crash are also numbered. The exact positions of vehicles during the sequence could not be definitively determined, but this representation is consistent with witness recollections. (Adapted from Maine State Police diagram. For additional information, see the Collision Reconstruction Report and Photos 1–8 in the [NTSB public docket](#) for accident HWY17FH014.)

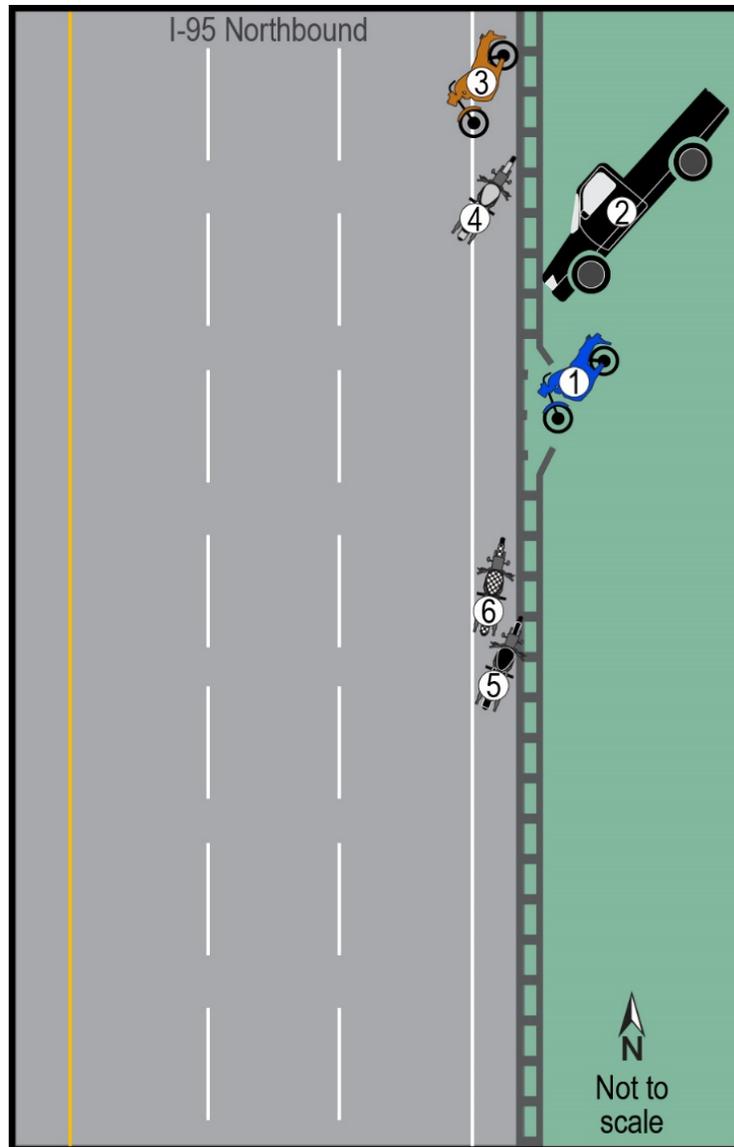
The pickup truck then went through the right guardrail, overturned, and came to rest on its passenger side. The 2007 Harley-Davidson motorcycle traveled through the guardrail and came to rest on its right side in a ditch beside the pickup truck. (See figure 4 for the final rest positions of the six vehicles involved in the crash.)

**Figure 4.** Final rest positions of crash-involved vehicles. (Adapted from Maine State Police diagram. For additional information, see the Collision Reconstruction Report and Photos 1–8 in the [NTSB public docket](#) for accident HWY17FH014.)
