# National Transportation Safety Board

## Highway Accident Brief

### Motorcoach Roadway Departure and Crash Into Ravine Near Loxley, Alabama, March 13, 2018

<b>Accident Number:</b>	HWY18MH008
<b>Accident Type:</b>	Motorcoach roadway departure and crash into ravine
<b>Location:</b>	Westbound on Interstate 10 in Baldwin County near Loxley, Alabama
<b>Date and Time:</b>	March 13, 2018, 5:28 a.m., central daylight time
<b>Vehicle:</b>	2018 Prevost 56-passenger motorcoach
<b>Motor Carrier:</b>	First Class Tours & Charters of Houston, Texas
<b>Fatalities:</b>	1
<b>Injuries:</b>	46

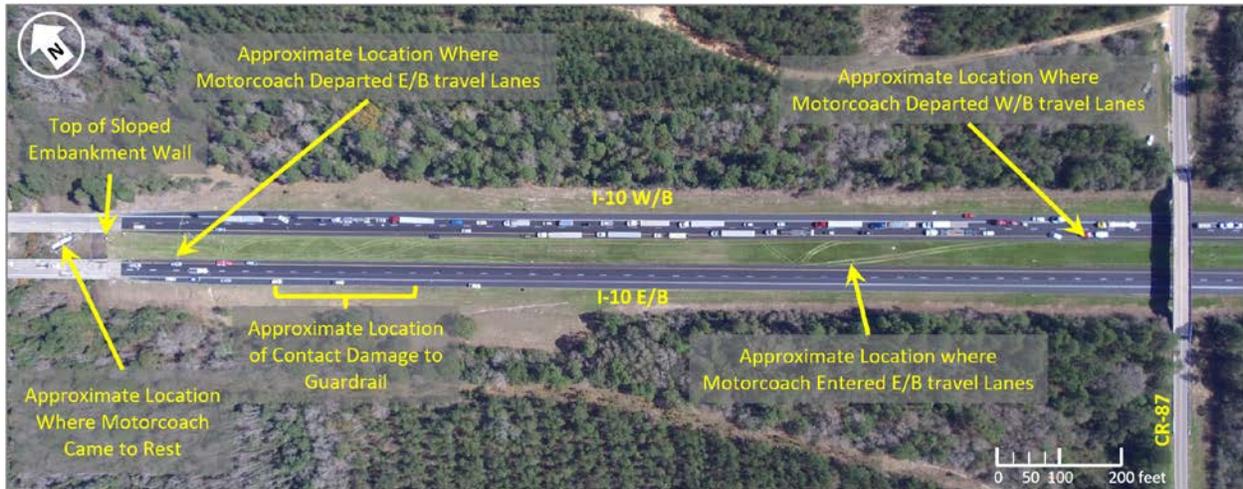
After traveling for more than a quarter-mile (1,561 feet) off its intended course, the motorcoach—now traveling roughly westbound in the median—drove off the roadway and fell into the Cowpen Creek ravine, which was spanned by two separate bridges for the eastbound and westbound I-10 roadways. At the bottom of the ravine, the motorcoach came to rest on its passenger side with its roof wedged against a vertical bridge support. (See figure 2, which identifies various points along the motorcoach’s crash path.)

**Figure 2.** Aerial view of crash area. (Source: Baldwin County Sheriff's Office, annotated)

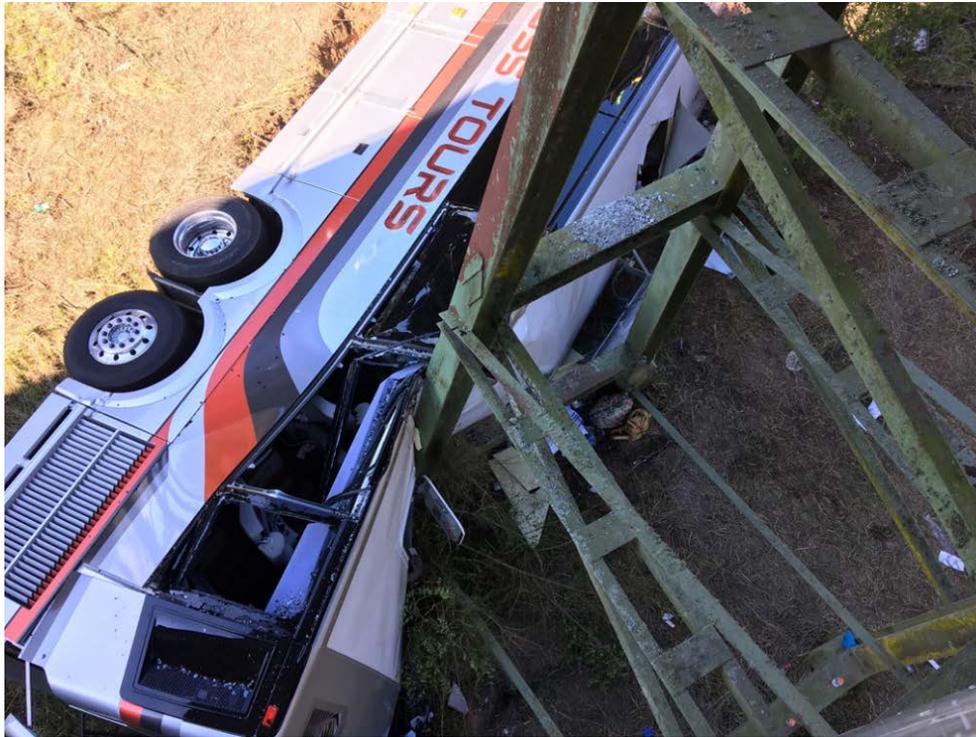
The motorcoach came to rest 105 feet below the top of the sloped concrete retaining wall in a 38-foot-deep ravine, against a structural bridge support. The motorcoach sustained extensive damage from the impact with the ground and the collision with the bridge support. (See figure 3.)

**Figure 3.** Rear of the motorcoach at the bottom of Cowpen Creek ravine, with its roof crushed against a bridge support structure.

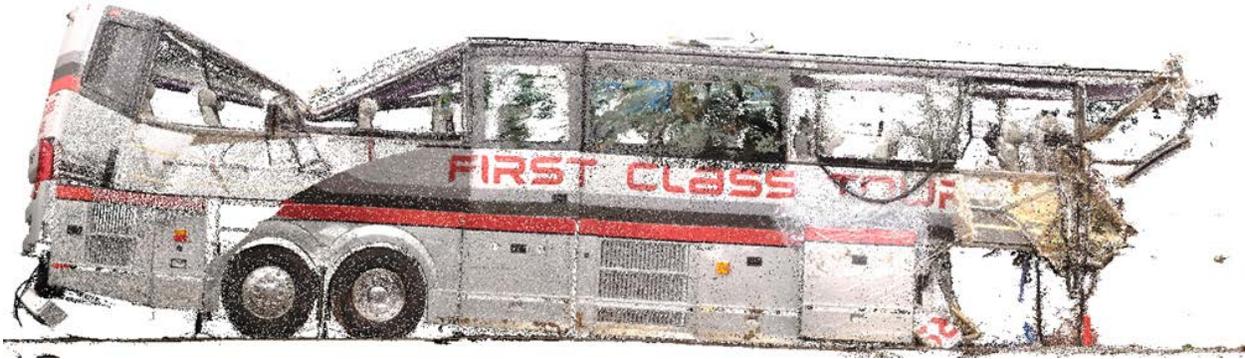
The aft segment comprised the remainder of the motorcoach. The passenger compartment seating area and the floor were generally intact, although the floor deck exhibited deformation, particularly above the forward cargo bay. The roof near the rear of the motorcoach was displaced downward, with intrusion of about 20 inches into the occupant compartment. Intrusion of the roof was greatest on the passenger side of the vehicle. (See figure 4.)

**Figure 4.** Cross-section image of the 3D point cloud scan of the aft section of the motorcoach as viewed from the passenger side.
