National Transportation Safety Board

Highway Accident Brief

Rear-End Collision Between a Car Operating with Advanced Driver Assistance Systems and a Stationary Fire Truck, Culver City, California, January 22, 2018

Accident Number:	HWY18FH004
Accident Type:	Rear-end collision involving partially automated vehicle
Location:	Southbound Interstate 405, Culver City, Los Angeles County, California
Date and Time:	Monday, January 22, 2018, 8:40 a.m., Pacific standard time
Vehicle 1:	2014 Tesla Model S P85 car
Vehicle 2:	2006 Seagrave custom fire truck (pumper)
Fatalities:	0
Injuries:	0

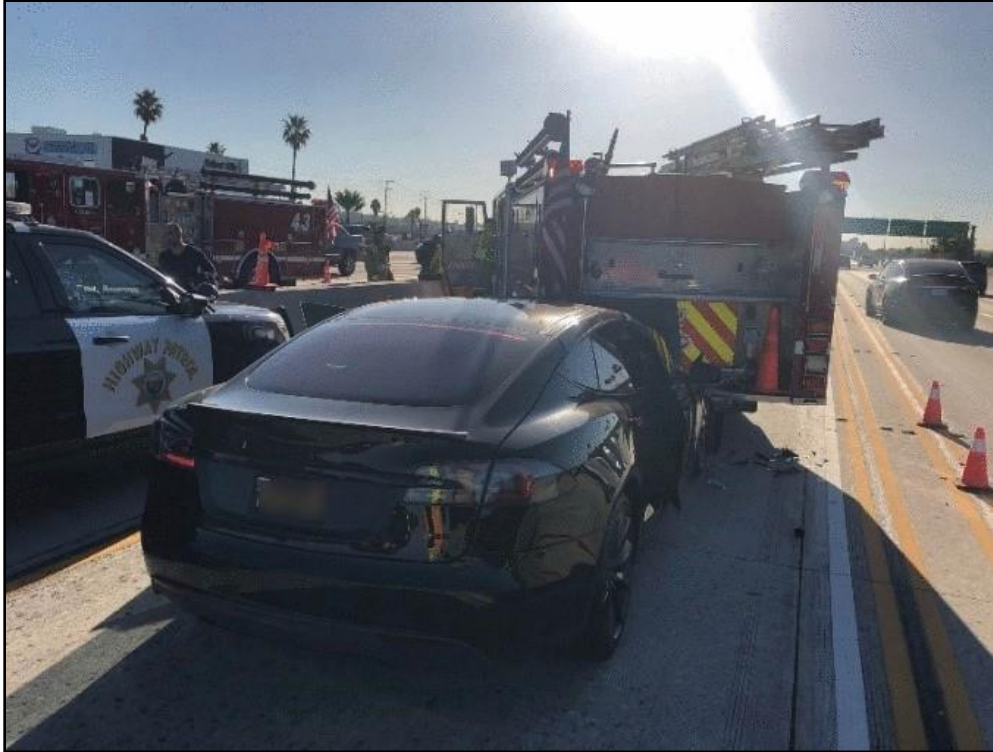
About 8:40 a.m. on Monday, January 22, 2018, a 2014 Tesla Model S P85 car was traveling in the high-occupancy vehicle (HOV) lane of southbound Interstate 405 (I-405) in Culver City, California. The Tesla was behind another vehicle. Because of a collision in the northbound freeway lanes that happened about 25 minutes earlier, a California Highway Patrol (CHP) vehicle was parked on the left shoulder of southbound I-405, and a Culver City Fire Department truck was parked diagonally across the southbound HOV lane. The emergency lights were active on both the CHP vehicle and the fire truck. When the vehicle ahead of the Tesla changed lanes to the right to go around the fire truck, the Tesla remained in the HOV lane, accelerated, and struck the rear of the fire truck at a recorded speed of about 31 mph (figure 1).

Figure 1. View of crash scene showing striking vehicle in HOV lane behind fire truck, southbound I-405, Culver City, California. (Source: CHP)

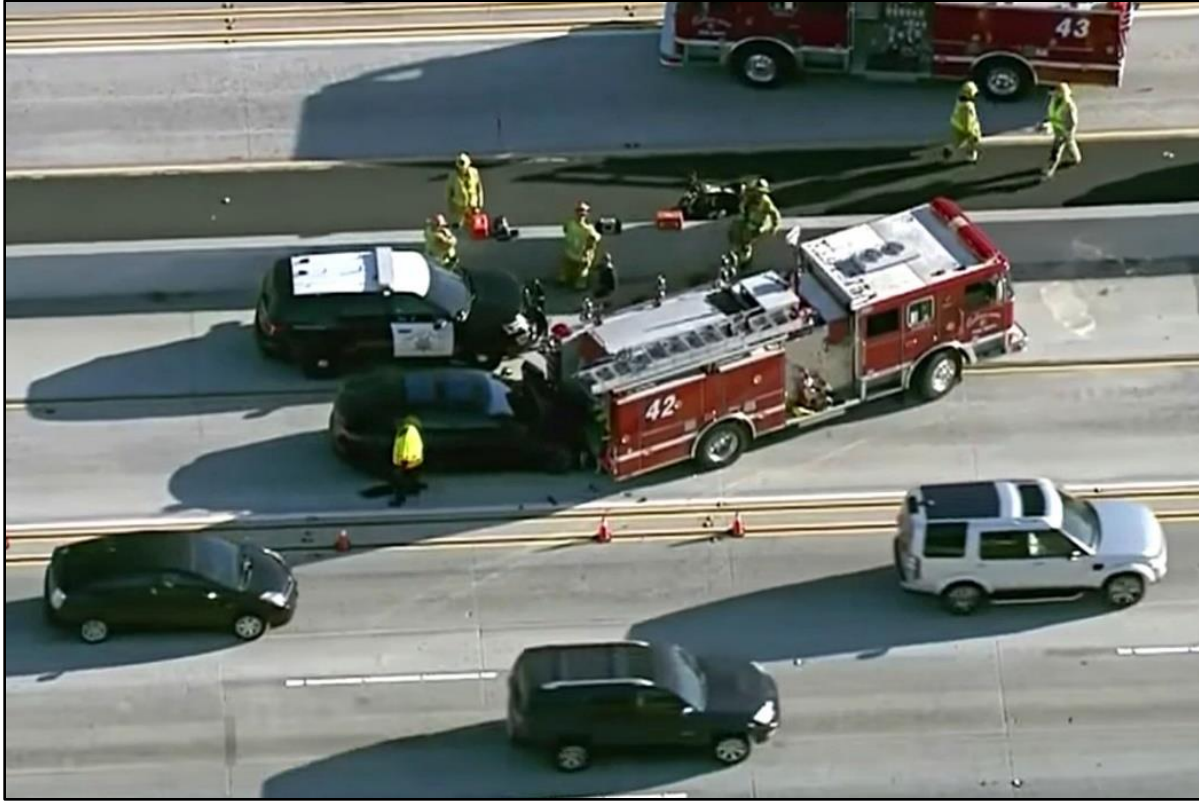
The crash occurred in the southbound HOV lane of I-405, about 350 feet north of Washington Boulevard in Culver City (figure 2). A concrete barrier divides the northbound and southbound lanes.

Figure 2. Overhead view of crash scene showing Tesla and fire truck at final rest on southbound I-405. (Source: CHP)

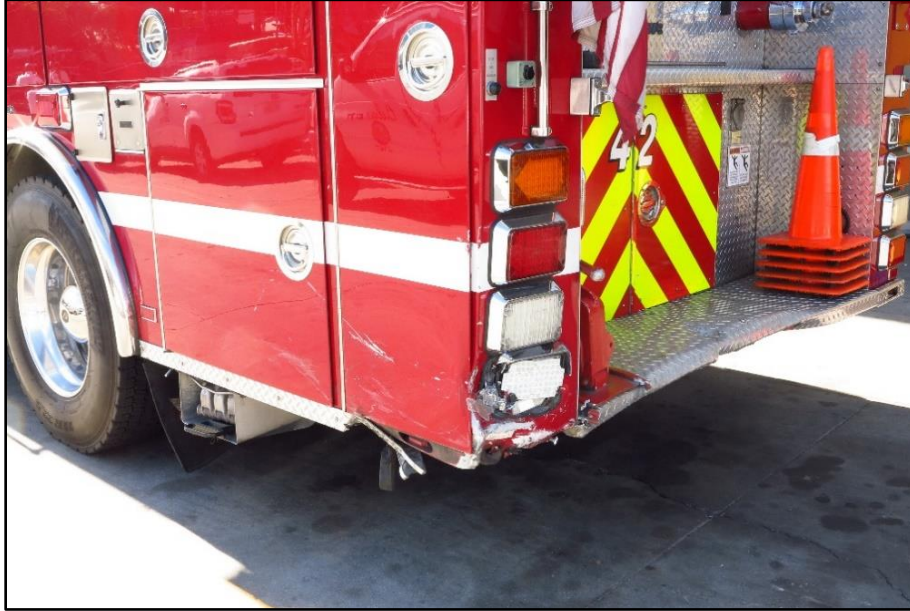
The fire truck sustained damage to the rear deck and the left rear corner (figure 4). The lower part of the left rear corner had crush damage. Gouges, scrapes, and black transfer marks originating at the left rear corner extended forward about 40 inches along the two equipment

compartment doors on that side. The lower part of the compartment door and the left part of the rear deck sustained impact damage. The lens of the lowest red emergency light on the left rear was crushed, but the light was functional.⁵ The left side of the rear deck was distorted upward, which prevented the rear compartment doors from opening.

Figure 4. Crash damage to rear deck and left rear corner of fire truck.
