National Transportation Safety Board

Highway Accident Brief

Single-Vehicle Run-Off-Road Crash and Fire Fort Lauderdale, Florida, May 8, 2018

Accident Number:	HWY18FH013
Accident Type:	Single-vehicle run-off-road crash and postcrash fire
Location:	1300 block of Seabreeze Boulevard, Fort Lauderdale, Broward County, Florida
Date and Time:	May 8, 2018, 6:46 p.m. eastern daylight time
Vehicle:	2014 Tesla Model S P85D
Driver:	18-year-old male
Passengers:	18-year-old males (2)
Fatalities:	2
Injuries:	1

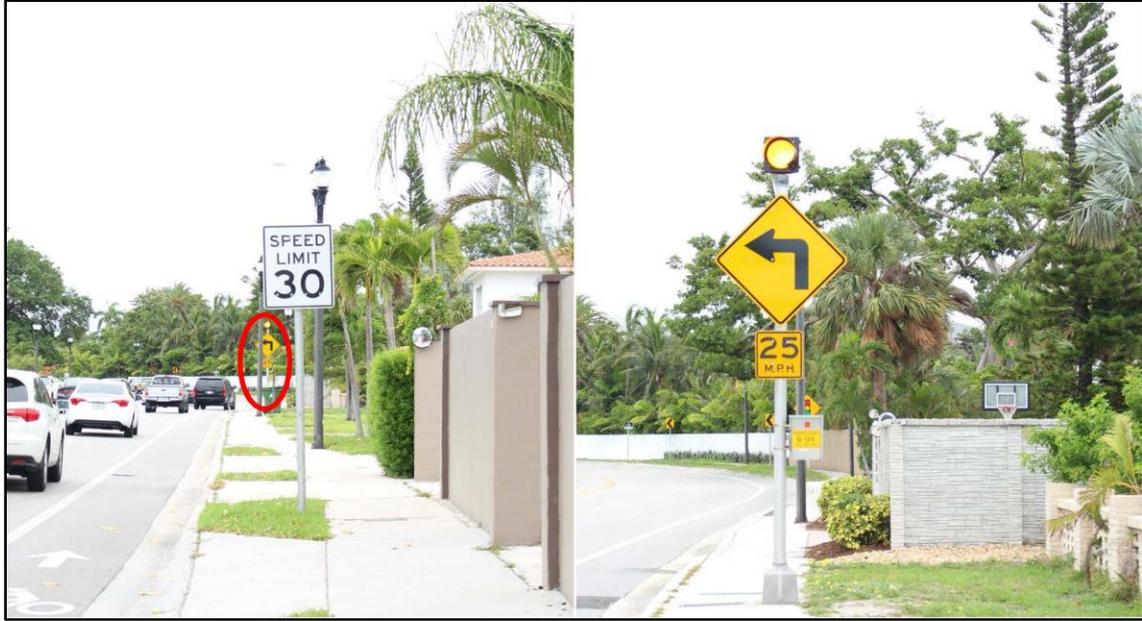
Figure 2. (Left) southbound Seabreeze Boulevard with speed limit sign and turn-warning sign (circled in red); and (right) closeup of approach to curve with turn-warning sign, flashing beacon, and advisory speed sign.

A speed limit sign facing southbound traffic was posted 474 feet north of the curve where the crash occurred. A turn-warning (W1-1) sign and a 25-mph advisory speed plaque (W13-1P) were posted facing southbound traffic 171 feet before the start of the curve.⁴ An amber flashing warning beacon was posted above the turn-warning sign. The beacon was functioning at the time of the National Transportation Safety Board (NTSB) on-scene investigation.

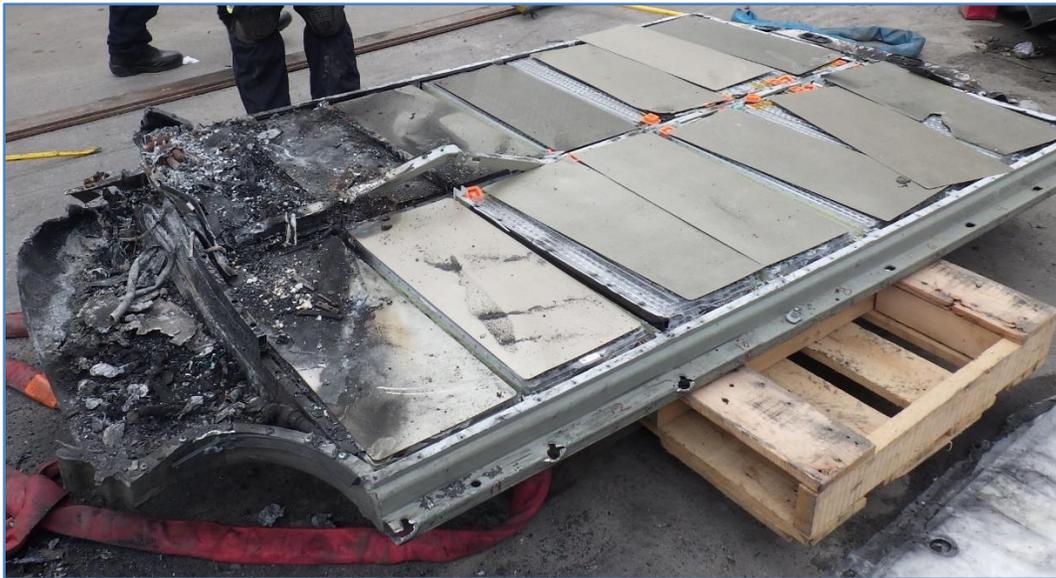
The vehicle's 400-VDC, 85-kWh lithium-ion traction battery was located under the floor of the car and spanned an area from the front tires rearward. The battery was divided into 16 modules (numbered from rear to front), plus a compartment for the battery management system. Each module contained individual battery cells stacked vertically. Figure 3 shows the fire-damaged battery. Modules 15 and 16, at the front of the car, were the most severely burned.

Figure 3. Photo of battery showing fire-damaged region at front that contained modules 15 and 16, loose individual cells (rust-colored), vertically stacked cells below loosened covers, and orange insulation caps covering high-voltage terminals.

The 400-VDC, 85-kWh lithium-ion battery sustained damage. It was slightly twisted, with the right front corner raised. That corner was crushed on about a 45-degree diagonal and raised above the rest of the battery. The steel top of the battery case was pushed back and exhibited corrosion typical of severe heat exposure. The contents of battery modules 15 and 16 were found separated from the battery, and the module 15/16 portion of the battery case was empty. Loose battery cells were found in the passenger compartment and outside the vehicle. Holes were found in the steel top of the battery case, matching holes in the bottom of the passenger-side floorboard. The holes were caused by electrical arcing at high-voltage terminals and individual cells exploding, as a result of crash damage to the battery case and the battery fire.

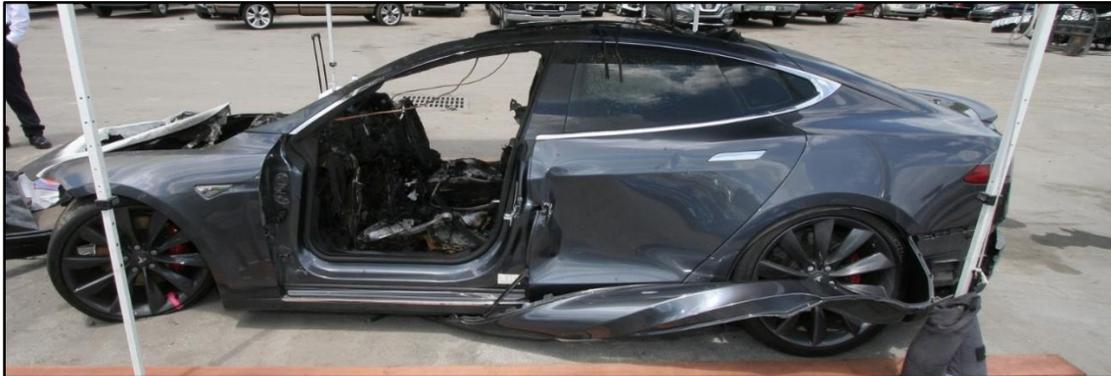
The left (driver) side of the car exhibited minor-to-moderate crash damage along its length. Thermal damage was minimal and limited to the left front fender, forward of the wheel (figure 4).

Figure 4. Left side of car showing minor-to-moderate crash damage and limited fire damage.

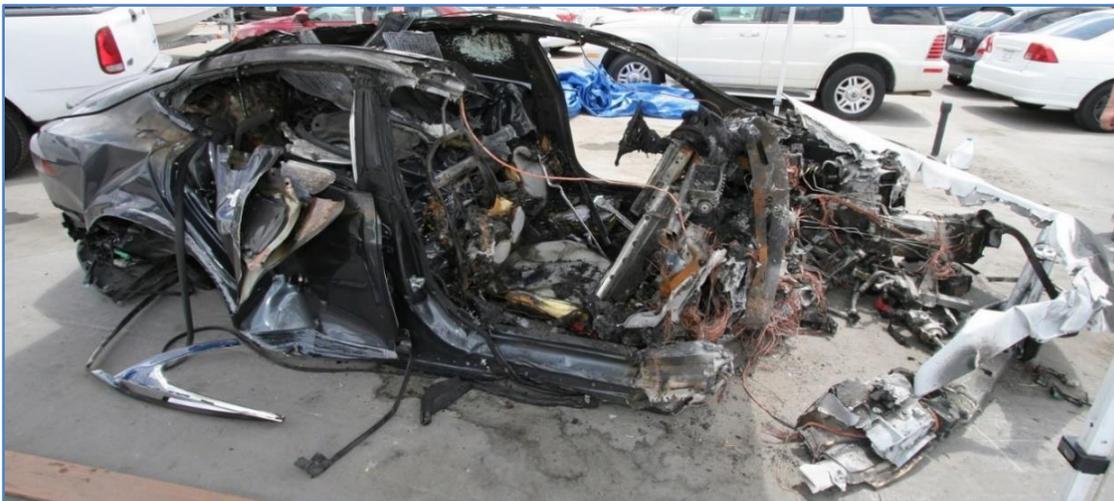
On the right (passenger) side, impact damage extended from the rear wheel all the way forward (figure 5). All window glass on the right side was broken out. The entire aft half of the right rear door was deformed forward. The right front corner of the car had significant missing parts, including the A-pillar, upper body frame, and entire front body. The right front door had separated from the body and exhibited severe thermal damage and a large vertical deformation pattern whose dimensions were similar to the light pole the car struck. Both right wheels were separated from the body; neither exhibited fire damage.

Figure 5. Right side of car, showing severe crash and fire damage.

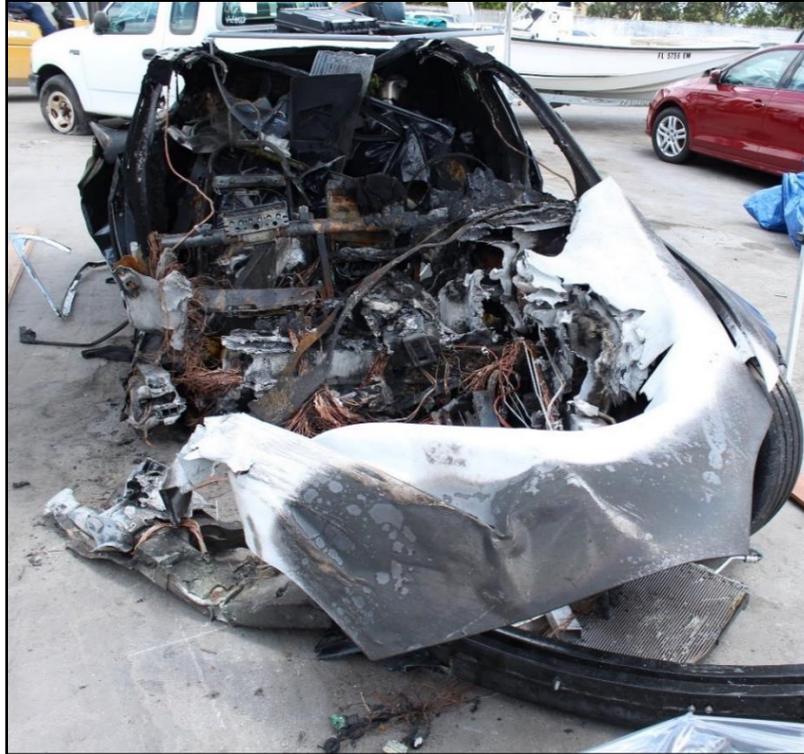
The car's interior was severely fire-damaged. The front dashboard area was consumed by fire. The front seats were heavily fire-damaged, and large portions of the cushions were burned away. The rear seating compartment had severe thermal damage, but the seat cushions were mostly intact. Figure 6 shows fire damage to the vehicle interior and crash damage to the front.

Figure 6. Front of car, showing severe crash damage and significant interior fire damage.
