National Transportation Safety Board

Highway Accident Brief

Collision Between Car Operating with Partial Driving Automation and Truck-Tractor Semitrailer Delray Beach, Florida, March 1, 2019

Accident Number:	HWY19FH008
Accident Type:	Intersection collision involving partially automated vehicle
Location:	Southbound US Highway 441, Delray Beach, Palm Beach County, Florida
Date and Time:	Friday, March 1, 2019, 6:17 a.m. eastern standard time
Vehicle 1:	2018 Tesla Model 3
Vehicle 2:	2019 International truck-tractor in combination with 2008 Vanguard semitrailer
Fatalities:	1
Injuries:	0

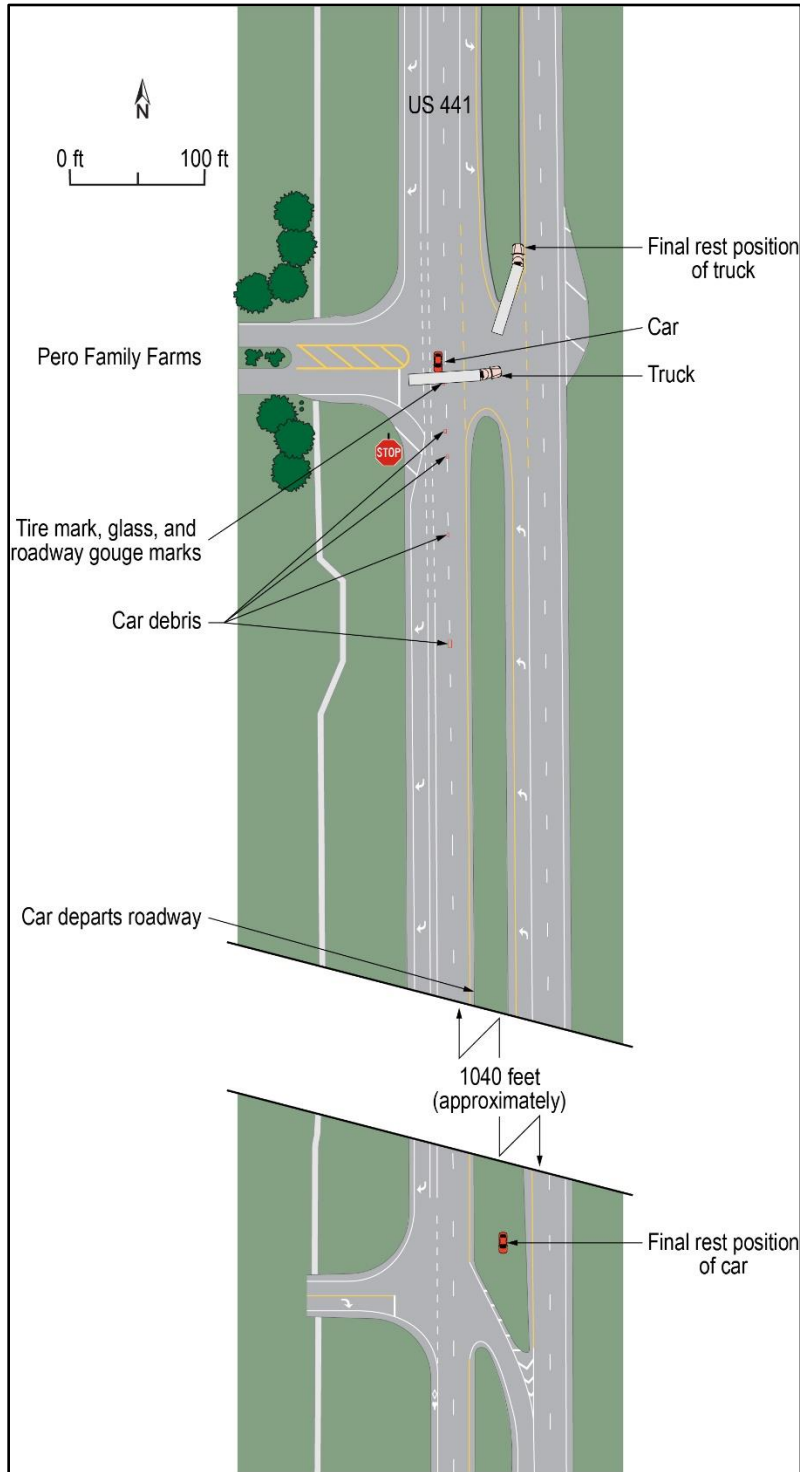
The car hit the left side of the semitrailer just aft of the trailer's midpoint. The roof of the car was sheared off as the vehicle underrode the semitrailer and continued south. Postcrash, the car coasted to a stop in the median between the southbound and northbound lanes, about 1,680 feet from where it struck the semitrailer (figure 1). The 50-year-old male car driver died as a result of the crash. The 45-year-old male truck driver was uninjured.

Figure 1. Diagram showing positions of car and truck at impact and final rest.

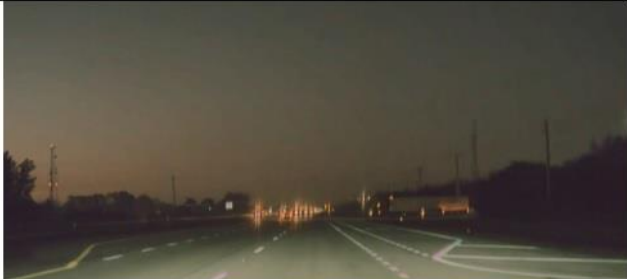
<p>Time to Collision = 5 seconds Distance to Impact = 506 feet</p> <p>Tractor-trailer combination vehicle visible and exiting a private driveway from an agricultural facility.</p>

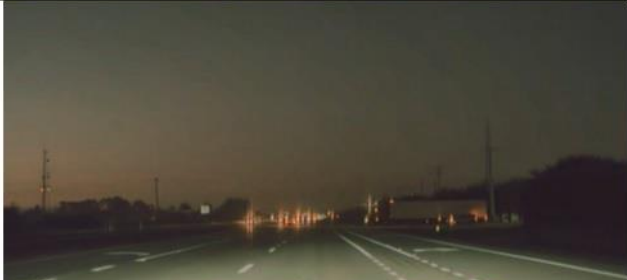
<p>Time to Collision = 4 seconds Distance to Impact = 405 feet</p> <p>Tractor-trailer combination vehicle begins to cross right turn lane of US 441 ahead of Tesla.</p>

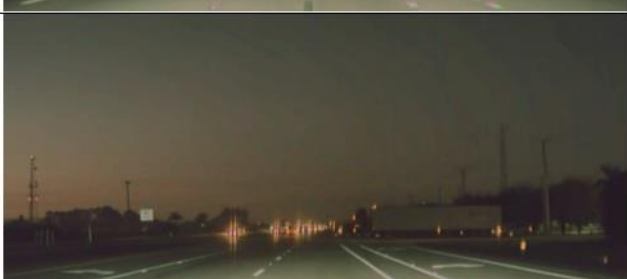
<p>Time to Collision = 3 seconds Distance to Impact = 304 feet</p> <p>Tractor-trailer combination vehicle begins to encroach into lane of travel occupied by Tesla.</p>

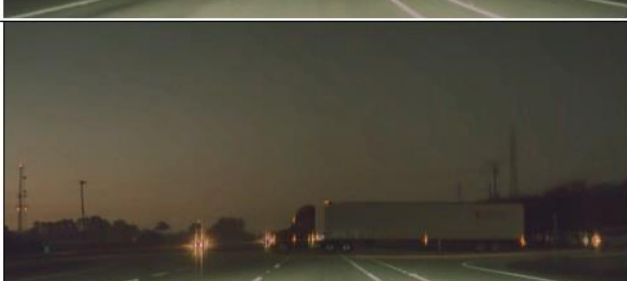
<p>Time to Collision = 2 seconds Distance to Impact = 202 feet</p> <p>Tractor-trailer combination vehicle blocking Tesla's path and entering "fast lane" to left of Tesla's lane of travel.</p>

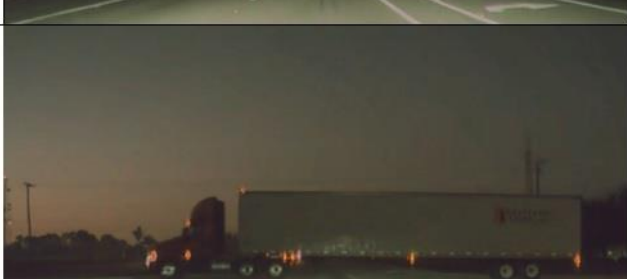
<p>Time to Collision = 1 second Distance to Impact = 101 feet</p> <p>Tractor-trailer combination vehicle still in motion and completely blocking all US 441 southbound lanes.</p>

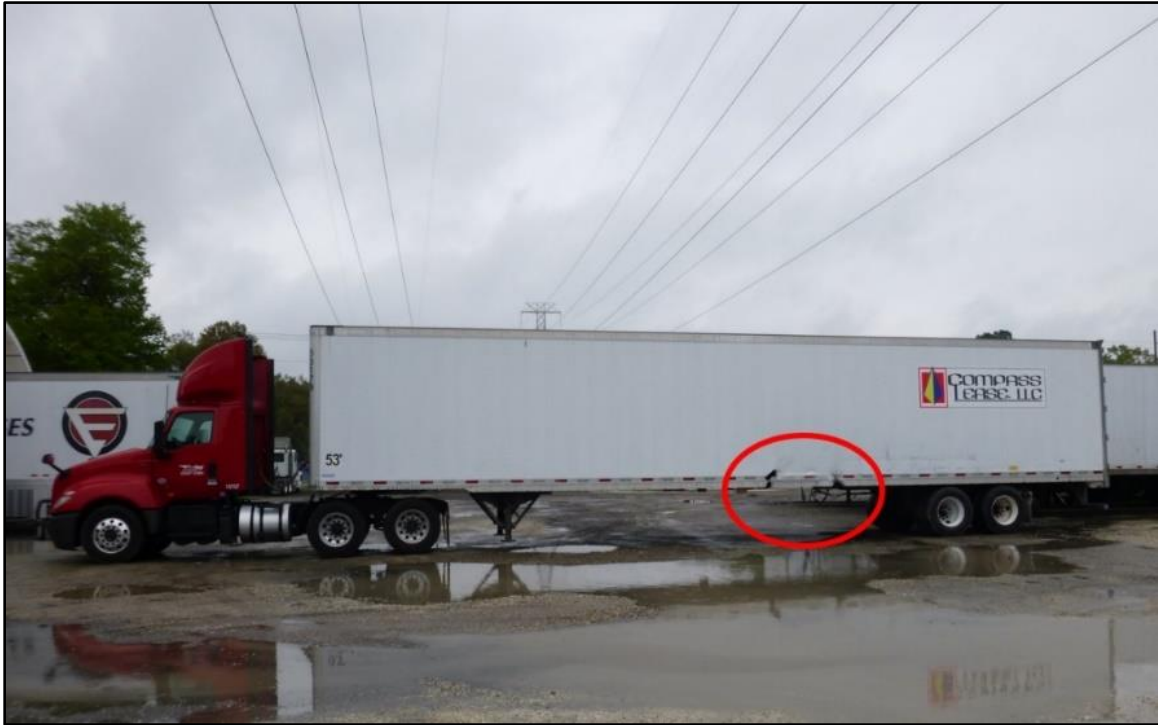
the undercarriage between the opposing damaged rails (figure 4). The lower edge of the trailer measured 3.6 feet high and correlated with damage to the car.

Figure 4. Left side of combination vehicle. Damage to lower edge of semitrailer sidewall rails is circled in red.

The combination vehicle's lighting system was illuminated during the inspection. The headlights and the trailer's side amber marker lights were clearly visible. As required by federal regulations (49 CFR 393.11 and 393.13), the trailer was equipped with red-and-white conspicuity reflective tape along the lower edge on both sides of the trailer.

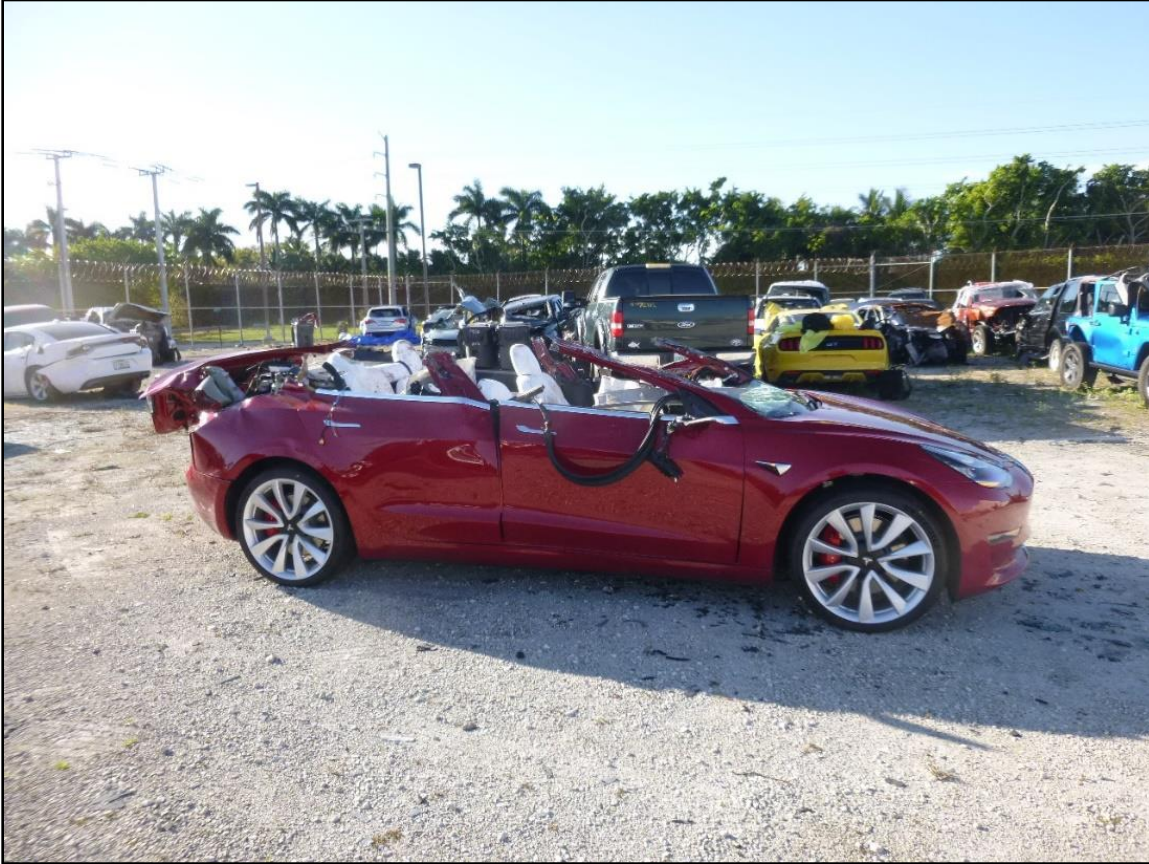
The Tesla Model 3 sustained major damage that included separation of the glass roof panel and forward-facing surfaces of both the A- and B-pillars just below where the roof met the pillars and rearward displacement of the headrest on the front passenger seat (figure 5). The trunk lid was displaced aft of its original position, and the right rear quarter-panel was buckled.

Figure 5. Right side of car in postcrash damaged condition.
