National Transportation Safety Board

Highway Accident Brief

Failure of Overhead Electrical Conduit Support System in Lehigh Tunnel and Subsequent Truck-Tractor Crash, I-476, East Penn Township, Pennsylvania, February 21, 2018

Accident Number:	HWY18FH006
Accident Type:	Impact of truck-tractor semitrailer combination vehicle with broken overhead electrical conduit; subsequent crash
Location:	Interstate 476 (I-476; Pennsylvania Turnpike) southbound, Lehigh Tunnel, East Penn Township, Carbon County, Pennsylvania
Date and Time:	February 21, 2018, 6:02 p.m. eastern standard time
Vehicle:	2017 International truck-tractor in combination with 2017 Strick semitrailer
Fatalities:	1
Injuries:	0

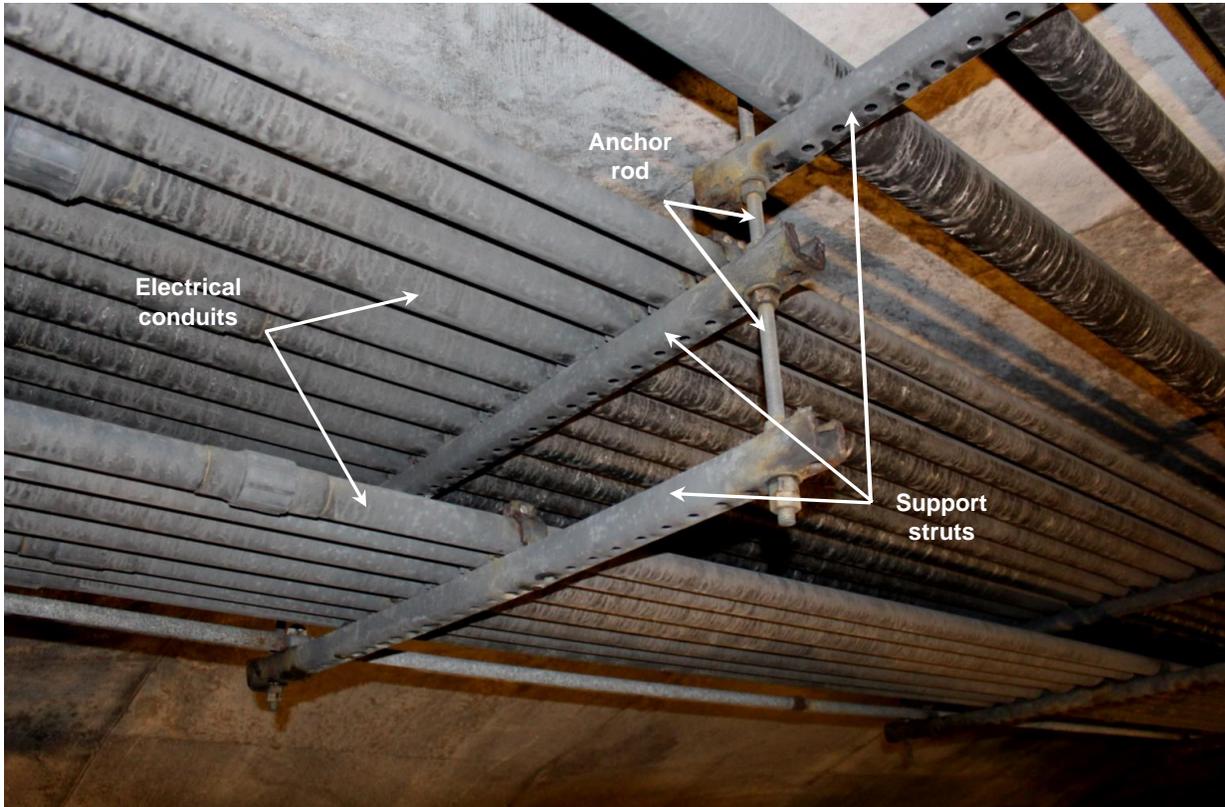
Configuration. In the area of tunnel no. 2 where the failure occurred, the suspended electrical conduit system consisted of three levels: top, bottom, and side.⁹ The top level held about 13 conduits ranging from 1 to 2 inches in diameter; the bottom level held about 9 conduits ranging from 0.75 to 2 inches in diameter; and the side level held 6 conduits ranging from 0.75 to 3 inches in diameter. The conduits, which ran parallel to the roadway, were supported by transverse-oriented support struts attached to mechanical anchors in the tunnel ceiling by ⁵/₈-inch-diameter threaded stainless-steel anchor rods (figure 5). The conduit support struts were typically spaced at about 6-foot intervals throughout the length of the tunnel. Nuts and washers held the struts in place on the anchor rods.

Figure 5. Electrical conduits, support struts, and anchor rod in Lehigh Tunnel no. 2. (Photo taken February 26, 2018, by NTSB investigators)

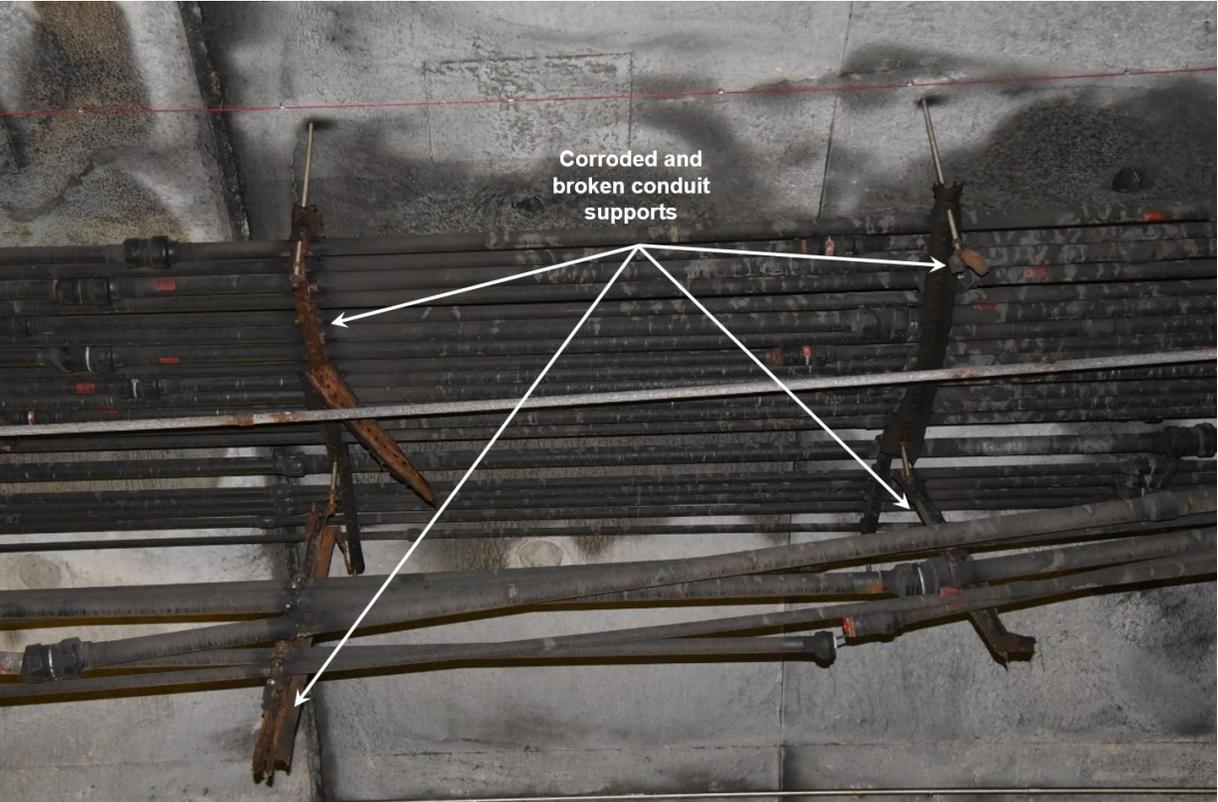
Post-Impact Examination. Investigators from the National Transportation Safety Board (NTSB) and the Federal Highway Administration (FHWA) examined various portions of the electrical conduit and suspension system throughout tunnel no. 2 on February 26, 5 days after the crash. Investigators found corroded, fractured, and missing transverse conduit supports at multiple locations, also photographed by the Pennsylvania State Police on the night of the crash (figure 6).

Figure 6. Corroded and broken conduit support struts in the area of the impact. (Source: Pennsylvania State Police; photo taken about 4 hours after the crash)

In the area of impact, nine transverse support struts had failed, for a total collapsed length of about 60 feet. The 10-foot-long section of electrical conduit that struck the truck-tractor's windshield was a portion of the 60-foot-long collapsed section of conduit. Damage to the electrical conduit support system in this section appeared to include both preexisting damage and damage caused by the collision with the truck-tractor. Damage also included detached electrical conduits and wiring that should have been contained inside the electrical conduit but were dangling down to the surface of the roadway. The transverse conduit support struts in and adjacent to the area of the collision were found to be heavily corroded, with most failures occurring inside the horizontal supports near their connections with the threaded vertical anchor rods (figure 7). The anchor rods remained connected to the mechanical anchors in the concrete tunnel liner. None of the mechanical anchors appeared to have been pulled out of the concrete tunnel liner.

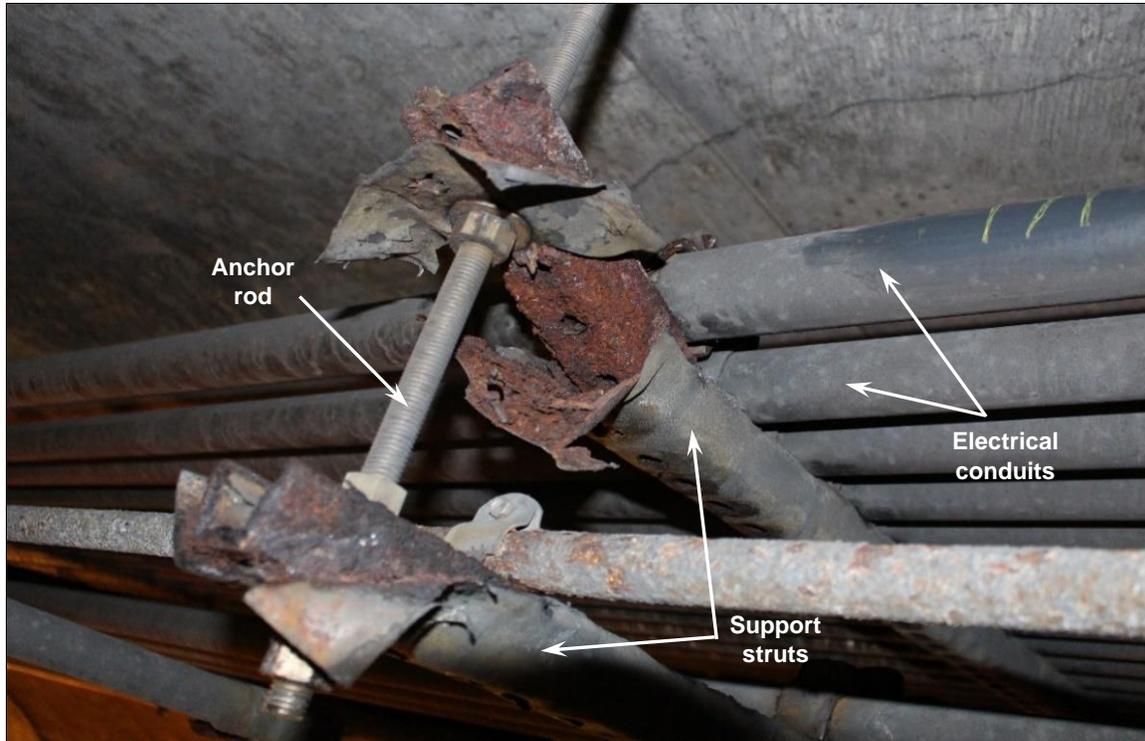
Figure 7. Closeup photo of transverse support struts, which have fractured and failed in areas where their PVC coating separated from the underlying steel surface, leading to corrosion of the steel. (Photo taken February 26, 2018, by NTSB investigators)

Most of the holes on the bottom of the support struts had a diameter of 0.49 inches. Near the ends of the support struts were larger holes that had been drilled out during the installation process to accommodate the vertical anchor rods. These anchor rod holes, when intact, measured 0.77 inches—more than 0.28 inches in diameter greater than the standard bottom holes.¹¹ Drilling larger holes in the support struts removed the protective PVC coating and consequently accelerated the corrosion of the struts' underlying steel in the area of the holes. In addition to the compromised PVC coating near the anchor rod holes, the support struts were likely cut from longer sections, resulting in disturbance of the protective PVC coating also at the cut ends. The general pattern of corrosion at the cut ends indicated disbonded/ineffective PVC coating or no PVC coating at all, leading to accelerated corrosion to the exposed metal surfaces in those areas. Other areas where the underlying metal was exposed would also have been susceptible to similar degradation from corrosion. Therefore, the NTSB concludes that the electrical conduit support system in Lehigh Tunnel no. 2 likely failed due to the fracture of extensively corroded PVC-coated steel support struts, allowing the electrical conduit to drop into the path of the oncoming truck-tractor.

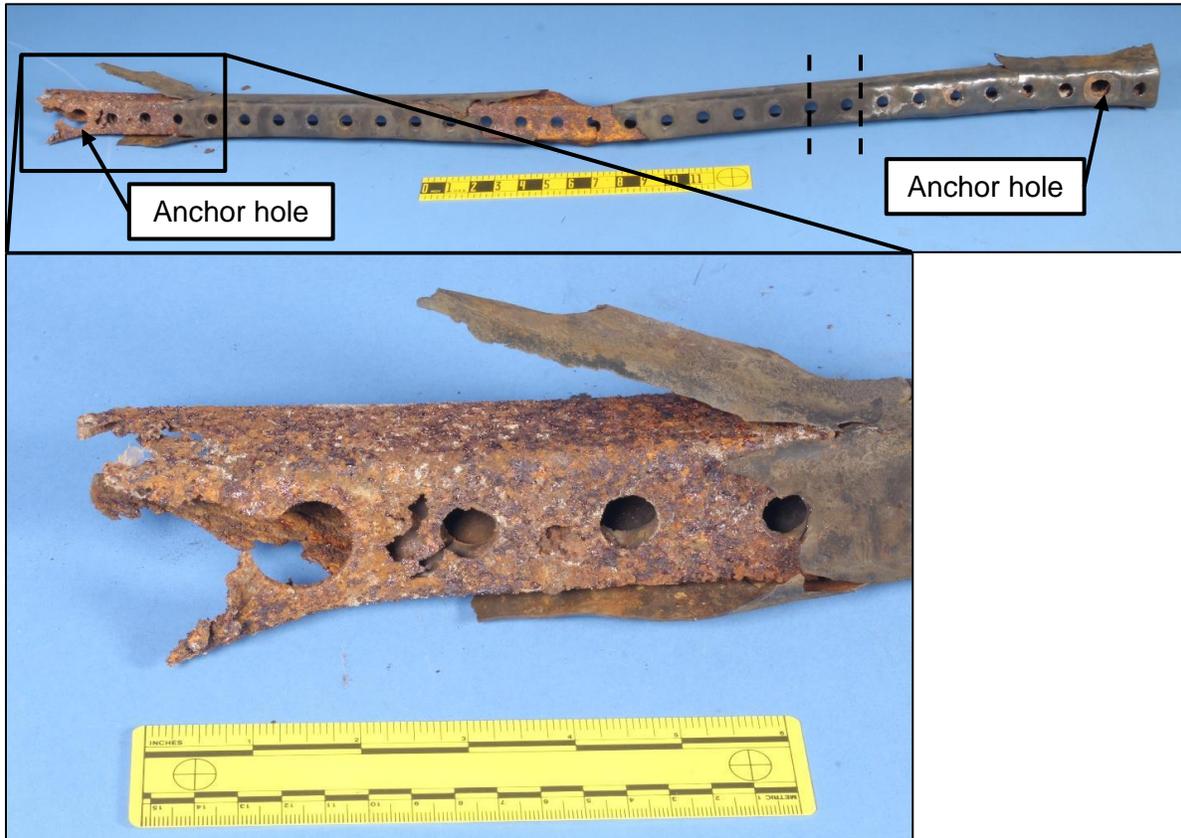
Several components of the electrical conduit and conduit support system were examined and analyzed by the NTSB Materials Laboratory. The components included a 4-foot-long section of electrical conduit, five support struts, conduit coupler pieces, pipe straps, and anchor nuts and washers.¹⁰ The examination revealed that the exterior of the pipe straps, support struts, conduit, and conduit coupler pieces had a gray polymer coating that was identified as PVC. Portions of the PVC coating were either missing or separated from the surface, and the underlying metal surfaces were covered with oxides (rust) (figure 8). Many of the exposed metal areas showed section loss from corrosion with missing pieces of underlying metal throughout the components, particularly evident near the anchor point for the support struts.

Figure 8. Overall view of a support strut, with a closeup view of the end. The black dashed lines in the upper image indicate the location where investigators made transverse cuts (also see figure 9). The mid-section of the strut shows an area of corrosion, as well as disbonded and missing PVC coating.

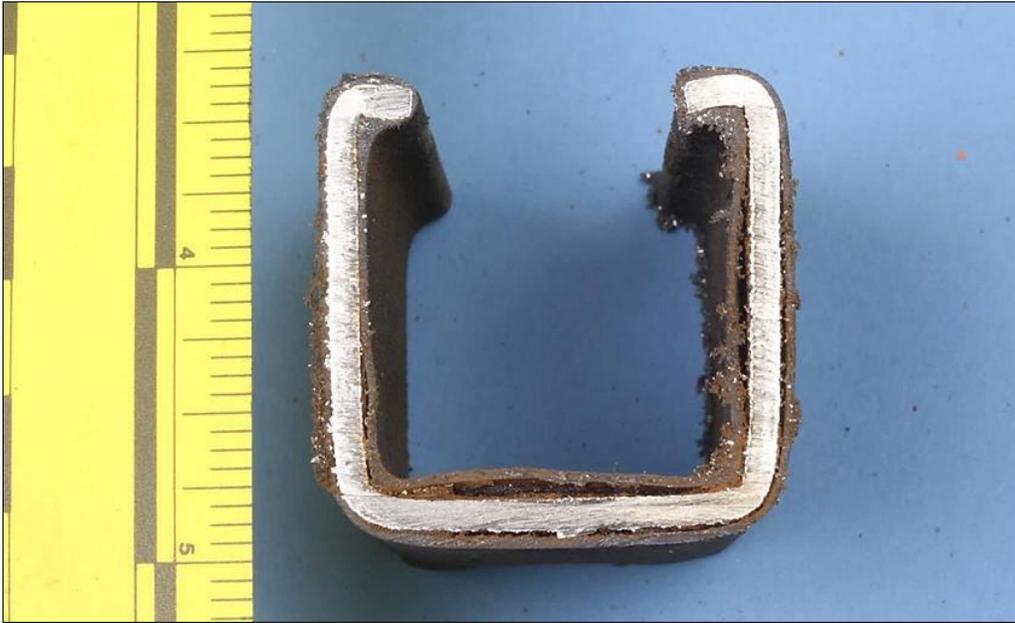
Galvanic corrosion associated with using stainless-steel anchors in combination with PVC-coated steel supports did not appear to be a factor in the rate of corrosion.¹² The corrosion was generally greatest at the outer ends of the support struts, including the vertical flanges, with lesser corrosion found around the anchor holes.

The underlying steel was susceptible to corrosion from exposure to moisture and salts, and the coating tended to mask the corrosion while simultaneously accelerating it by trapping moisture and other corrosive elements on the steel surface. The transverse cuts that investigators made in the struts (shown by the dashed lines in figure 8) revealed locations where the PVC coating appeared to be visually intact, but on closer examination the coating had partially disbonded from the underlying metal surfaces, which showed rust oxides (figure 9).

Figure 9. Cross-section of strut 16, showing oxidation and PVC disbondment from the metal.

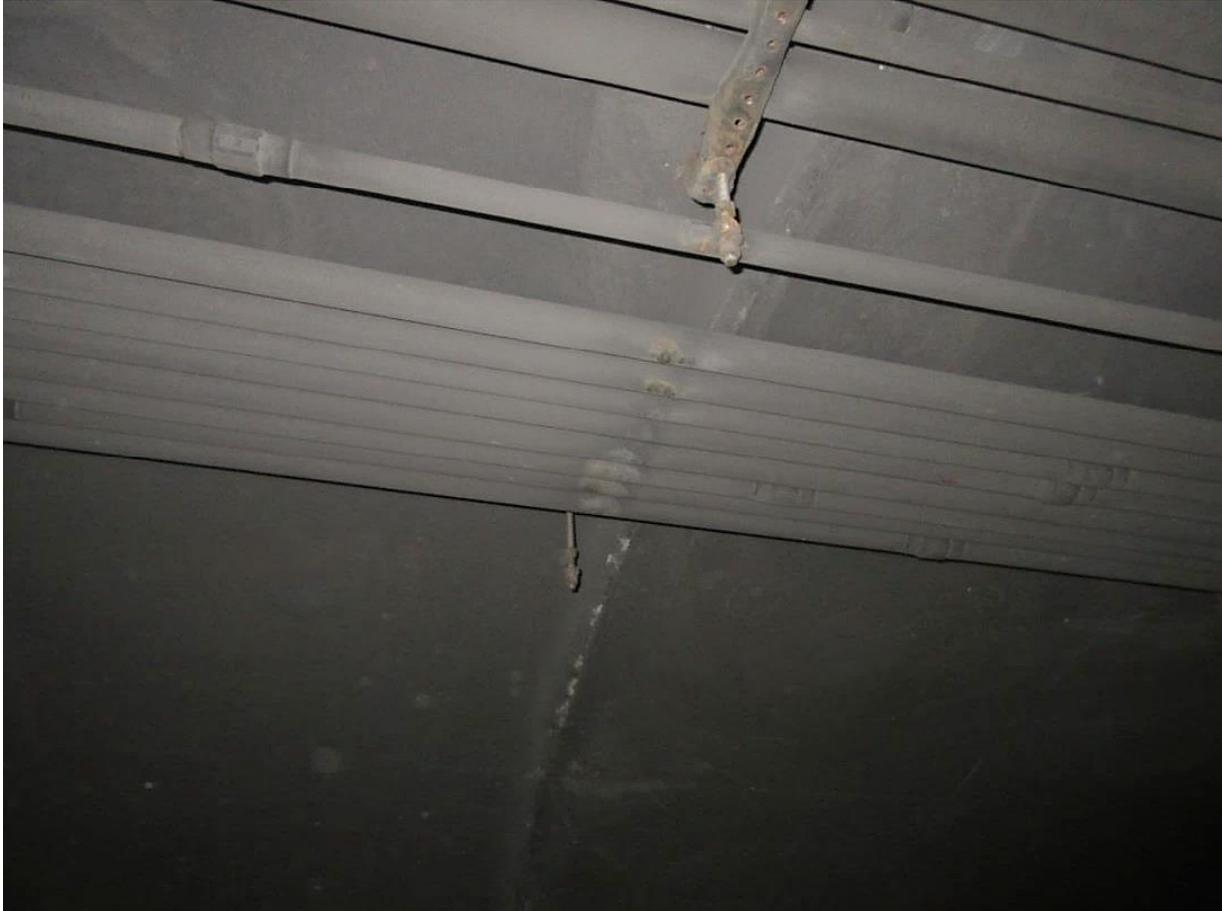
With respect to tunnel no. 2, the 2016 inspection report noted “missing conduit supports throughout the tunnel,” and several photographs showed the condition of the electrical distribution system (figure 10).¹⁹

Figure 10. Photo showing a section of missing conduit support in Lehigh Tunnel no. 2. (Source: HDR Engineering, Inc., 2016 Tunnel Inspection Report)

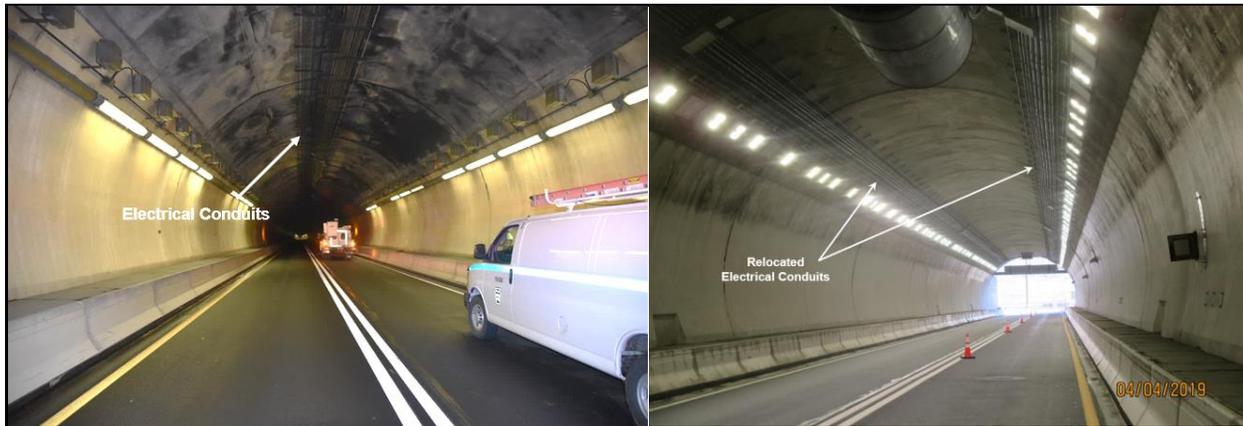
Figure 11. Before (left) and after (right) replacement of the electrical distribution system in Lehigh Tunnel no. 2, relocated from the top center of the tunnel to the edges. (Source: Pennsylvania Turnpike Commission)

In addition to immediately repairing and re-suspending the electrical conduit system in the area of the failure, about a week after the collision, the Pennsylvania Turnpike Commission replaced an additional 16 conduit support struts and one broken anchor rod. The replacement support struts were made from uncoated stainless steel. The Pennsylvania Turnpike Commission assessed the electrical conduit and support system after these repairs were completed on February 28, 2018, and informed the NTSB by e-mail that no additional immediate repairs were needed before the already planned upgrade of the electrical system.

Less than a week before the failure and collision, on February 15, 2018, the chief engineer of the Pennsylvania Turnpike Commission signed a contract for installing a newly designed electrical distribution system in Lehigh Tunnel no. 2 and replacing the electrical distribution system in tunnel no. 1. The construction contract was awarded to Mosites Construction & Development Company, and part of the work for tunnel no. 2 specified placing the new electrical distribution system toward the outside edges of the tunnel as opposed to having it directly above the center of the roadway.²¹ The work in tunnel no. 2 began in April 2018 and was completed on October 31, 2018. Figure 11 shows before and after photos of the electrical distribution system replacement in tunnel no. 2.
