NATIONAL TRANSPORTATION SAFETY BOARD

HIGHWAY ACCIDENT REPORT

CHARTERED INTERSTATE BUS CRASH
INTERSTATE ROUTE I-80S
NEAR BEAVER FALLS, PENNSYLVANIA
DECEMBER 26, 1968

SS-H-5

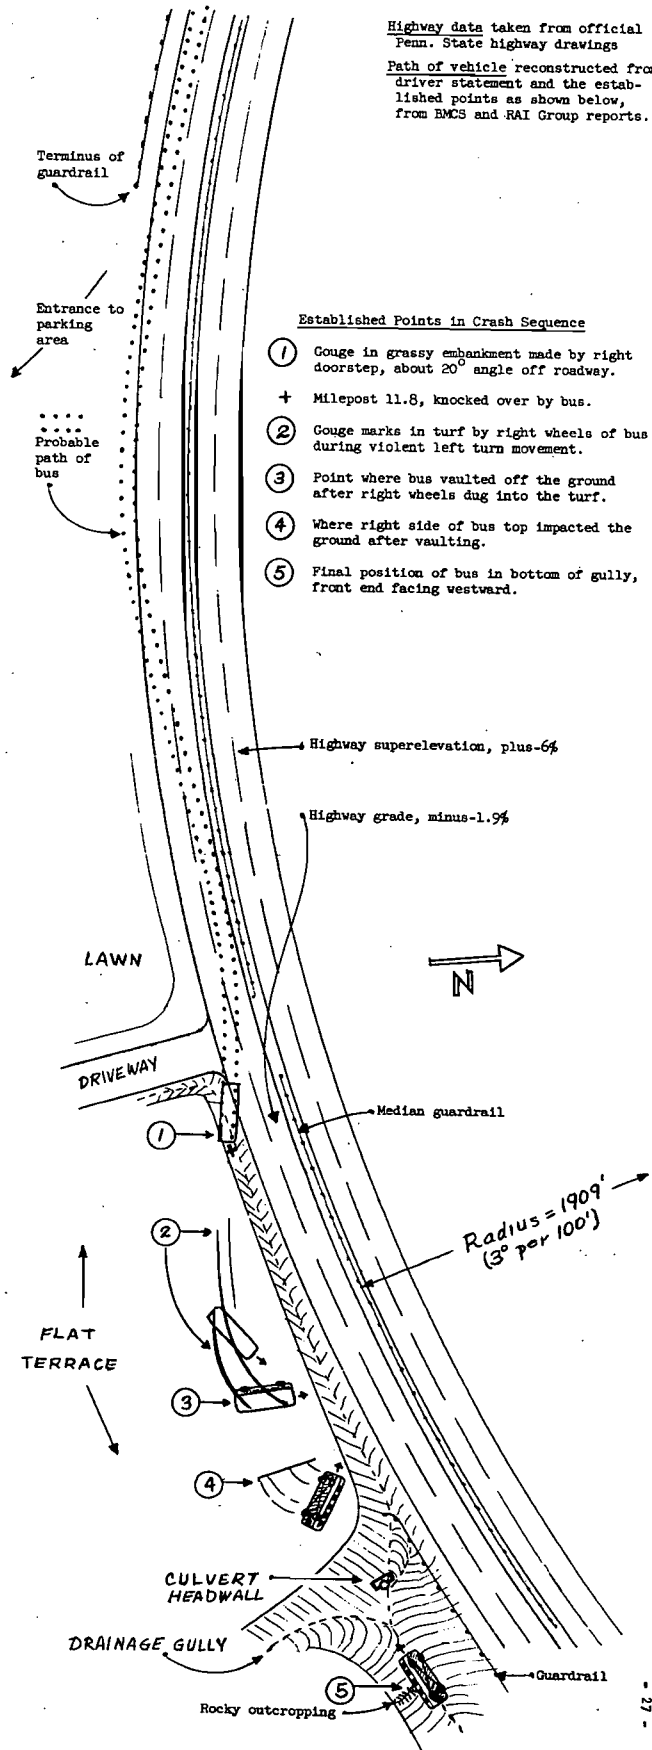
PICTORIAL REPRESENTATION OF ACCIDENT SCENE
(not to scale)

On December 26, 1968, about 2:40 a.m., a chartered 39-passenger intercity bus enroute from Chicago, Illinois, to Washington, D. C., was traveling east on Interstate Highway, I-80S, the Pennsylvania Turnpike, near Beaver Falls interchange, at a speed of about 60 to 65 m.p.h. Shortly after the bus entered a transitional curve to the left, it ran off the traveled lane to the right, and the rear of the bus slid to the right on a snow-covered shoulder, which sloped down away from the pavement. Following a hard left steering action, the bus yawed to the left. After another over-corrective steering action, it yawed to the right, then headed off the right side of the highway. It crossed the shoulder and ran up onto a raised grassy terrace in front of a turnpike maintenance building. On the frozen snow-covered terrace, the bus veered abruptly to its left as the driver tried to return to the roadway, then vaulted onto the right side of its roof after the right wheels dug into the frozen turf. Still on its roof, the bus slid and bounced off the east end of the terrace and down into a drainage gully, a drop of 10 or 12 feet, and came to a stop with its top and left side resting in the bottom of the gully, its front facing westward (see Attachment 1 for sketch of accident scene).

The accident occurred off the eastbound lanes of Interstate I-80S, the Pennsylvania Turnpike, west of the Beaver Falls interchange, at milepost 11.8 in front of the Homewood Maintenance Base of the Turnpike. The highway at this point slopes downward to the east (-1.9 percent) and is near the end of a 1,000-foot curve to the left of 1,909-foot radius (3 percent per 100 feet). There are two eastbound 12-foot lanes of concrete in excellent state of repair. Superelevation at this point is about 3/4 of an inch per foot (or plus 6 percent). (Highway data from Pennsylvania State highway design blueprints. See Attachment 1 for drawing of accident scene.)

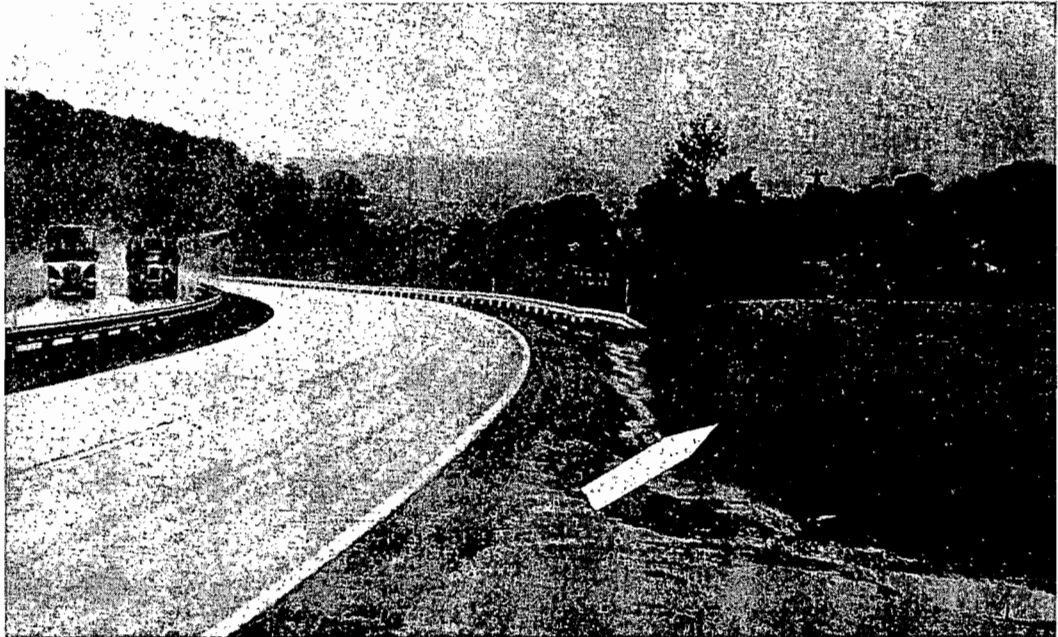
ATTACHMENT 2B

Point at which bus left the highway, just east of the maintenance base driveway, and ran up onto terrace embankment. Safety Board photo taken Sept. 24, 1969.

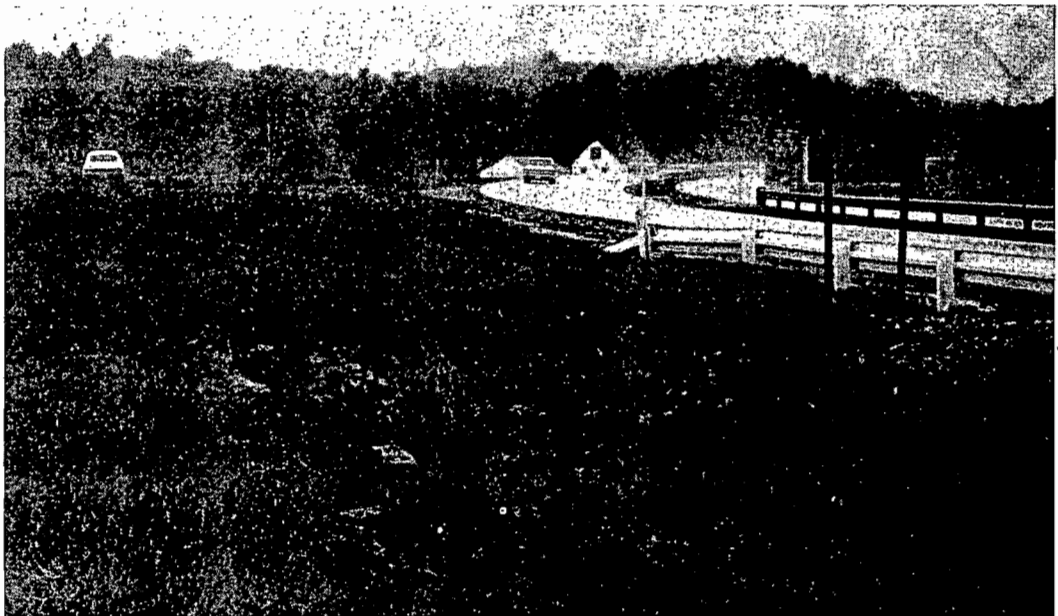
Gully into which bus crashed, looking westward, showing the terrace on which the bus overturned and the highway approach. Safety Board photo taken September 24, 1969.

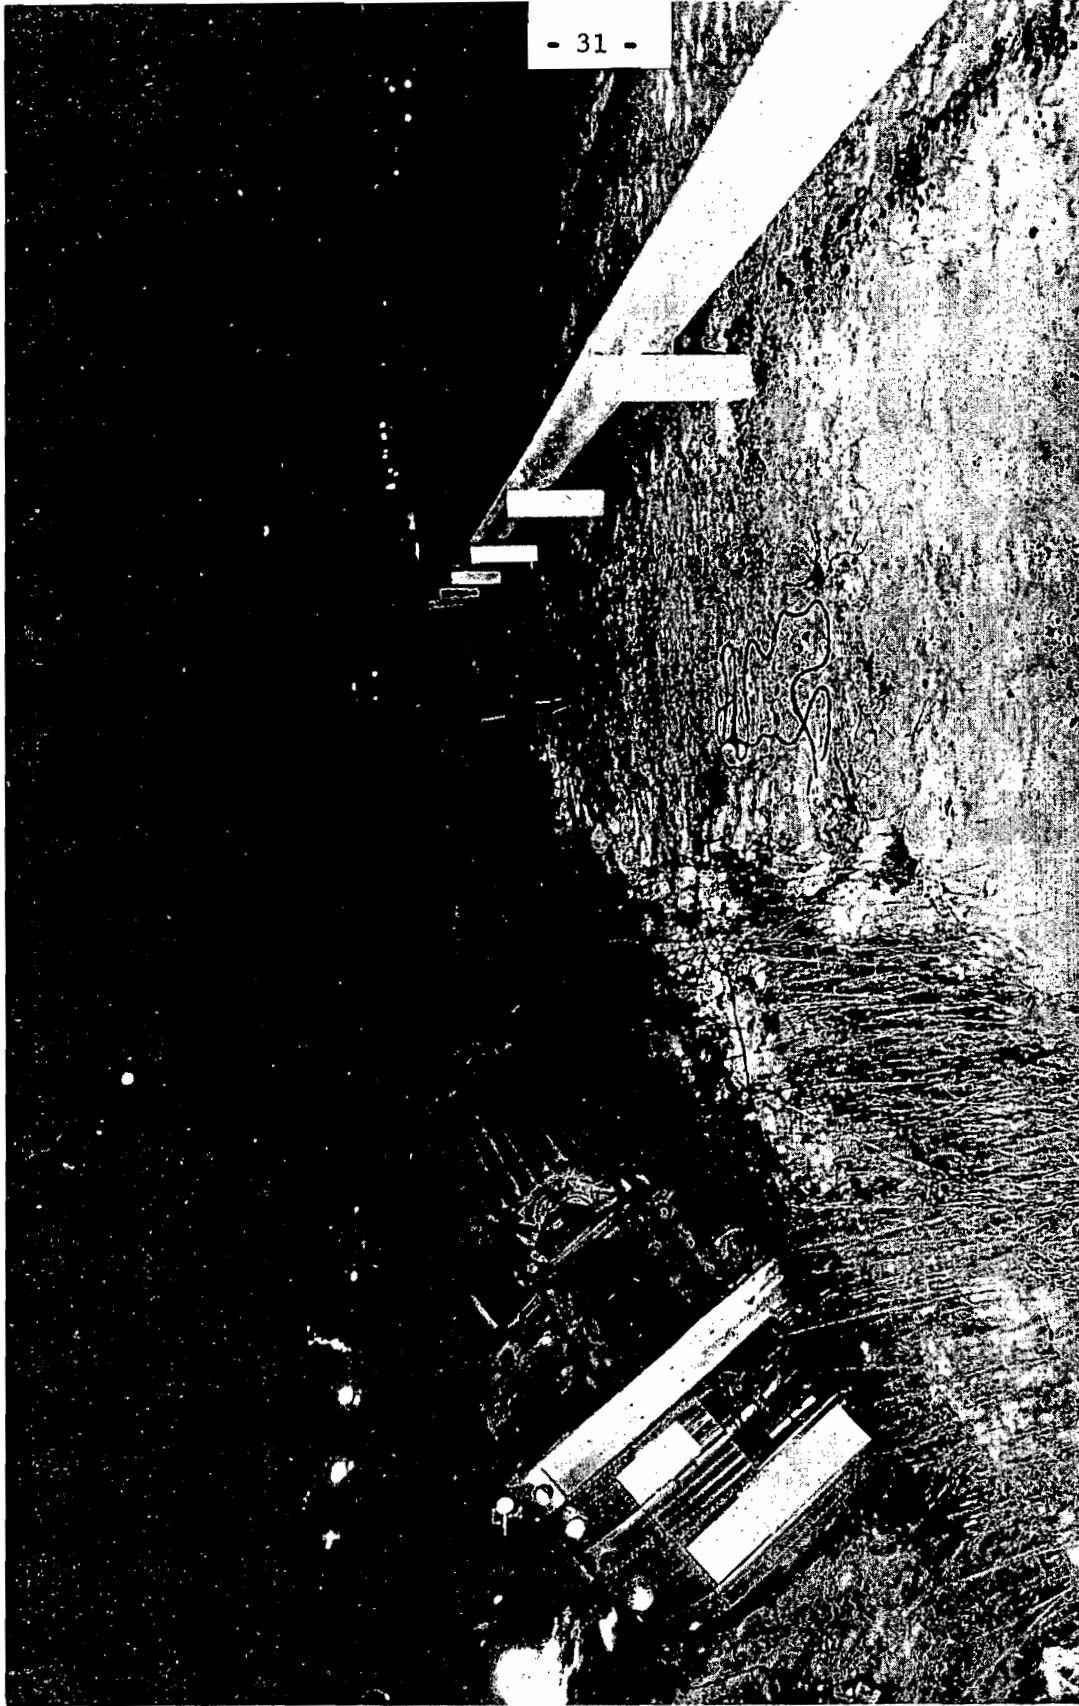
No precipitation was reported just before or during the accident. The pavement was reportedly clear and dry; it had been salted during the morning of December 25th, but a half-inch of snow overlay the shoulder, the median, and the frozen terrain south of the highway. Photographs (Attachment 3) taken during rescue operations at the scene show a covering of snow on the south highway shoulder, right up to the edge of the pavement. Maintenance base personnel and the State Patrolman are certain there was no frosting or slipperiness of the pavement at the time this accident occurred. There was no highway lighting in the area, and because of the dark and overcast conditions, ambient light was almost nil.

ATTACHMENT 3. Bus lying in ditch, facing west. Note presence of snow overlaying the area, and snow on highway shoulder. Photo by Beaver Falls News-Tribune, December 26, 1968.

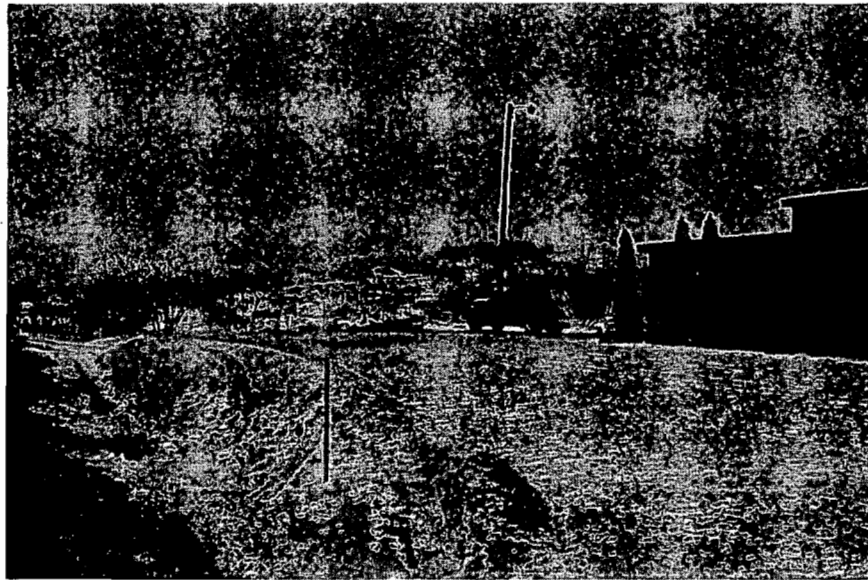
Fig. A Marks of bus wheels as it went up onto the snow-covered terrace. (Mileage marker had been knocked over, but was replaced by maintenance crew.)

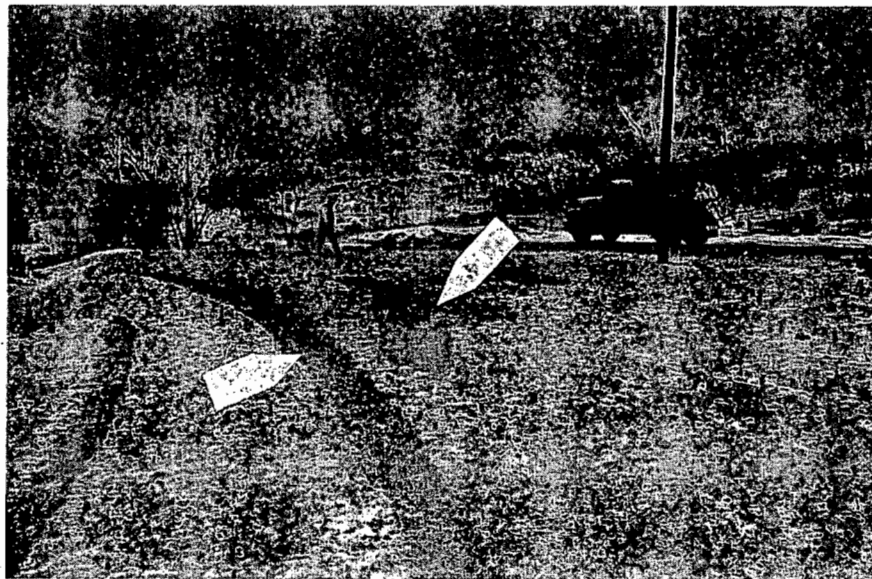
Fig. B Marks of bus tires as bus swerved left on the terrace. Points where wheels broke through the frozen surface are indicated by arrows.

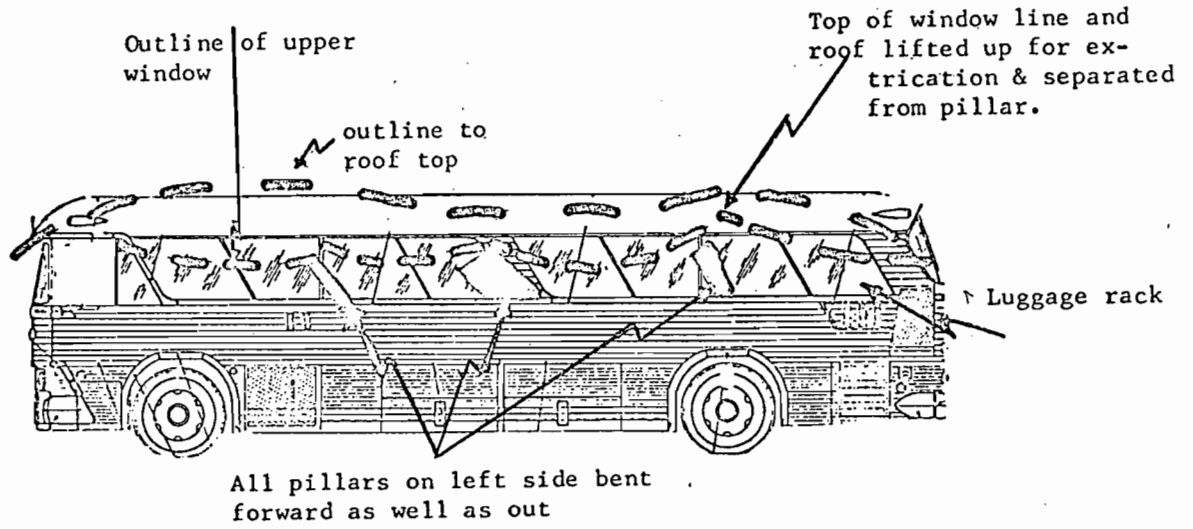
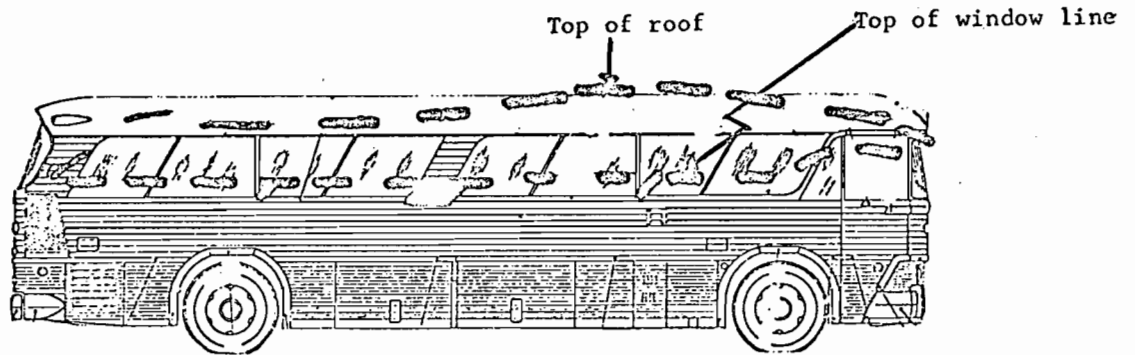
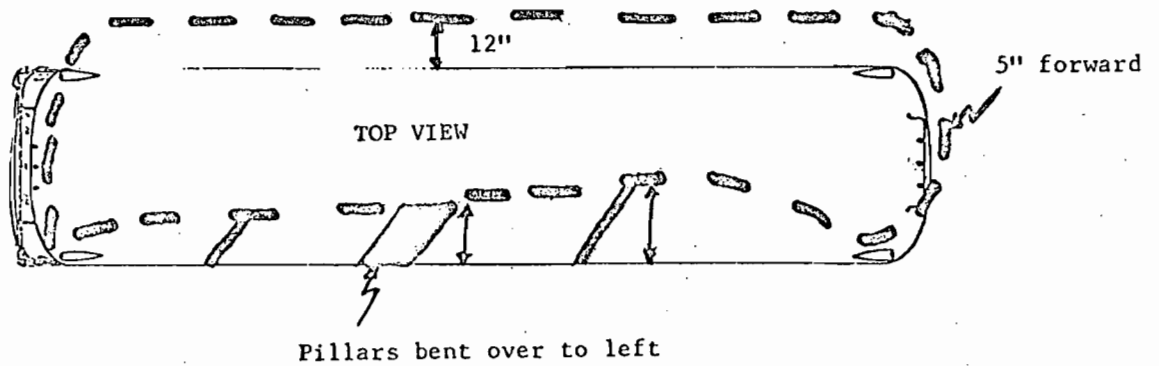
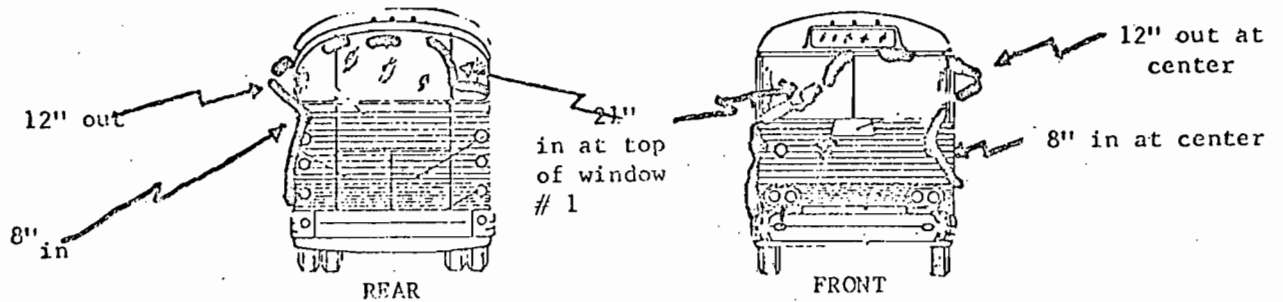
DEFORMATION OF BUS ROOF

1. A slight inward bending and grinding of metal in the leading edge of the right front body (ahead of the door-step) was the first damage incurred when the bus first climbed the terrace embankment, gouging into the slope.
2. Downward and leftward collapse of the right roof area occurred when the roof impacted ground after the bus overturned on the terrace. Because it struck first and

hardest, the right front roof area suffered more damage on initial impact than the rear roof area.

8. The rearward motion of the bus in the gully forced the entire roof structure forward.
9. Some seats were bent backward by the collapse of the roof structure, and some were distorted inward by the flexing of the body sidewalls. Seats principally involved were Nos. 5, 9, 13, 17, and 25 on the left side, against the windows, and Nos. 12 and 20 against the right windows. The backrest of the driver's seat was bent backward by the weight of the driver's body in the final deceleration. No seats were torn loose from their mountings.

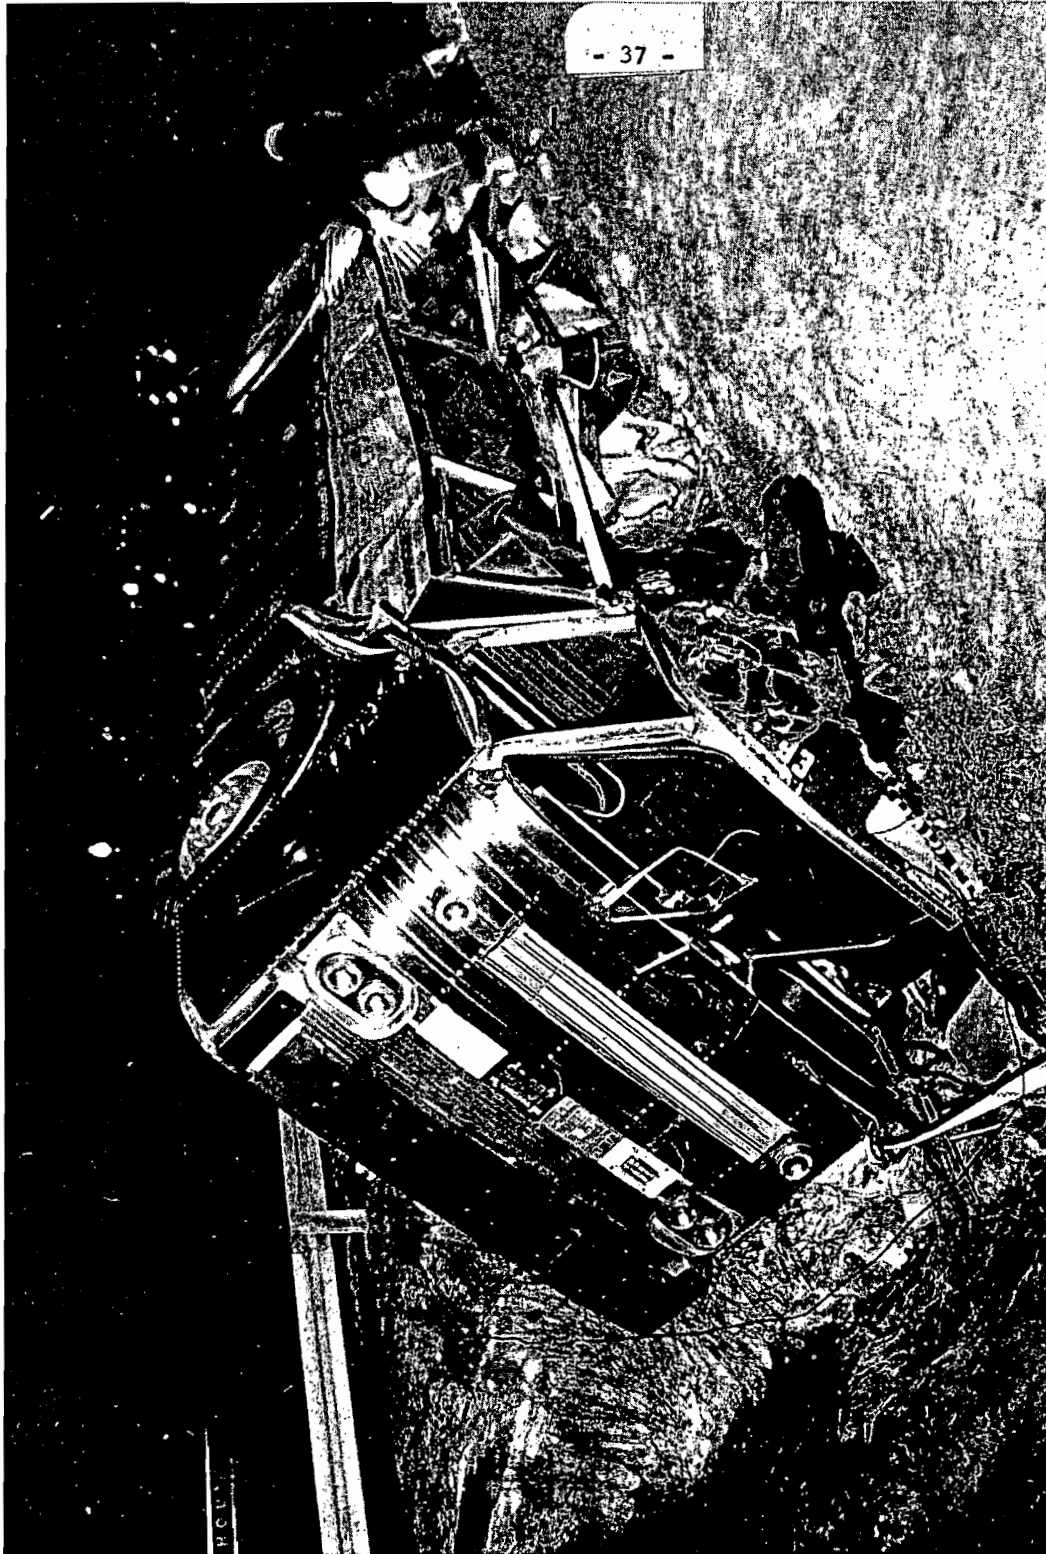
ATTACHMENT 9

Photograph of bus in bottom of gully, facing west, showing extensive inward crushing of right-side window and roof support structure and inward flexing of the body side panel. (Photo by Beaver Falls News-Tribune)

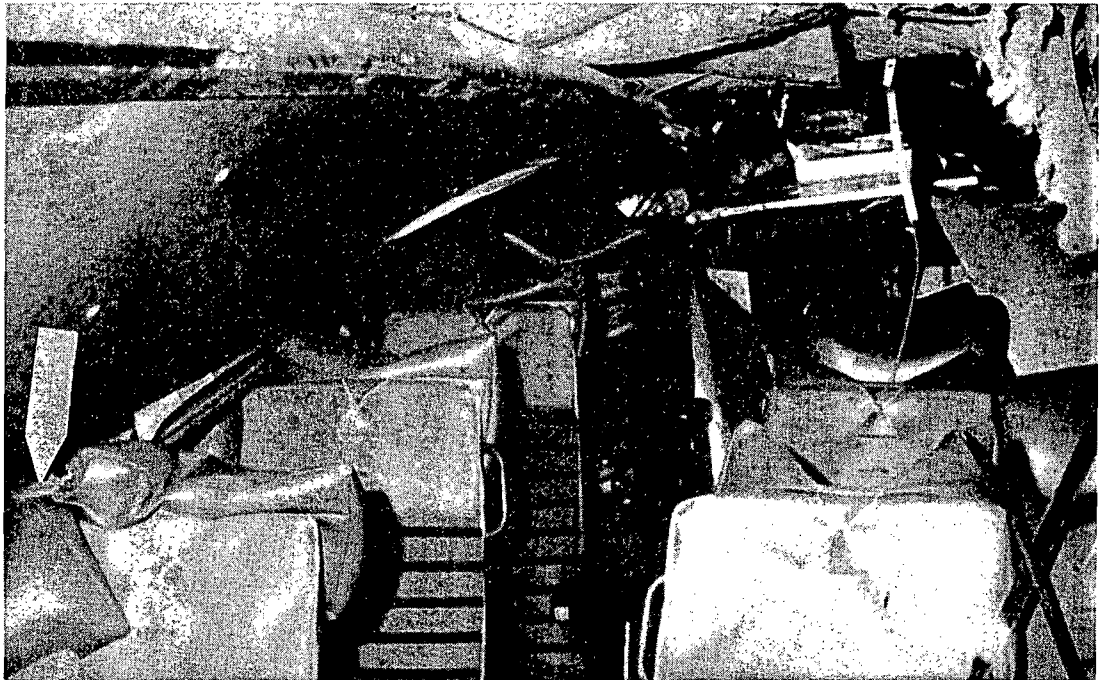
ATTACHMENT 10

4. When the bus landed upside down in the gully, at least one passenger (seat No. 12) was killed by the inward and leftward collapse of the roof support structure. The occupant in seat No. 33 was partially ejected through the broken out window structure, and crushed in the collapse of that structure. The occupant of seat No. 1 would logically have been further thrown about, possibly aggravating already-serious injuries (death followed about an hour later). Other occupants impacted the bent-in side and roof structure, or were cut by the fractured edges of the plastic roof liner and parcel shelf; some were injured by the crushing

INTERIOR PHOTO OF BUS, SHOWING ROOF COLLAPSE

One of the roof support pillars on the right side was bent over and significantly reduced the available space for the occupant in seat No. 12.

5. The National Highway Safety Bureau, FHWA, study the feasibility and practicality of a standard for passenger buses requiring that surfaces overhead of passengers, including roof linings, mouldings, parcel or luggage shelves, edges and support hardware be designed so as to reduce or prevent direct contact injuries in roll-over and upset accidents, and that such areas resist separation or fracture of a type which would expose edges to passengers. This protection will continue to be of importance in the absence of passenger restraints, currently not required.
