HIGHWAY ACCIDENT REPORT

AIRPORT TRANSPORT BUS -

AUTOMOBILE COLLISION

REPORT NUMBER NTSB-HAR-71-2

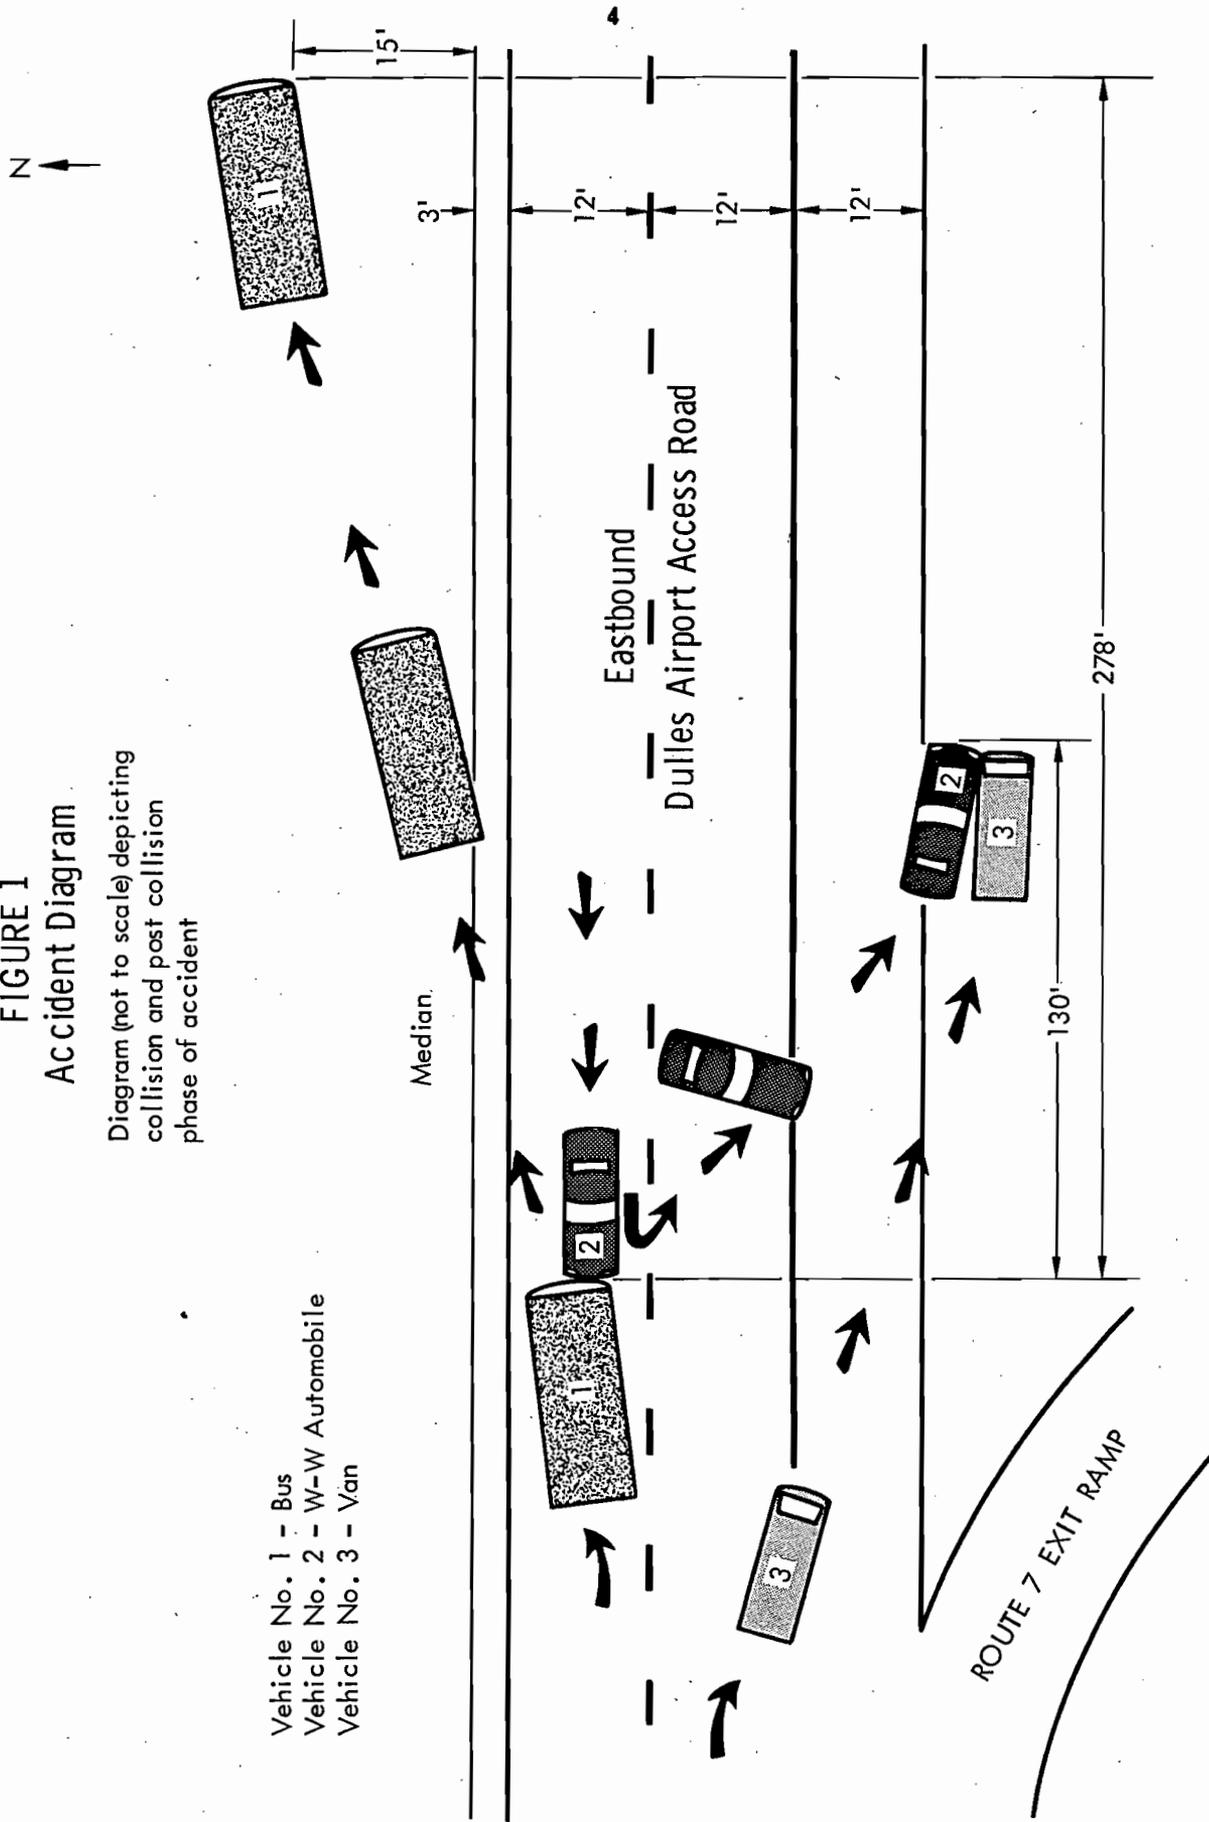
FIGURE 1
Accident Diagram

Diagram (not to scale) depicting collision and post collision phase of accident

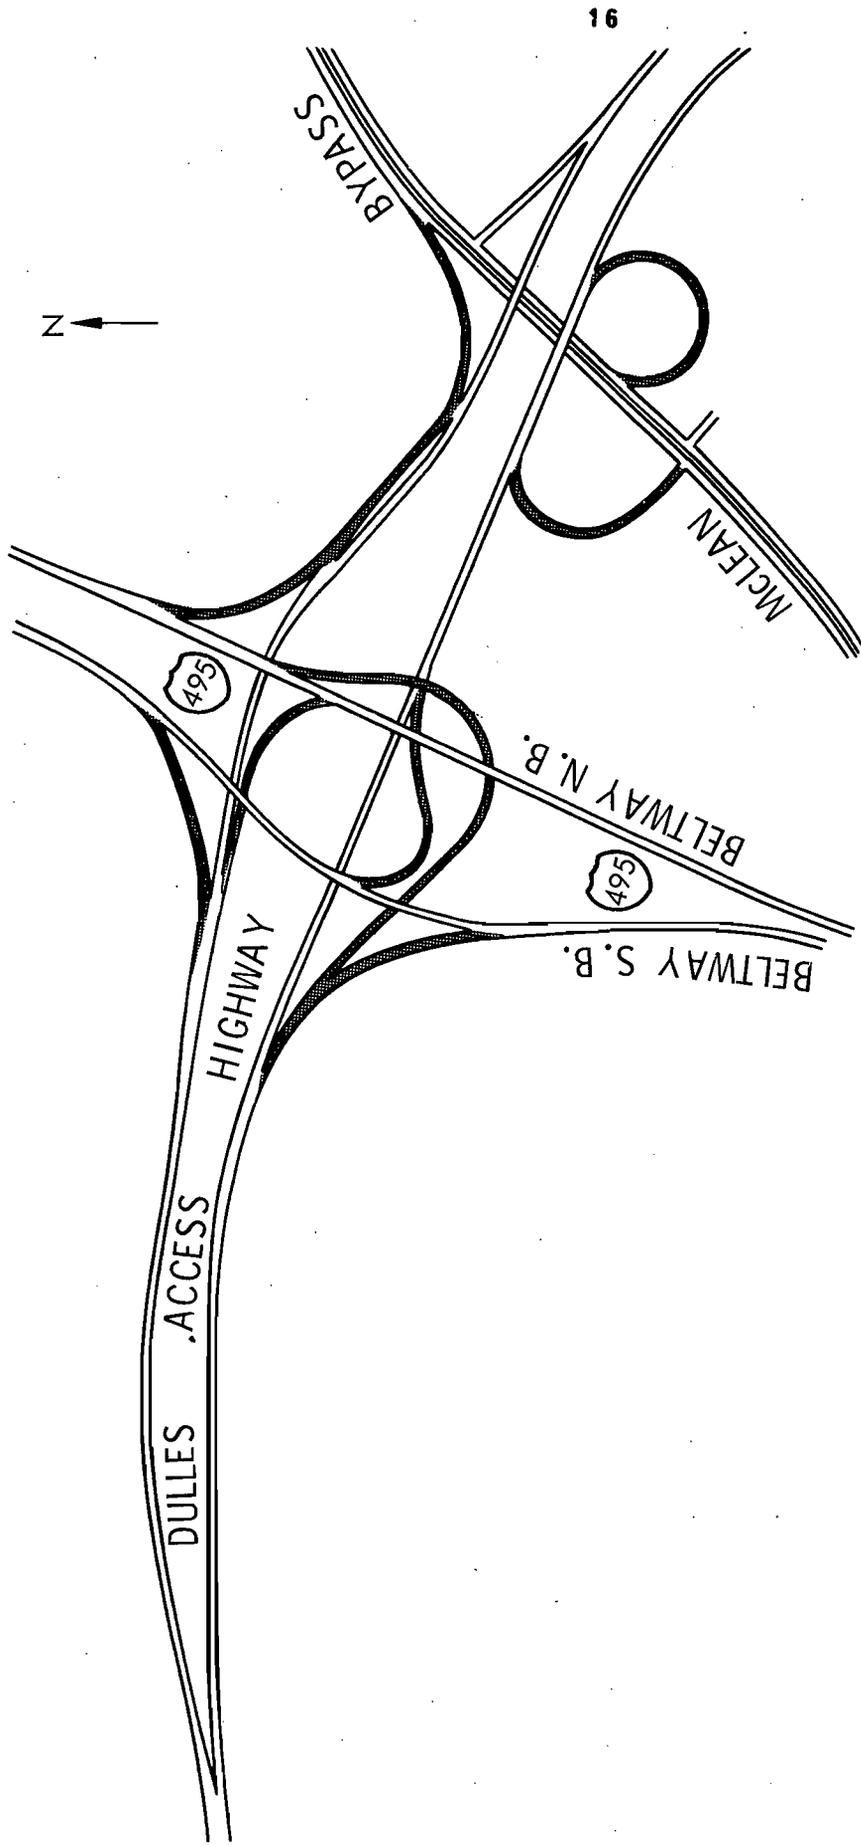
FIGURE 2
 DULLES ACCESS ROAD - I-495 INTERCHANGE
 DIAGRAM

1. From I-495 via the northbound exit ramp, heading the wrong way.
2. From I-495 via the southbound exit ramp, heading the wrong way.
3. From Virginia Route 123 via the exit ramp, heading the wrong way.

Diagram depicts all ingress and egress ramps of the Dulles Airport Access Road at I-495 and McLean Bypass (Route 123).

A review of all possible actions by the driver suggest that he was southbound on I-495 and desired to reverse direction to proceed toward his home in a northbound direction on I-495. Under that premise, it is probable that he completed the following maneuvers: (1) exited from southbound I-495 via the McLean (left) off ramp; (2) drove down the ramp; (3) as he approached the tapered ramp terminus, found his vehicle parallel with the eastbound portion of the Access Road; (4) in an alcohol-induced state of confusion, he could have executed a left turn (90°) over the flat, uncurbed gore area; and (5) completed the remainder of a 180° turn on the eastbound roadway, placing him in a westbound configuration. Driving in the inside (left) lane (his right), he proceeded westbound, possibly seeking a route which would place him in a northbound direction.

1. The Federal Highway Administrator, in the implementation of his notice of November 18, 1970, "Notice of Determination of Applicability of Highway Program Standard to Federally Administered Areas," should review all current operational and experimental procedures, and urge implementation of those found to be most effective in preventing wrong-way traffic movements.

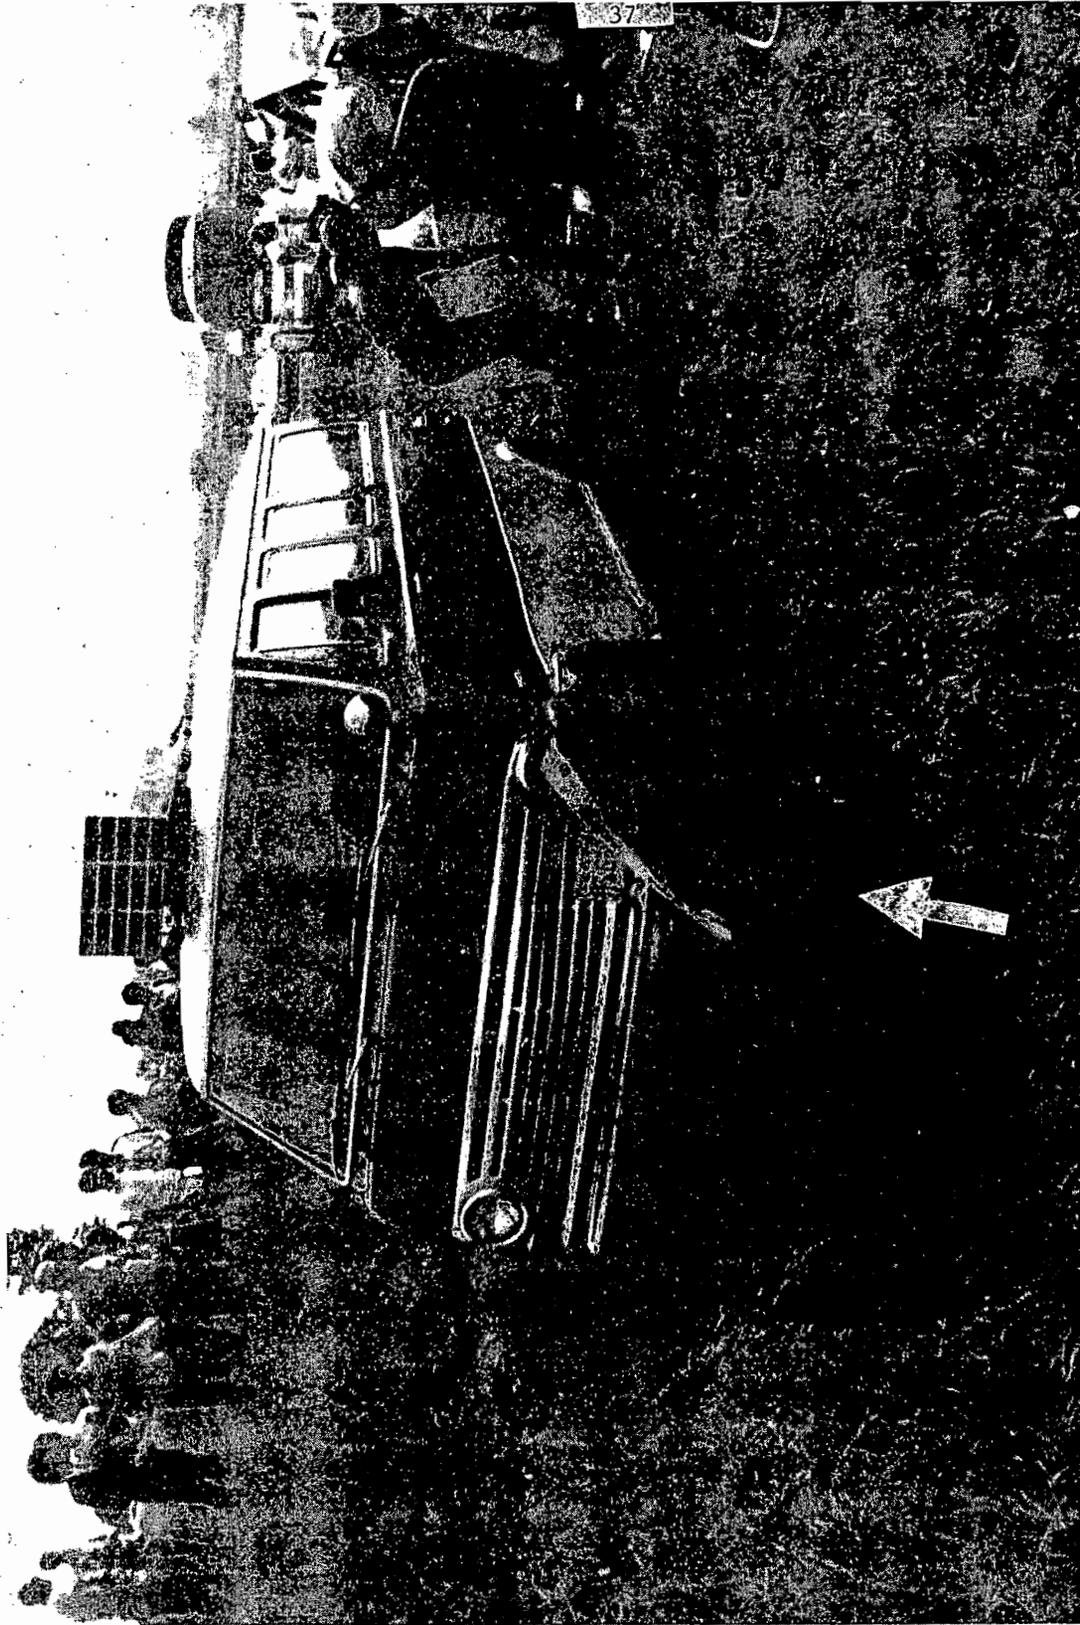
An on-site inspection of the van was not conducted due to its unavailability. A study of available photographs taken at the accident site indicates that this vehicle suffered minor damage to its left front door area.

Photograph of the van taken at the accident scene showing left front side damage and section (arrow) of the automobile's right front fender.
