HIGHWAY ACCIDENT REPORT

INTERSTATE BUS-AUTOMOBILE
COLLISION AND ROLLOVER
ON INDIANA ROUTE 57, SOUTH
OF PETERSBURG, INDIANA
NOVEMBER 24, 1969

REPORT NUMBER: NTSB-HAR-71-4

ADOPTED: FEBRUARY 10, 1971

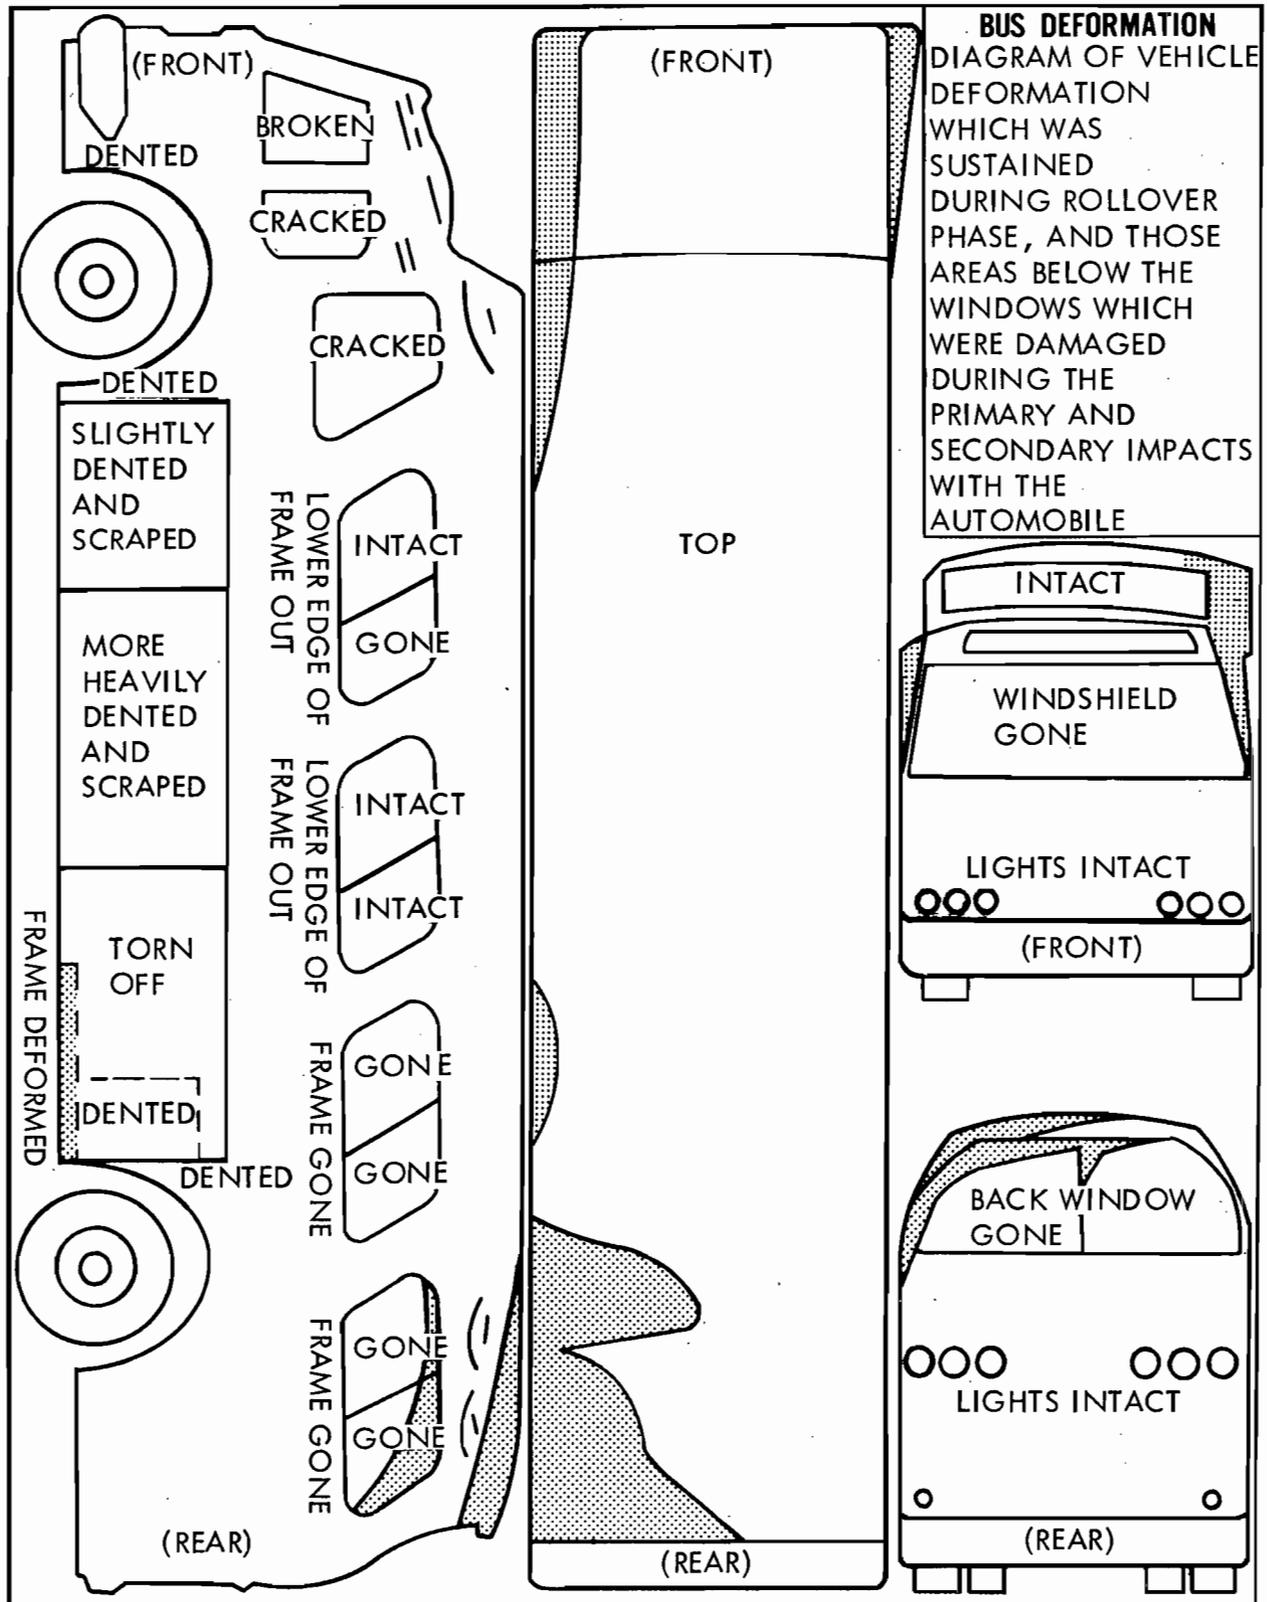
Figure 3

Most significant damage to the bus was on the left upper front and rear of the body. (Figure 3.)

The left air-conditioner access door and air intake grill, just behind the left front wheel, was bent in slightly. The sheet metal framing at the rear edge of the air intake grill was deformed inward and to the rear about 2 inches. The left forward baggage compartment door was deformed inward slightly. The left rear baggage compartment door was torn off. The vertical body frame member at the rear of the left rear baggage compartment was bent inward and rearward, and the battery cage at that point was

The windshield was missing, and the windshield area was distorted to the right. The left side (driver's) forward window was bulged outward and partly broken out, and the rearward pane was cracked but in place. The large fixed window back of the driver's area (in the step-up portion of the bus) was cracked but intact. Of the four large passenger windows on the left side, the first had a damaged frame and missing rear pane; the second had a damaged frame but both glass panes were in place; the third and fourth had lost their frames and panes completely. The body over the fourth window was crushed downward and inward approximately 18 inches at the rear.

The door at the right front of the bus was hanging by its top hinge only. The door glass and the small pane just to its rear were intact. The large fixed window in the "step-up" area was missing. Of the four large right side passenger windows, the front one was missing its frame and glass; the second had a cracked forward pane and a damaged rear frame; the third had a damaged frame and a cracked rear pane; and the fourth had both panes missing and a damaged frame.

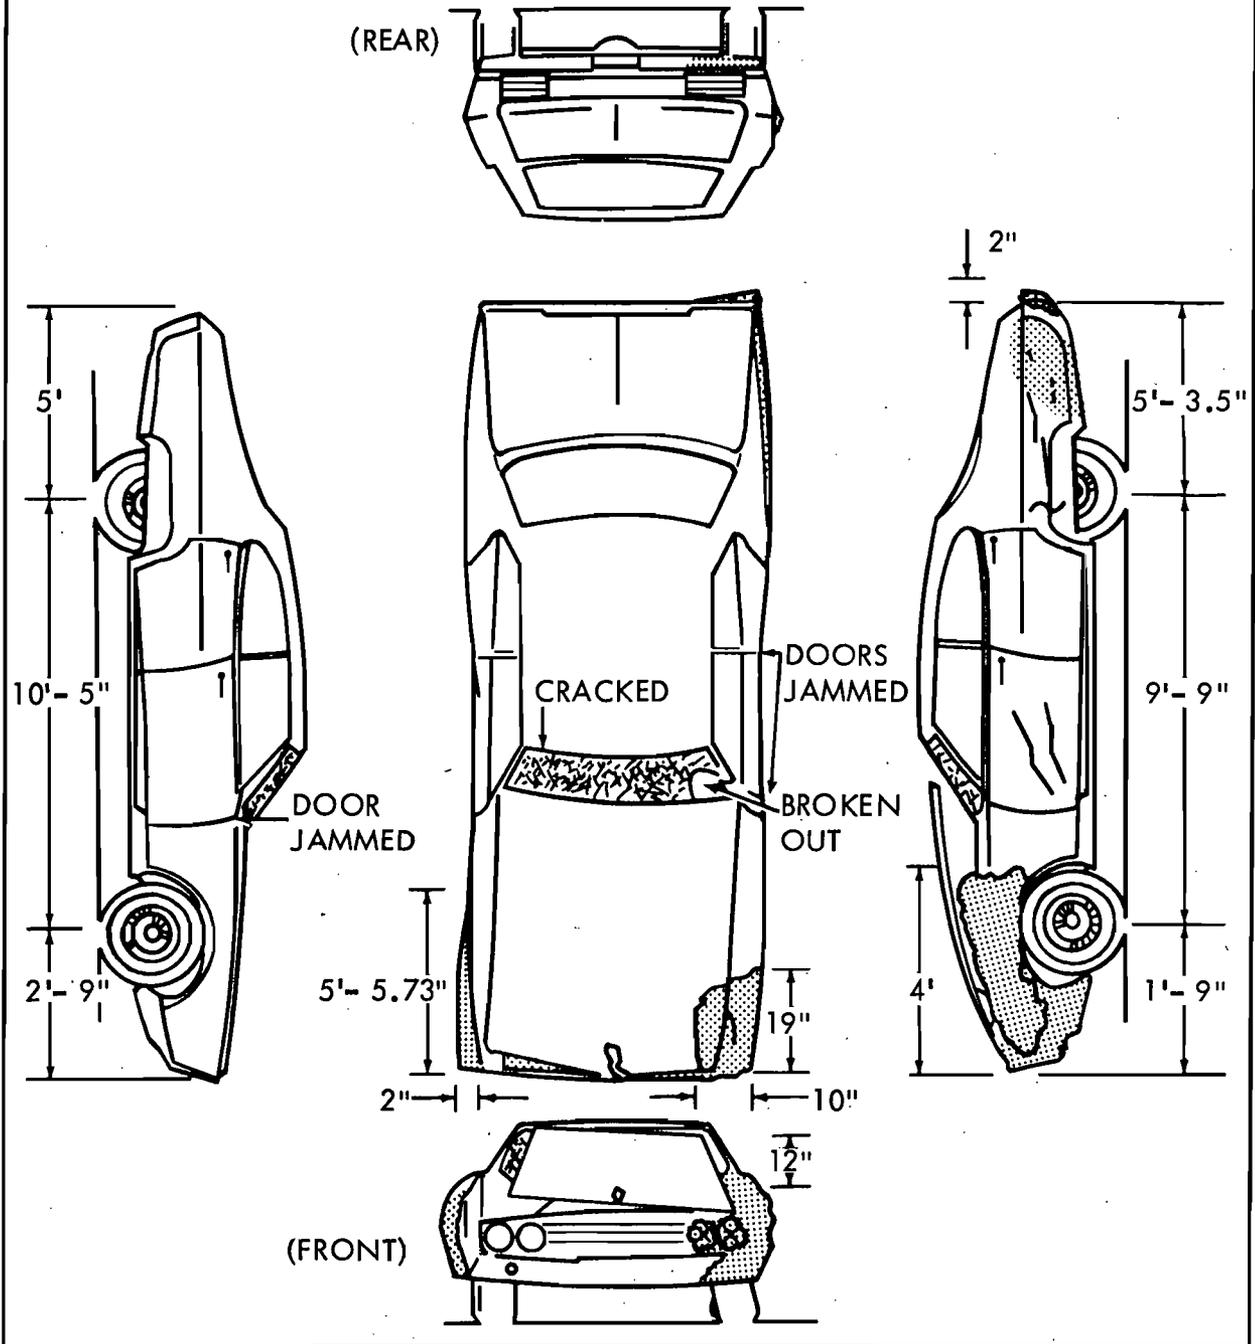
Figure 4

The most significant damage to the automobile was on the left front corner, the windshield, and the left rear corner. (Figure 4 and Appendix 10.)

Along the right side, the outward displacement of the right front fender caused a partial jamming of the right front door.

Interior damage to the automobile consisted only of a slight dent in the chrome covering of the left A-pillar.

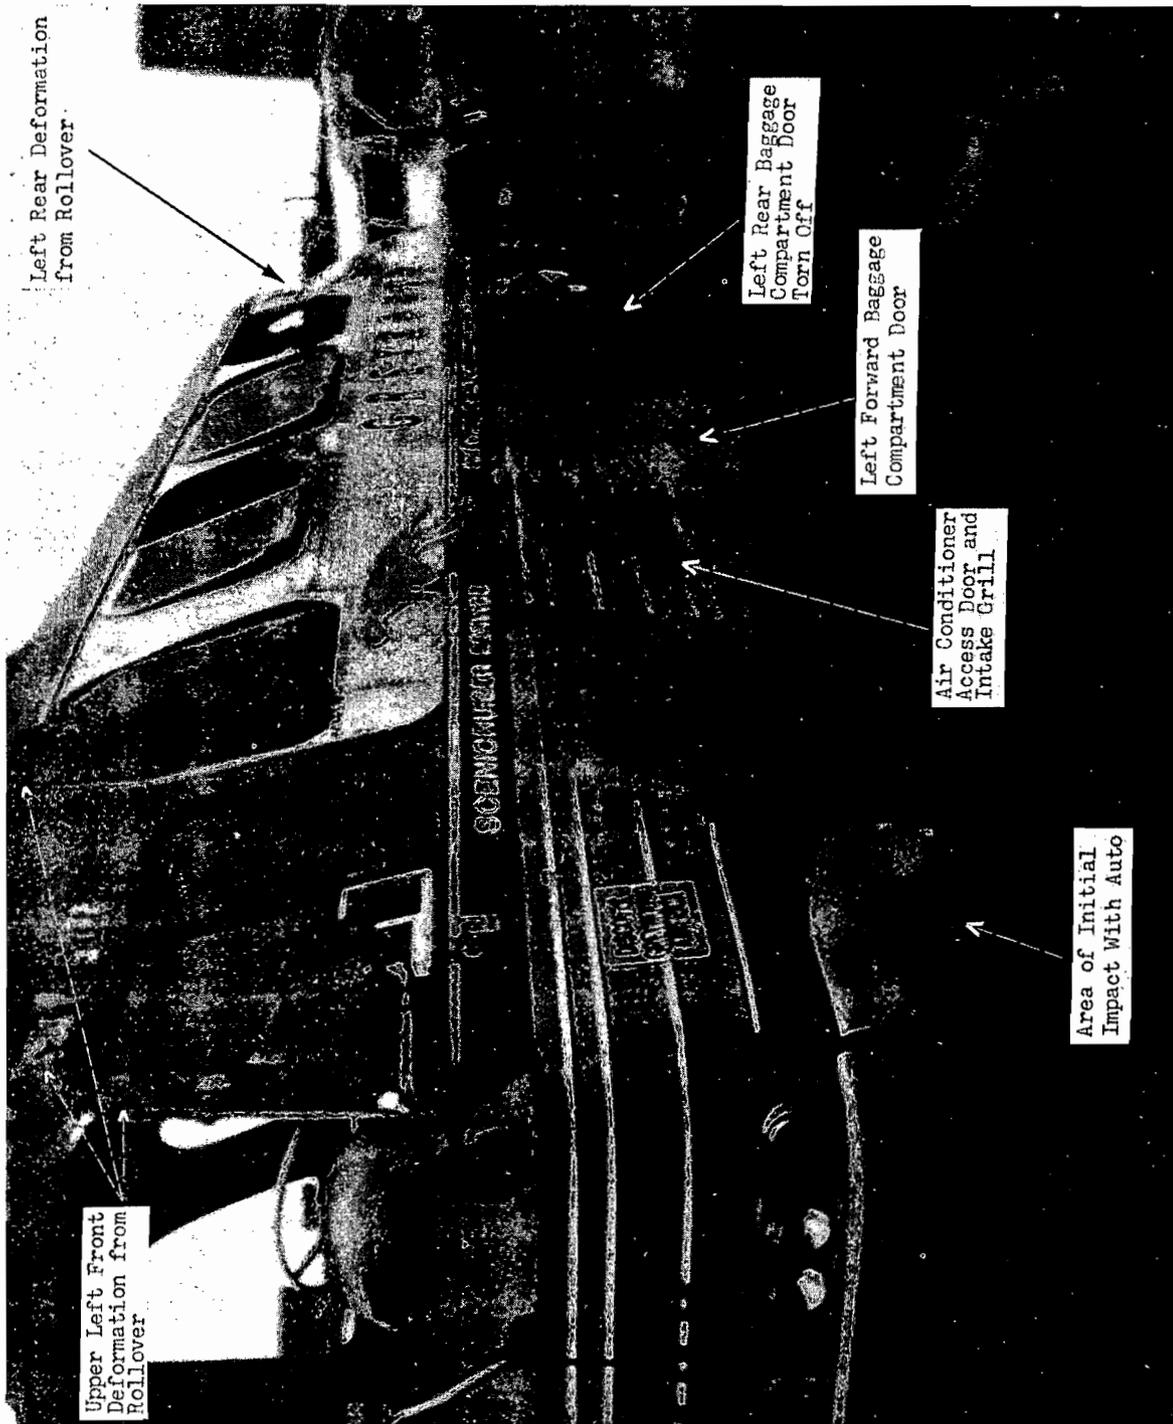
Bus Deformation from Initial Impact with Automobile and Rollover.

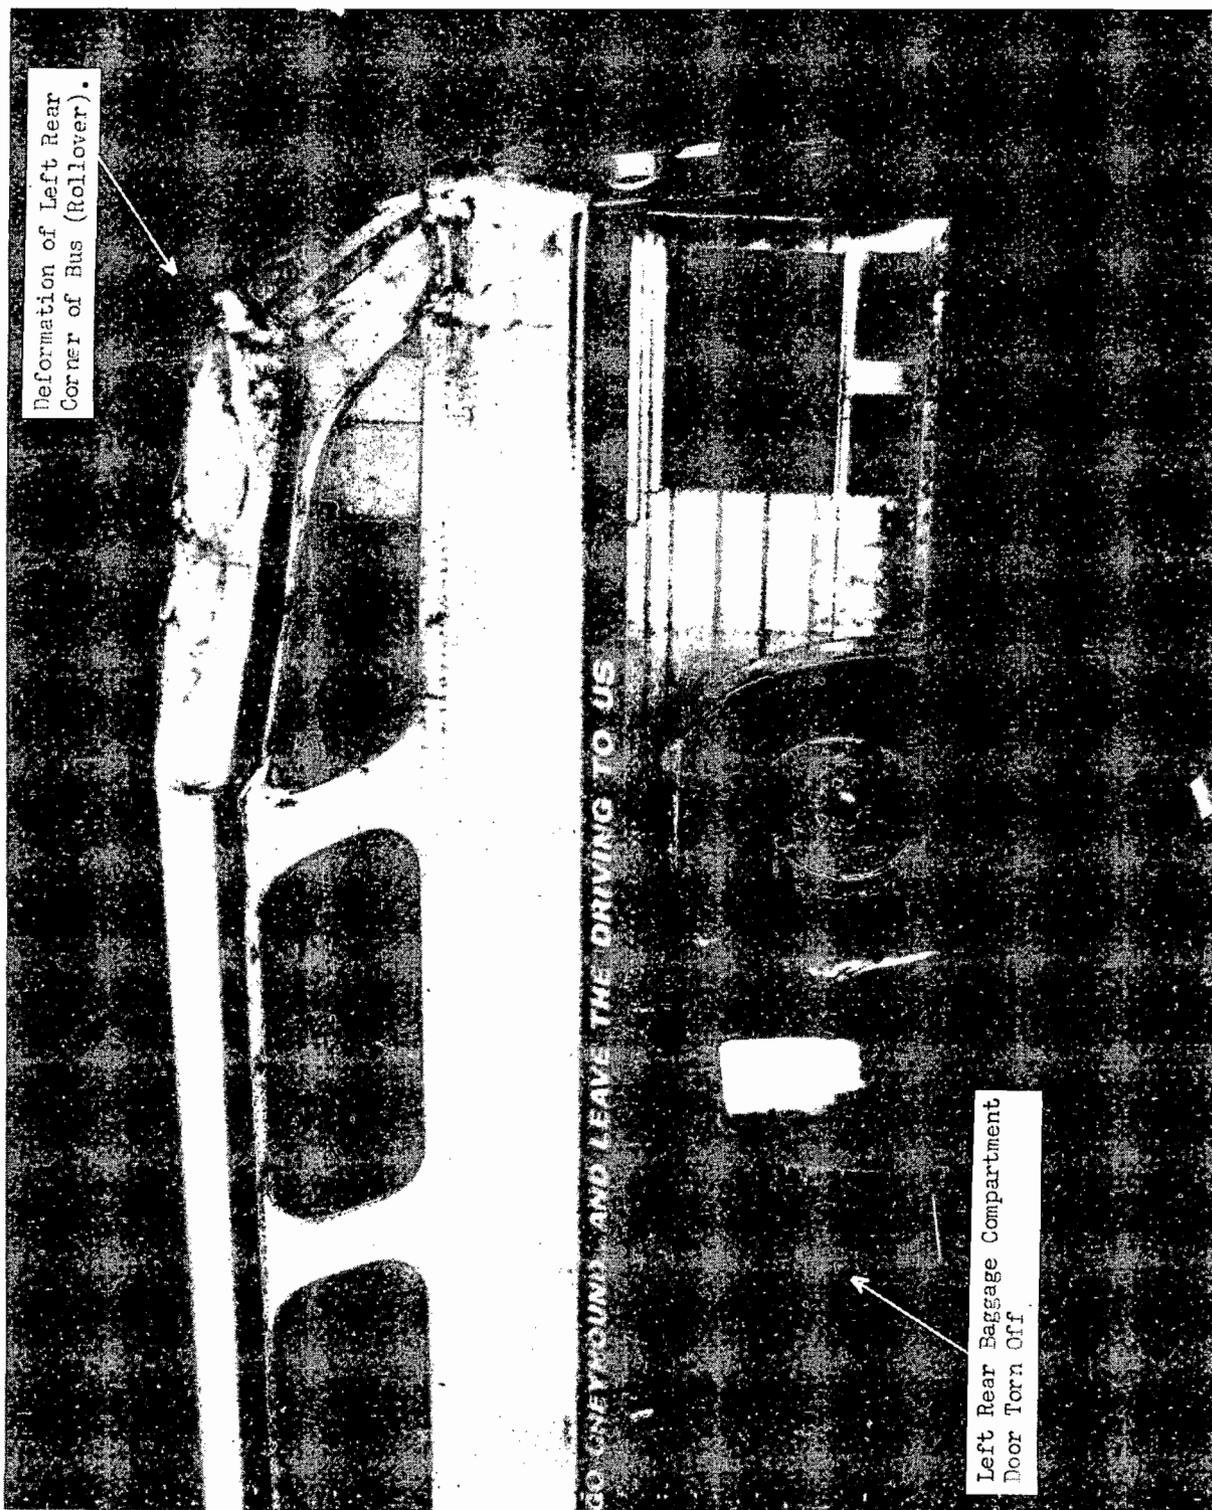
The rear window glass was missing and the frame area was distorted downward and partly inward along the left side. (Appendix 7.)

Deformation to Left Rear of Bus.

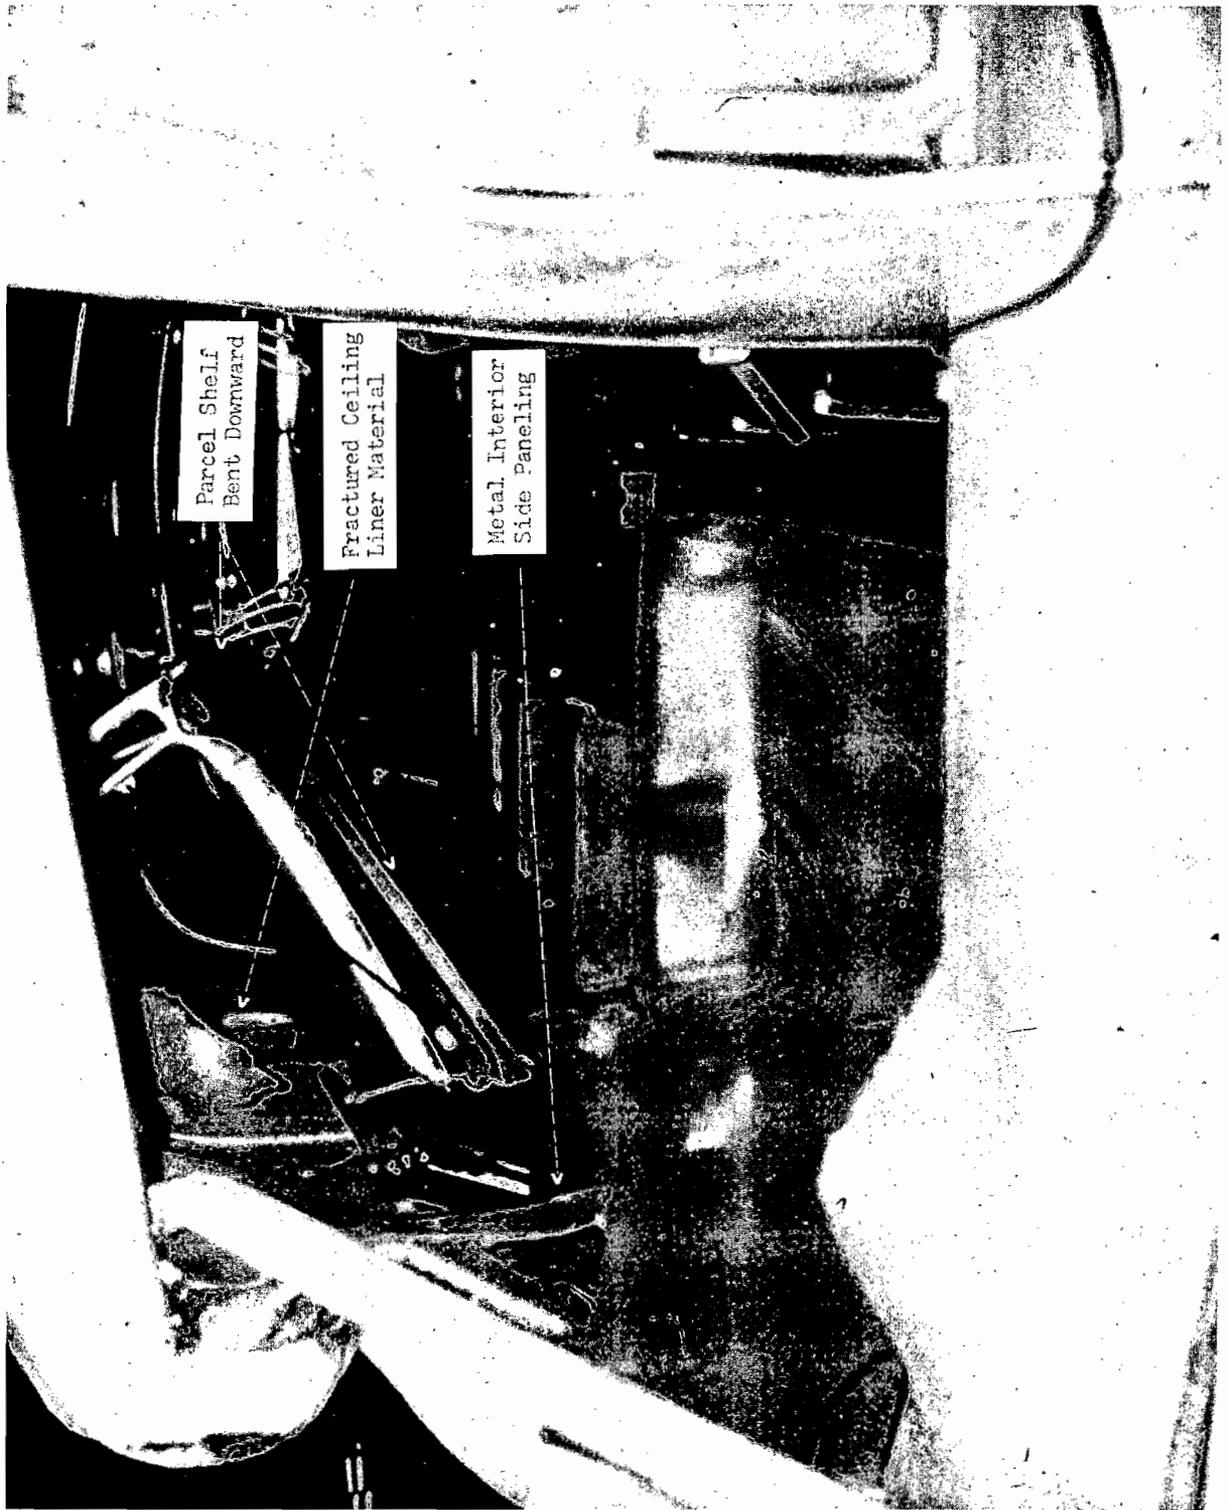
The portion of interior metal paneling covering the left rear roof pillar, which broke free and protruded into the left rear seat area, projected approximately 7 inches to the right from the crushed-in body structure. The bus's body at this point had been deformed to the right approximately 8 inches from its normal orientation. The rear edge of the left overhead luggage rack was deformed extensively downward, but is not believed to have caused injury to any of the occupants.

Bus Left Rear Interior Deformation.

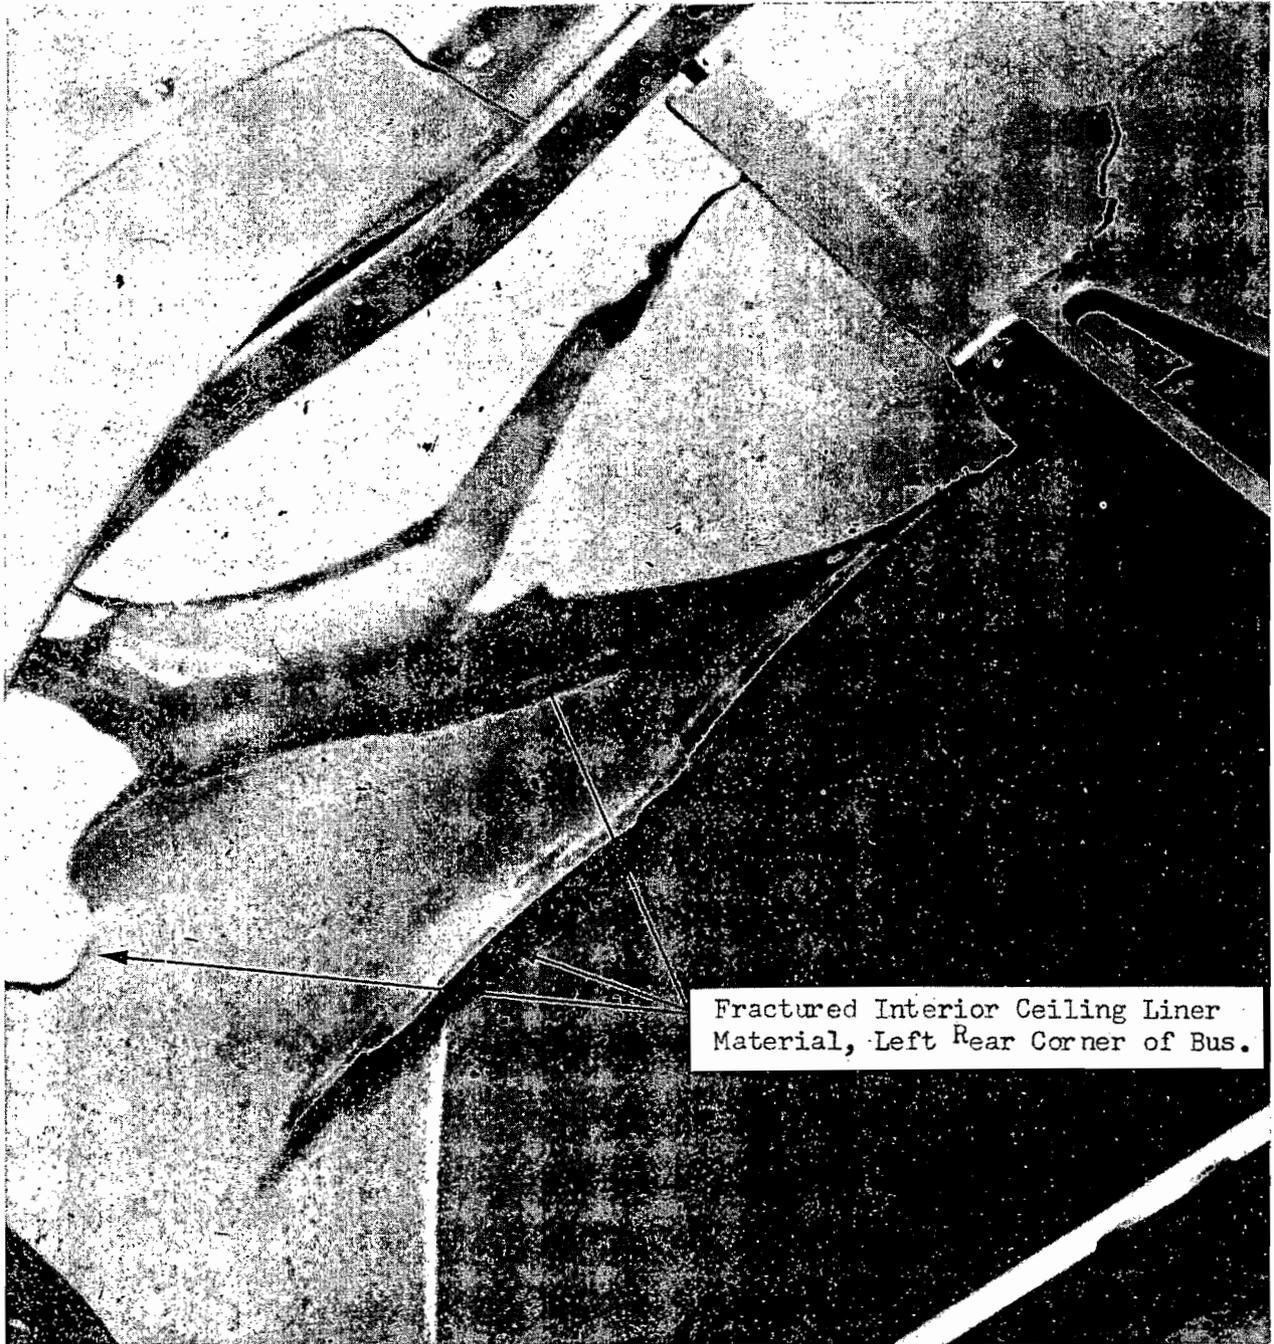
APPENDIX 9

Many passengers complained of headache, neck pain, shoulder pain, and back pain. Much of this discomfort and injury was probably caused by contact with the overhead luggage racks during the rollover. At several locations, the luggage rack was deformed upward between its supports, and only occupant contact would readily explain this deformation. Of the few occupants who could recall their kinematics, several indicated secondary collisions with the luggage racks.

Close up of Fractured Ceiling Liner Material
Over Seats at Left Rear of Bus.

4. The National Highway Traffic Safety Administration study the feasibility and practicality of a standard for passenger buses requiring that overhead surfaces which include roof linings, moldings, parcel or luggage shelves, edges, and support hardware be designed so as to reduce or prevent direct contact injuries in rollover and upset accidents, and that such areas resist separation or fracture of a type which would expose edges to passengers. Such protection is of particular importance in the absence of passenger restraints not currently required.

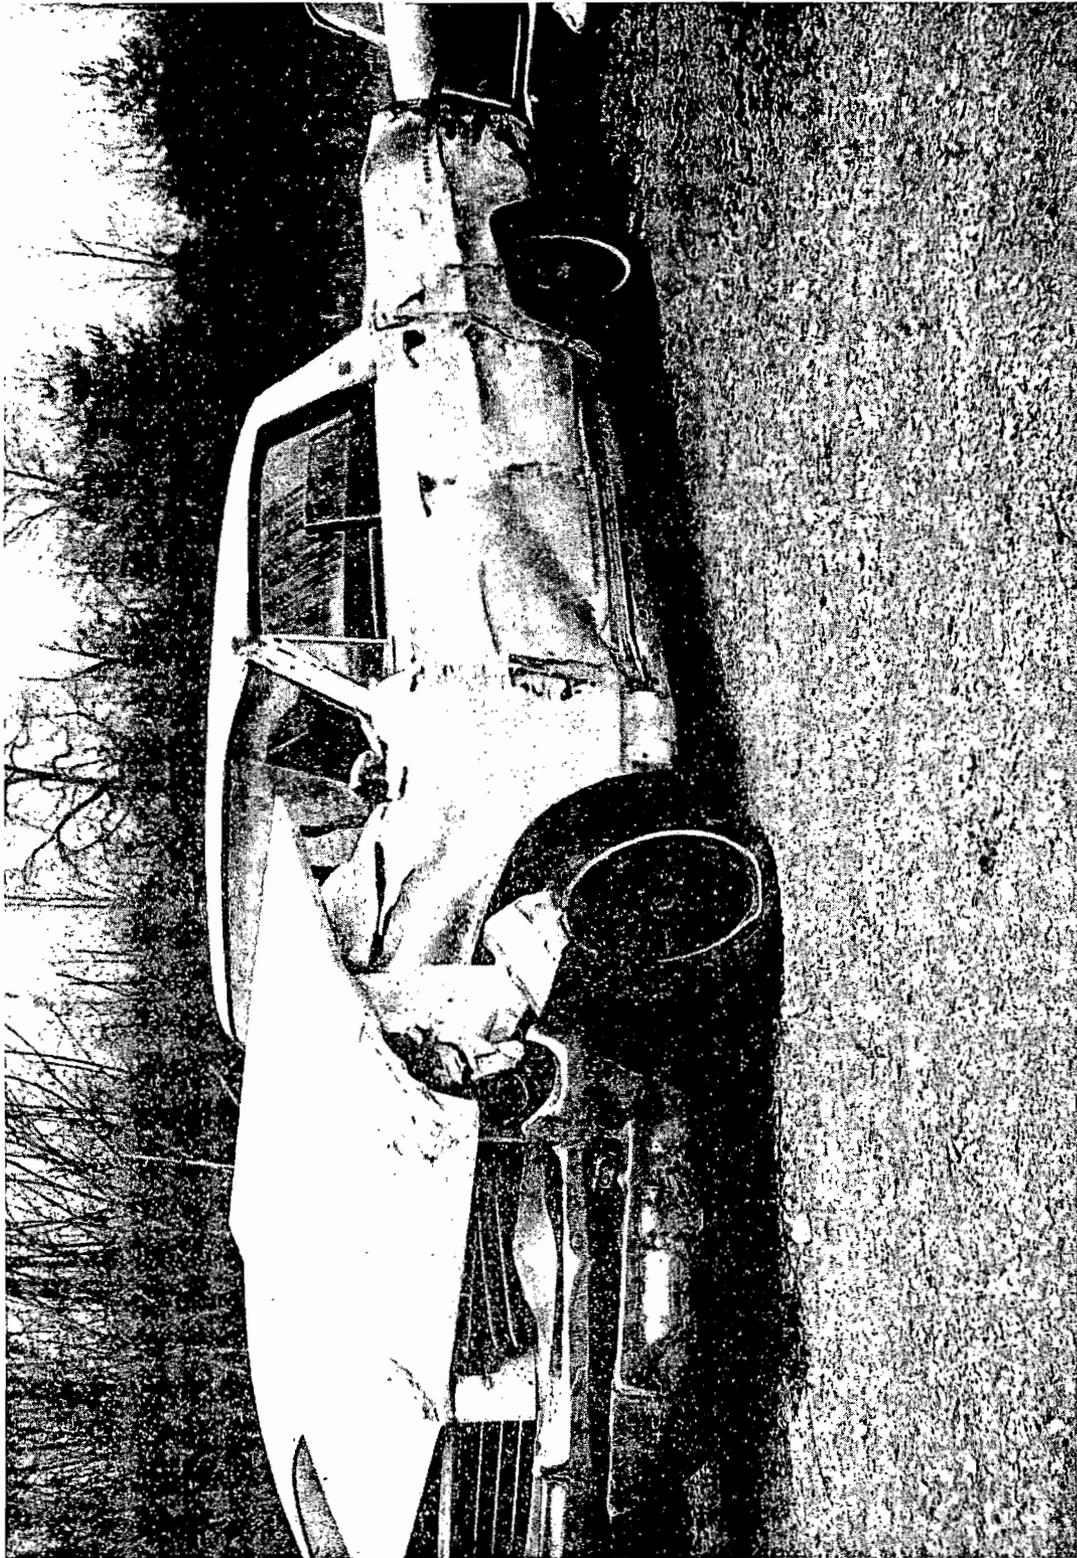
As a result of its left front impact, the automobile's left A-pillar was bent inward and broke the windshield at the left edge. The nature of the breakage observed here was typical of pre-1966, 15-mil laminate windshields. The sharp edges of glass which resulted could have been a source of laceration injury to the automobile driver, who was accelerated toward this left front area during the collision. A dent observed on the interior of the automobile's left upper A-pillar probably resulted from occupant contact but apparently caused no significant injury to the driver. Following impact, the left doors were inoperable, so the driver exited through the right front door after shutting off the engine.

Front and Left Side of Automobile.
