# NATIONAL TRANSPORTATION SAFETY BOARD

## HIGHWAY ACCIDENT REPORT

COLLAPSE OF  
NEW YORK THRUWAY (I-90) BRIDGE  
OVER THE SCHOHARIE CREEK,  
NEAR AMSTERDAM, NEW YORK  
APRIL 5, 1987

NTSB/HAR-88/02

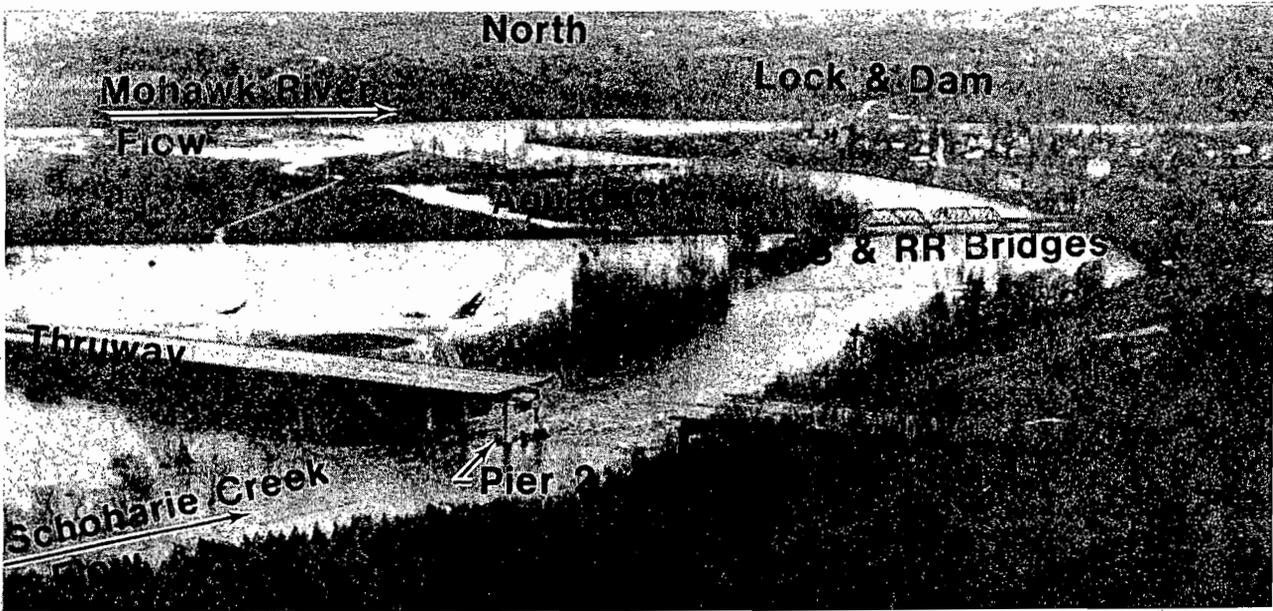
About 10:45 a.m., pier 3 collapsed and the third and fourth spans of the Schoharie Creek Bridge 2/ fell about 80 feet into the rain-swollen creek. (See figures 1 and 2.) Four persons who were monitoring the high water conditions at the Route 5S Bridge (about 2,000 feet downstream from the Schoharie Creek Bridge) observed the collapse. Two of these persons, who were local volunteer firemen, stated that they initially heard a loud noise that sounded like "an explosion or thunder." When they looked up, they saw two sections of the bridge fall. They stated that both sections fell together rapidly along with two eastbound vehicles (a tractor-semitrailer and a passenger car), which were traveling across the falling bridge sections. Shortly afterwards, two more eastbound cars drove into the void in the bridge and plunged into the creek. About a second later, a westbound car also drove into the void and sank immediately into the fast moving water. Shortly afterwards, one witness observed bundles of paper products and what appeared to be oil on top of the water.

Figure 1.--Flood of 1987 after the initial collapse looking north.

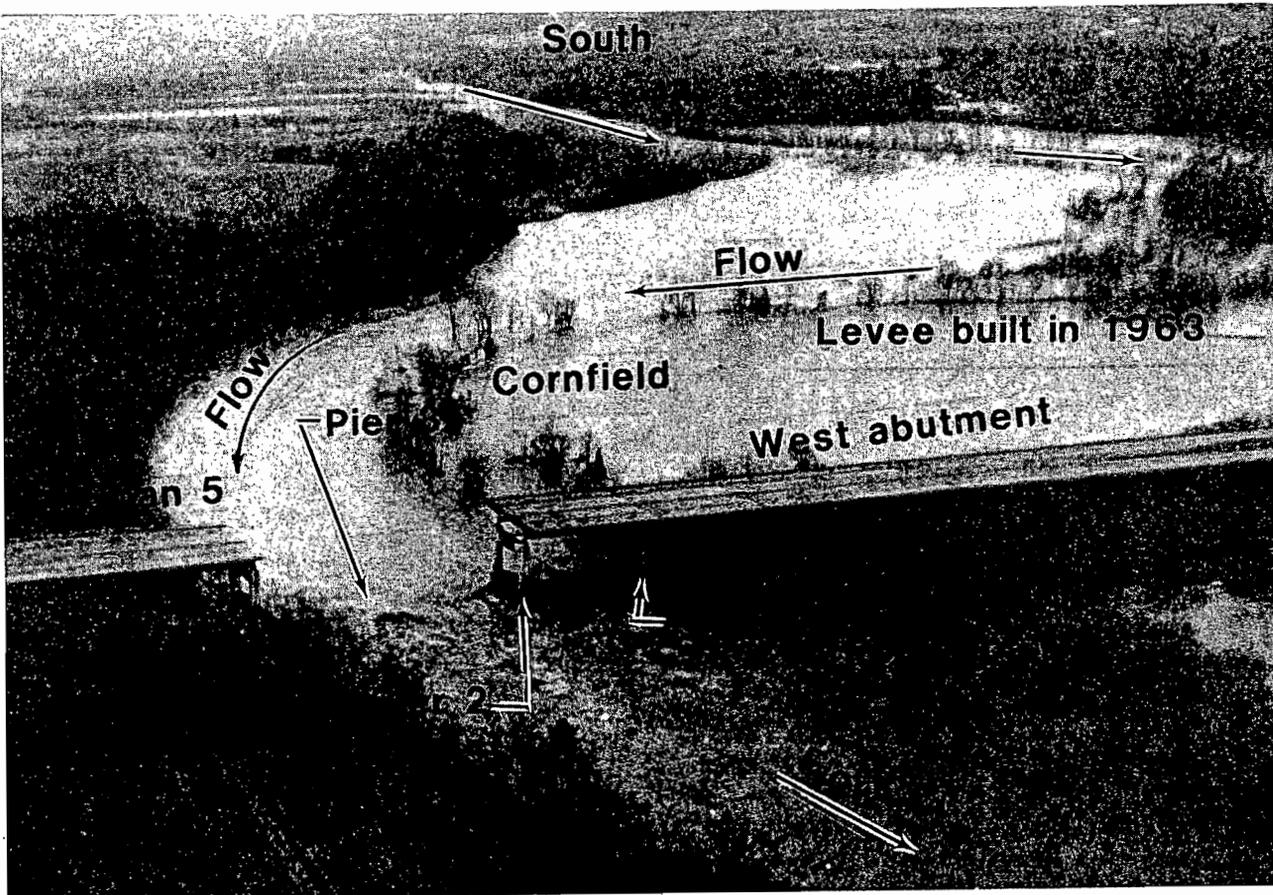
Figure 2.--Flood of 1987 after the initial collapse looking south.

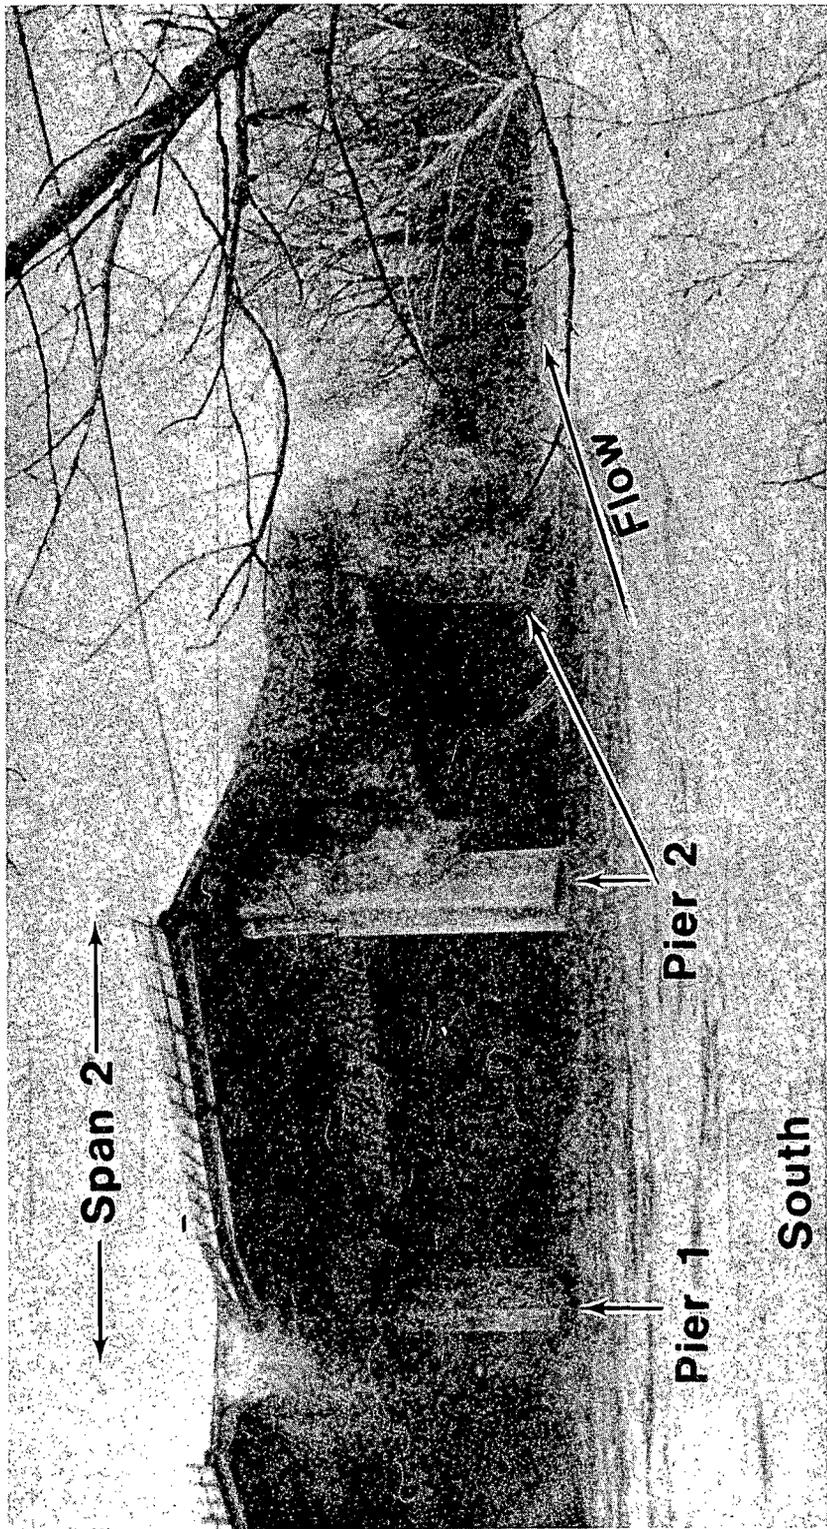
The collapsed bridge was almost a total loss. (See figures 10 and 11.) The estimated total cost for the construction of the replacement bridge, detours, forensics, overtime, and lost Thruway revenues was about \$44 million dollars.

Figure 10.--Photograph looking northwest during the collapse of span 2.

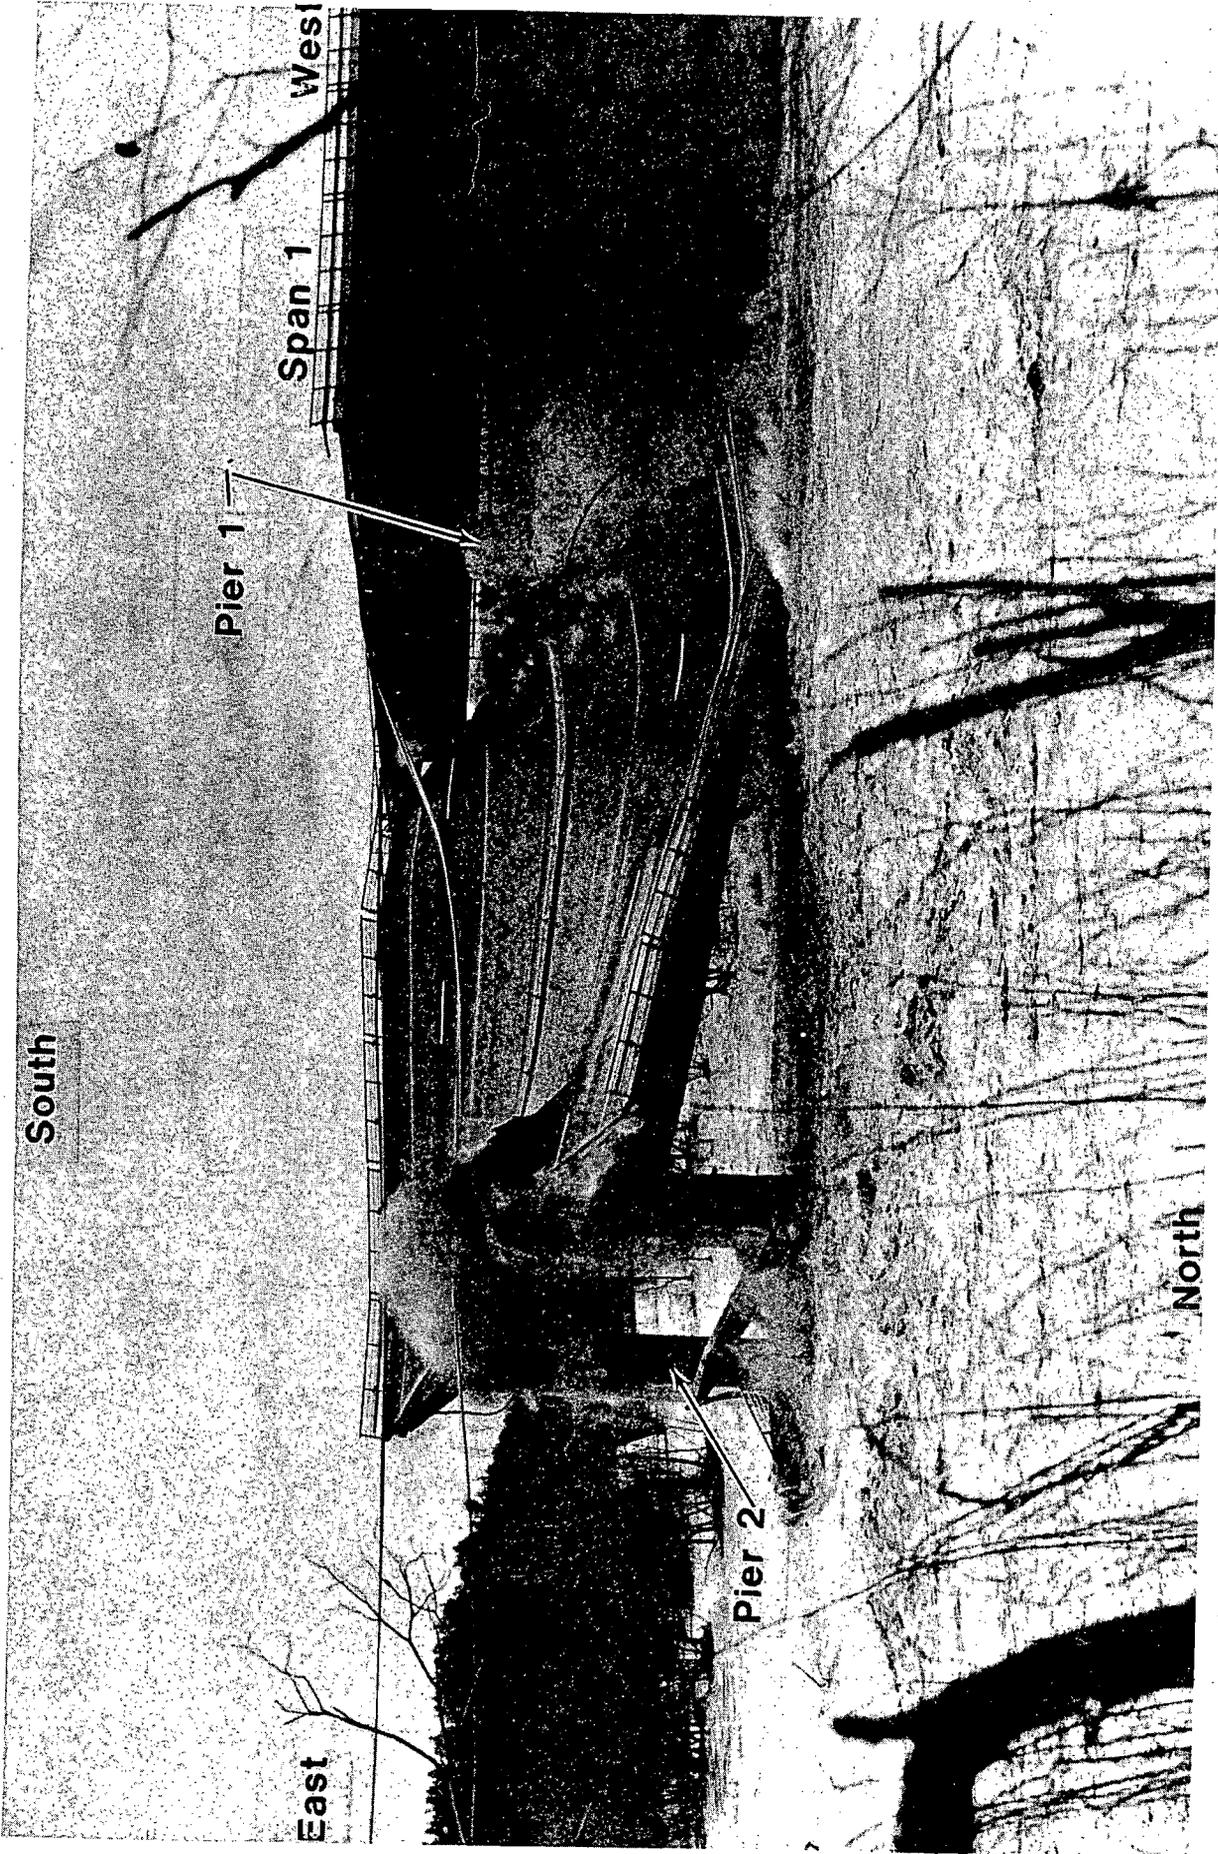
Figure 11.--Collapse of span 2.

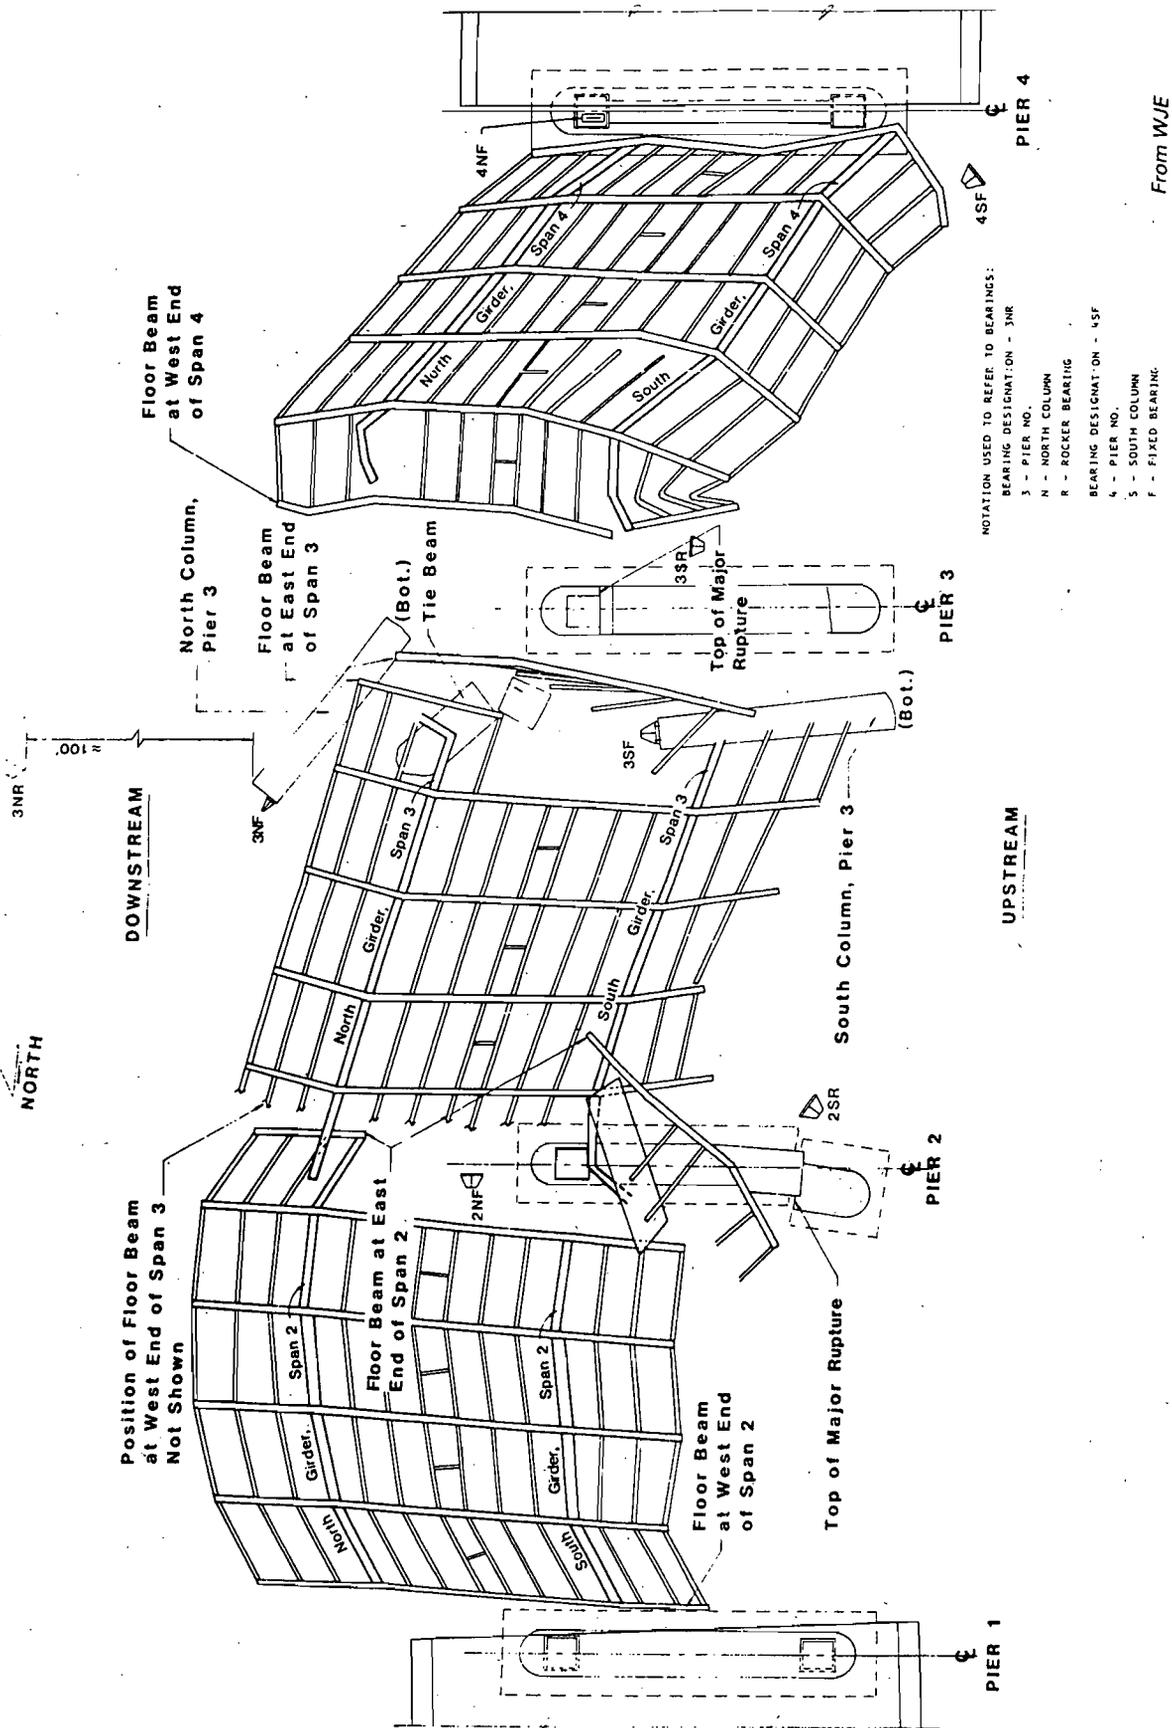
Figure 12.--Plan view of collapsed spans 2, 3, 4.

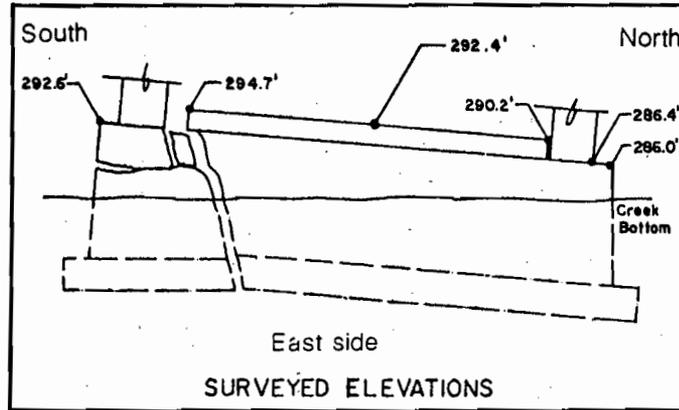
Pier 1

Pier 1.--Pier 1 tilted significantly to the north and east. WJE reported that the columns were out-of-plumb. In addition, the plinth was broken into two pieces, with the break beginning at the junction of the plinth reinforcement and the south column, and extending downward into the plinth. The break was wide at the top and WJE projected that it extended down through the footing. A horizontal separation in the plinth about 6 feet below the base of the south column appeared to have begun along a construction joint. The north end of the footing at pier 1

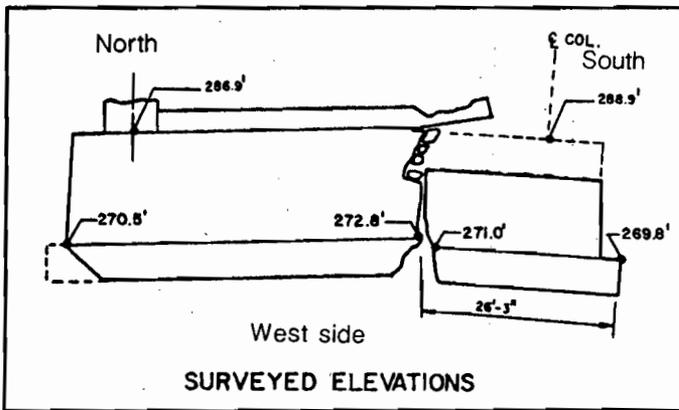
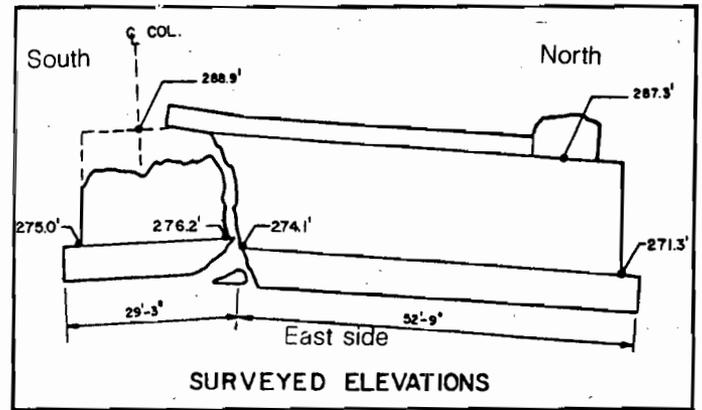
Pier 2

WJE found extensive erosion of the soil under pier 2. Survey measurements indicated that the pier had settled along its entire length and was also tilted toward the west. The north end had settled about 5 feet below its originally constructed elevation. The north column, as measured at the interface between the column base and the top of the plinth, settled an average of 3.9 feet. The south column settled an average of 2.1 feet. The north column remained standing after the collapse, and was removed during the demolition work.

The plinth of pier 2 had broken into two pieces. WJE reported that the break began about 6 feet north of the junction of the plinth reinforcement and the south column, extending downward vertically through the plinth and footing. Measurements of the top of the eastside footing adjacent to the break showed that this area was at its original as-constructed elevation of 275.0 feet. The south column separated from the plinth at the bottom of the column steel reinforcement dowels, which were embedded 5.5 feet below the top of the plinth.

In addition, pier 2 rotated to the west about the longitudinal axis of the plinth. The elevation of the western end of the south pier segment was 5 feet lower than the eastern end, while the north pier segment had a change of 1.2 feet in height along its 19-foot width. The northwest corner of the footing was broken off at about the edge of the plinth.

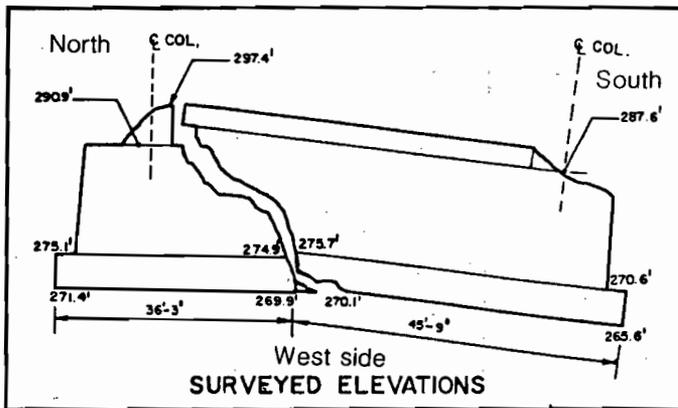
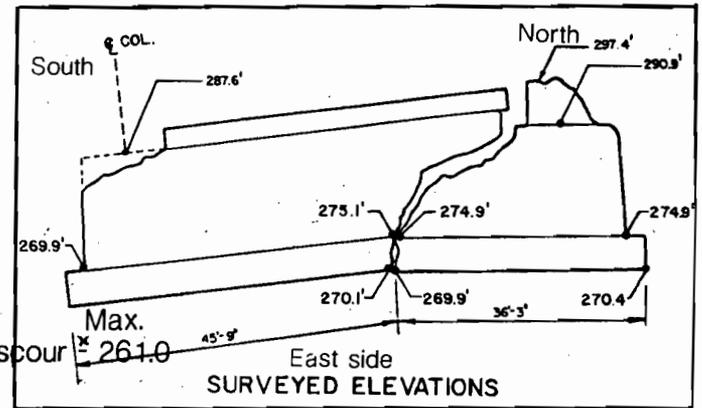
Pier 3

The plinth of pier 3 had broken into two pieces. WJE reported that the break began near the junction of the plinth reinforcement and the north column and extended down, near the center of the plinth. The break intersected another vertical crack that extended through the footing. WJE stated that the lower crack had occurred sometime before the bridge collapsed, as indicated by the dirty interface between the crack.

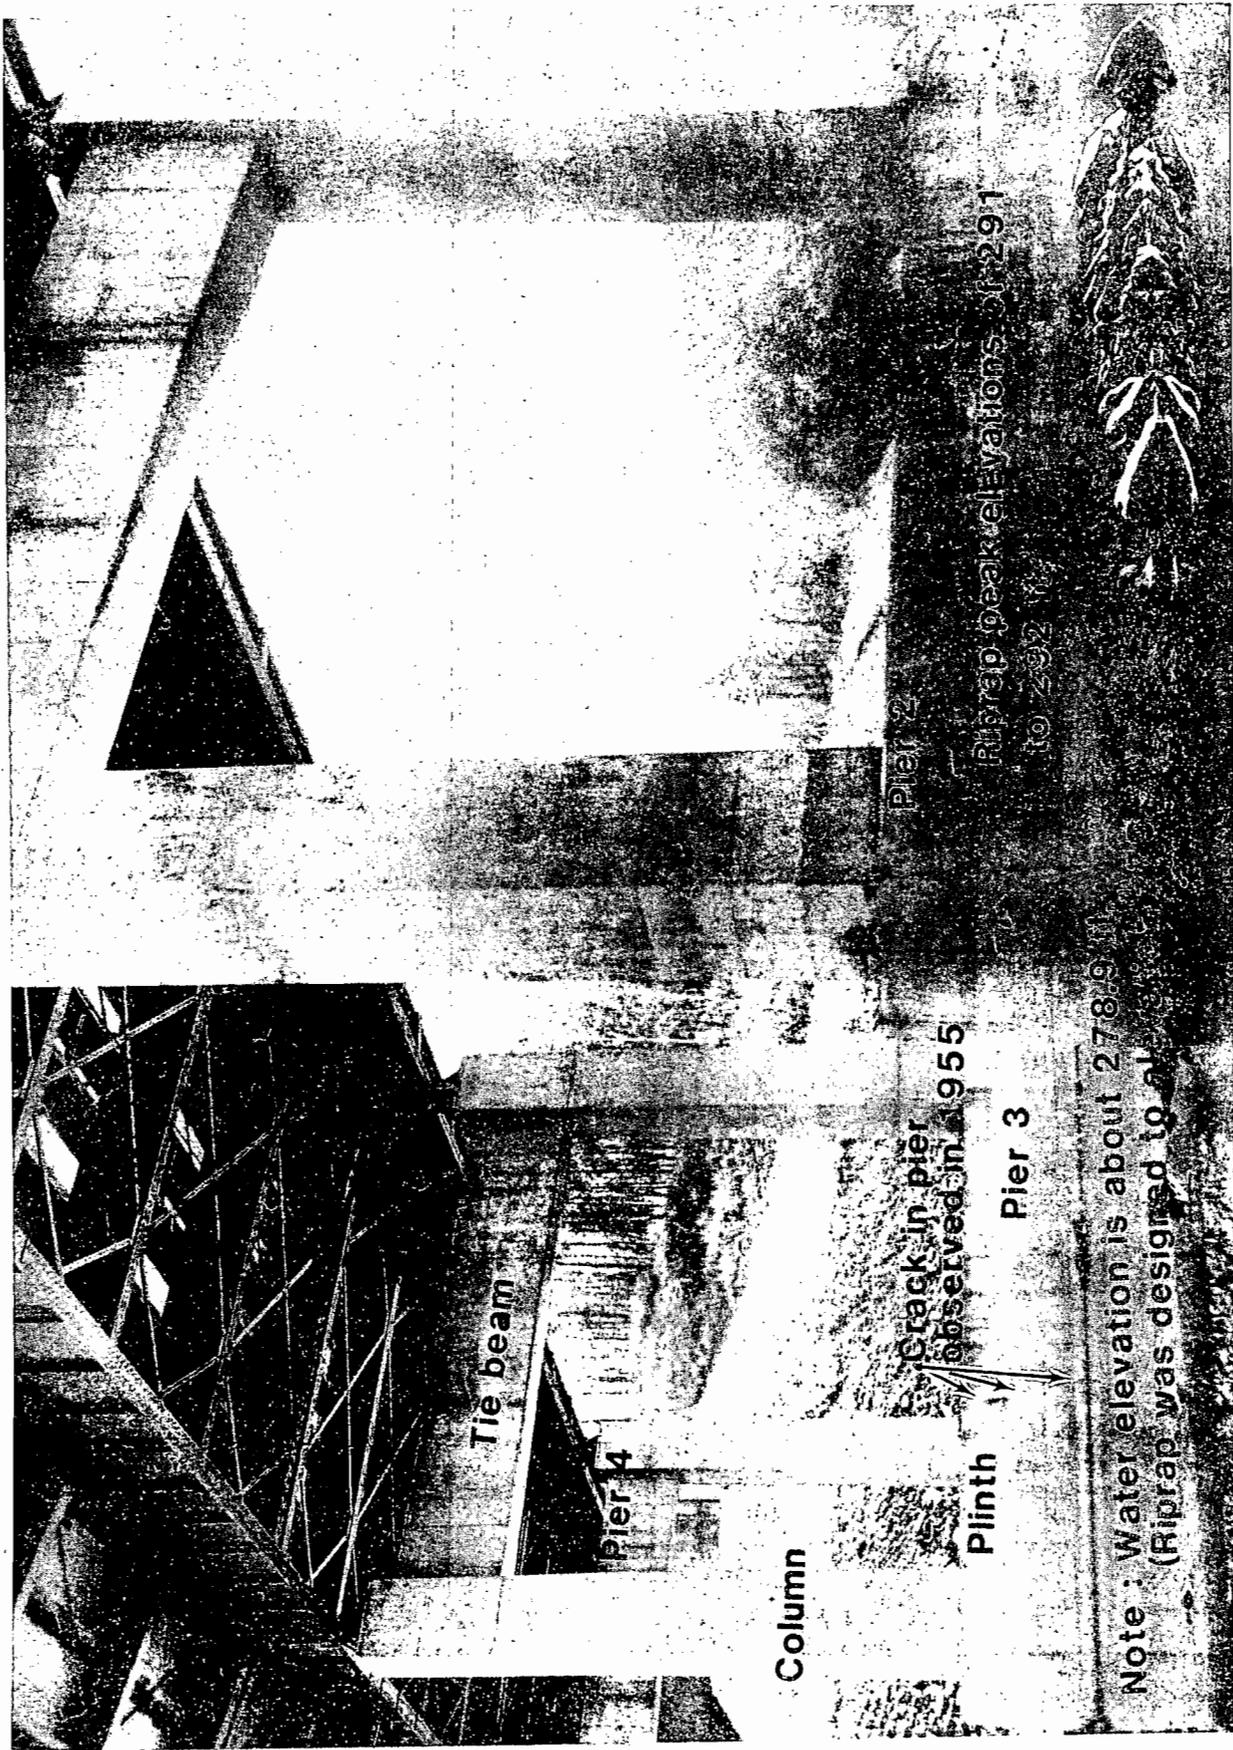
Three photographs taken on October 30, 1956, show riprap at the bridge piers. These photographs show that the water level was between elevation 278 and 279 feet, which is about 1 foot below the top of the riprap as called for in the design plans. In one photograph (figure 21), very little riprap was visible on the southeast side of pier 2, while a slight mound of riprap visible on the northeast corner extends upward to an elevation of about 281 feet. The second photograph (figure 22) shows a water elevation of about 279 feet, with only a few pieces of riprap visible on the west side of pier 3. On the west side of pier 2, some riprap is visible to an elevation of about 281 feet. In the last photograph (figure 23), between the columns of pier 3 on the east side, riprap is visible at an elevation of 283, which was 3.5 feet above the height called for.

Figure 22.--Photograph of the east side of pier 3 taken on October 30, 1956.

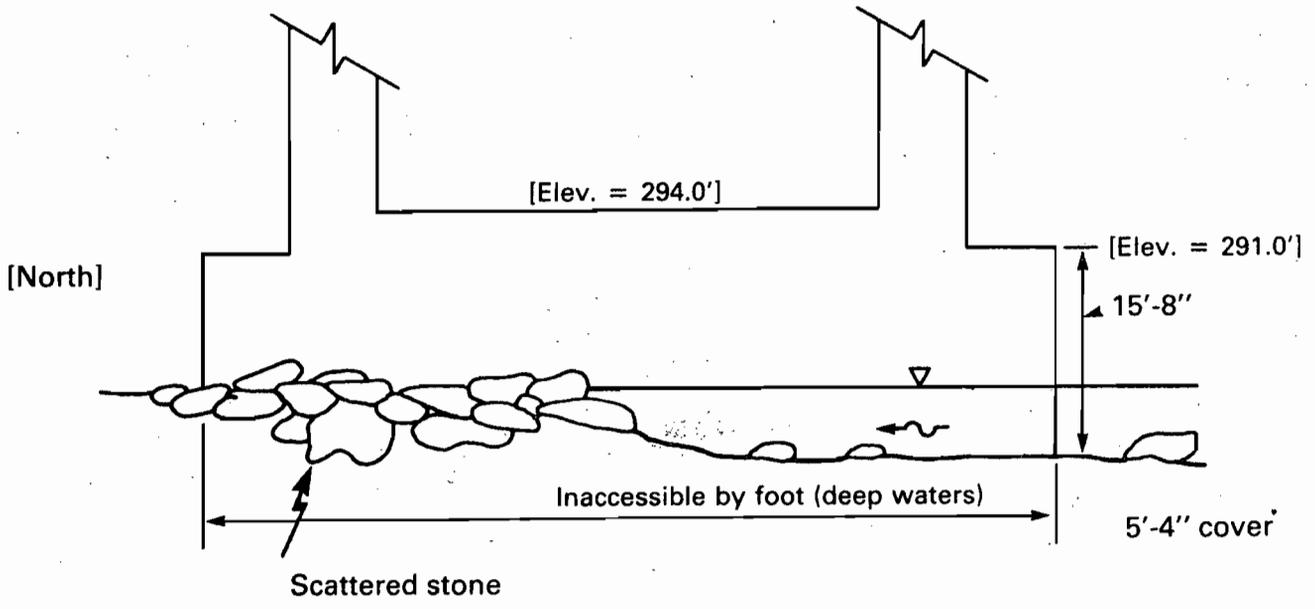
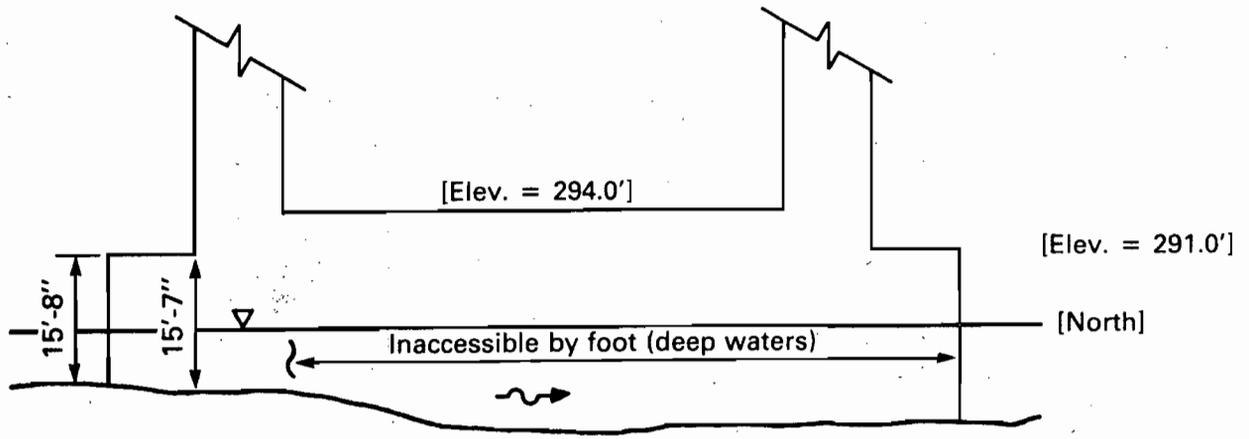
Figure 24.--Seelye sketches of pier 2.

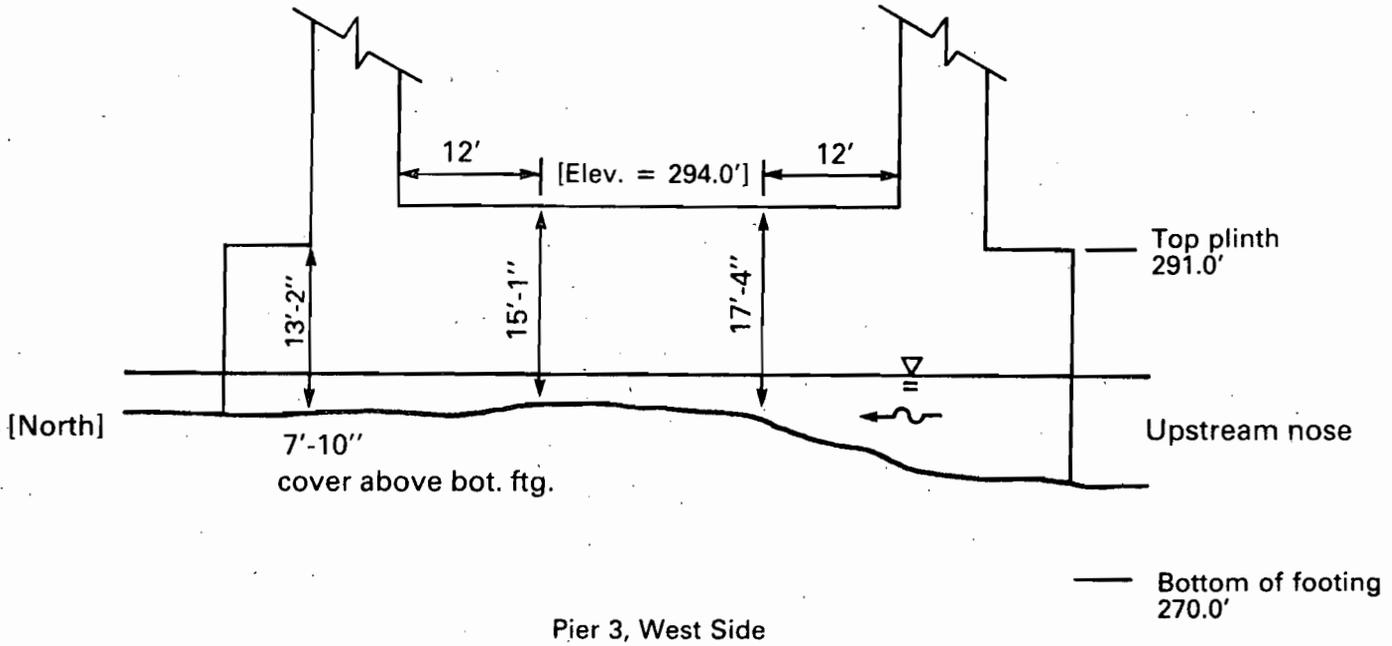
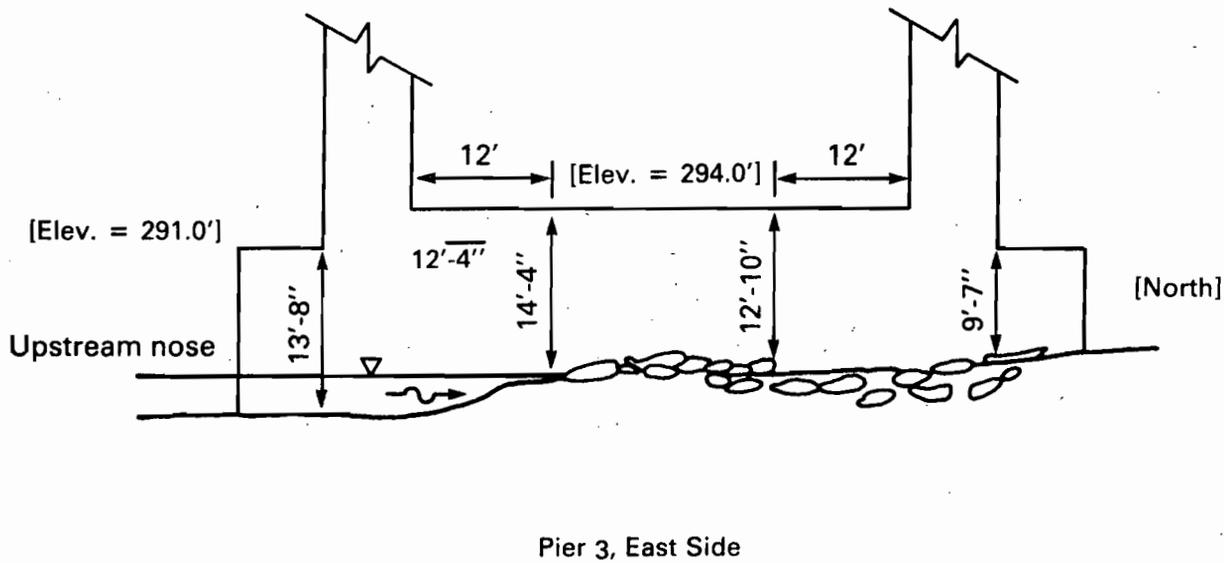
Figure 25.--Seelye sketches of pier 3.

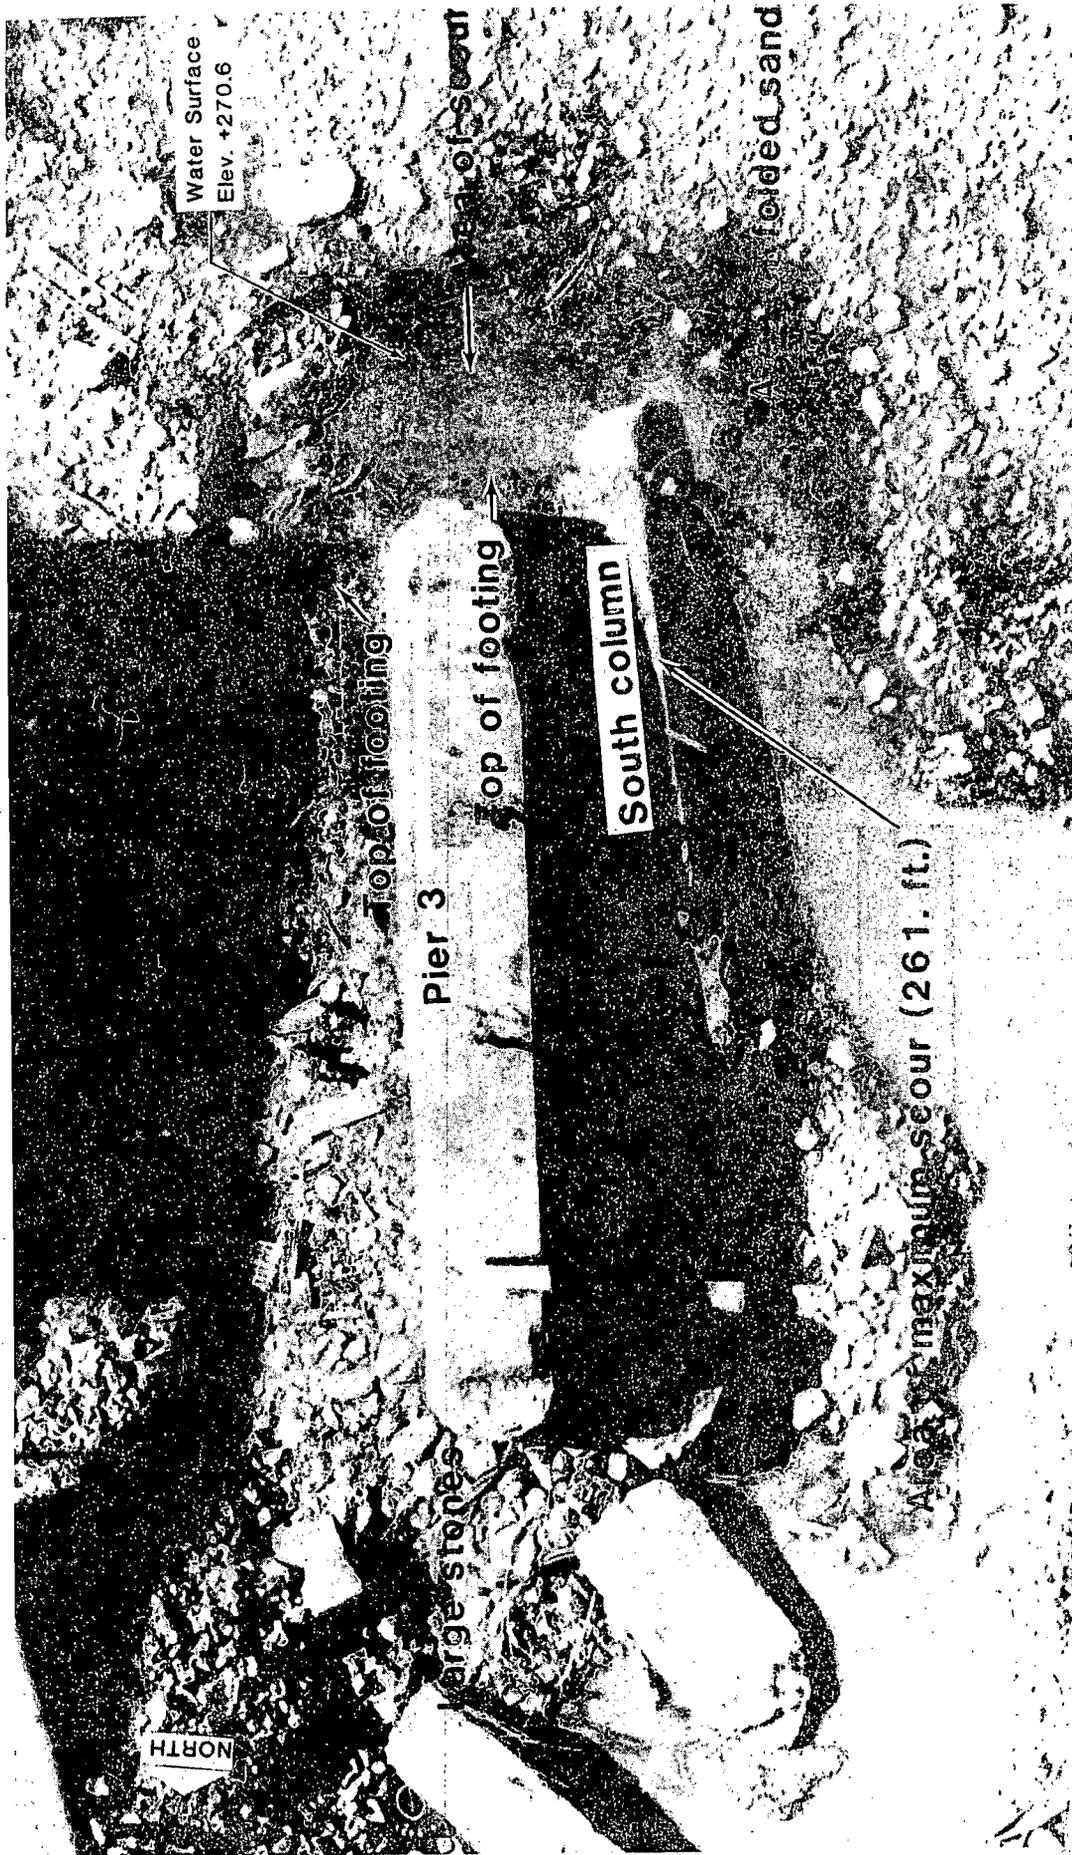
Figure 28.--Photograph of pier 3 after dewatering,  
before excavation of sides.

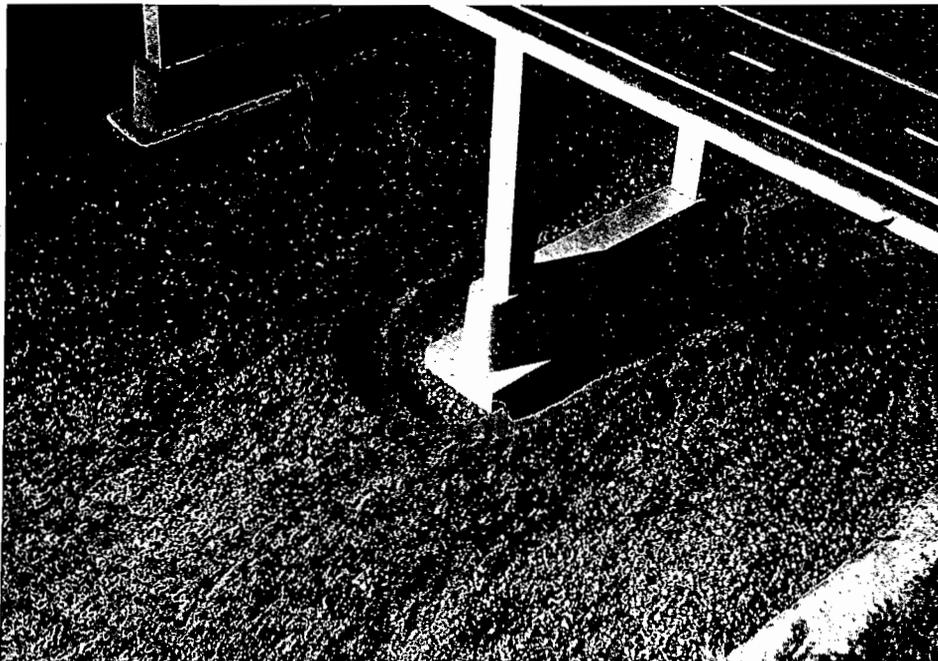
Figure 34.--Pier 3 from the right bank showing the scour hole in the dry channel after simulation of the 1987 flood prior to bridge failure. Pier 2 at the top of the picture has considerably less scour than pier 3.

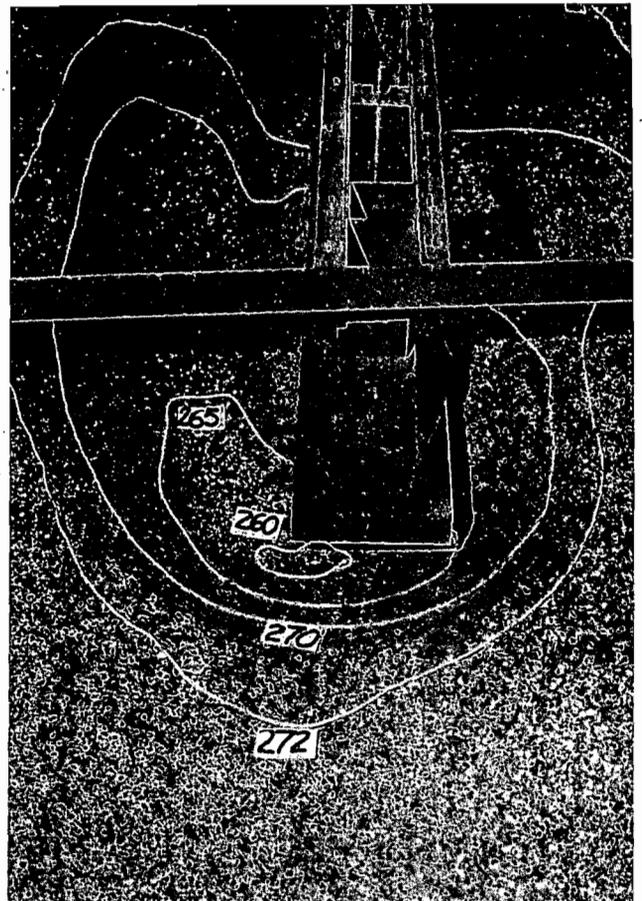
Figure 36.--Contour of the dry scour hole under pier 3 for the 1987 flood conditions in the 1:15 model.

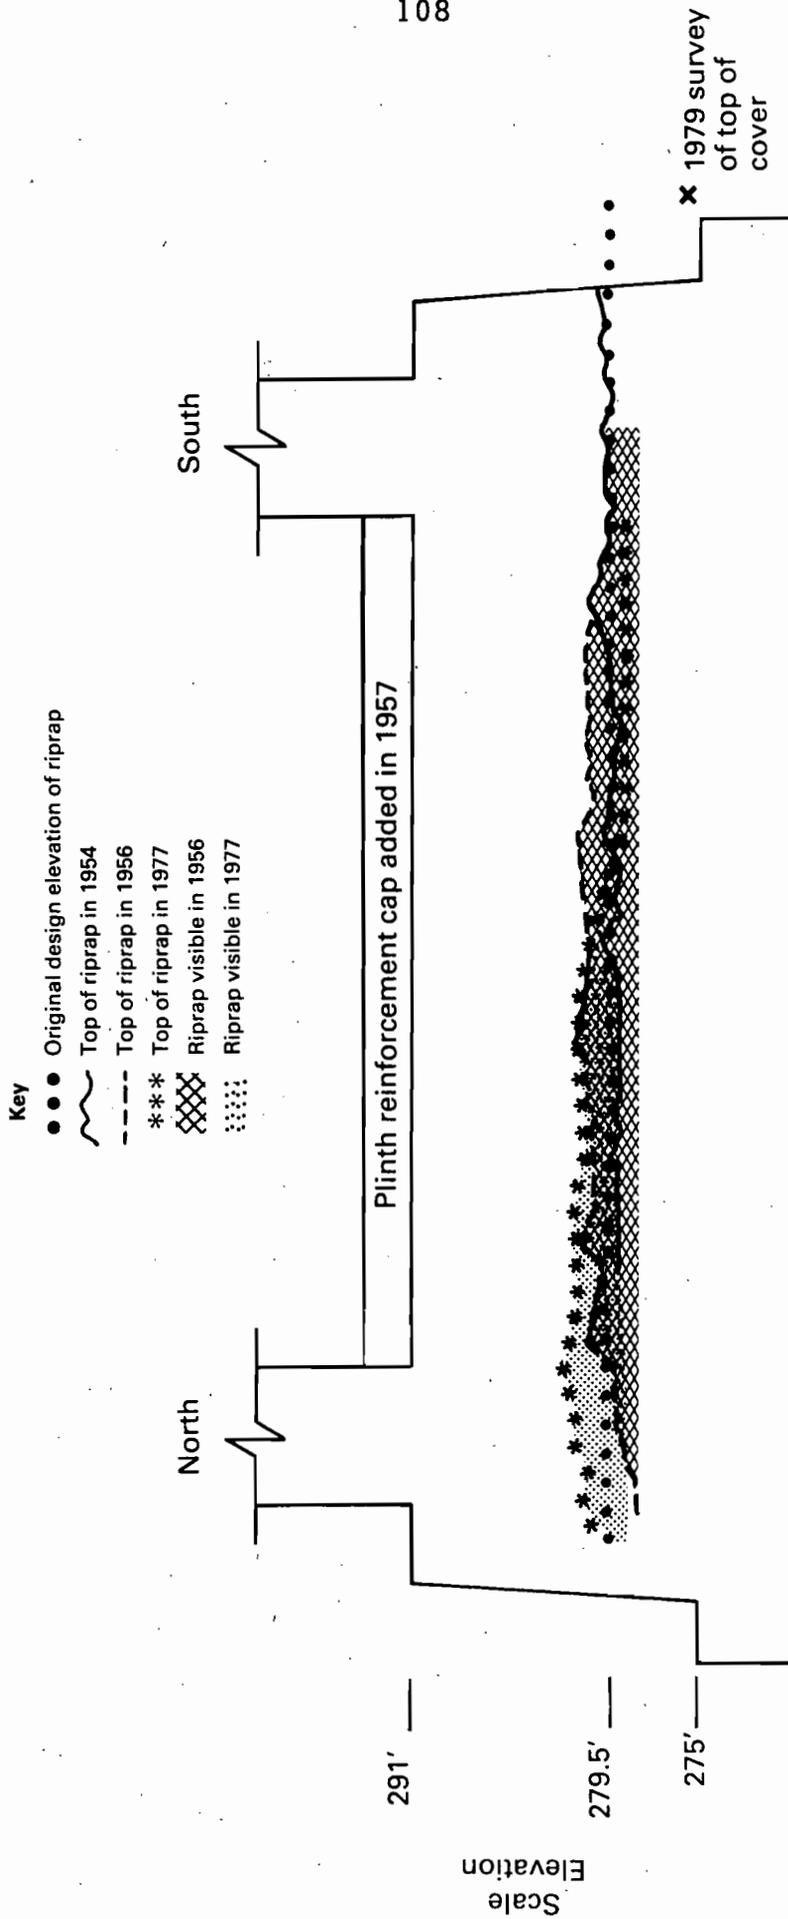
Depth of Initial Riprap.--Based on observations at the site and on the results of the RCI/CSU physical model runs, the Safety Board believes that riprap was not initially placed to the bottom of the pier 3 footing. Observation at the site after the collapse included the following:

Figure 38.--Movement of riprap along the west side of pier 2.

1. Riprap was not found at the bottom of the footing in those areas at the north end of pier 3 where the footing was covered with rock; in fact, the material found under the rocks was similar to the material expected to be found in the streambed.
2. Drops of paint used on the bridge's superstructure in 1985 and 1986 were found on large rocks at the north end of the pier, indicating that the large rocks probably had not moved during either the 1986 or the 1987 flood.
