Motorcoach Run-Off-the-Road and Rollover
U.S. Route 163
Mexican Hat, Utah
January 6, 2008

NTSB/HAR-09/01
PB2009-916201

Highway Accident Report

National Transportation Safety Board. 2009. *Motorcoach Run-Off-the-Road and Rollover, U.S. Route 163, Mexican Hat, Utah, January 6, 2008.* Highway Accident Report NTSB/HAR-09/01. Washington, DC.

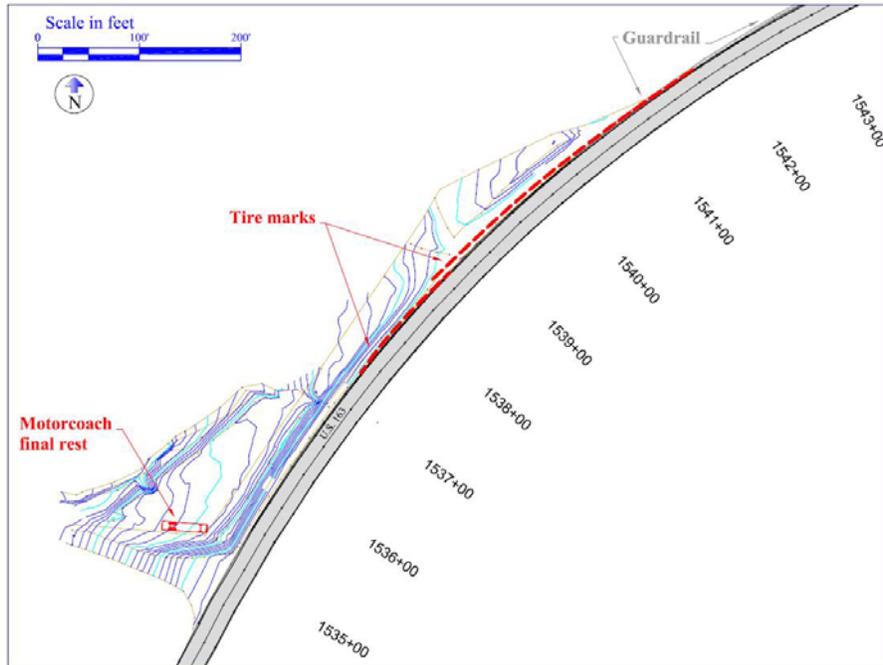
Figure 2. Scene diagram showing tire marks (dashed plow marks show the tire tracks gradually departing the road).

⁵ Survey information in figure 2 shows the plow marks of the tires departing the pavement at station number 154,200 and ending at approximately station number 153,850, a difference of 350 feet.

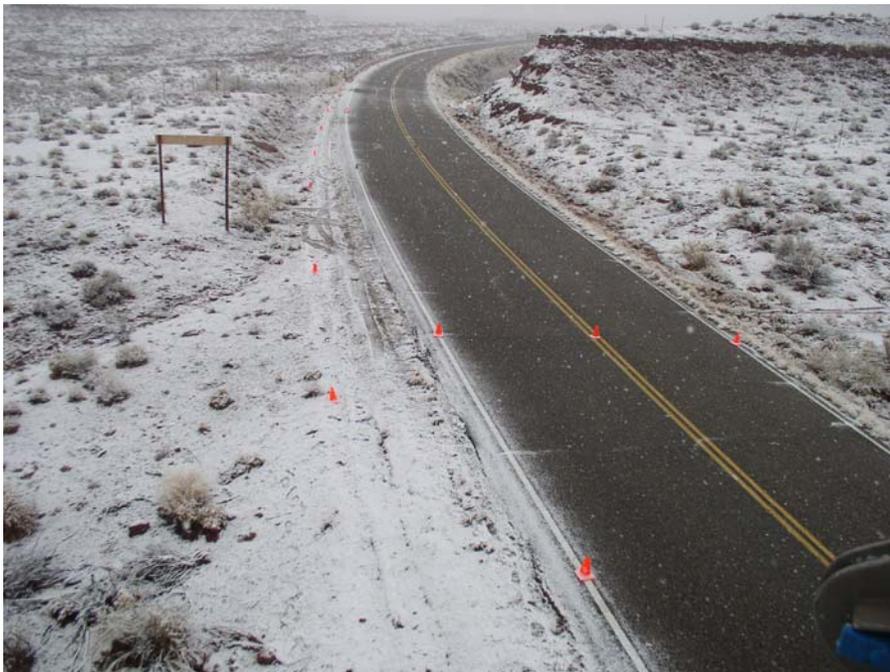
Figure 3. Tire marks on roadway (row of traffic cones to left of roadway follow the tire marks onto the foreslope).

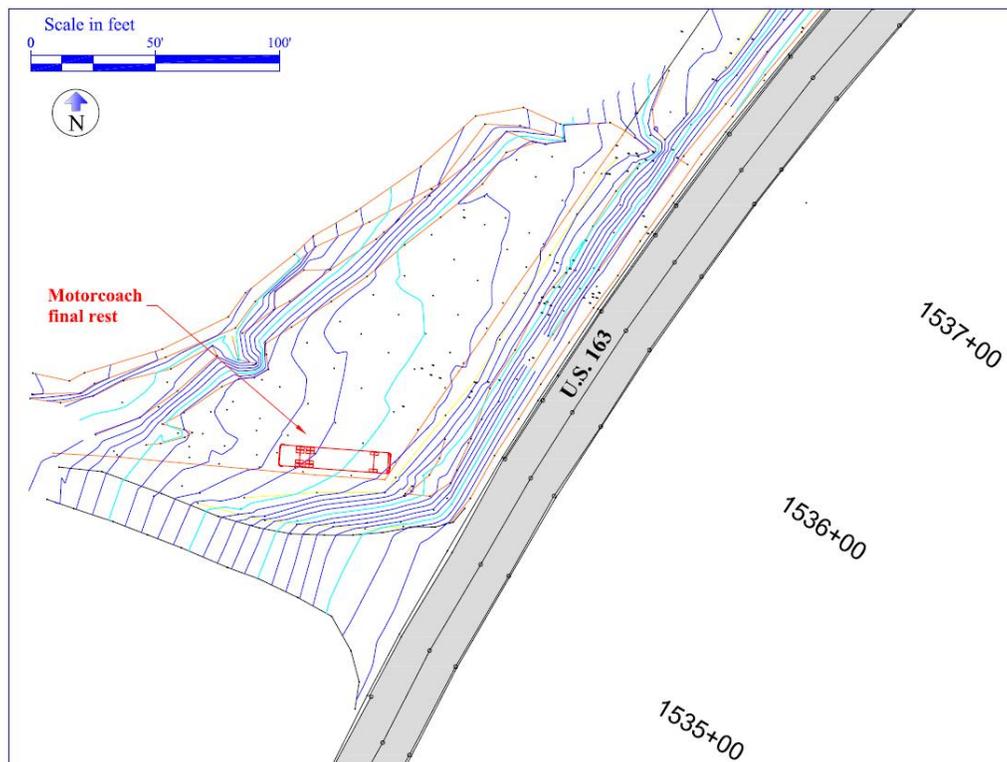
After departing the roadway, the motorcoach traveled approximately 350 feet before the rear wheels went off the embankment.⁵ The rear of the motorcoach rotated counterclockwise, with the front of the motorcoach facing perpendicular to the roadway.⁶ The motorcoach overturned, rolling to the right, and struck a rocky drainage ditch at the bottom of the embankment approximately 10 feet lower than the roadway. During the rollover sequence, the roof separated from the bus body at the point where the vertical posts attached to the base of the window sash along the right side and, subsequently, the roof separated from the motorcoach. During the accident sequence, the motorcoach impacted the ground and completed a full rotation (360 degrees) before coming to rest on its wheels. Figures 4 and 5 show the accident motorcoach in its final location after the accident.

Figure 4. Position of accident motorcoach at end of rollover sequence (topographical contour lines indicate steepness of the embankment or slope; the closer the lines, the steeper the slope).

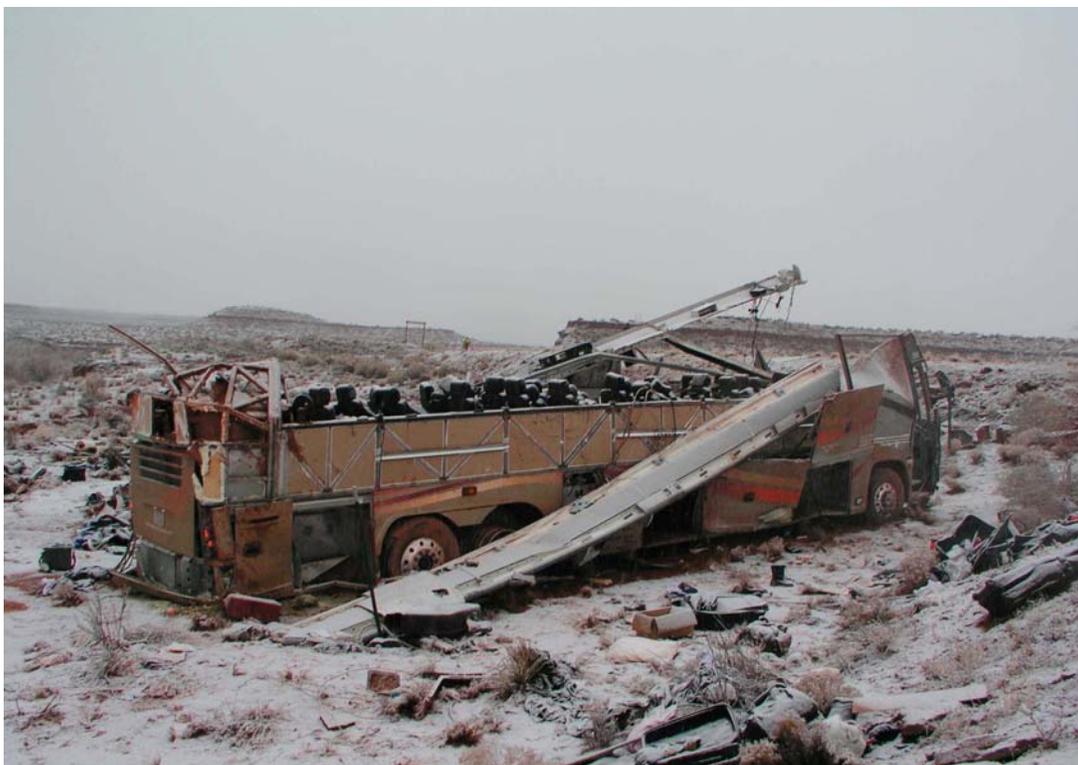
Figure 5. Accident motorcoach's final location, as viewed looking back toward the route traveled. (U.S. 163 is behind the motorcoach, with the curve coming around the bluff in the center of the horizon.)

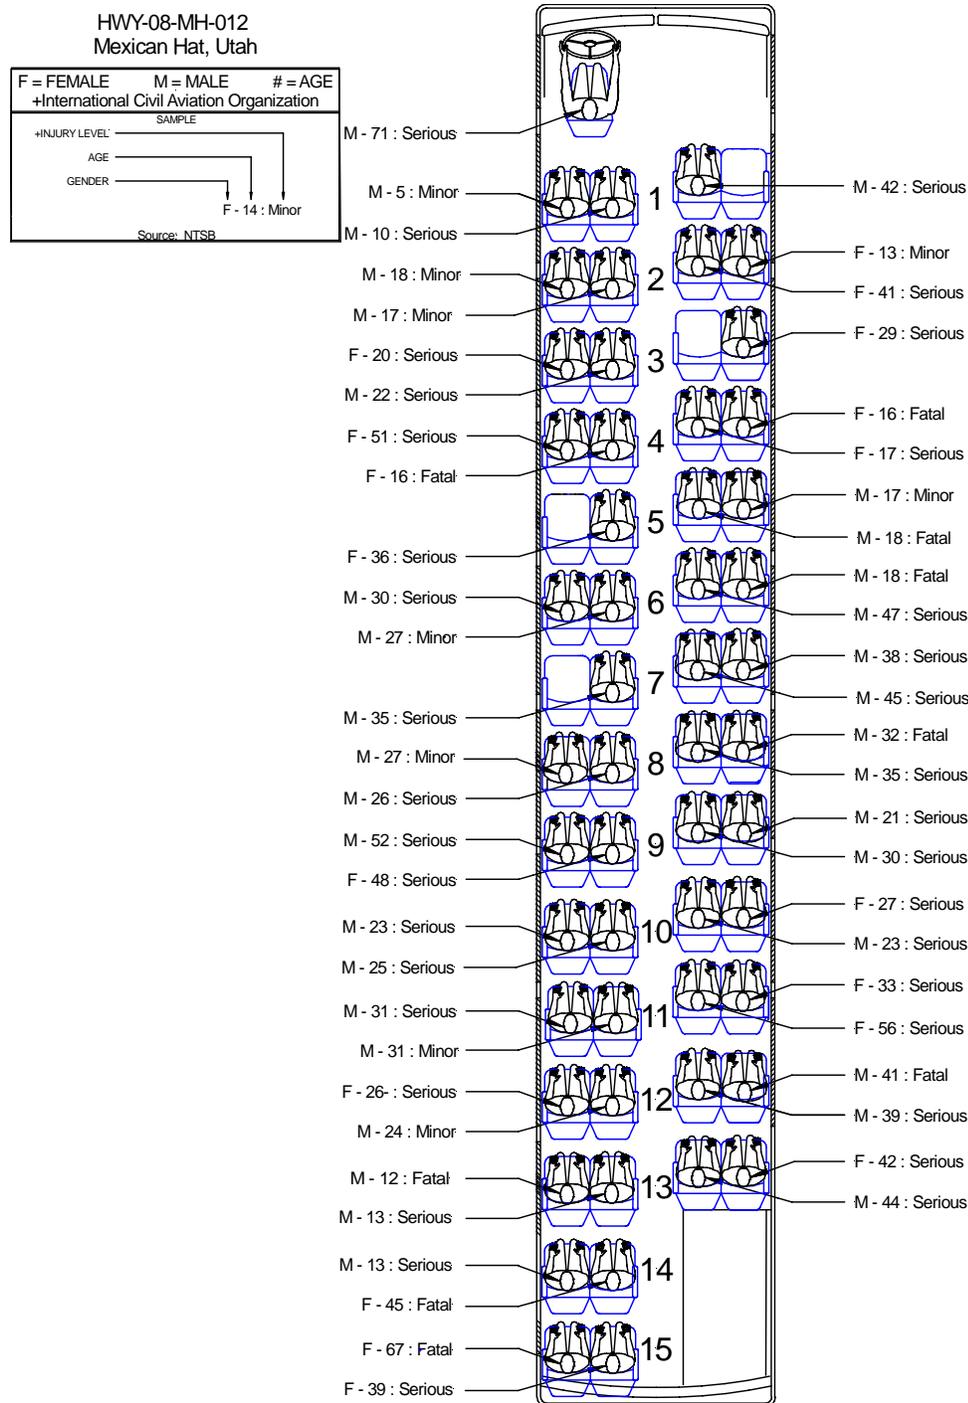
Figure 6. Seating diagram.

As a result of the accident, 9 passengers sustained fatal injuries, 34 passengers and the driver sustained serious injuries, and 9 passengers received minor injuries. Figure 6 shows the seating locations and injury patterns of motorcoach occupants.

Of the 24 passengers who were seated on the right side of the motorcoach, 5 sustained fatal injuries (4 of 5 of these occupants were seated next to windows), 17 sustained serious injuries, and 2 sustained minor injuries. Of the 28 passengers who were seated on the left side of the motorcoach, 4 sustained fatal injuries (3 of 4 of these occupants were seated in the last three rows), 17 sustained serious injuries, and 7 sustained minor injuries.

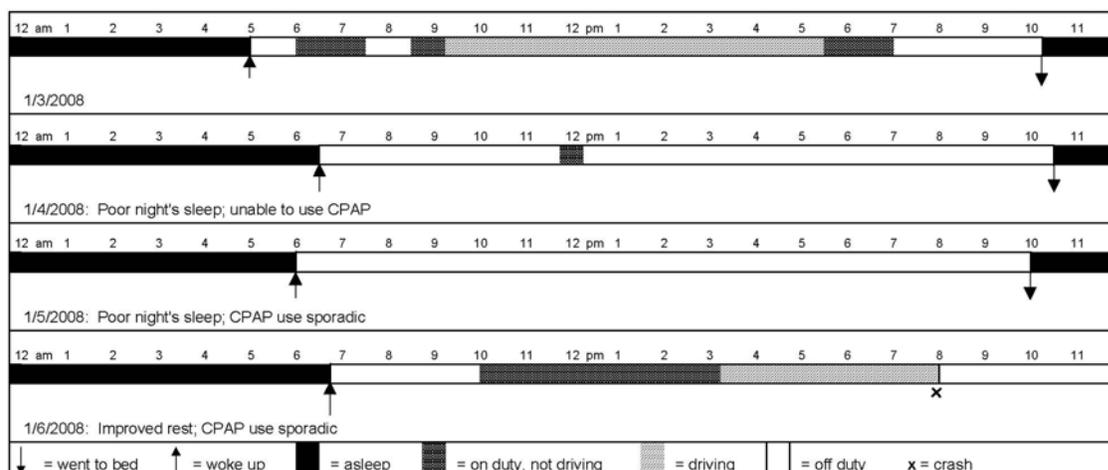
The driver told the tour group leader, who was one of his passengers, that he had been sick for the 3 days in Telluride preceding the return portion of the accident trip.²⁶ The driver stated to investigators that, due to his head congestion, use of the CPAP device was difficult. The driver could not use the CPAP device the first night in Telluride and used it only sporadically the other 2 nights, adversely affecting his sleep for the 3 nights preceding the accident. The driver's activities in the 72 hours before the accident are shown in figure 7.

Figure 7. Accident driver's sleep and activity log. (Note: Black bars indicate time available for sleep, not necessarily sleep obtained. Driving time occurs within, but is not synonymous with, on-duty time.)

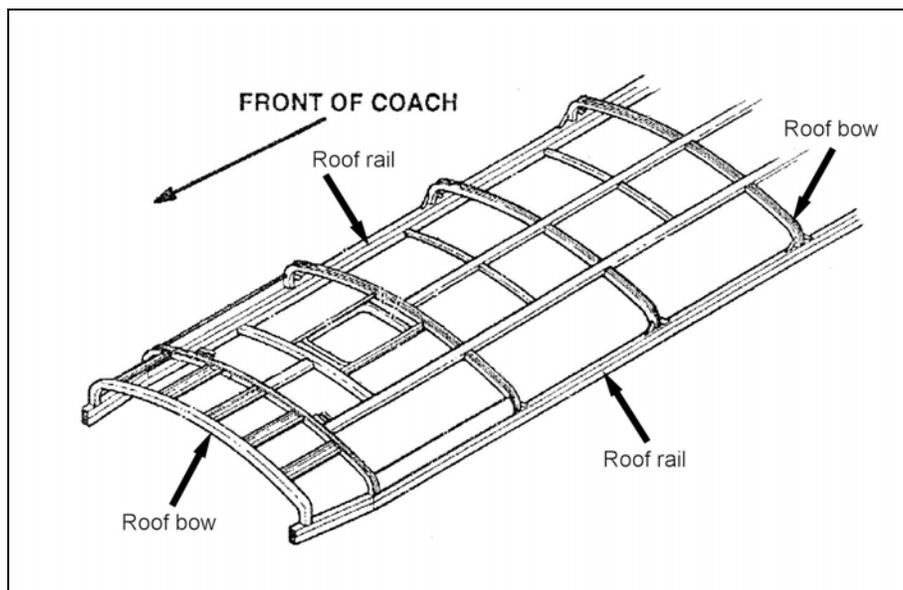
The roof of the motorcoach became detached from the body during the rollover. The motorcoach rotated about its longitudinal axis, rolling over 360 degrees to its right, and approximately 180 degrees about its vertical axis, stopping on its wheels facing east. During the rollover, the right side of the motorcoach's roof, at the lower edge of the window sill (sash rail) and vertical support posts for the window, became separated from the body. At final rest, the motorcoach was right side up, with the roof lying on the ground near the motorcoach, top side down. The windshield glazing and all windows along both sides of the motorcoach were displaced during the rollover.

Figure 8. Motorcoach roof design. (Source: MCI.)

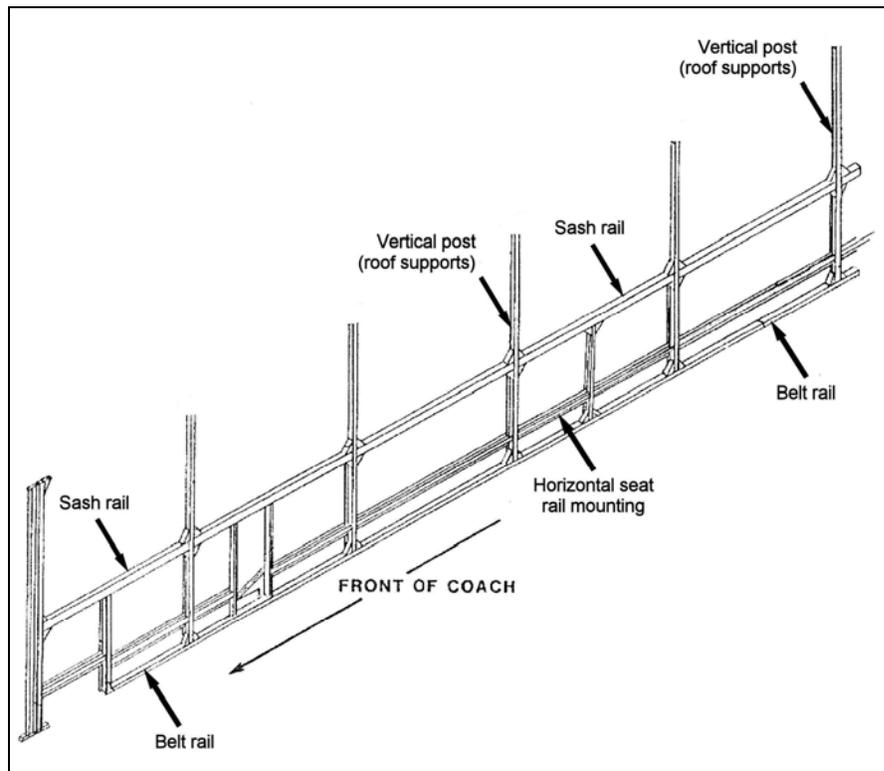
Figure 9. Motorcoach side supports for roof. (Source: MCI.)

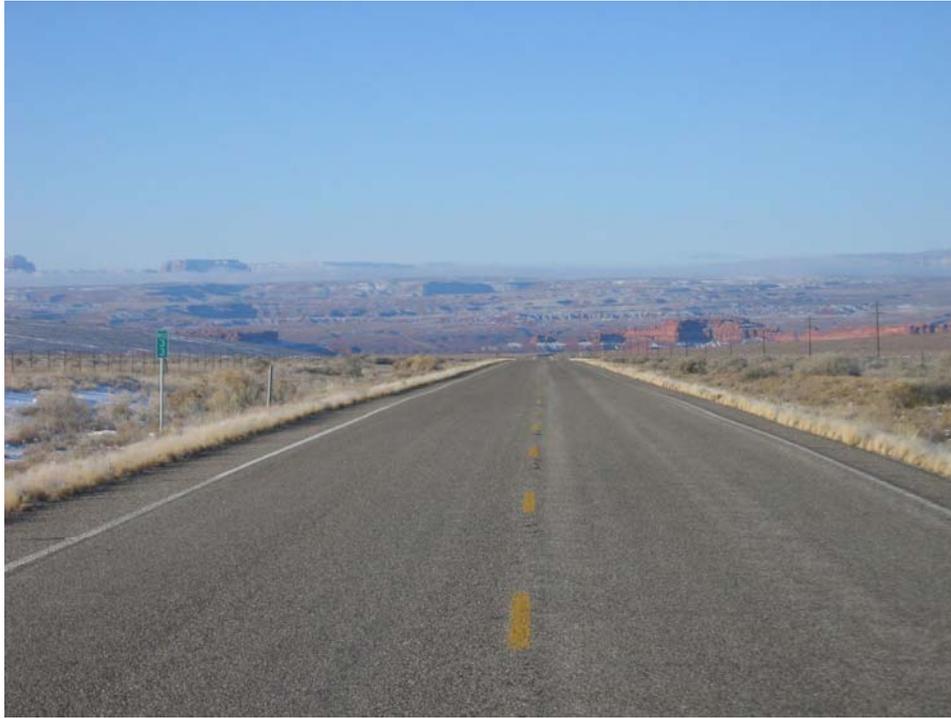
Figure 10. View of descending road grade, 4 miles before the accident site.

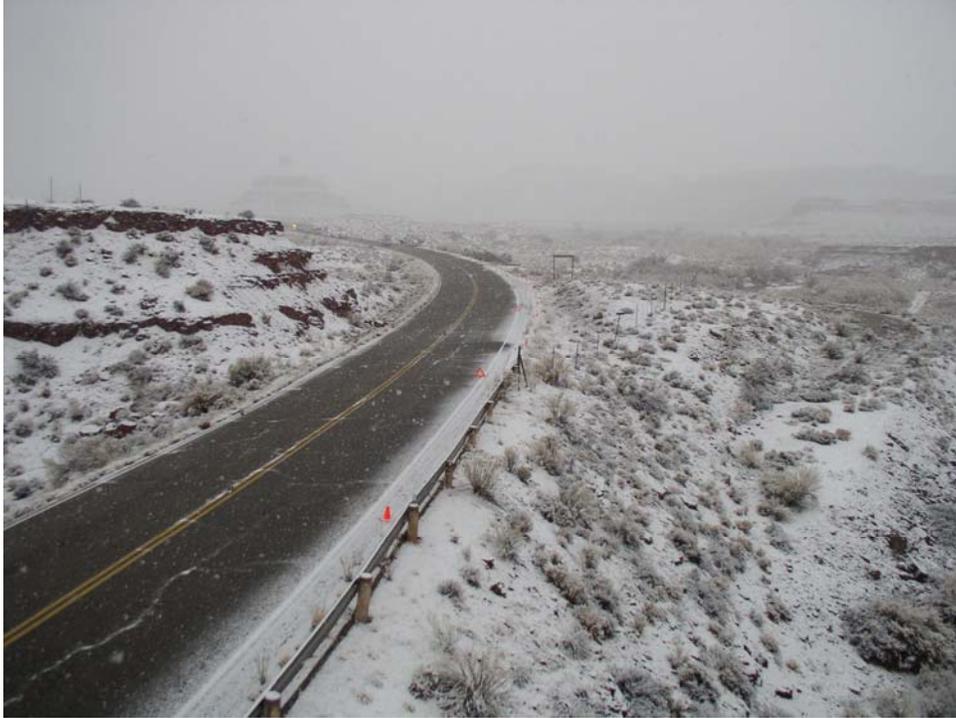
horizontal curve that was well marked with chevron curve signs⁵⁴ and a 35-mph speed advisory warning. Beginning 4 miles before the accident site, about milepost 33, the highway begins a gradual descent,⁵⁵ as shown in figure 10. The immediate approach to the curve where the accident occurred is a long, straight downgrade (1,200 feet long with a 5.6-percent downgrade), as shown in figure 11.

Figure 11. View of descending road grade in the direction of travel, immediately preceding the accident curve.

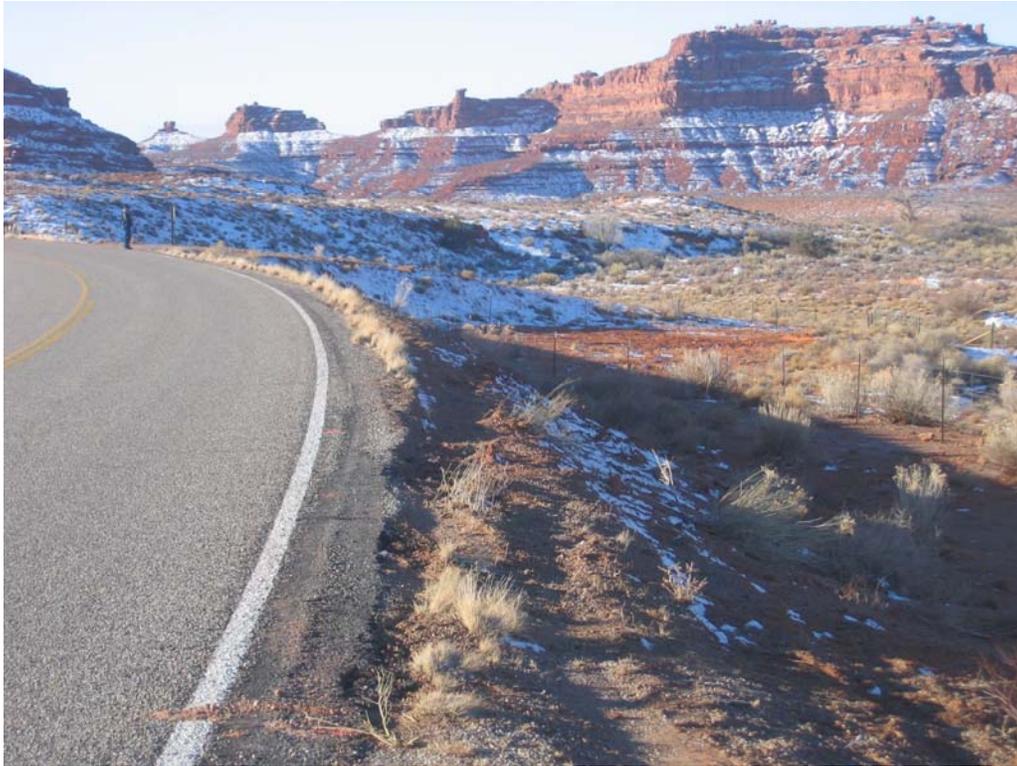
The accident occurred on a long left-hand curve that extends for nearly one-third of a mile (1,641 feet) at milepost 29. The curve, shown in figure 12, has a spiral transition and a 1,400-foot radius resulting in a 4-degree curve. The curve had a 6-percent superelevation or bank. A curve warning sign is posted on the right-hand roadside approximately 750 feet in advance of the curve.⁵⁶ The curve warning sign does not have a posted advisory speed warning sign. The posted speed for the area is 65 mph.

Figure 12. View of accident curve.

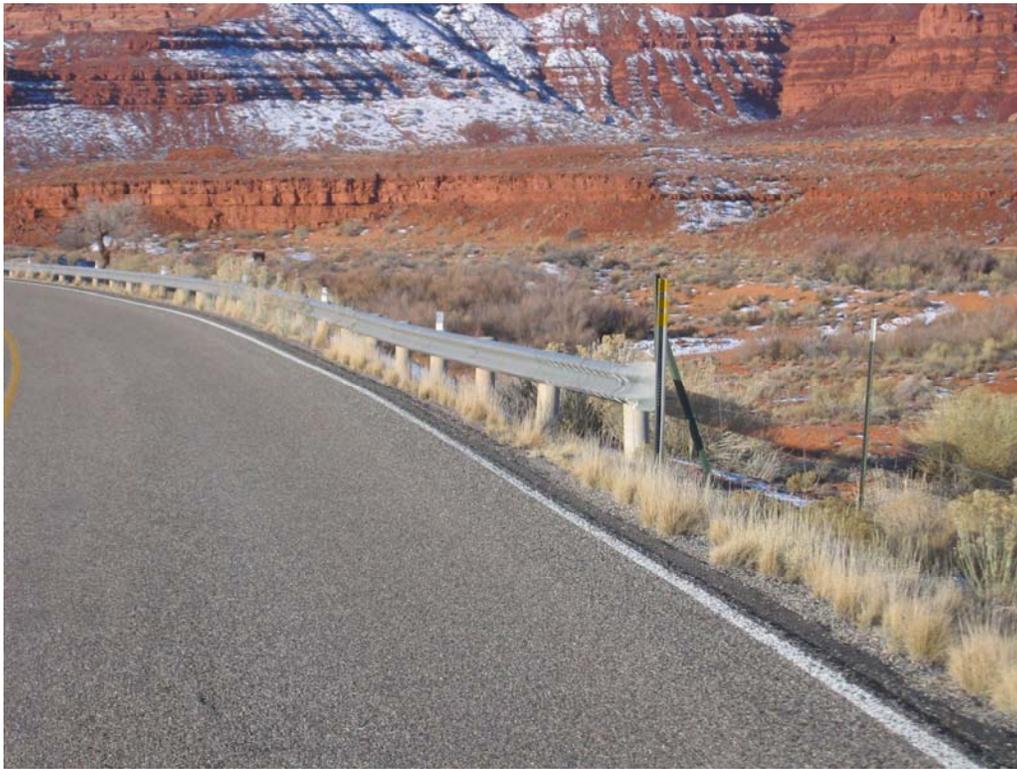
vehicle running off the road onto the slope would likely overturn. The existing guardrail had no end treatment.⁶²

Figure 13. View of guardrail.

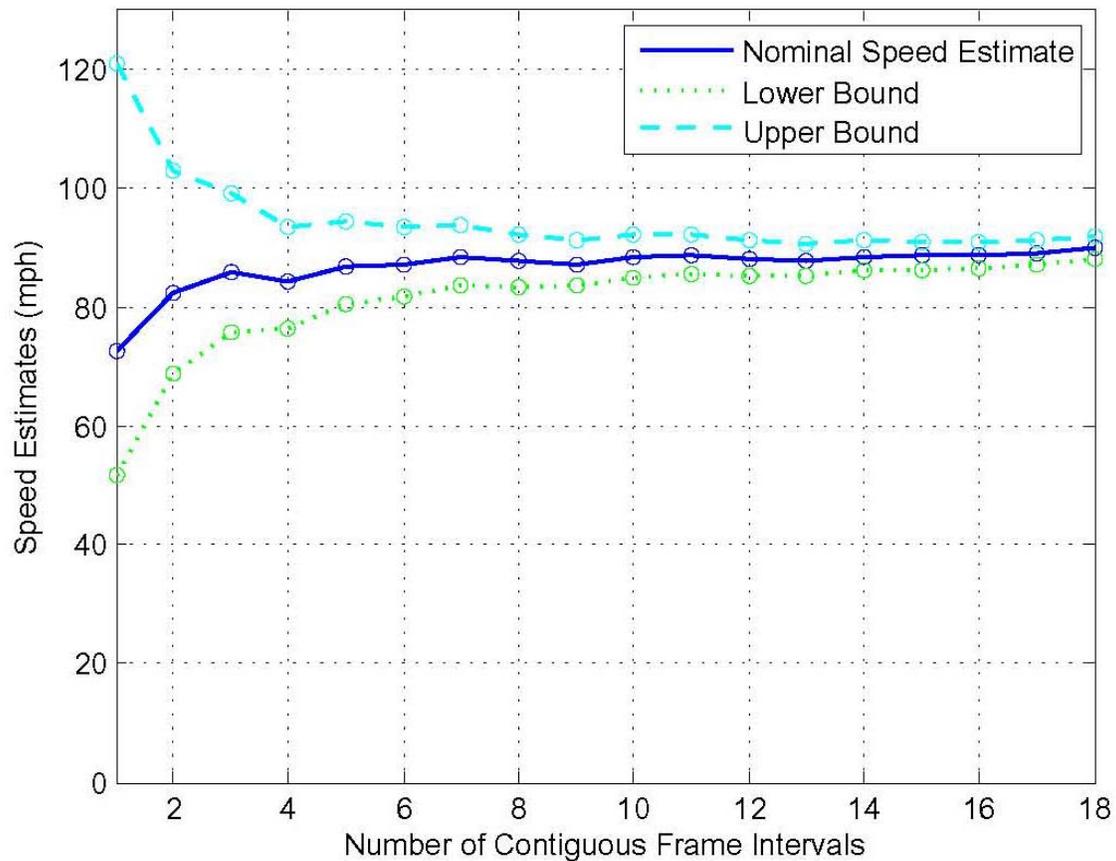
Figure 14. Vehicle speed estimate versus number of frame intervals (video analysis).

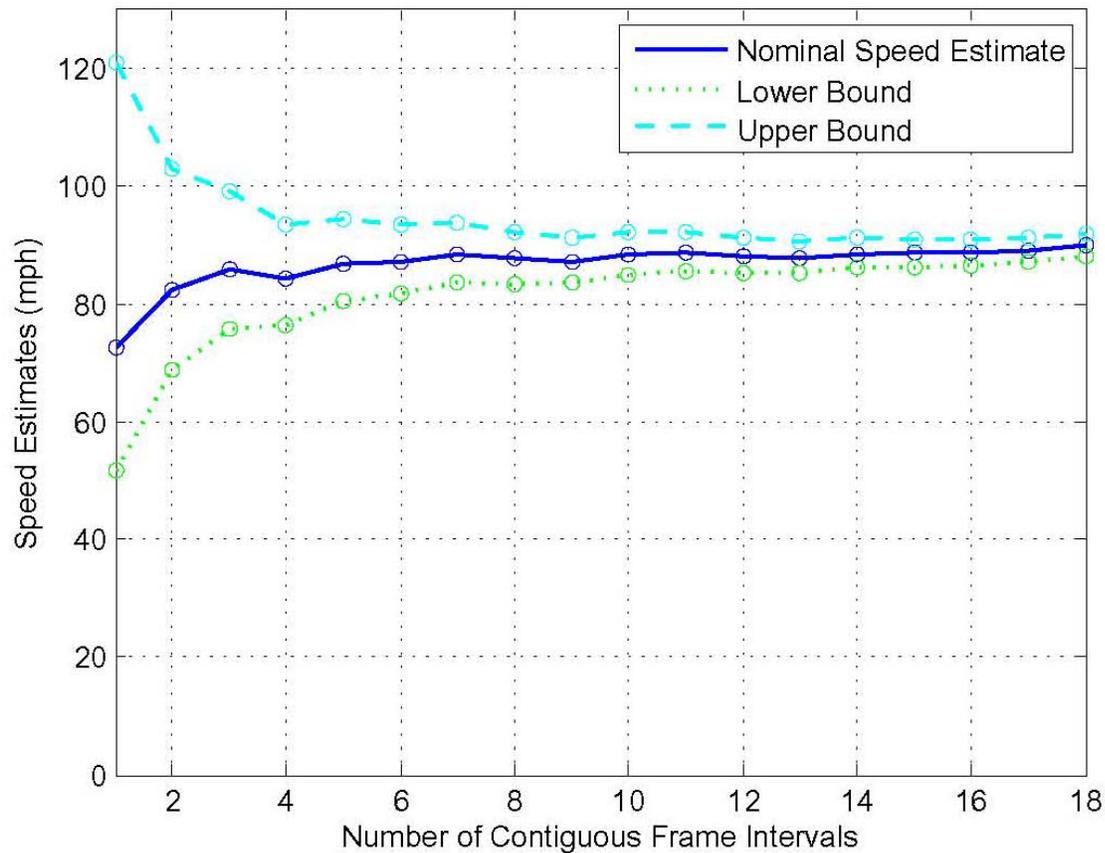
Figure C-4. Vehicle speed estimate versus number of frame intervals.

The nominal speed estimate is based on exact 0.25-second timing of the camera frame intervals. If camera timing is not exact, this nominal speed estimate could be too high (if the actual Δt was longer than $0.25 \times n$) or too low (if Δt was shorter than $0.25 \times n$). The possible speed estimation error due to such video frame timing was analyzed in detail and taken into account. The bottom line in the figure C-4 graph represents the lower bound of the speed estimate and the uppermost line represents the upper bound. The lower bound is higher than 85 mph if 10 or more camera frame intervals are considered. After 18 frame intervals, the lower bound of the motorcoach's speed is estimated to be 88 mph and the upper bound, 92 mph.
