Multivehicle Collision
Interstate 44 Eastbound
Gray Summit, Missouri
August 5, 2010

Accident Report

NTSB/HAR-11/03
PB2011-916203

Highway Accident Report

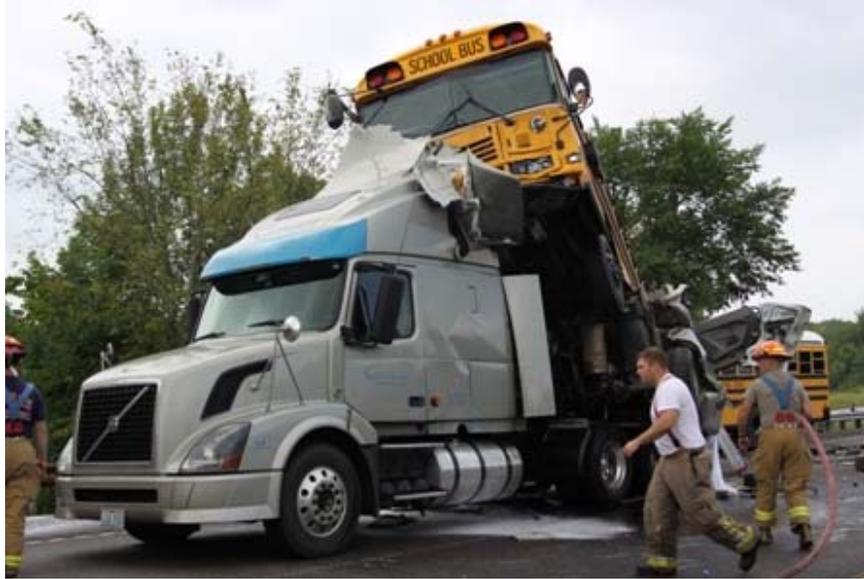
Figure 3. Gray Summit accident scene, showing Volvo tractor and lead school bus. GMC pickup is located between the two vehicles and acted as a ramp for the school bus. The following school bus is located at right rear of photo. (Courtesy of Boles Fire Protection District)

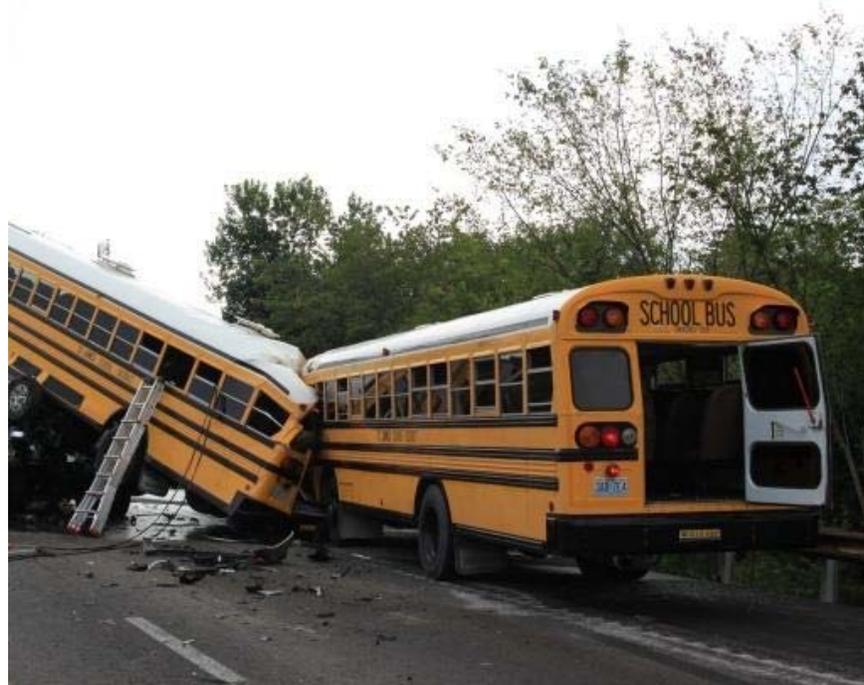
Figure 4. Override and intrusion of following school bus into lead school bus. (Courtesy of Boles Fire Protection District)

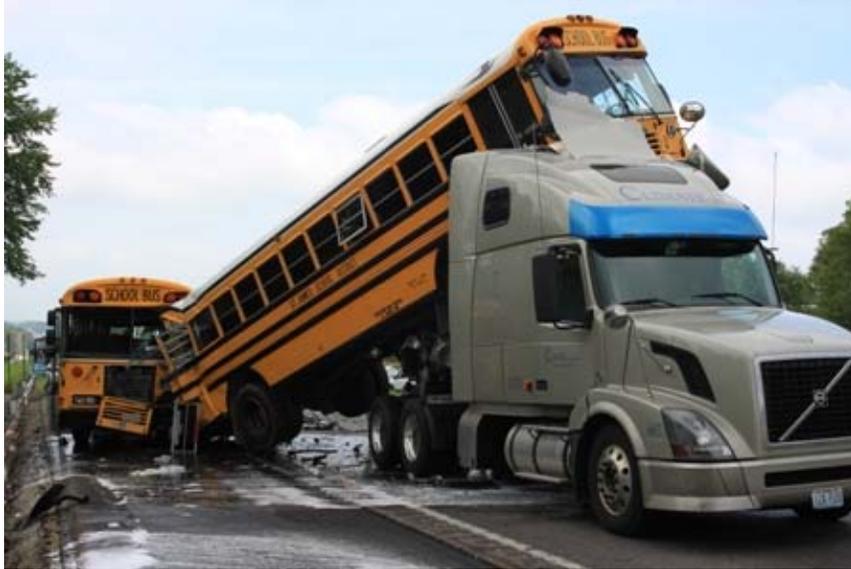
Figure 5. Position of accident vehicles at rest, with GMC pickup located between lead school bus and top of rear wheels of Volvo tractor. (Courtesy of Boles Fire Protection District)

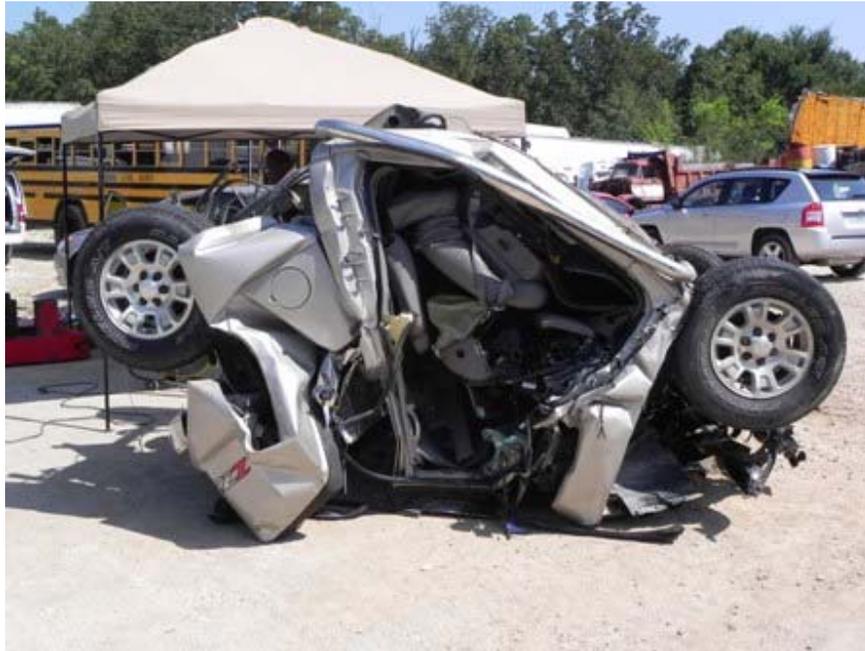
The GMC pickup was taken to an impound lot in Saint Clair, Missouri, where it was examined by NTSB investigators. The damage to the exterior and interior was catastrophic. The front end of the pickup was severely damaged due to its impact with the rear of the Volvo tractor. The subsequent impact by the lead school bus resulted in the pickup overriding the back of the Volvo tractor and its undercarriage being folded into a “U” shape. During the accident sequence, the pickup’s high-density polyethylene gasoline tank was torn and released fuel at the site. (See figures 8 and 9.)

Figure 8. GMC pickup in an inverted “U” shape, with its rear at left and its front at right. Undercarriage of pickup forms exterior of “U” shape.

The GMC pickup was extensively damaged; all major mechanical systems were compromised. The frame of the truck was folded into an upside down “U” shape during the collision sequence. The degree and nature of the collision damage limited the extent to which the vehicle could be inspected following the accident.

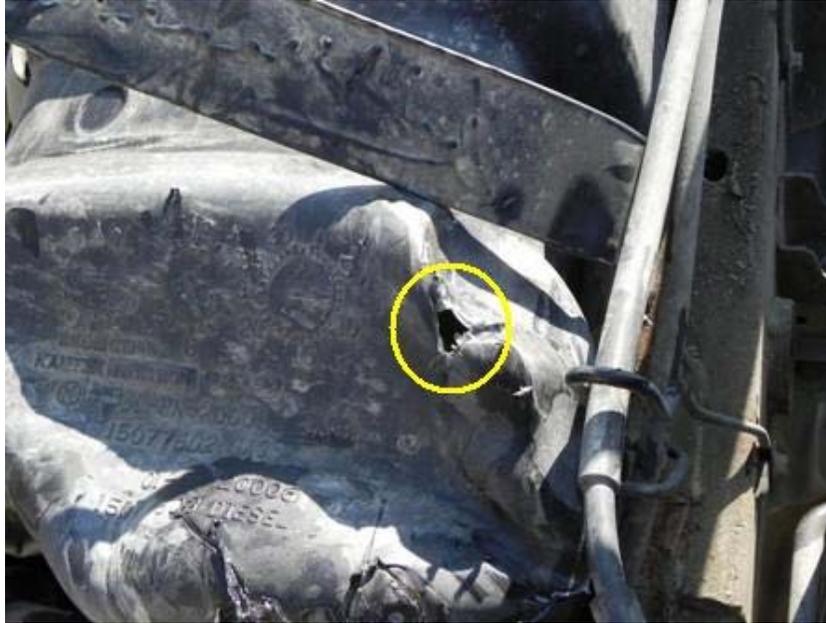
Figure 9. Gas tank tear in GMC pickup.

- Although the major components of the vehicle’s powertrain remained within the wreckage, the main driveshaft between the transmission and the rear differential was broken off at its universal joints and was displaced from the vehicle.
- The functions of the steering system could not be inspected because of the extent of damage.
- The front suspension remained relatively intact, but the rear suspension was severely damaged. The forward halves of the rear leaf springs were bent and ungrouped. The left rear shock was bent, and the right rear shock was bent and broken away from its top mounting.
- The fuel system was also compromised; the rear fuel tank mounting strap was torn loose, and the bottom rear section of the tank had a small tear.

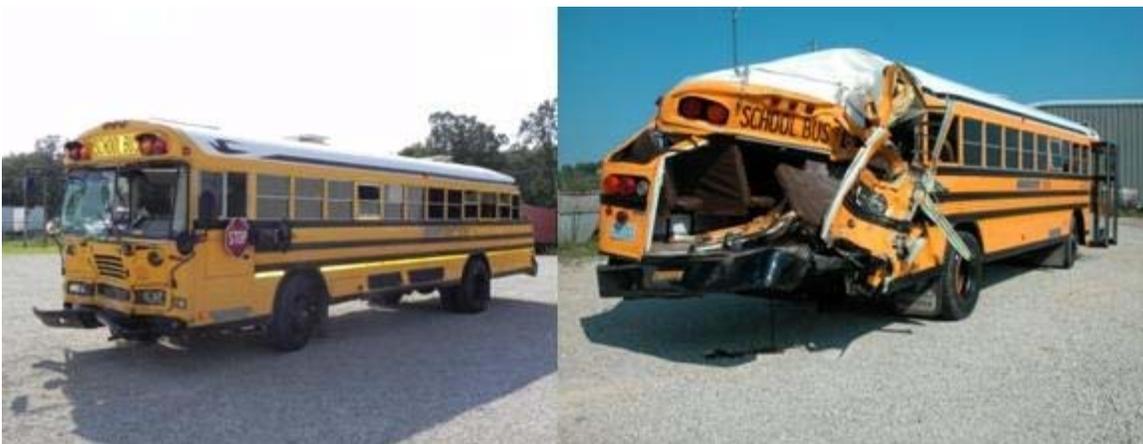
The lead school bus sustained moderate front-end damage from hitting the back of the GMC pickup and undercarriage damage from overriding the pickup and the sleeper berth of the Volvo tractor. The rear of the bus was seriously damaged as a result of being overridden by the following school bus. (See figure 10.)

Figure 10. Front and rear views of lead school bus. Emergency door supports and several roof pillars were cut to extricate an entrapped passenger.

The impact from the following school bus severely damaged the rear of the lead school bus. Direct damage to the rear bumper was primarily on the right side and spanned a width of 35 inches. The bumper was crushed inward 6 inches at its maximum point. The maximum residual crush into the passenger compartment was 62 inches. The override impact crushed the rear emergency door and rear wall inward, and caused the roof to buckle and crush inward and upward. In addition, the right outside side wall was crushed inward and to the right. The emergency door supports and several roof pillars were cut to extricate a passenger.

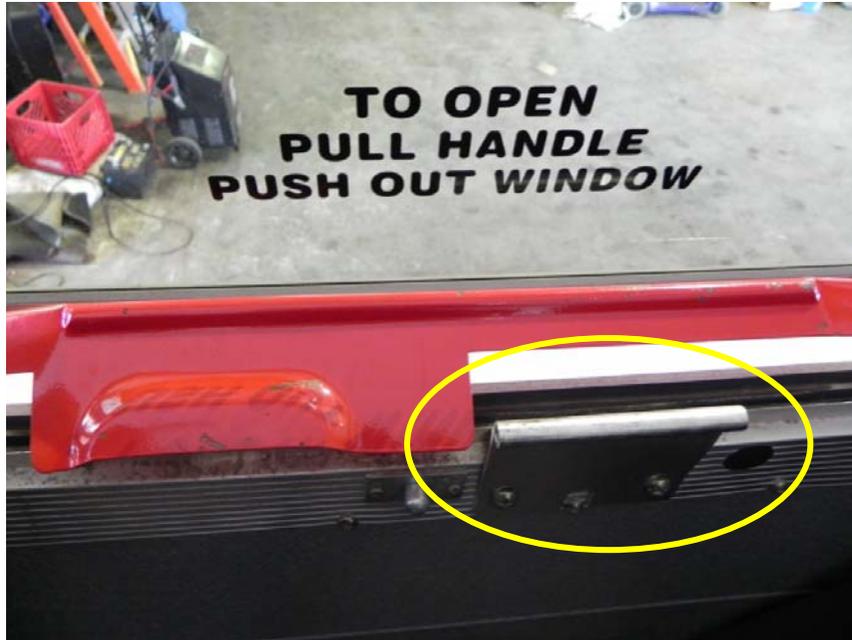
Figure 11. Raised emergency release latch plate (circled) at bottom of emergency exit window, lead school bus.

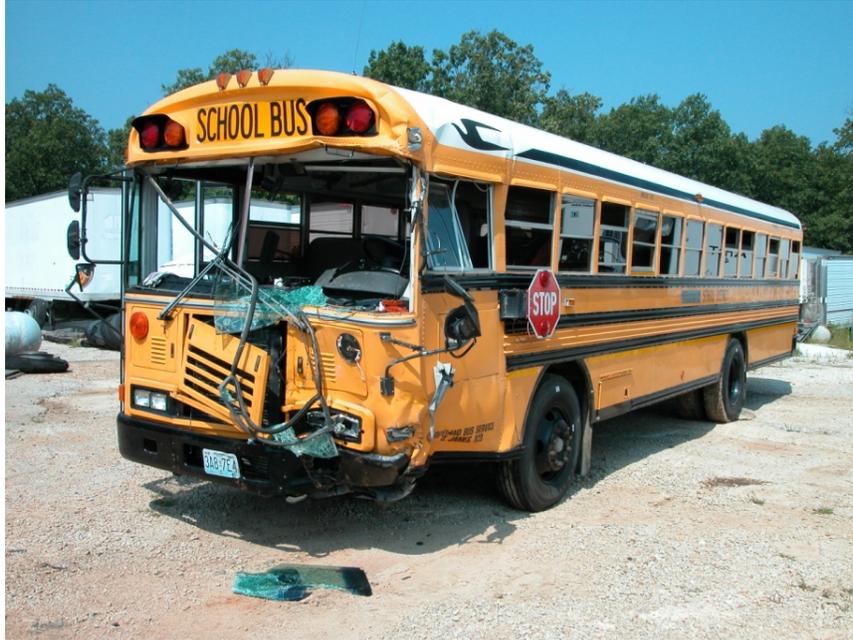
The following school bus sustained moderate front-end damage from hitting the back of the lead school bus. (See figure 12.) According to manufacturer specifications, the following bus had an original overall length of 420 inches, an overall width of 94 inches, and a wheelbase of 190 inches. The frontal impact damage began at the left corner and extended to the right 64.5 inches. The damage also extended vertically to the roof. Maximum crush to the left front bumper was 13.5 inches. Damage to the left side of the bus extended approximately 49.5 inches, detaching the side rearview mirror and shattering the driver's window. Both windshield panes were also shattered. Postaccident measurement of the wheelbase showed the left side to be 189.5 inches and the right side 190.25 inches.

Figure 12. Front view of following school bus.

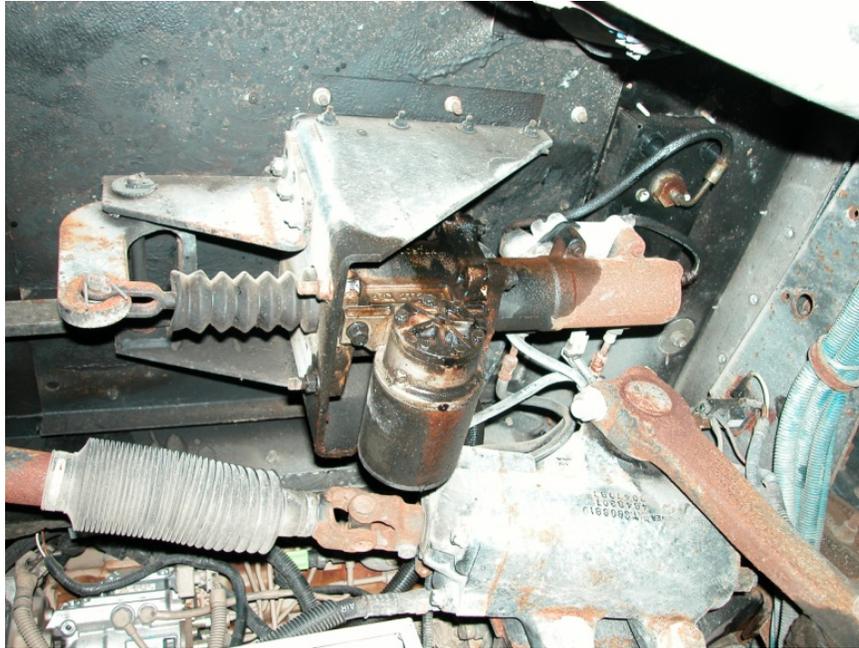
On October 19, 2010, NTSB investigators further evaluated the hydraulic brake system. The brake fluid reservoir was found to be empty down to the fluid intakes at the bottom of both chambers, and no braking force was available. Mechanics from Central States Bus, the service and repair company that Blue Bird uses for school buses in the accident area, removed and replaced the two lines that ran from the master cylinder to the ABS unit so that further deceleration tests could be conducted. The brake lines were then shipped to the NTSB Materials Laboratory for further examination, where it was found that both lines were corroded, and one had a 0.06- by 0.03-inch hole.

Figure 13. Master cylinder (center) in lead school bus, with hydraulic fluid seepage covering cylinder body.

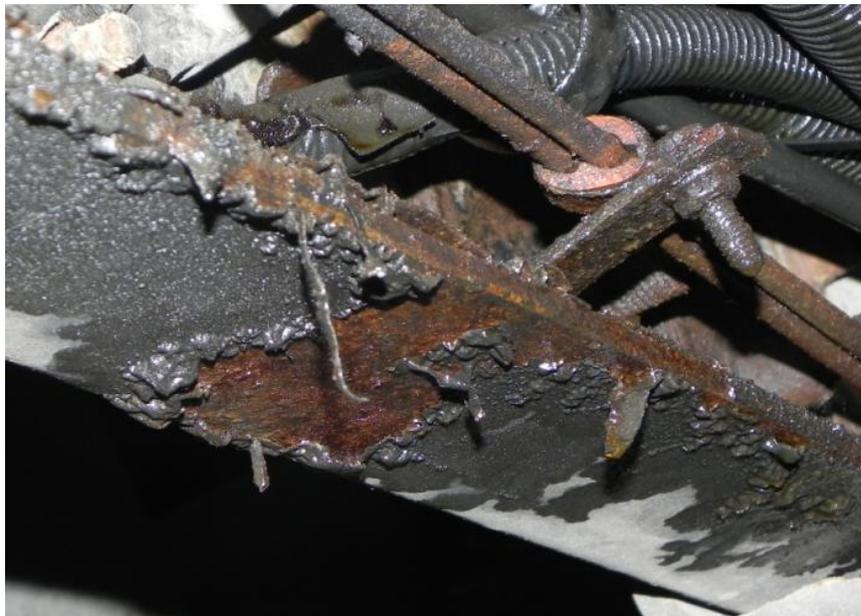
Figure 14. Location of ruptured brake line on lead school bus, with leaking hydraulic brake fluid apparent.
