Highway–Railroad Grade Crossing Collision  
Midland, Texas  
November 15, 2012

NTSB/HAR-13/02  
PB2014-100830

# Highway Accident Report

**Abstract:** About 4:35 p.m. on November 15, 2012, in Midland, Texas, a freight train collided with a parade float at a highway–railroad grade crossing, resulting in 4 fatalities and 12 injuries. The float consisted of a 2006 Peterbilt truck-tractor in combination with a 2005 Transcraft D-Eagle drop-deck flatbed semitrailer and was traveling south on South Garfield Street as part of a parade procession honoring US military men and women. The float, occupied by 12 veterans and their spouses, continued along South Garfield Street until it reached the intersection of West Front Avenue, where the traffic signal displayed red. Law enforcement personnel stationed to block cross traffic permitted the float and its escorts to continue across the intersection unhindered. About 80 feet south of the West Front Avenue intersection was an active highway–railroad grade crossing, and the crossing’s warning system activated as the float approached. The float continued across the railroad tracks at an estimated speed of 5 mph. A Union Pacific Railroad freight t

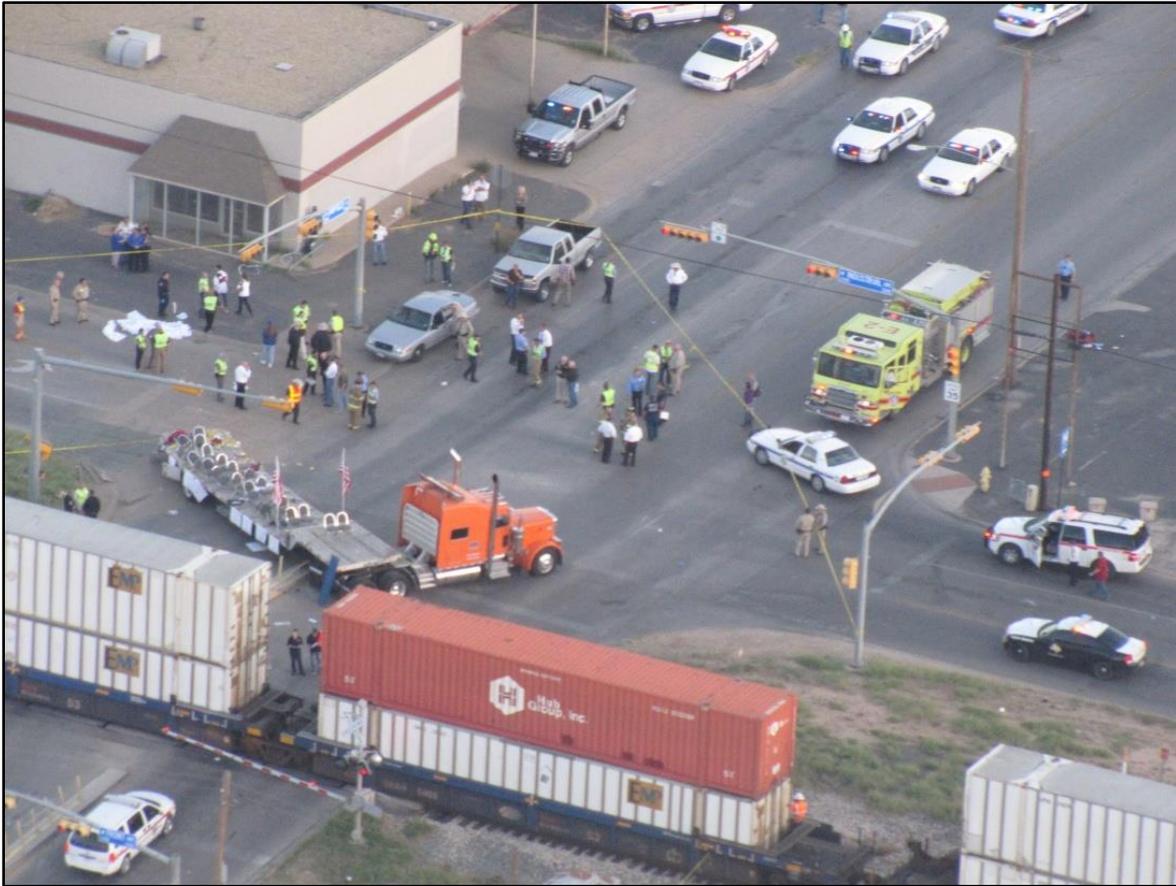
The collision caused the flatbed to rotate 122 degrees clockwise and the truck-tractor to rotate 28 degrees clockwise (see figure 7). The flatbed struck a 2008 Ford Crown Victoria (Ford), which was parked on the northbound intersection of South Garfield Street and West Industrial Avenue and was occupied by a deputy for the Midland County Sheriff's Office. The collision killed four float passengers. Eleven float passengers were injured, and the sheriff's deputy was also injured. The two train crewmembers, the float driver, and nine float passengers were not injured.

**Figure 7.** Postcrash scene showing the extent to which the flatbed rotated clockwise after being struck by the train. (Photo courtesy of the Midland City Police Department)

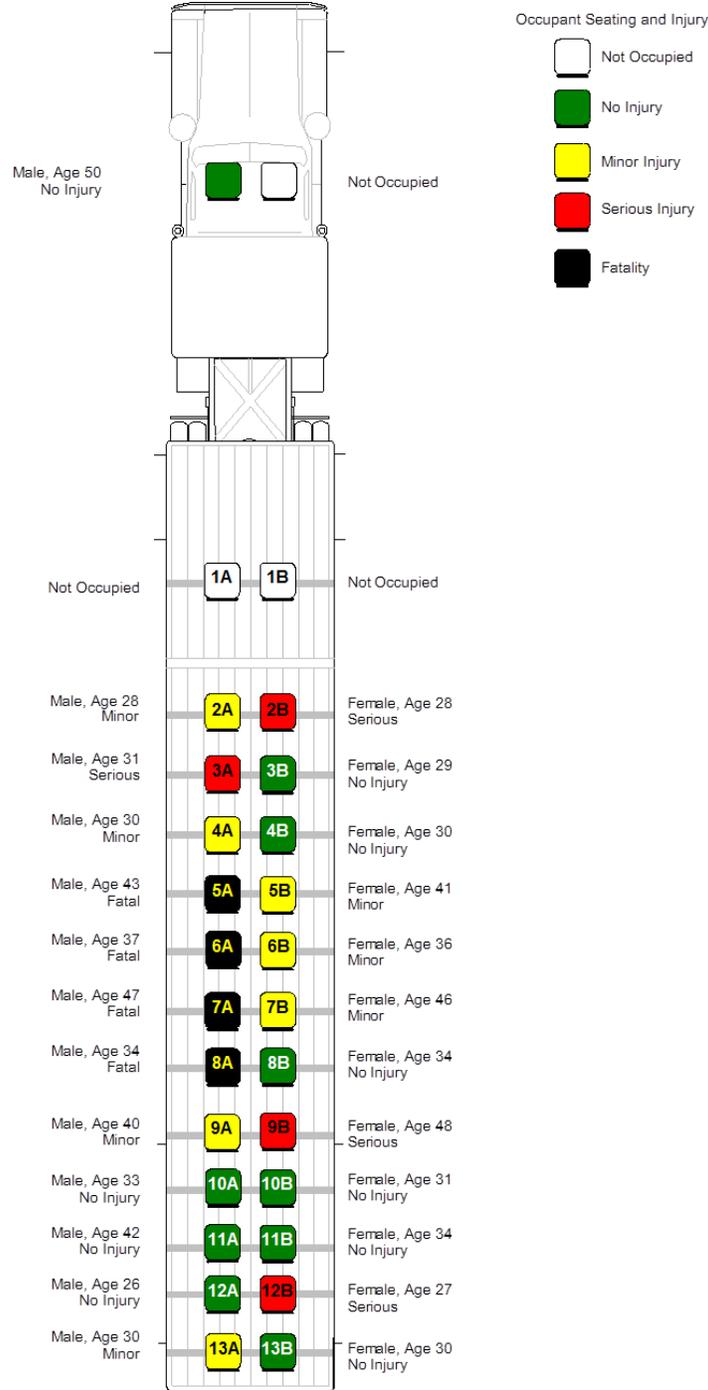
The four passengers who were killed had either evacuated the left side of the float or were in the process of doing so when the train struck. Autopsies showed that the deaths were caused by multiple blunt force traumatic injuries from contact with either the ground or the rotating flatbed. Of those who were seriously injured, one person was hit directly by the train and three were hit by the trailer portion of the float. The minor injuries occurred primarily from evacuating or falling.

**Figure 9.** Depiction of the occupant injuries by seating location on the parade float. Note that several occupants had vacated their seats and the float itself prior to the collision with the train.

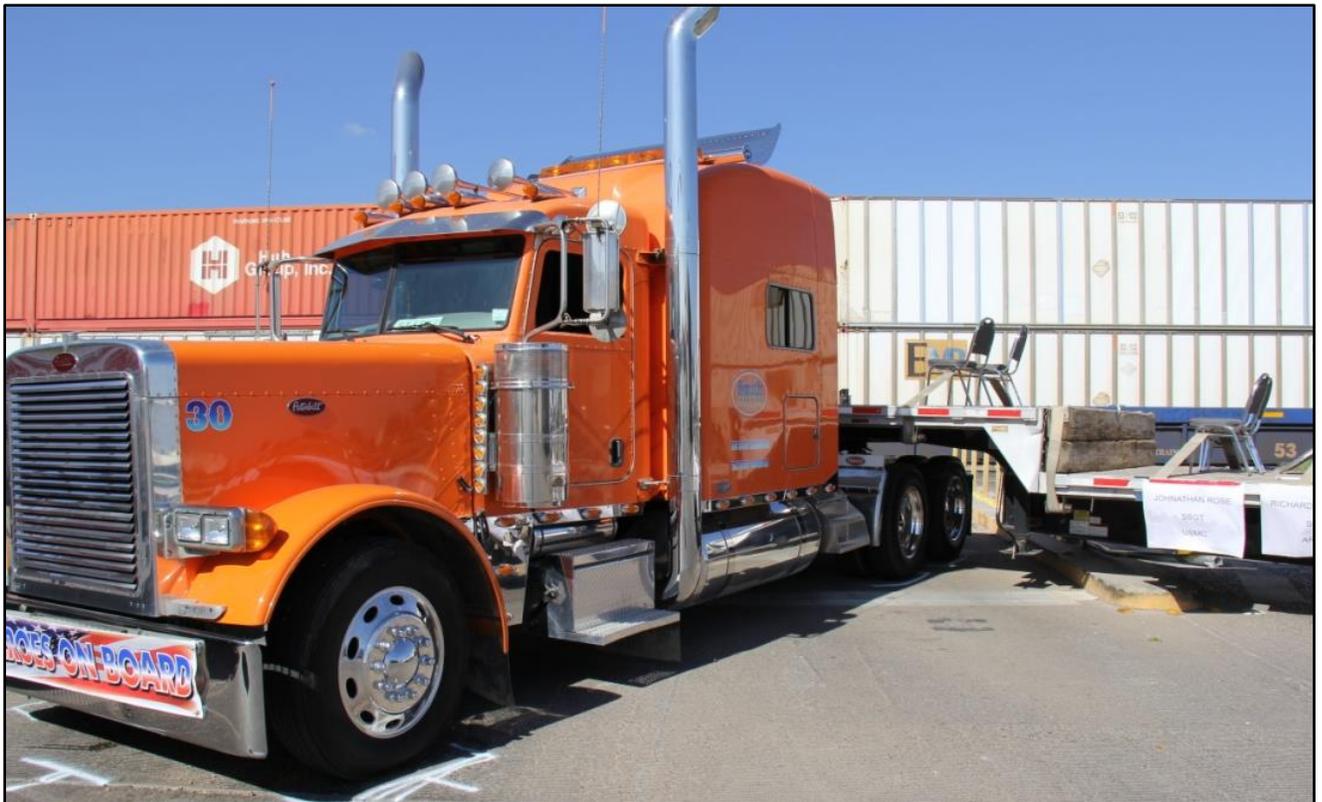
The truck-tractor portion of the float was not damaged in the collision (see figure 10); however, the flatbed suffered extensive direct and indirect damage throughout its structure (see figures 11, 12, and 13). The damage included bent and separated frame rails and deck rails; a torn and displaced end plate holding the rear lights, including the antilock brake system (ABS) malfunction indicator light; and a bent and torn outer wheel rim on the right side of the fifth axle. The rear end of the flatbed was deformed laterally toward the driver side, resulting in a skew of its deck, measuring approximately 2 feet at the aft end. In addition, the fourth and fifth axles on the left side of the flatbed had minor damage caused by the collision with the Ford.

**Figure 10.** Front view of the undamaged truck-tractor at the crash site.

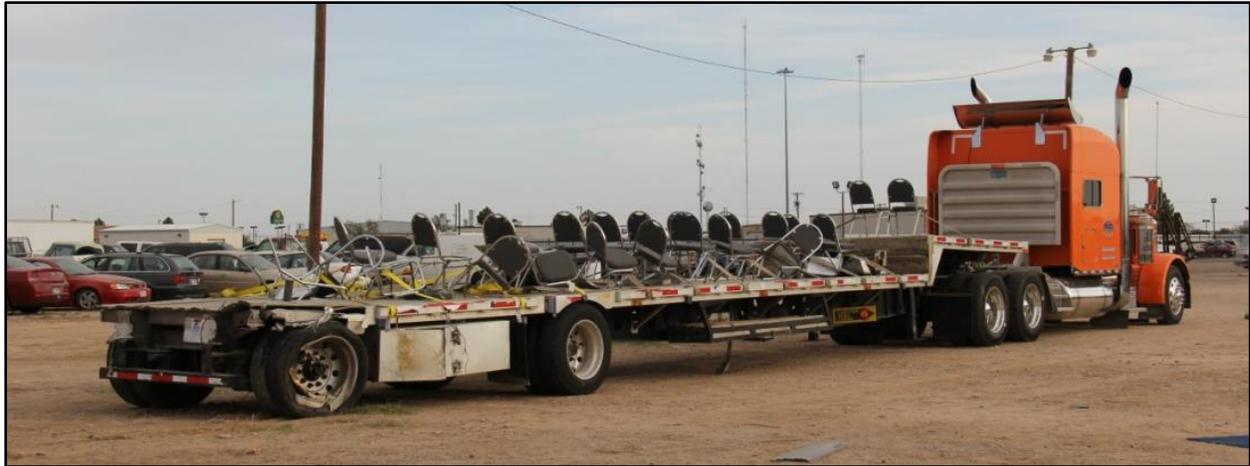
**Figure 11.** Damage to the flatbed tire rim on the right side of the fifth axle.

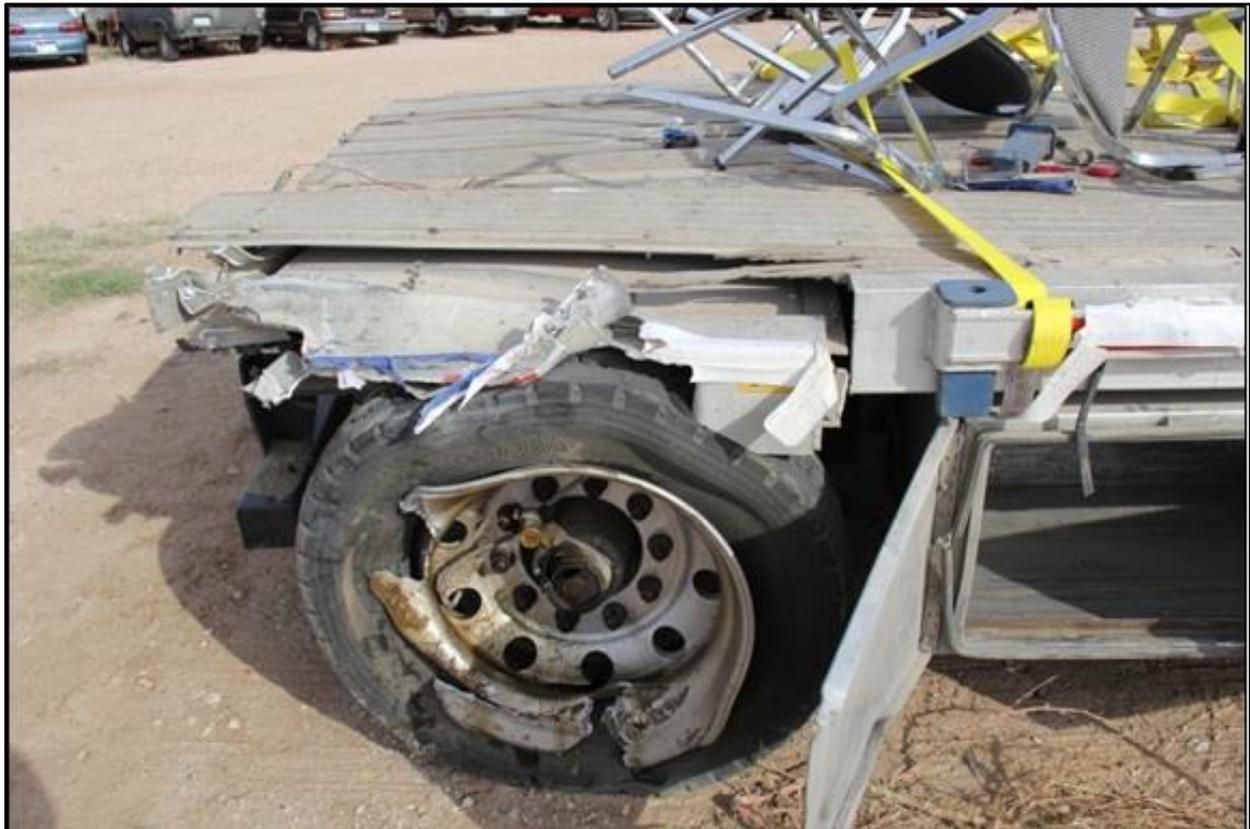
**Figure 12.** Damage on the right side of the flatbed at the fifth axle tire and rim, the area directly impacted by the train.

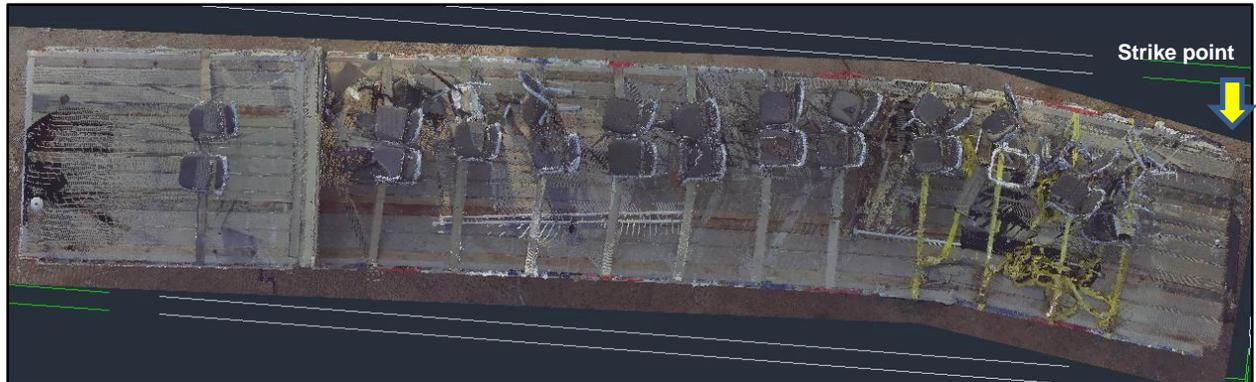
**Figure 13.** Computerized image showing the degree to which the flatbed was deformed by the collision with the train, with front of flatbed to the left.

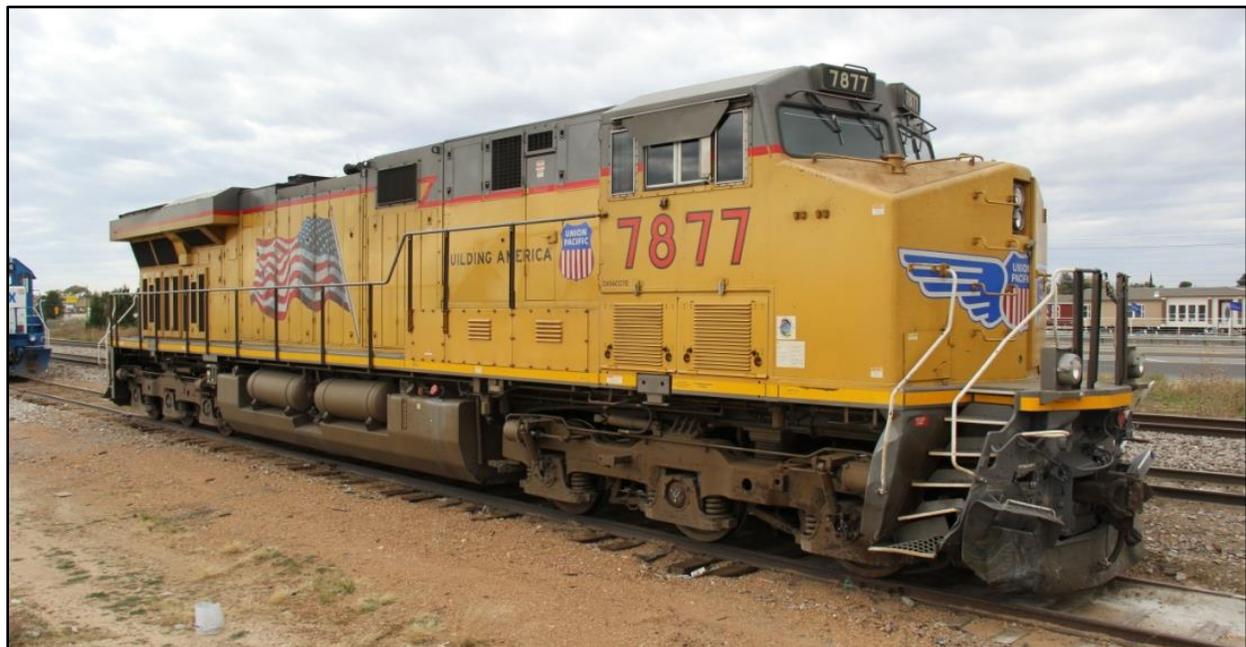
The train, which consisted of 4 locomotives and 84 loaded freight cars, was 7,247 feet long and weighed 5,556 gross tons. The locomotives, configured for multiple-unit operation, were controlled from the lead locomotive. Three locomotive units were on the front of the train, and the fourth was at the rear. Damage to the train was limited to the right front corner of the lead locomotive. The plow, end plate, side steps, and side step mounting plate on the right side all exhibited rearward displacement. The hand rail and uncoupling lever were bent, and the plow was cracked (see figures 14 and 15).

**Figure 14.** Damage to the lead locomotive of the train.

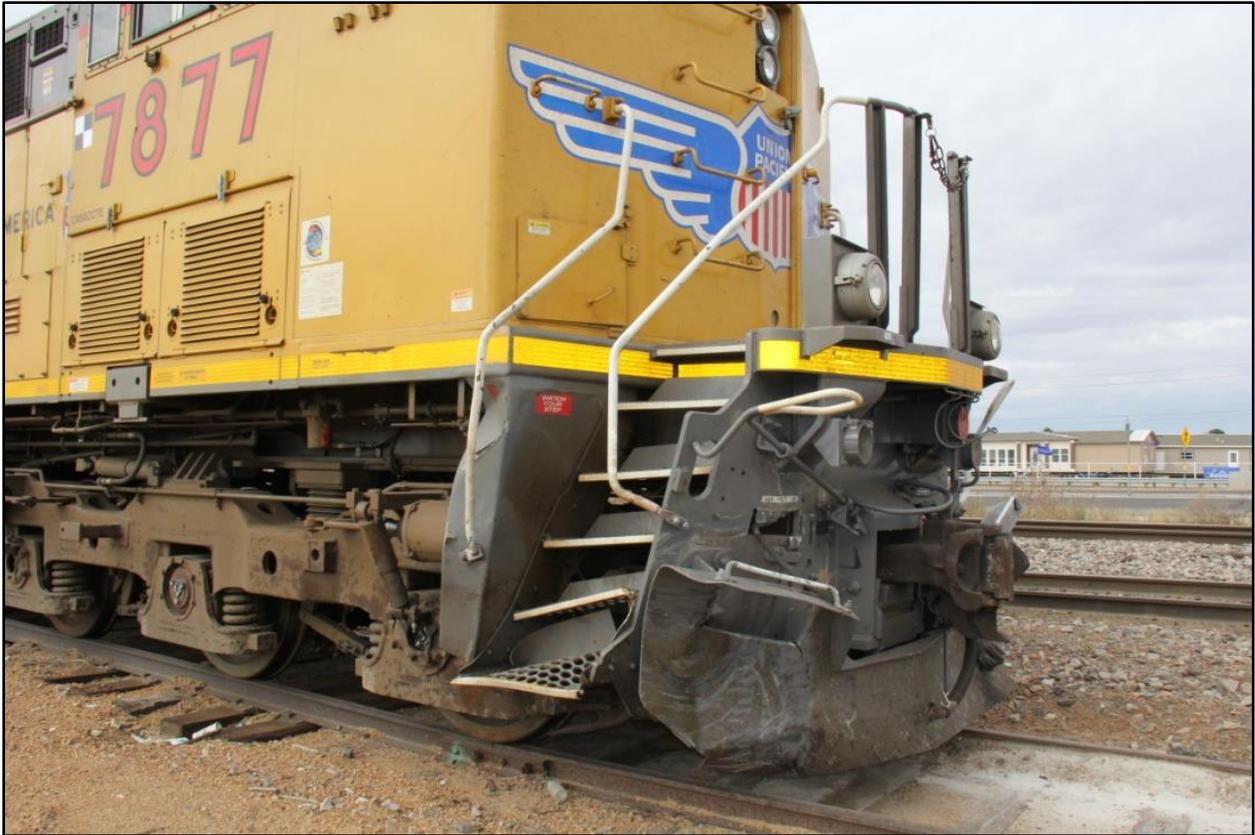
**Figure 15.** Close-up view of the damage to the front of the lead locomotive, showing gouges and scrapes on lower right corner of the plow and deformation to the side steps.

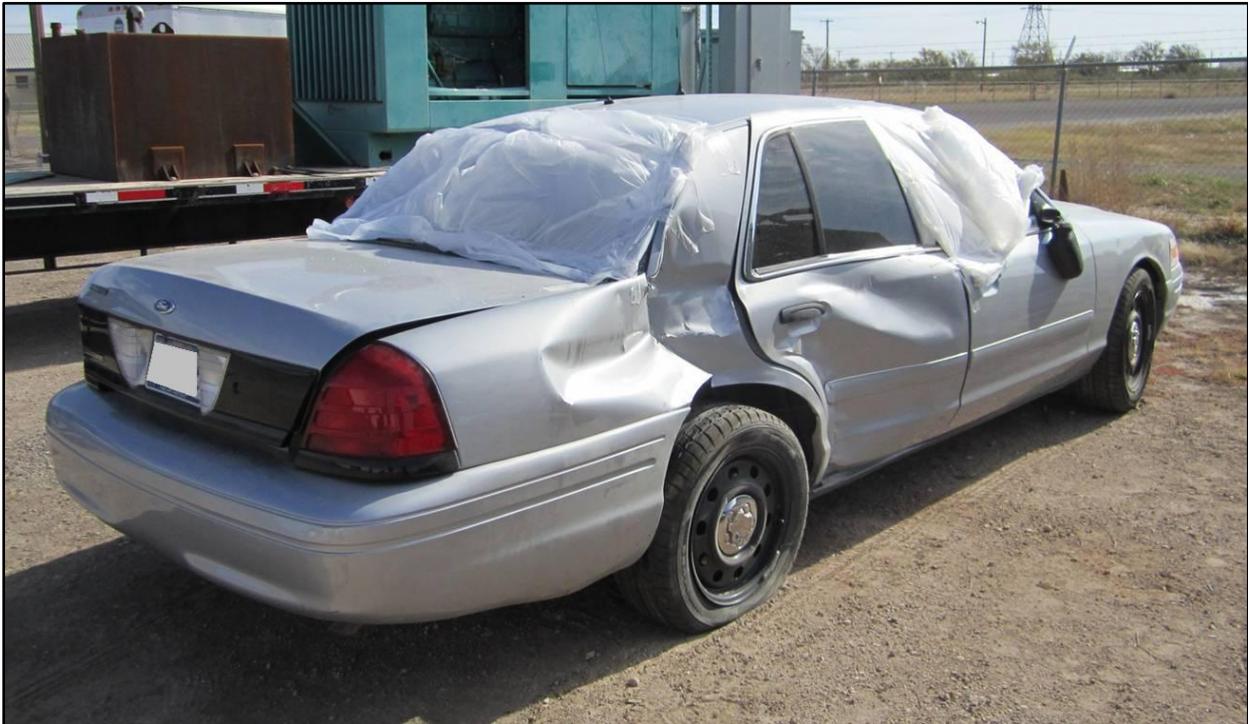
The Ford was damaged on its right front quarter panel, right rear door, rear quarter panel, and trunk lid (see figure 16). The right rear-view mirror was broken off. Both the right front passenger window and the rear windshield were broken. The right rear wheel was damaged and the tire was deflated. The right rear portion of the back seat exhibited signs of deformation from the inward displacement of the right rear passenger door and C-pillar.<sup>5</sup> Additionally, the right rear C-pillar interior molding was separated from the headliner.

**Figure 16.** Damage to the Ford.

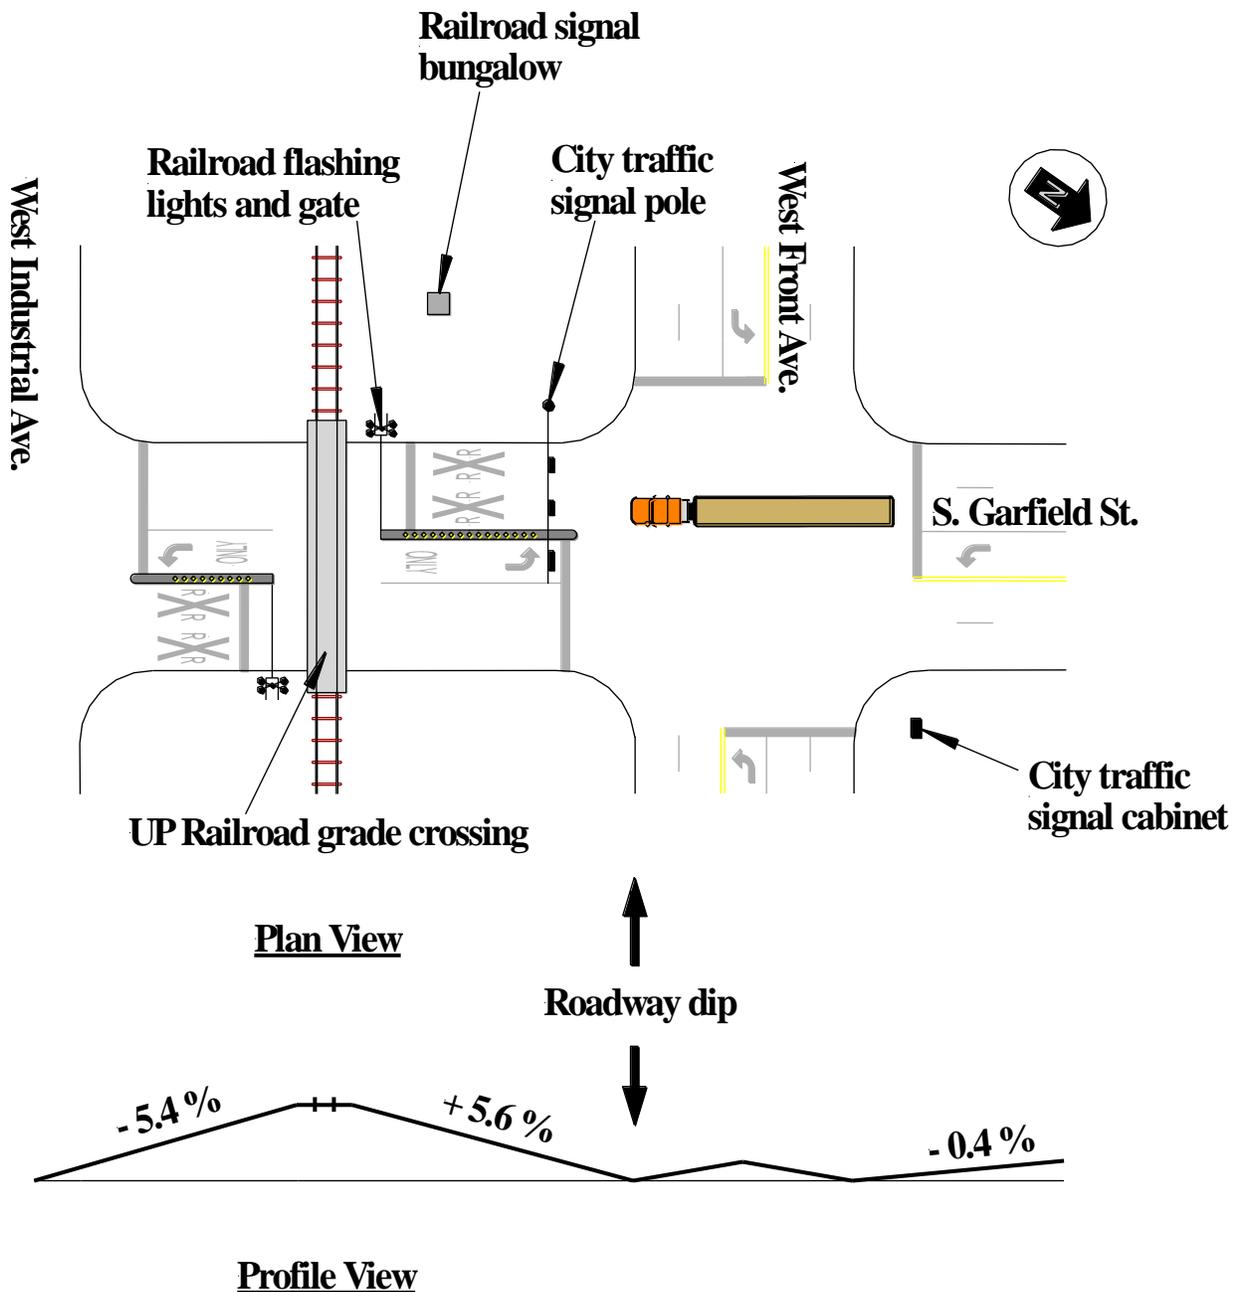
**Figure 17.** Depiction of the change in vertical slope between West Front Avenue and South Garfield Street, which resulted in a slight dip in the roadway (vertical scale in profile view is exaggerated to better illustrate the changes in slope).

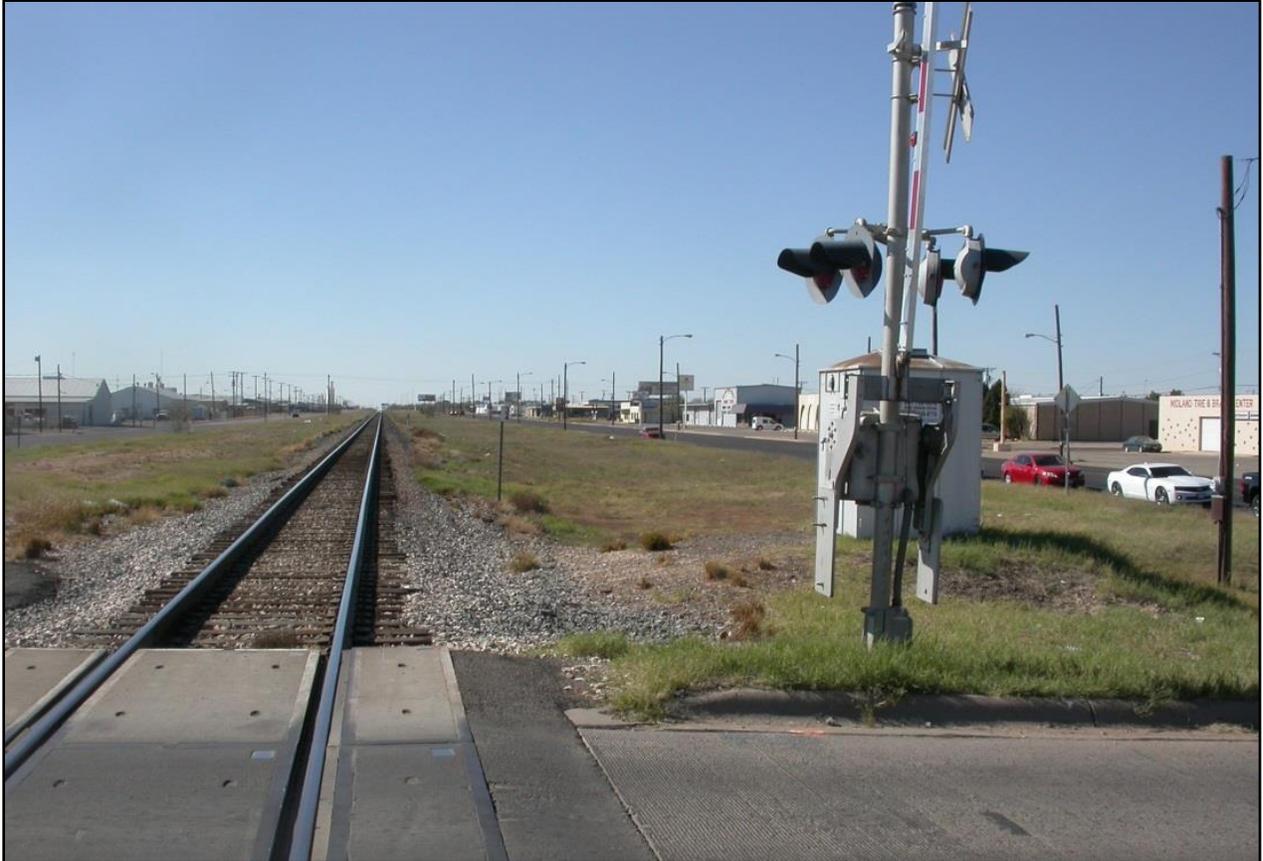
**Figure 22.** View of the 12-foot distance between the rails and grade crossing mast on the southbound side of South Garfield Street and the warning light configuration, which provides visual warning for both northbound and southbound traffic. (The grade crossing mast on the northbound side of South Garfield Street is equipped in an identical fashion.)

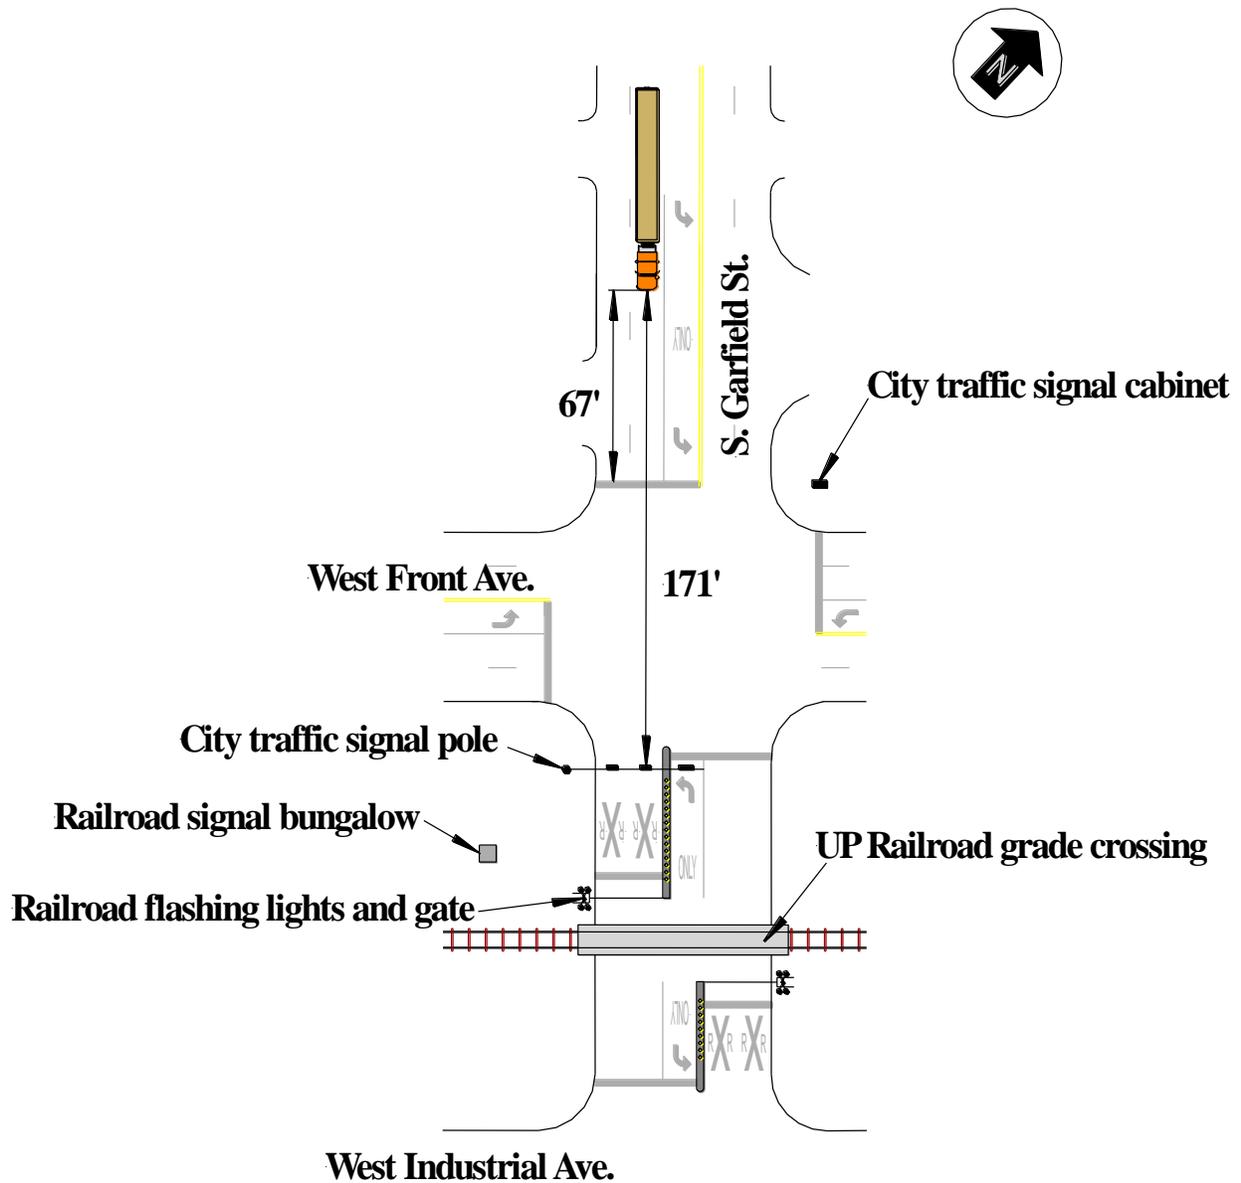
Information obtained from the highway traffic signal controller and video footage from a Midland County Sheriff's vehicle dash camera indicated that the highway traffic signal facing southbound South Garfield Street at the West Front Avenue intersection was already displaying red when the float was 67 feet from the stop line (see figure 25). A reconstruction of the collision sequence—based on video evidence, data gathered from the downloaded logs of the grade crossing warning system, and the highway traffic signal controller—established that the highway traffic signals transitioned to advance preemption when the float was approximately 10–17 feet from the north curb line of the West Front Avenue intersection. Because the southbound facing highway traffic signal was programmed to display red during advance preemption, it simply continued to display red, with no overt sign given to drivers on South Garfield Street that the highway traffic signal had transitioned in response to an approaching train.

**Figure 25.** Illustration of the point, 67 feet from the stop line, at which the red stop signal was noticeable on the Midland County Sheriff's vehicle dash camera.
