Collapse of the Interstate 5 Skagit River Bridge
Following a Strike by an Oversize Combination Vehicle
Mount Vernon, Washington
May 23, 2013

Accident Report

NTSB/HAR-14/01
PB2014-106399

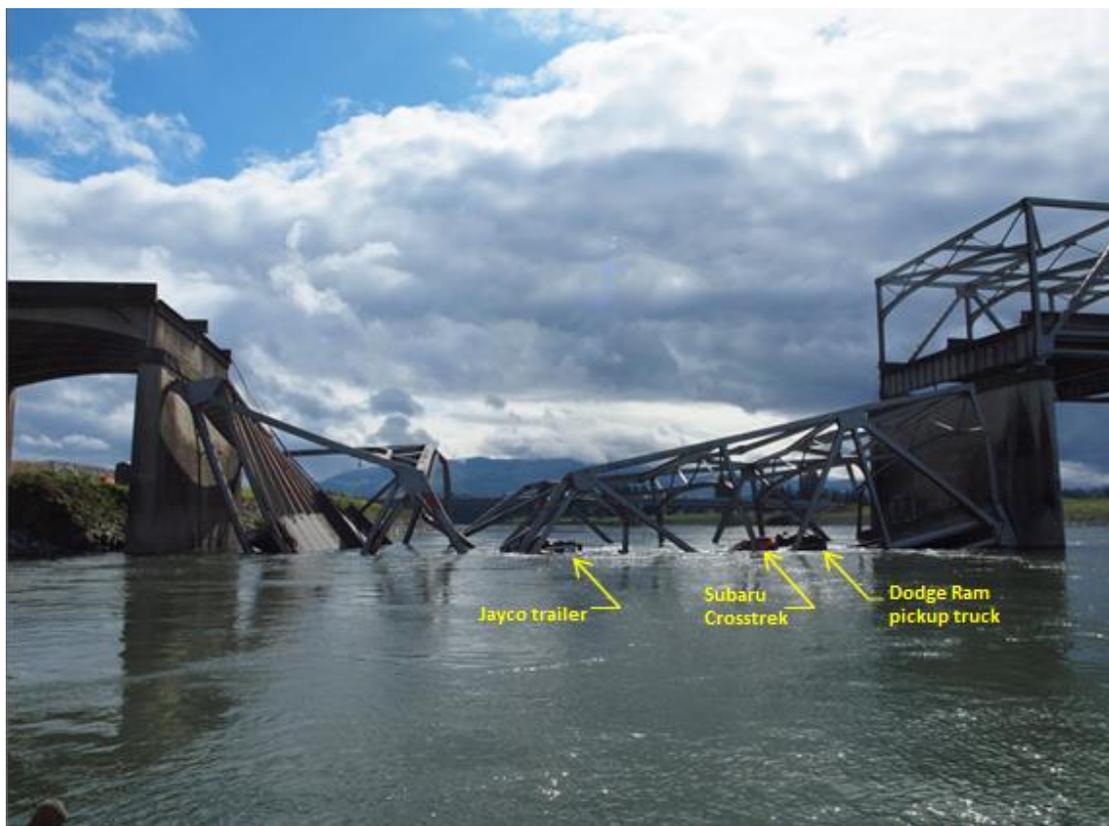
Two other passenger vehicles, a southbound 2010 Dodge Ram pickup truck towing a Jayco travel-trailer and a northbound 2013 Subaru XV Crosstrek, fell with the collapsing bridge span into the Skagit River. A driver and a passenger occupied the Dodge pickup, and a driver occupied the Subaru. First responders rescued these three people from their vehicles and transported them to local hospitals for treatment of minor injuries. Their vehicles were later retrieved from the river when the collapsed span was recovered. (See figure 6 below.)

Figure 6. Bridge span 8 in the Skagit River.

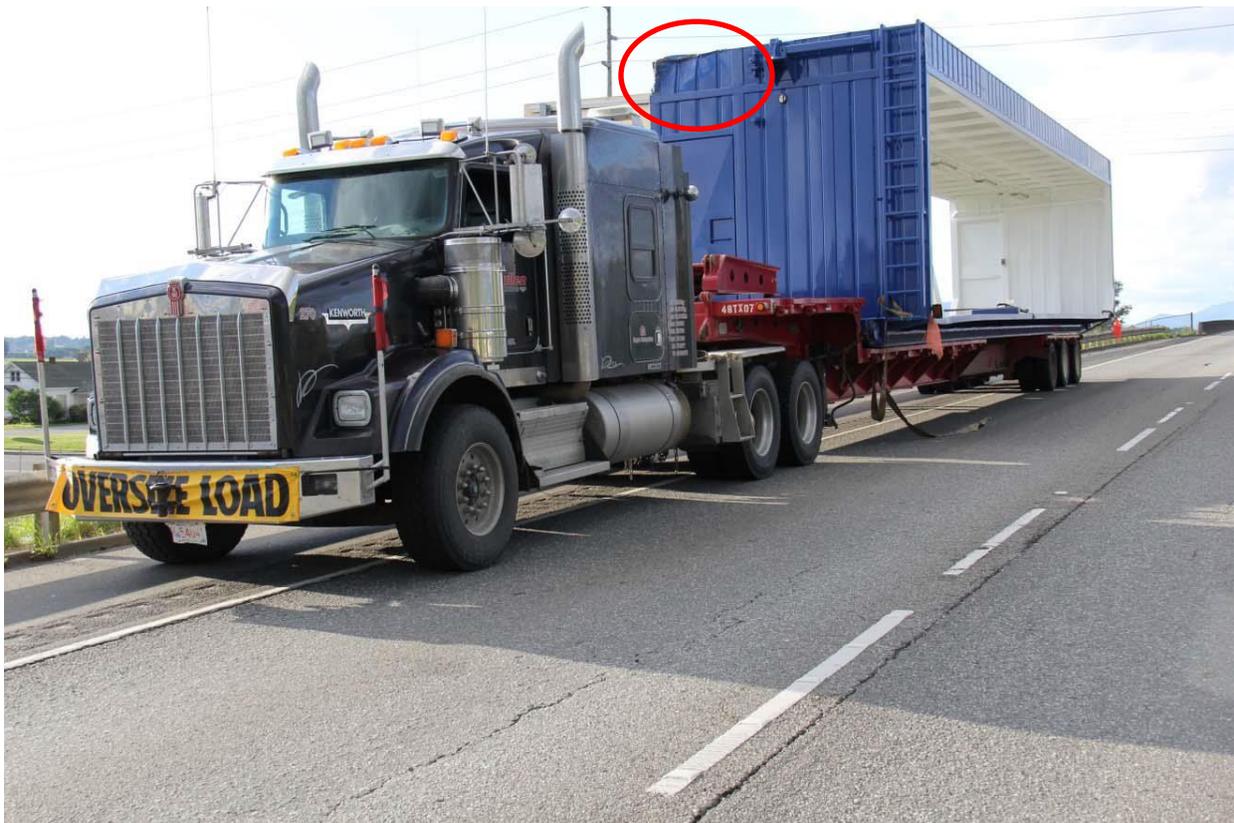
Oversize combination vehicle. The 2010 Kenworth truck-tractor showed no signs of damage. The oversize load—the casing shed section—sustained deformation damage to its upper right front corner. Scratches and dents were present along the entire length of the right top edge of the load. Scratches were also found on the upper left front side of the casing shed. The overall frame of the load was distorted rearward, most noticeably at its top right corner, where slight buckling had occurred. The entire load had shifted to the left on the semitrailer. (Figures 7 and 8 show the damage to the upper right front corner of the load. Note: Figure 7 is a facing view of the vehicle, so the right corner of the load is on the left in the photo. The same is true for the photo in figure 8.)

Figure 7. The oversize load, with the area of damage circled.

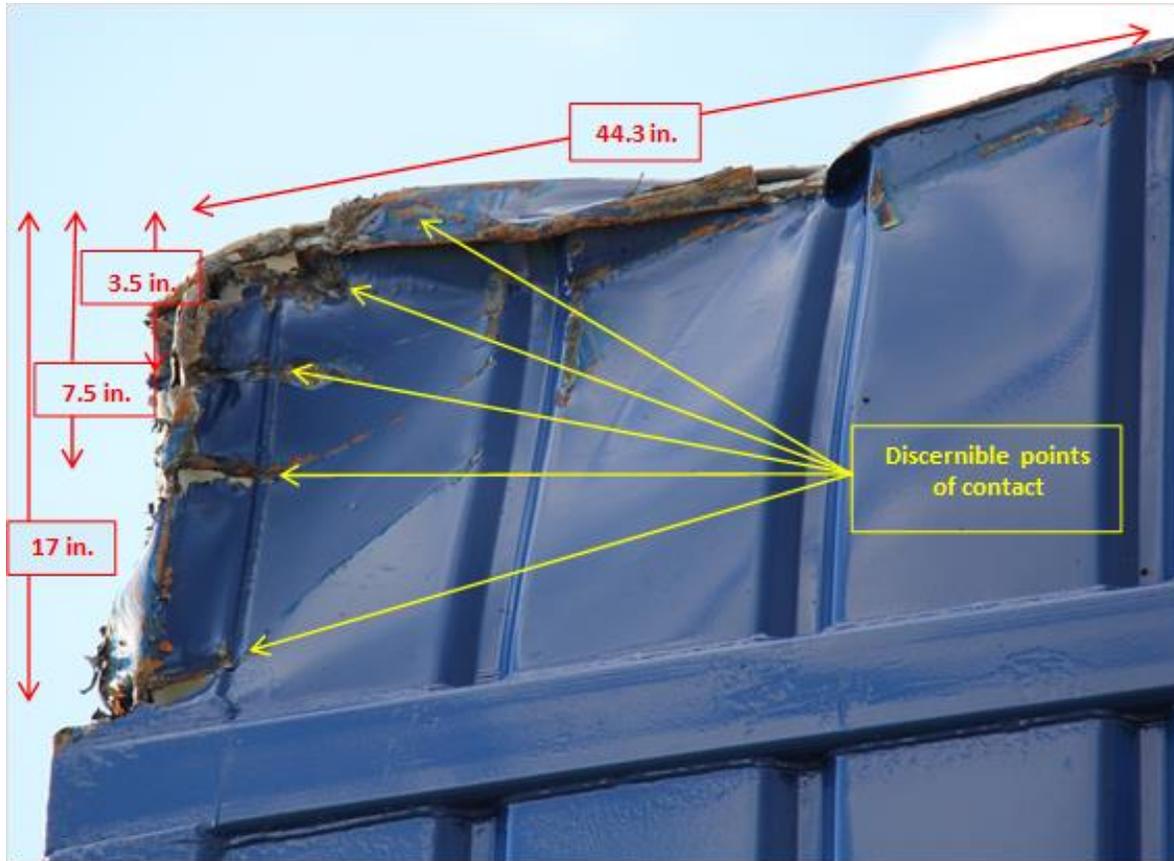
Figure 8. The upper right corner of the oversize load, with damage dimensions.

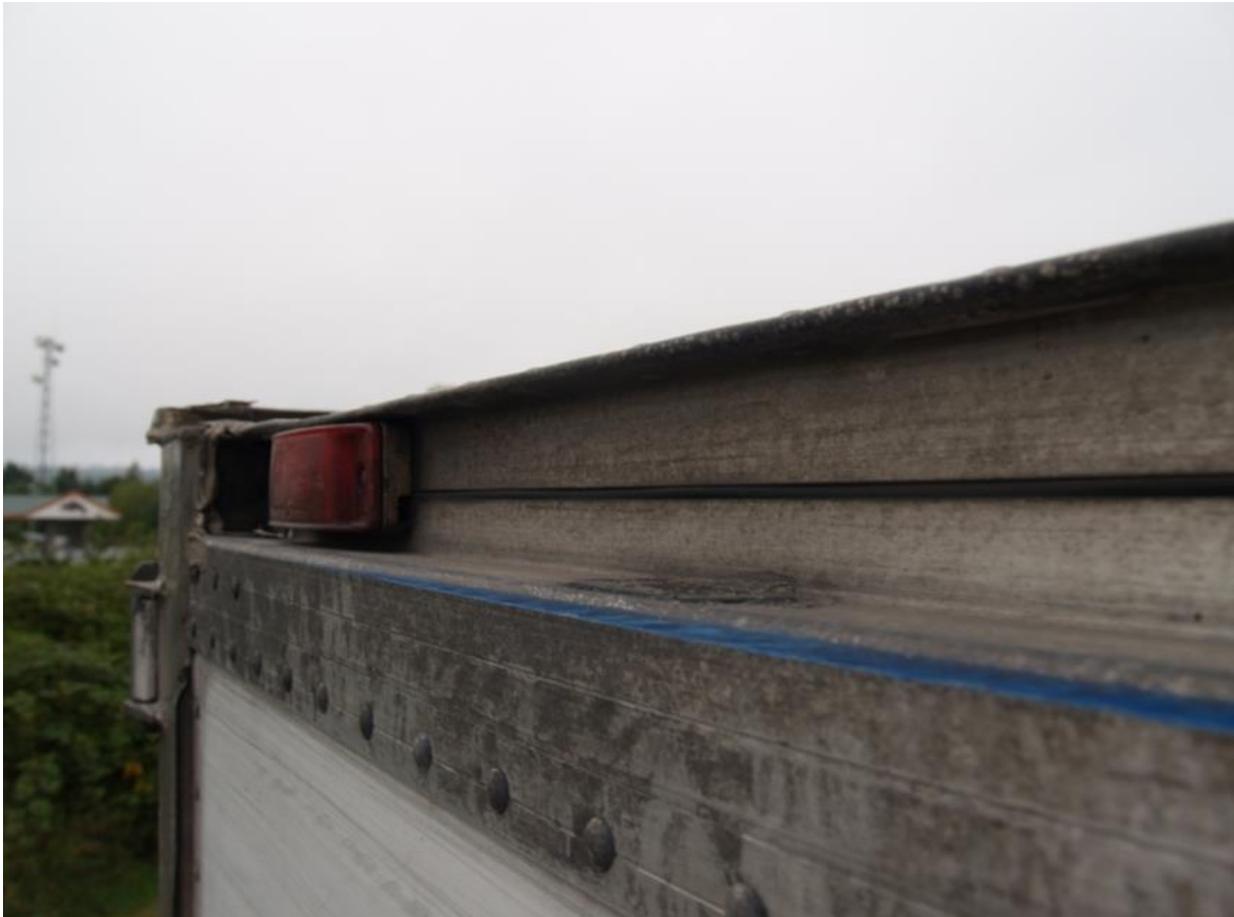
semitrailer. (See figure 9.) Although his vehicle was on the bridge as it was collapsing and was struck by the oversized load, the driver of the 2000 Kenworth truck told investigators he had not realized that he had been involved in the event and had continued driving.

Figure 9. Blue transfer paint from the oversized load found postcrash on the upper right side of the refrigerated semitrailer of the 2000 Kenworth truck.

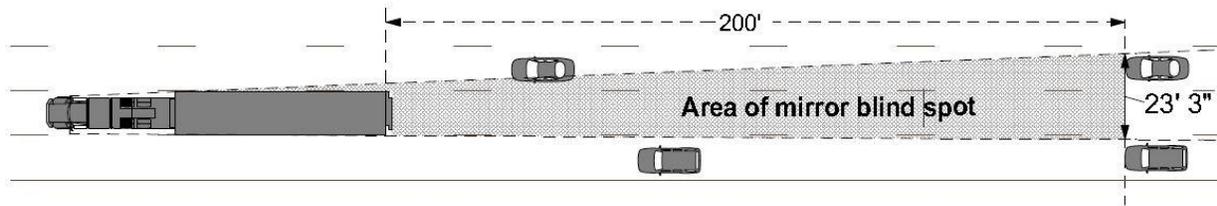
Investigators used 3D scans of the accident truck-tractor when it was coupled to a very similar casing shed and semitrailer to analyze the mirrors on the vehicle. The left and right side flat (plane) mirrors located inboard of the casing shed each had a substantial blind spot in the driver's rearward field of view.¹⁶ This rearward blind spot, with a span of more than 23 feet at a distance of 200 feet behind the vehicle, would have made lane changes hazardous without a trailing pilot/escort vehicle. (See figure 10.)

Figure 10. Diagram showing the blind spot in the rearward field of view through the flat mirrors on the crash tractor.

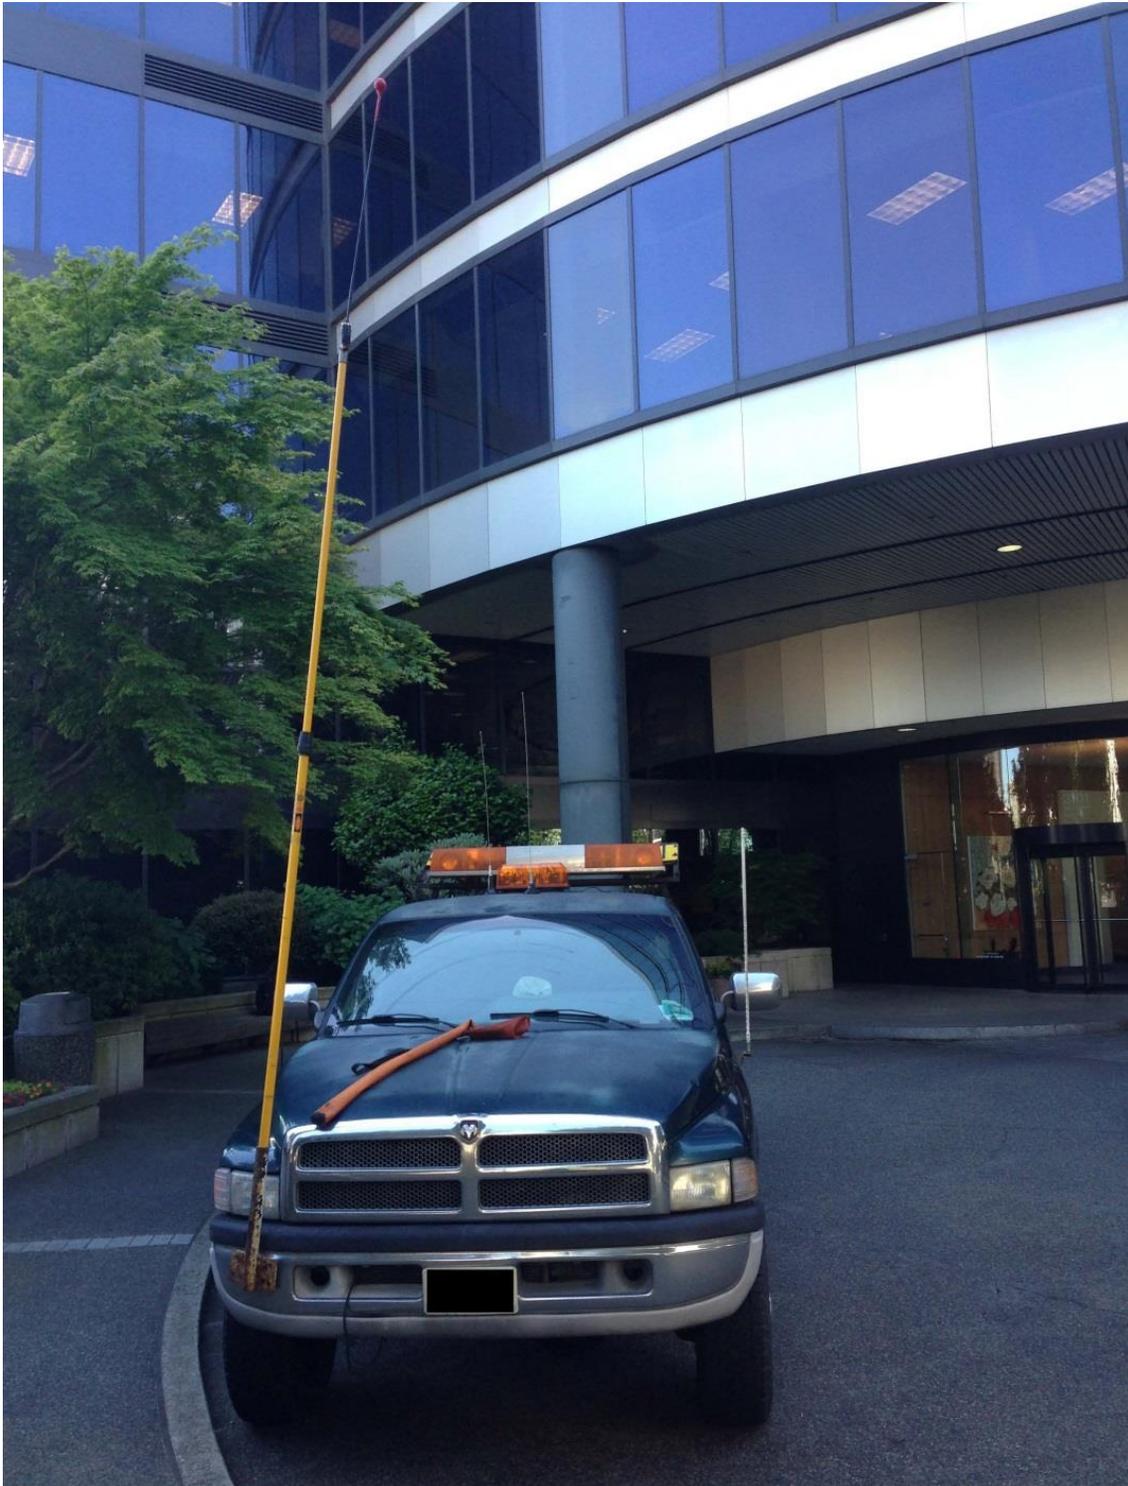
The pilot/escort vehicle driver said she set the vertical distance from the top of the pole (the ball) to the roadway surface at 16 feet 2 inches when she met the permitted vehicle at the Canadian–US border.¹⁷ She set the pole at this height because she reviewed the permit and saw that the load height was listed as 15 feet 9 inches, and the Washington State training guidelines for pilot/escort vehicle drivers recommend that the pole height be at least 3–6 inches above the height of the load as recorded on the permit.

Figure 11. Pilot/escort vehicle, showing the placement of the height pole on the front bumper.

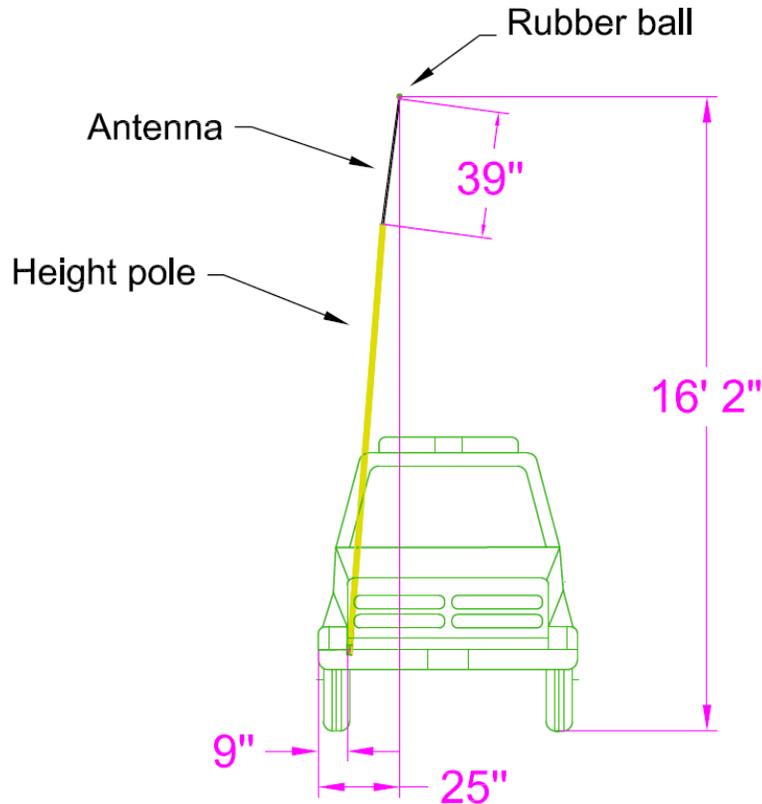
Figure 12. Diagram of the pilot/escort vehicle, viewed from the front. (The measurement of 16 feet 2 inches is the vertical distance from the roadway surface to the top of the height pole [the rubber ball].)

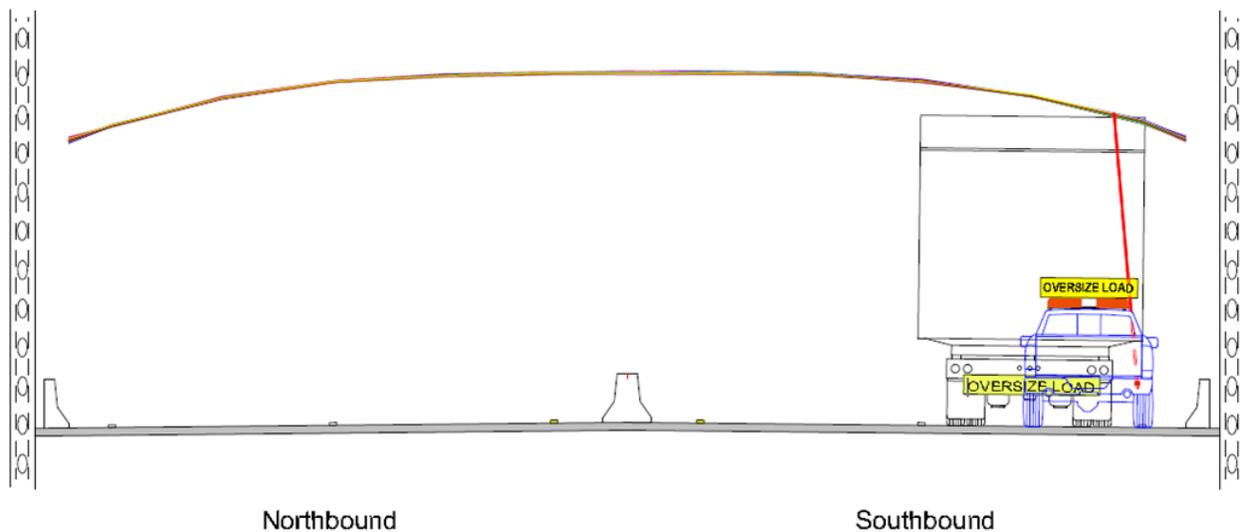
Based on the measured geometries of the bridge and the height pole, the right tire of the pilot/escort vehicle would have to have traveled atop the right lane edgeline for the pole to have made contact with the sway brace. (See figure 19.)

Figure 19. Image of the approximate position of the pilot/escort vehicle in the roadway necessary to ensure contact with the low-clearance sway braces.
