Commercial Vehicle Overturn Resulting in
Cargo Tank Rupture, Propane Release, and Fire
Stroud, Alabama
March 11, 2016

Accident Summary Report

NTSB/HAR-18/01/SUM
PB2018-100361

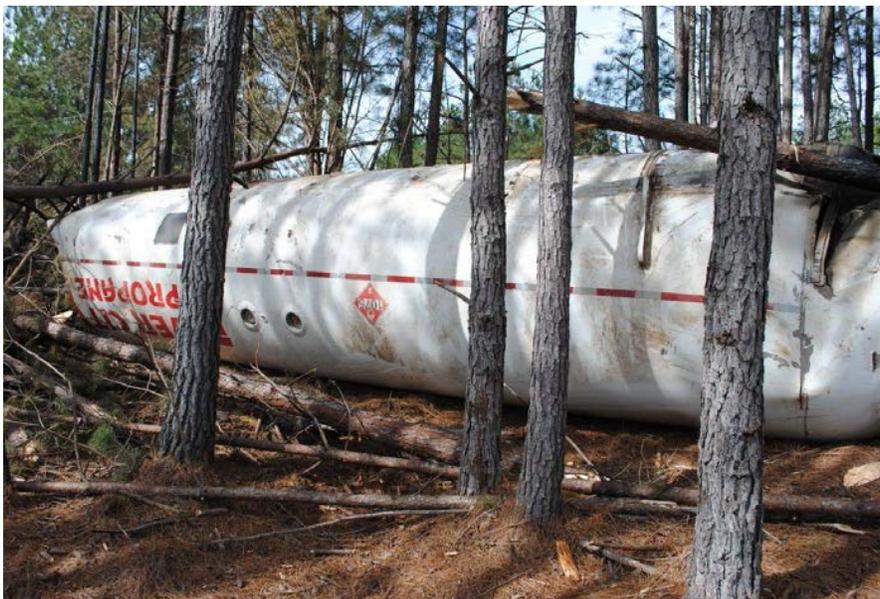
The truck-tractor came to rest on the eastern ditch/embankment area and was subsequently destroyed.⁴ The truck-tractor driver was ejected and severely injured as a result of the crash. The crash location is shown in figure 1. Figure 2 shows the cargo tank at final rest.

Figure 2. Cargo tank at final rest. (Courtesy Alabama Liquefied Petroleum Gas Board)

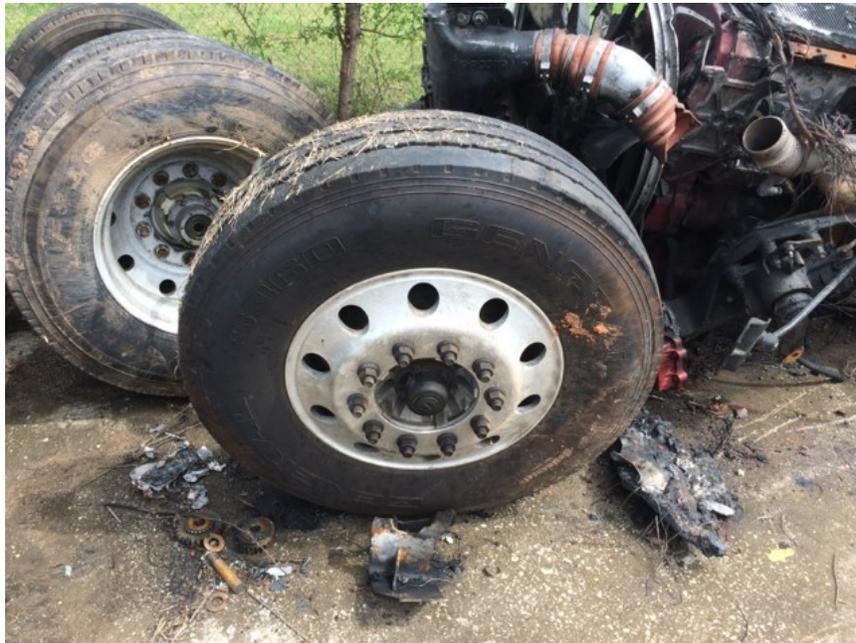
The power unit in this crash was a 2011 Peterbilt truck-tractor equipped with a Bendix antilock braking system, Cummins engine, and Eaton Fuller 10-speed transmission. Because the truck-tractor was largely consumed by the postcrash fire, investigators could not complete a full mechanical inspection. Instead, they performed a visual inspection of the remaining components. All remaining tires and brake components on the truck-tractor exceeded the minimum tread depth and pad thickness requirements. Given the driver's statement regarding a "pop" sound that occurred just before he felt the combination vehicle "go over," investigators specifically examined both steering axle tires for signs of failure (blowout); none were found. The passenger's side tire was still attached to the rim and inflated, indicating that it had not experienced a blowout. (See figure 3.)

Figure 3. Passenger's side tire.

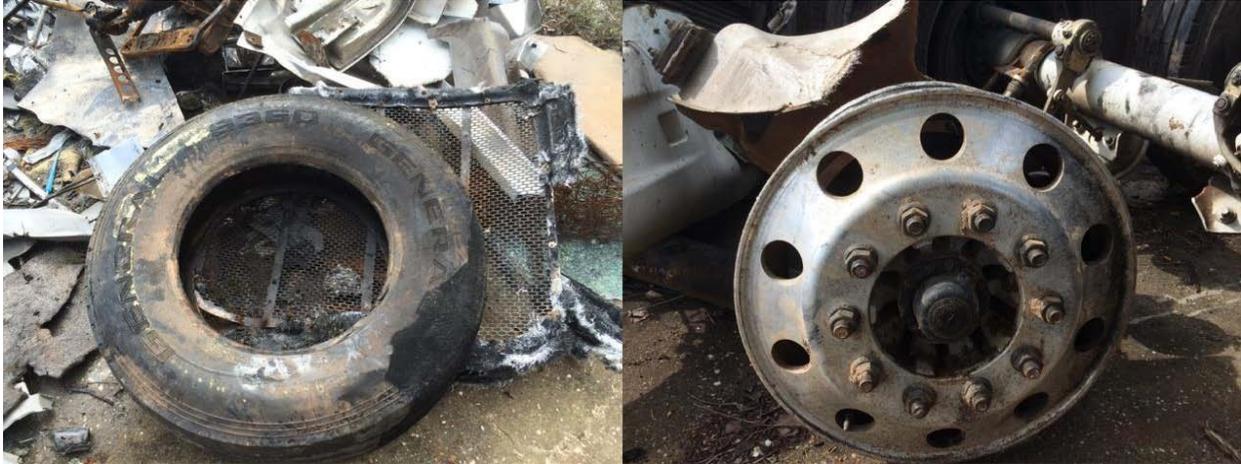
The driver's side tire was separated from the rim and had been damaged by the postcrash fire; however, it showed no signs of deformation, imbedded asphalt, or gouges, indicating that it had not experienced a blowout. (See figure 4.)

Figure 4. Driver's side tire and rim.

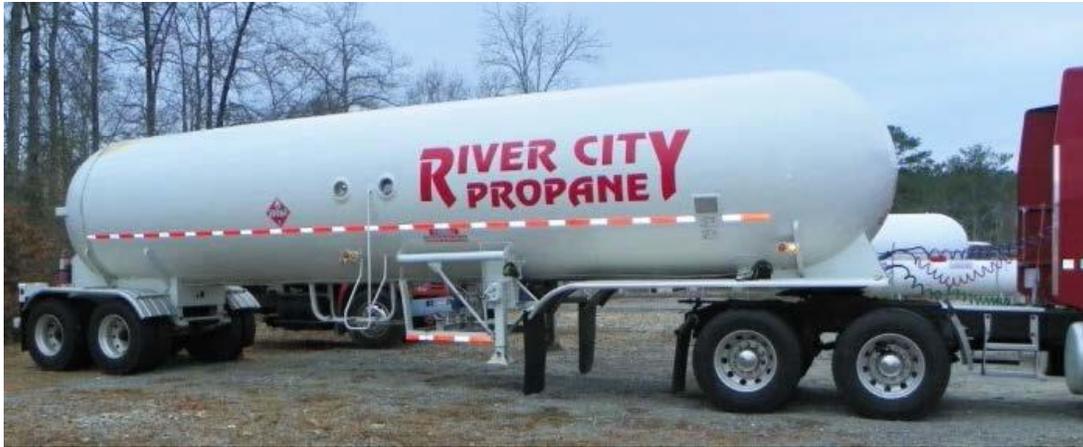
Background. The cargo tank semitrailer involved in the crash was purchased by River City Propane on September 1, 2011. When contacted by investigators, the previous owner stated that the cargo tank had been used by both that company and a previous owner for dedicated noncorrosive LPG transport service. (See figure 5.)

Figure 5. Crash cargo tank in precrash condition (photo taken February 5, 2013). (Courtesy Federal Motor Carrier Safety Administration)

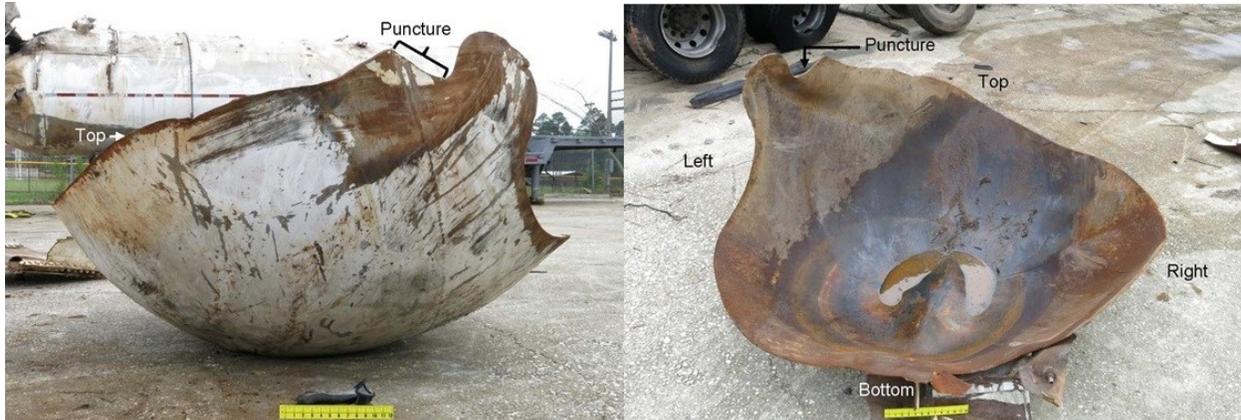
Front tank head. The front tank head was damaged and compromised during the crash sequence. It was scraped and dented, and the dent was oriented horizontally. The dent ran from the top center of the head to the left side, becoming deeper as it progressed until transitioning to a puncture. The puncture features were consistent with an impact with a large rock. The interior of the front head also exhibited surface corrosion, with thinning in the regions of heaviest corrosion, but the head's thickness remained above the legal minimum. Investigators found no visual indications of any preexisting damage or defects. The front head material was tested and found to meet the mechanical and chemical requirements for American Society of Mechanical Engineers (ASME) SA-517 grade F steel (also known as "T-1" steel). The front tank head is shown in figure 6. Based on the condition of the tank head, the NTSB concludes that the release of the cargo tank's contents was due to the puncture of the front tank head by impact with a rock; the rupture of the tank and subsequent release and ignition of propane increased the severity of the crash outcome.

Figure 6. Outside and inside view of front tank head.

Third, during the postcrash inspection, investigators noticed corrosion on the lower half of the front tank head. Had a proper internal inspection taken place, the presence of this corrosion should have prompted the inspector to conduct the required material thickness testing and note the results in the report.¹⁷ Although, despite the corrosion, the front tank head still exceeded the minimum required thickness at the time of the postcrash inspection, the report of the June 2011 inspection did not mention either corrosion or thickness testing.

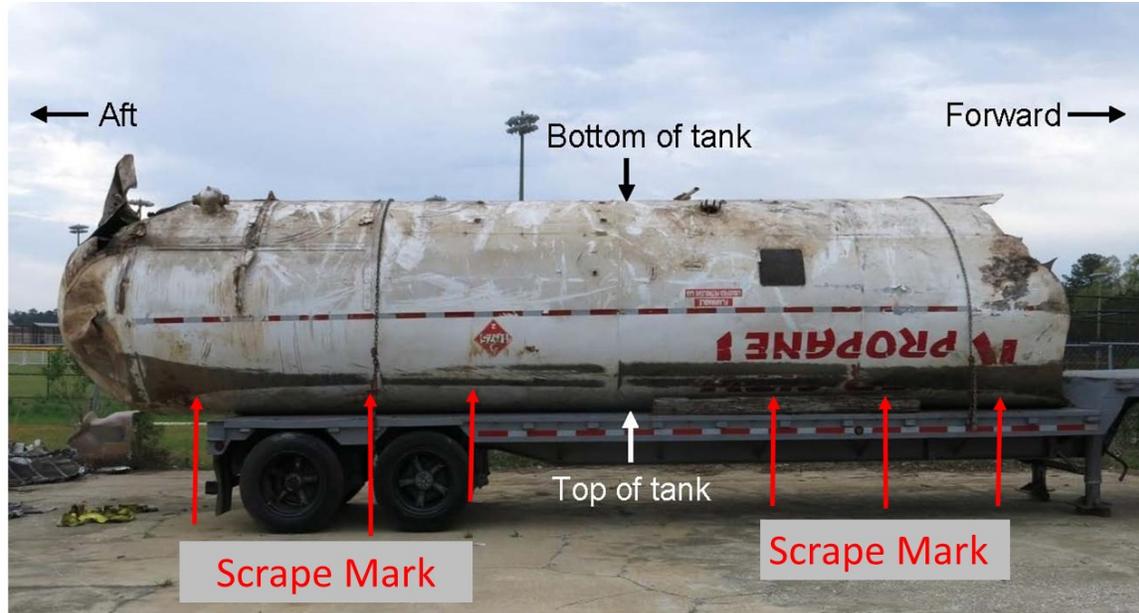
Left and right sides. The left side of the tank body was scraped near the top along its entire length. Along the right side of the tank body, a spiral crack extended from the point of impact on the front head and progressed into the first barrel section of the shell. A large flap of steel protruded about 90° from the tank where the crack arrested. The left side of the tank is shown in figure 7.

Figure 7. Left side of cargo tank.
