Motorcoach Run-Off-the-Road and Overturn  
US Highway 83  
Laredo, Texas  
May 14, 2016

NTSB/HAR-18/03  
PB2019-100083

# Highway Accident Report

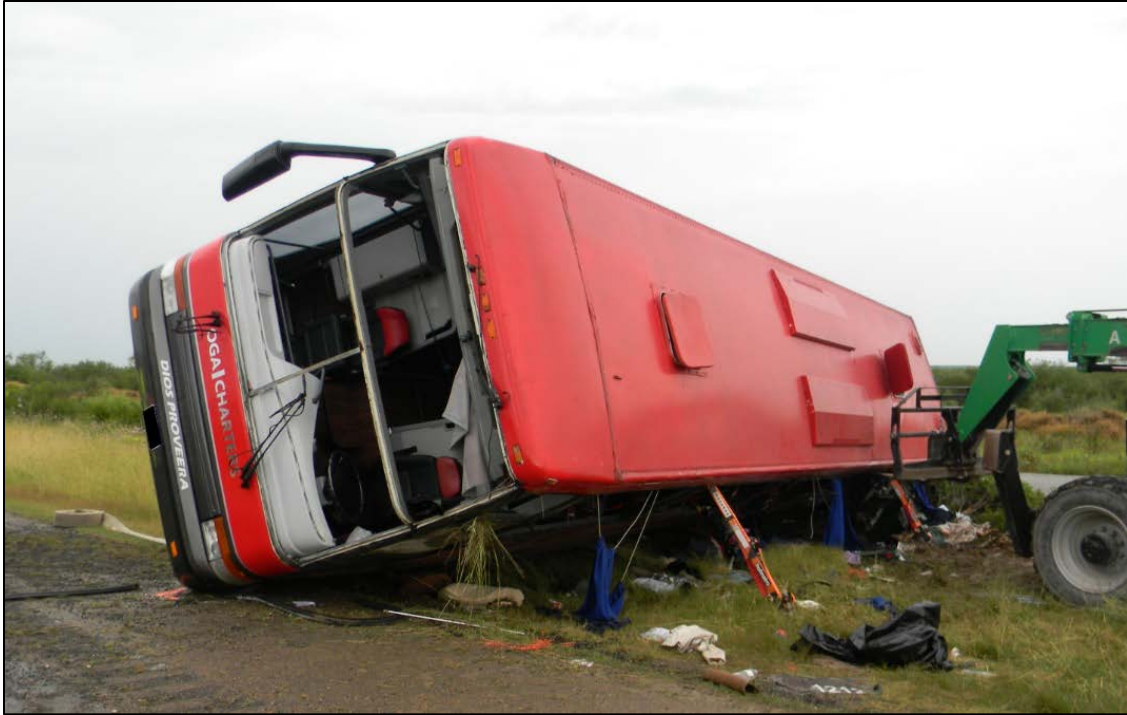
**Figure 3.** View of front left of motorcoach at its approximate final rest position. The left side of the vehicle has been partially raised and supported to facilitate extrication of the occupants. (Source: Texas Department of Public Safety)

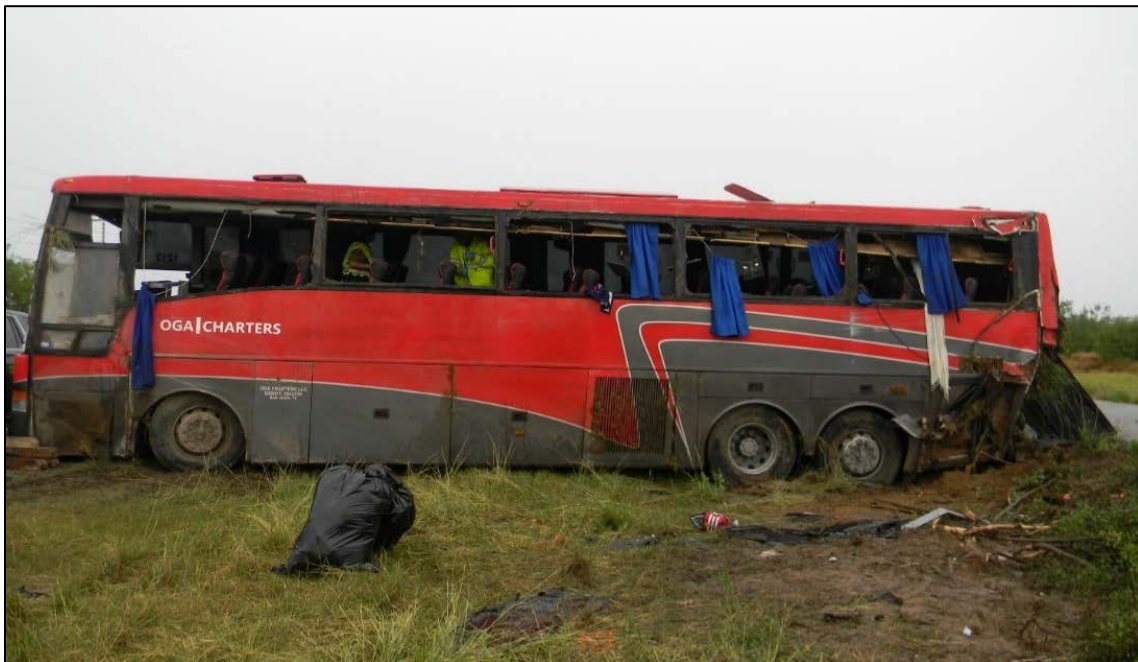
**Figure 4.** View of left side of motorcoach after the vehicle was uprighted from its final rest position. (Source: Texas Department of Public Safety)

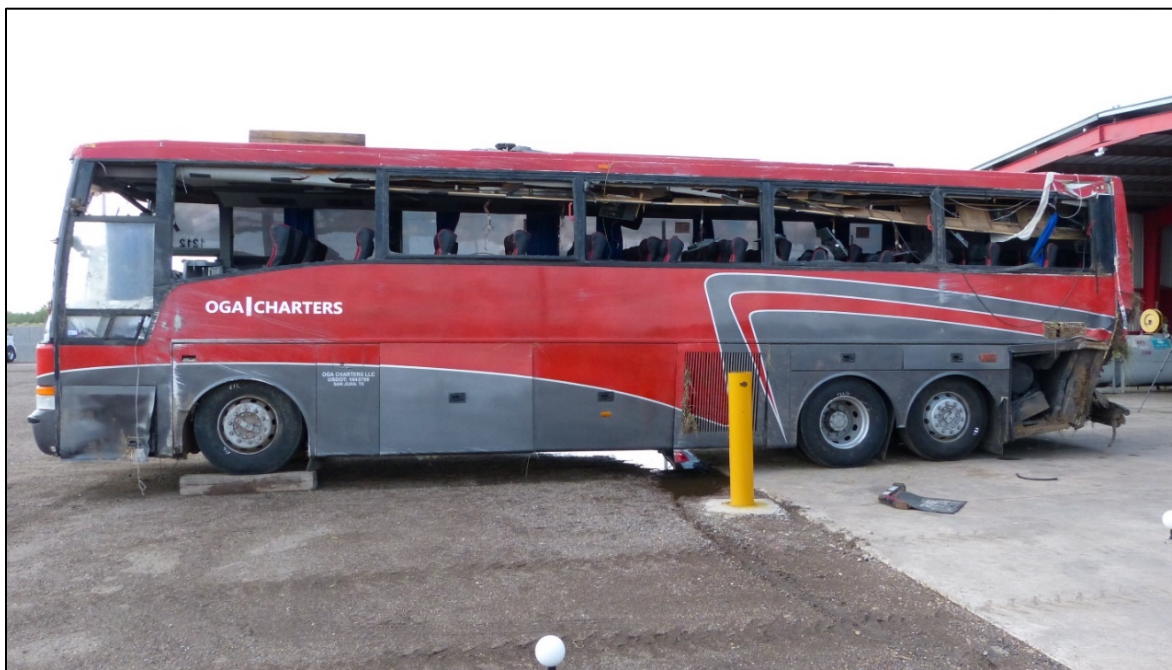
Exterior damage was observed primarily along the motorcoach's left side. Parallel scrapes and scratches extended the entire length of the left side, and various body panel seams and openings had grass and soil embedded in them. There was a small area of impact damage on an access door forward of the front wheel opening. The left rear corner of the vehicle also had impact damage. The damage was concentrated at the lower portion of the corner and extended up to the area of the rearmost passenger window.

The left side of the motorcoach had one multipane driver's window adjacent to the driver's seating position and five passenger windows. The upper pane of the driver's window was broken, and the remaining panes of the driver's window were soiled with mud and dirt. The forwardmost passenger window was 78 inches wide and tapered in height; it measured 44 inches high at the front and 36 inches high at the rear. Passenger windows two through four were the same size, measuring 74.5 inches wide and 32 inches high. The rearmost passenger window was 44 inches wide and 32 inches high. The glazing for all five passenger windows on the left side was broken and missing. Additionally, the window retention frame for passenger window two was displaced at the bottom, having a 2-inch-wide opening between the frame and the vehicle body. The frame for passenger window three was completely missing. Passenger windows two through five were configured for use as emergency exits. (See figure 6 for a postcrash view of the left side of the motorcoach.)

**Figure 6.** View of motorcoach's left side, showing missing window panes and impact damage to the front and rear of the vehicle.

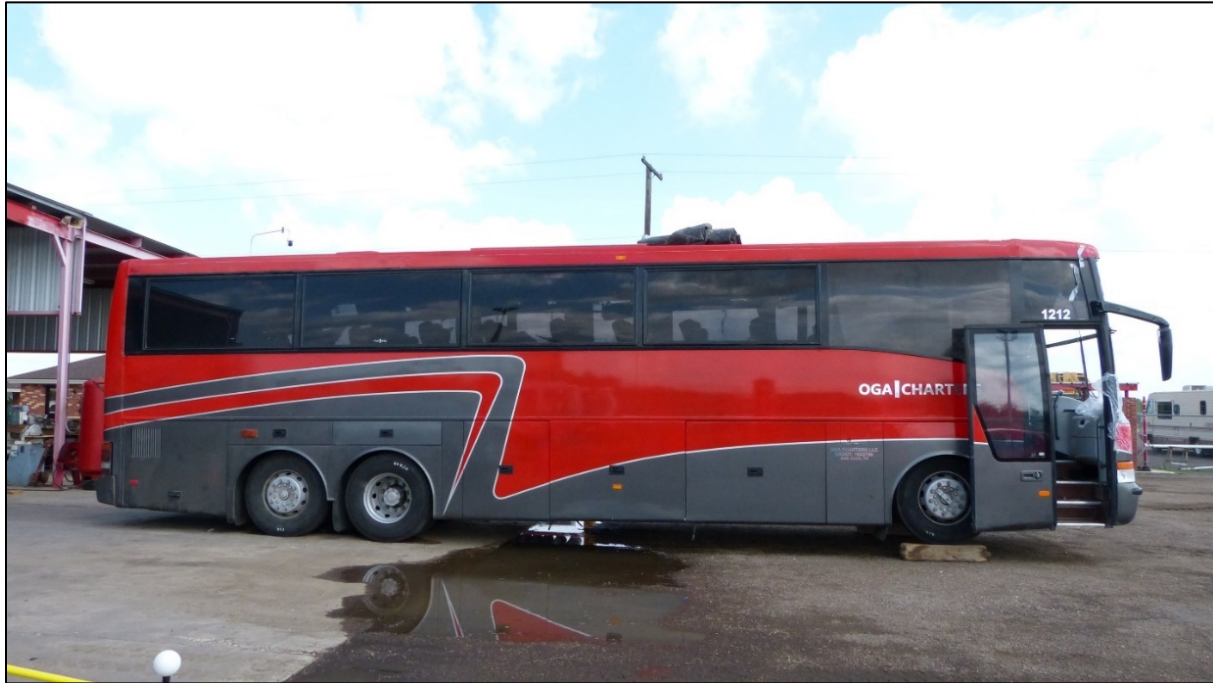
The right side and front of the motorcoach showed no signs of impact damage. The three laminated glass panes comprising the front windshield were missing. The passenger loading door area was intact and did not have significant damage. (See figure 7 for a postcrash view of the right side of the motorcoach.)

**Figure 7.** View of motorcoach's right side, showing intact window panes and minimal vehicle damage.

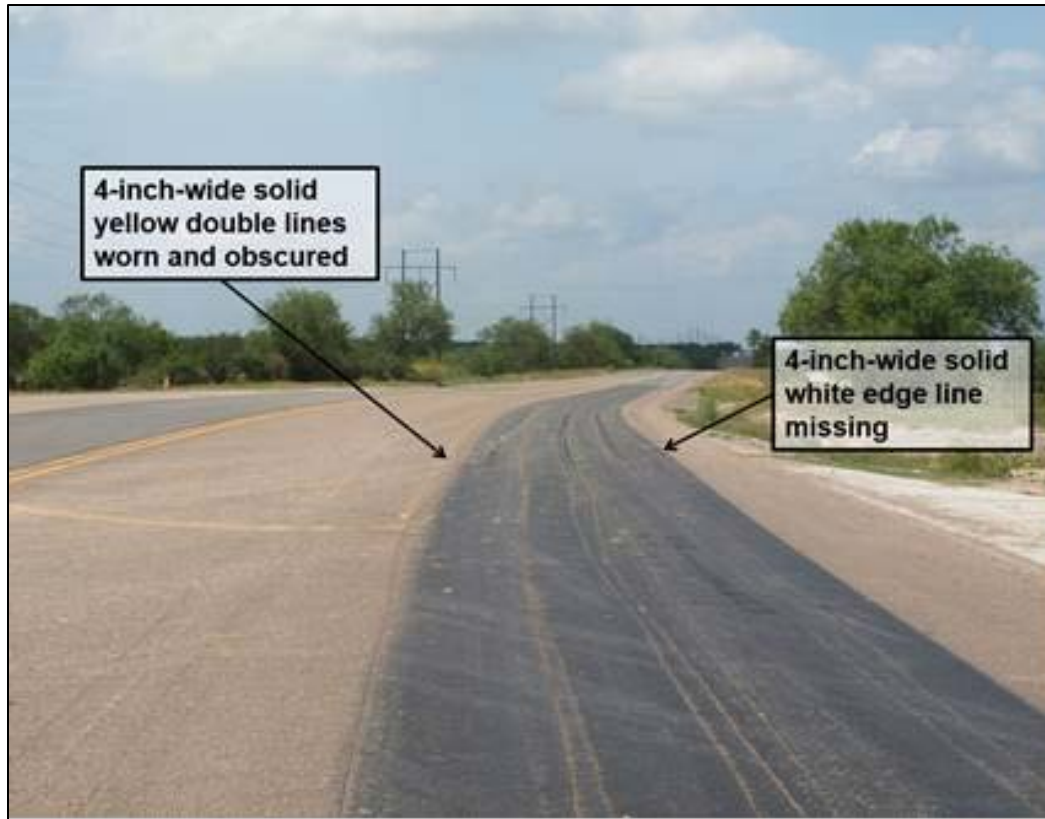
Within the curve, the turn lanes are delineated from the painted center median by 6-inch-wide painted lines. At the time of the crash, the double 6-inch-wide yellow lines that separate the northbound travel lane from the center median were worn and faded. Beginning at about the curve midpoint, the white edge line intended to separate the northbound travel lane from the paved shoulder was so faded as to be not visible. (See figure 9.)

**Figure 9.** Northbound view of US-83, showing the degraded condition of lane striping within the curve.

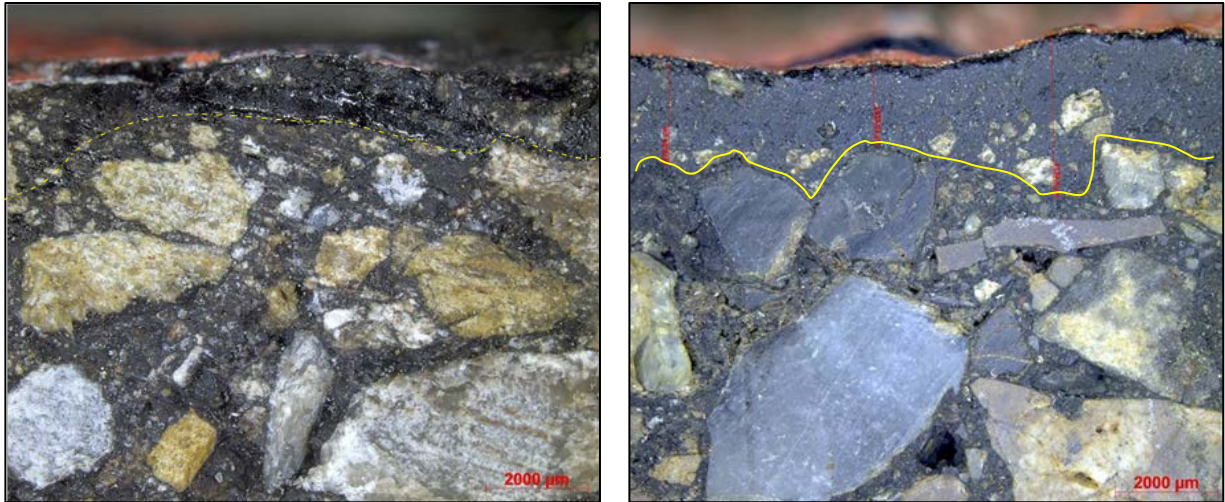
Based on forensic analysis of the core samples from the milled area of the northbound travel lane of US-83, the TFHRC concluded that the primary factor most likely contributing to the low pavement friction was the absence of adequate aggregate particles in the wearing course of the pavement, compounded by tack coat content that created a slick asphalt surface.<sup>45</sup> (See figure 11 for cross section images of two of the core samples, showing how little aggregate was in the top pavement layer, and figure 12 for an image of the slick-appearing surface of the roadway.)

**Figure 11.** Cross section views of pavement core samples 1B (left) and 5B (right), showing the 2–3-millimeter-thick top layer of asphalt emulsion. The area above the yellow line in each photograph is the surface of the roadway; when compared to the material below the line, little aggregate can be seen in this top layer.

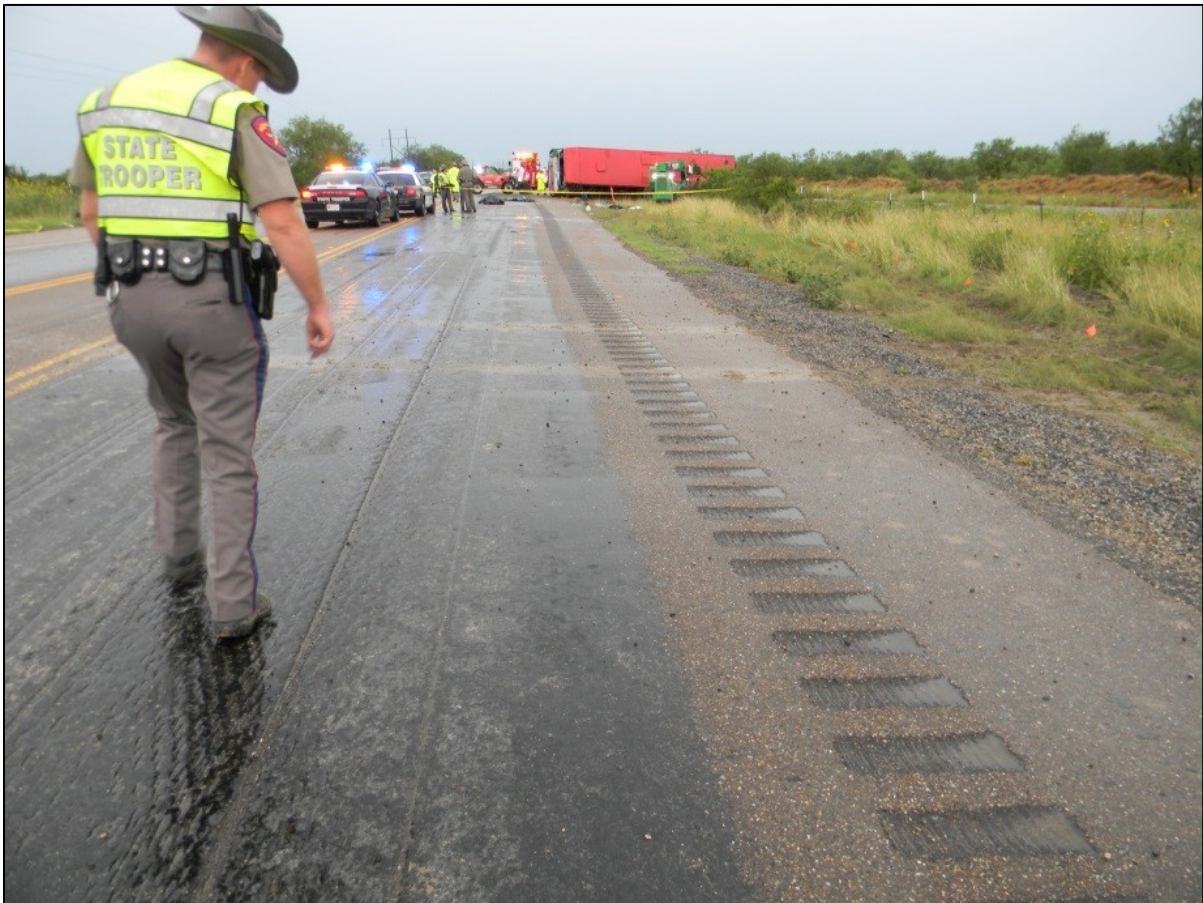
**Figure 12.** Postcrash view of US-83 northbound travel lane. The slick-appearing surface and increased reflectivity contrasts with the paved shoulder on the right. (Source: TxDPS)

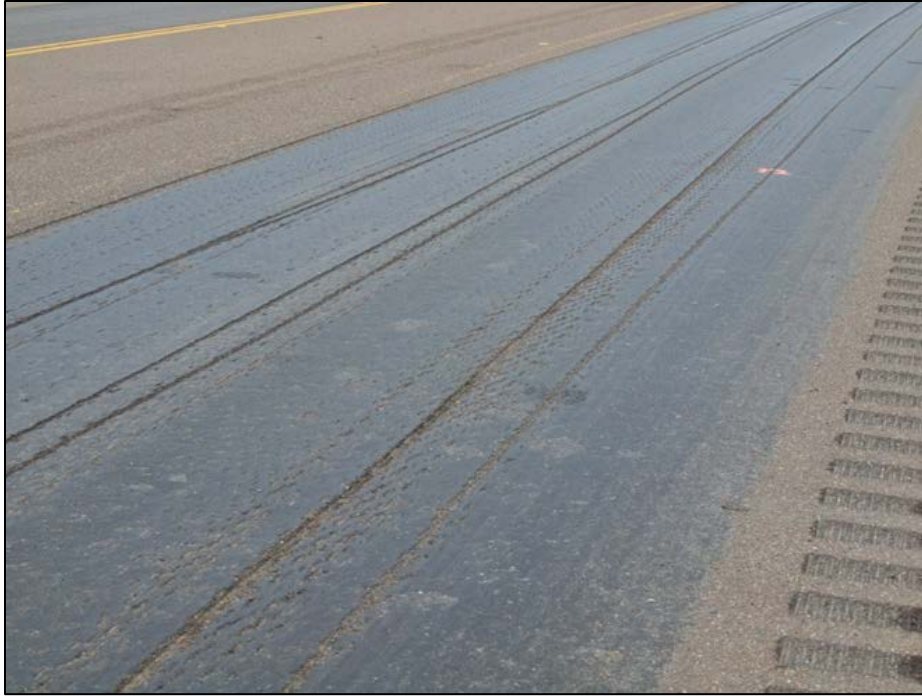
**Figure 13.** View of US-83 northbound travel lane shortly after the crash, showing gouges and continuous longitudinal grooves in the pavement surface.

The problems with the pavement texture in the crash area are particularly apparent when comparing the pavement immediately postcrash to the pavement as it was after successful maintenance operations—including chip sealing—were conducted in August 2016, about 3 months after the crash, as indicated in figure 14. After the successful work, the texture of the roadway surface was uniform, it no longer appeared slick, and the grooves and gouges were gone.

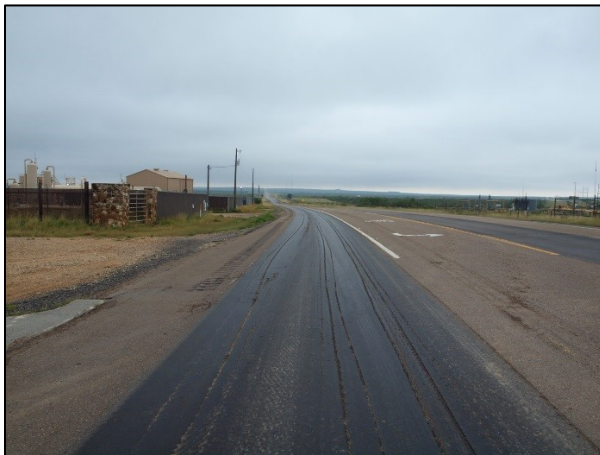
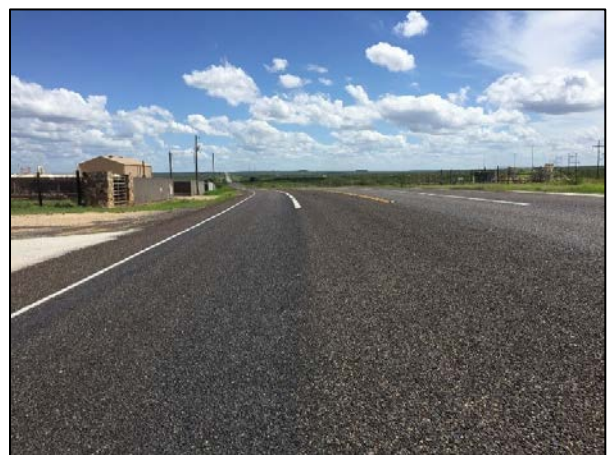
**Figure 14.** Views of the northbound US-83 lane looking south. The photo on the left shows the northbound travel lane as it appeared in May 2016. The photo on the right shows the northbound travel lane as it appeared in August 2016, after the completion of the successful chip seal operation.

The TFHRC report to the NTSB concluded that the results of the milling operation on October 26, 2015, produced results that did not conform to TxDOT standard specifications for planing and texturing as detailed in the TxDOT *Planing and Texturing Pavement Specifications*. It is unclear how the longitudinal grooves in the pavement surface were made, but the report theorized that they could have been produced by a milling head with misaligned teeth. The NTSB concludes that the pavement milling operation performed on US-83 by the TxDOT maintenance crew on October 26, 2015, was inadequate and did not conform to the agency's own specifications.

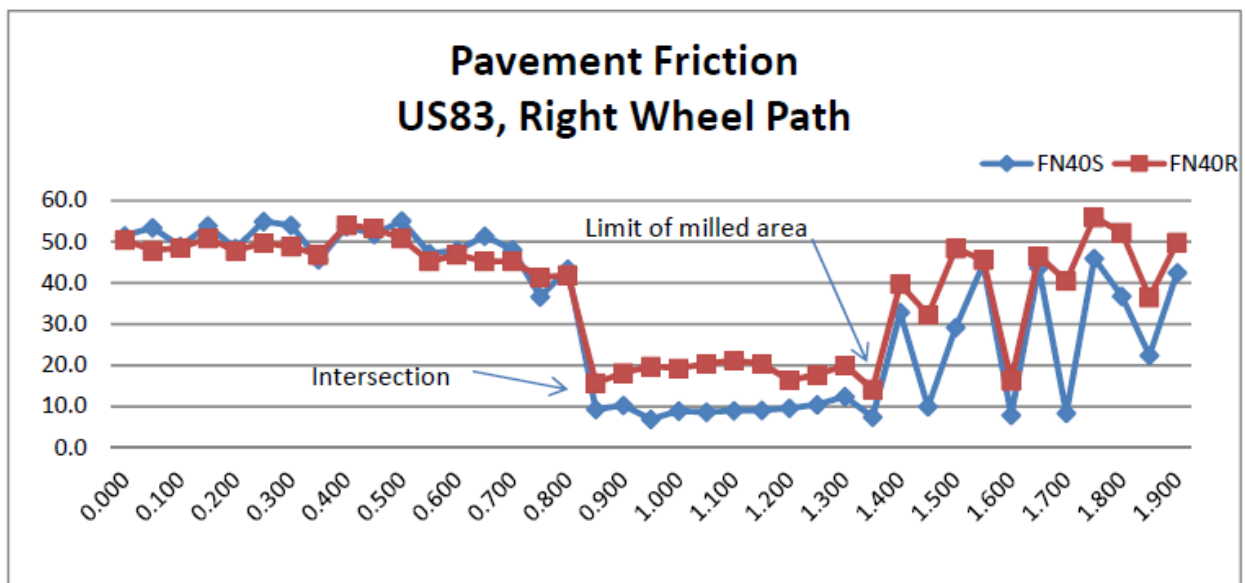
After the crash, TxDOT performed friction testing on the northbound lanes. Friction test results obtained using ASTM locked wheel skid trailer indicated abnormally low friction test values in approximately half mile of the northbound lane, in both wheel paths but most prevalent in the right wheel path.

**Figure 1:** Friction test values (FN40S and FN40R) reported by TxDOT. Locations of “intersection” and “end of milled area” are approximate. The crest of the vertical curve is approximately at DMI reference 1.200.

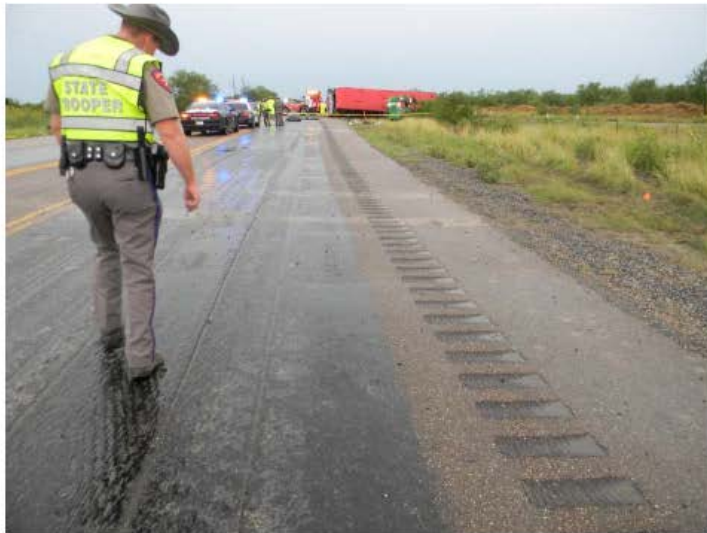
**Figure 4:** View of US83, northbound lane, looking north. Note the standing water in the rumble strips indicate the super-elevation of the roadway. Image obtained by Texas DPS on 05/14/2016, several hours after crash.

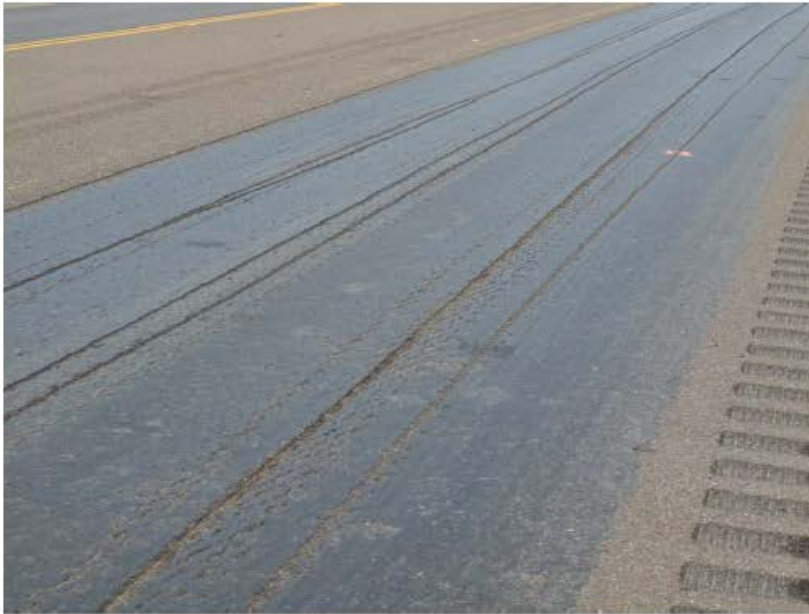
**Figure 7:** US83 northbound lane, close up of milled section in vicinity of driveways. The longitudinal grooves were reported to be from milling operation. Image obtained by NTSB on 05/15/2016.

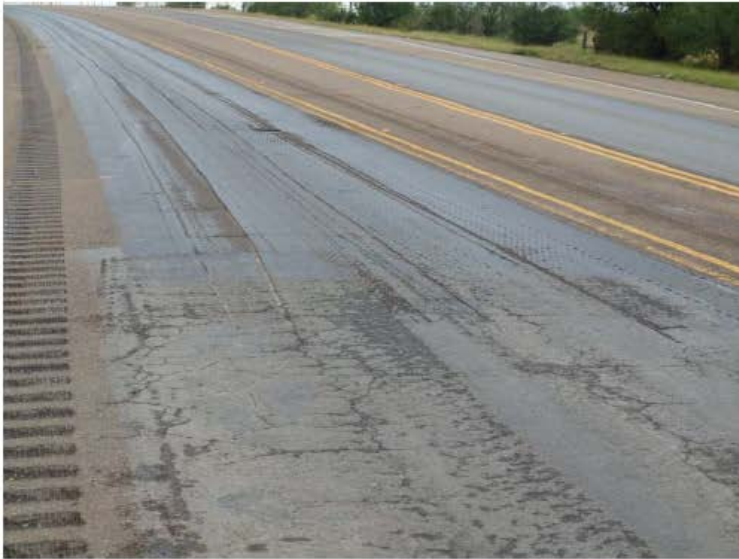
**Figure 9:** US83 northbound lane, looking south, at end of milled pavement. Note the pavement cracking in foreground is consistent with pavement conditions at time of milling. Image obtained by NTSB on 05/15/2016.

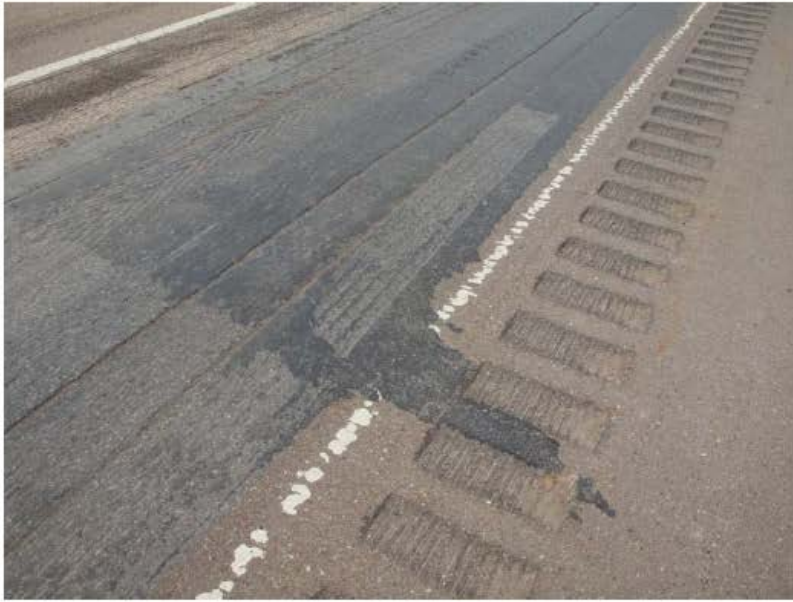
**Figure 11:** US83 northbound lane, close up of south end of milled section. Note the rumble strip (constructed February 10, 2016) intersects the surface asphalt material. Image obtained by NTSB on 05/18/2016

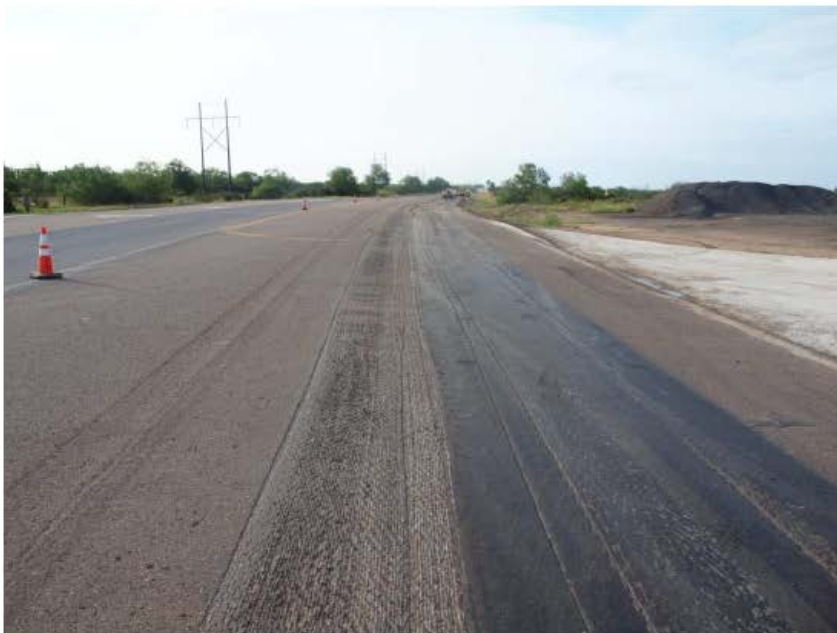
**Figure 14:** May 18, 2016 milling operations. Note the contrast of the May 18, 2016 milling results (texture) on the left compared to the results of the milling performed on October 26, 2015 on right.

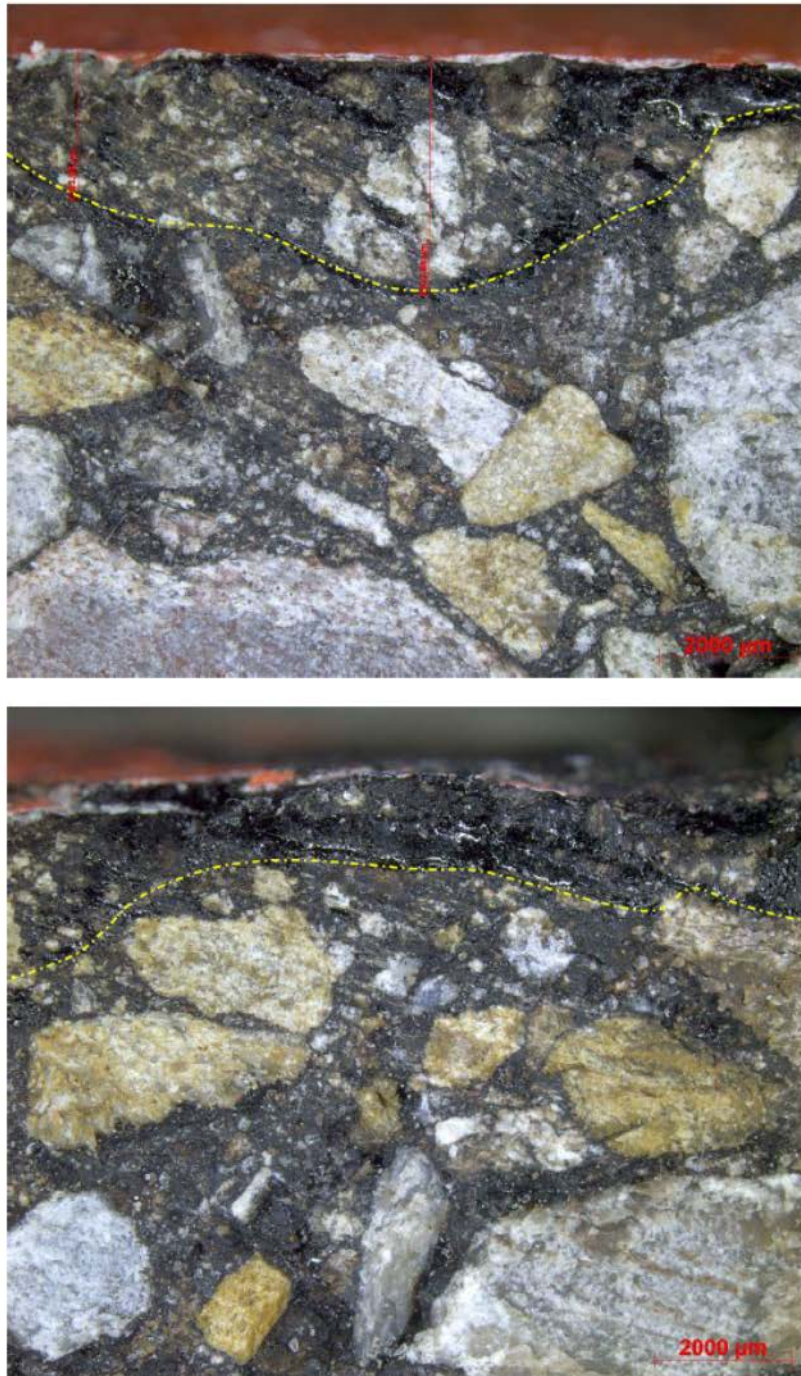
**Figure 15.** Cores 1B (NB #1B LWP). Saw cut section showing a thin top layer consisting of a somewhat mushy/gooeey asphalt and remnants of relatively small and soft limestone particles, overlying the first lift consisting of a normal relatively hard binder and a dominantly siliceous aggregates. Broken line marks boundary between the top, asphalt-rich thin layer and the immediate bottom lift/layer.

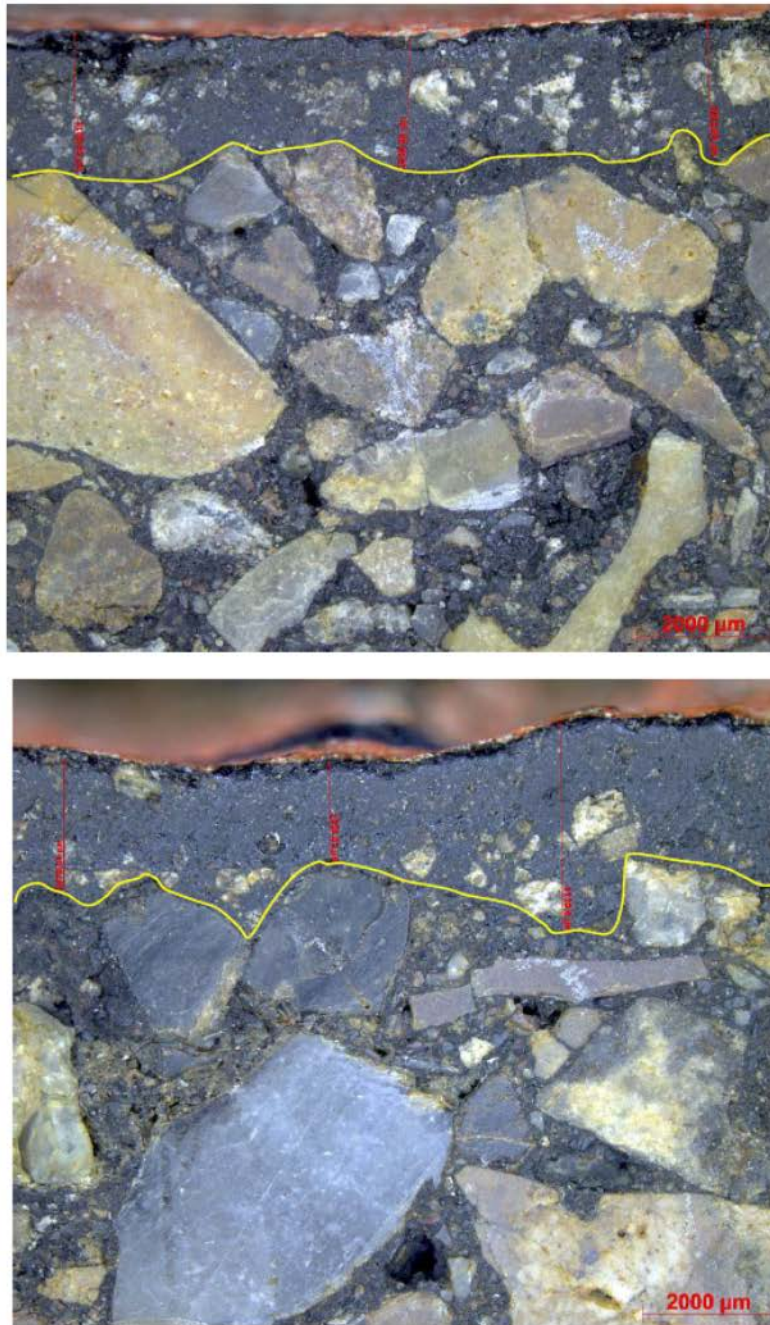
**Figure 16.** Core 5B (NTL RWP #5B). Saw cut section showing a thin layer along the top consisting of somewhat mushy/goeey asphalt and remnants of relatively soft and small limestone particles, overlying the first lift consisting of a normal relatively hard binder and a dominantly siliceous aggregates. Solid line marks boundary between the top, asphalt-rich thin layer and the immediate bottom lift/layer.
