Collision Between a Sport Utility Vehicle Operating With  
Partial Driving Automation and a Crash Attenuator  
Mountain View, California  
March 23, 2018

NTSB/HAR-20/01  
PB2020-100112

# Highway Accident Report

**National Transportation Safety Board. 2020. *Collision Between a Sport Utility Vehicle Operating With Partial Driving Automation and a Crash Attenuator, Mountain View, California, March 23, 2018. Highway Accident Report NTSB/HAR-20/01. Washington, DC.***

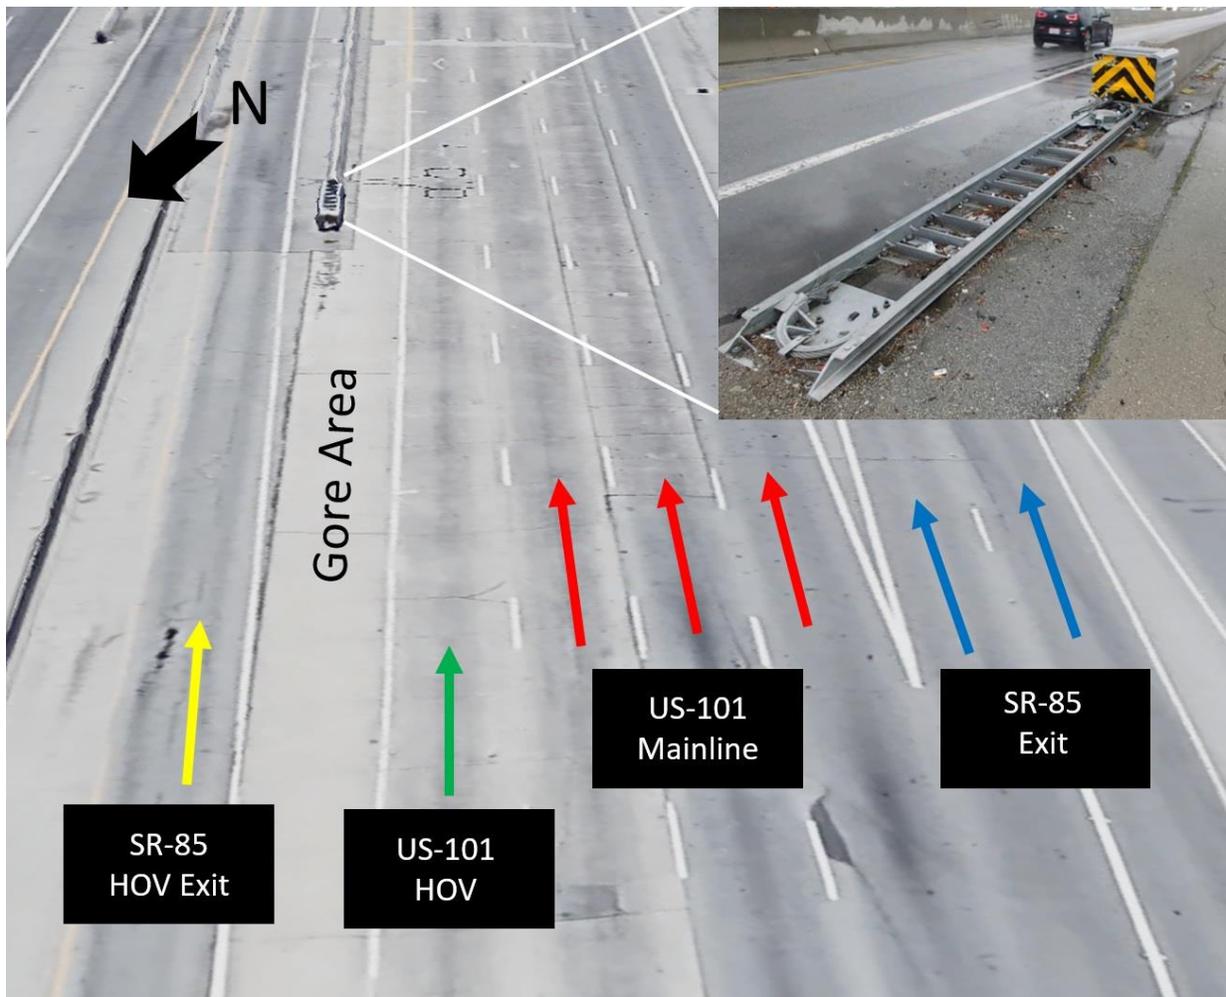
A 630-foot-long paved gore with an unmarked neutral (inside) area separated the left-exit HOV lane for SR-85 from the US-101 HOV lane.<sup>1</sup> The gore widened to about 17.5 feet at the point where a previously damaged and nonoperational crash attenuator was in place ahead of a 3-foot-high concrete barrier (see inset image in figure 2). The barrier separated the left-exit HOV lane for SR-85 from the US-101 HOV lane. At this location, the speed limit was 65 mph.

**Figure 2.** Depiction of travel lanes and gore area at the US-101–SR-85 southbound interchange. Inset photo depicts precrash damaged condition of the crash attenuator. (Source: Google Earth, image date March 2018. Inset photo provided by California Department of Transportation [Caltrans]; image date March 20, 2018).

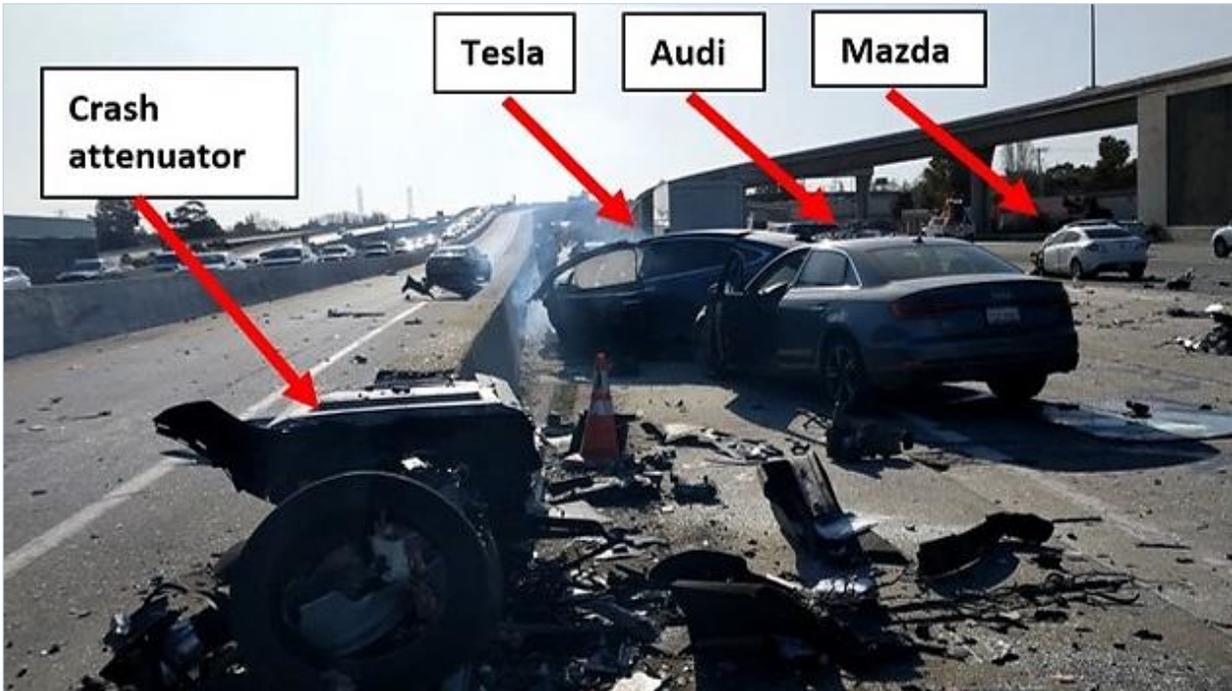
attenuator at a speed of 70.8 mph. The impact rotated the SUV counterclockwise and caused the front body structure to separate from the rear of the vehicle. The SUV was subsequently struck by two other vehicles, a 2010 Mazda 3 and a 2017 Audi A4, when it rotated into the lane to the right of the gore (see figure 3).<sup>3</sup>

**Figure 3.** Southbound view of US-101, depicting the Tesla, Audi, and Mazda vehicles at final rest. (Source: witness S. Engleman)

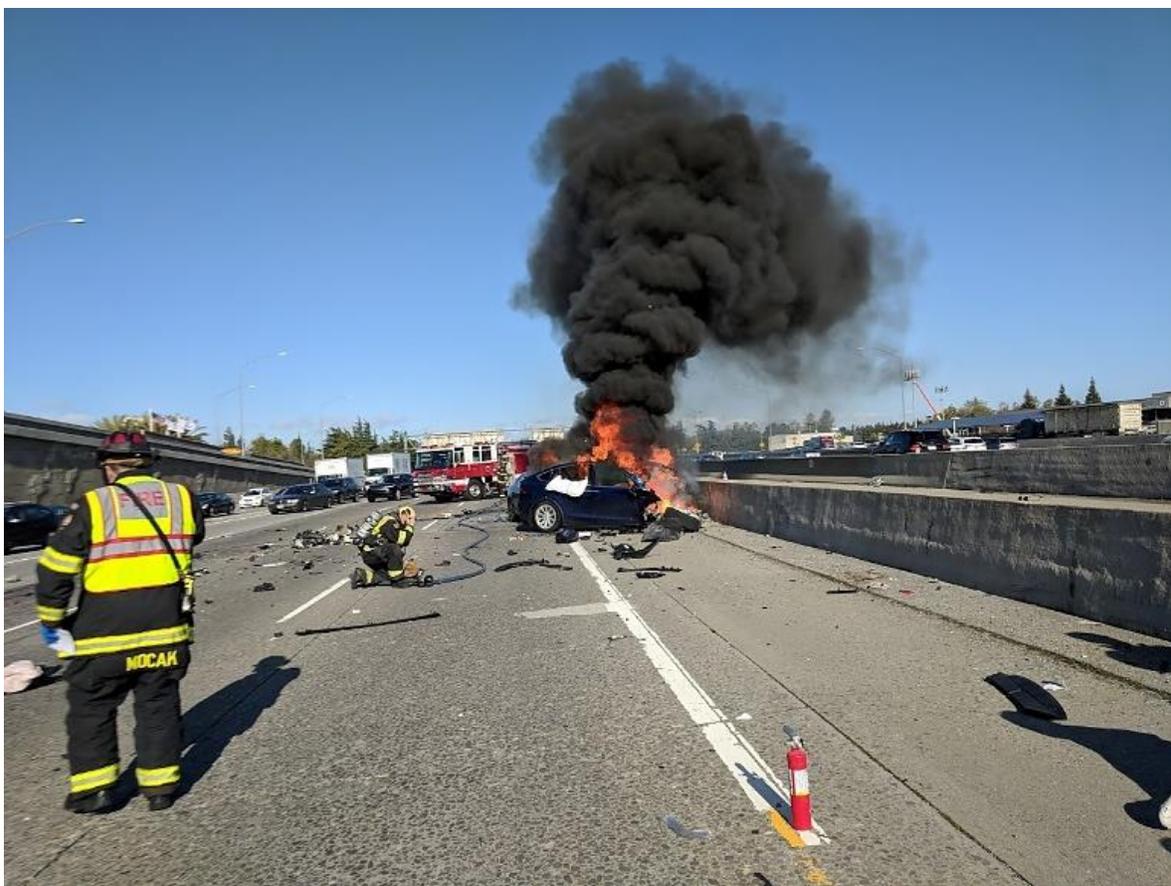
The Tesla's high-voltage battery was breached in the collision and a postcrash fire ensued (see figure 4). After the crash, on-scene witnesses found the driver in his seat with his lap/shoulder belt buckled. They removed him from the vehicle before it was engulfed in flames, and he was transported by ambulance to the hospital for treatment.

**Figure 4.** Northbound view of US-101 depicting Tesla postcrash fire. (Source: witness S. Engleman)

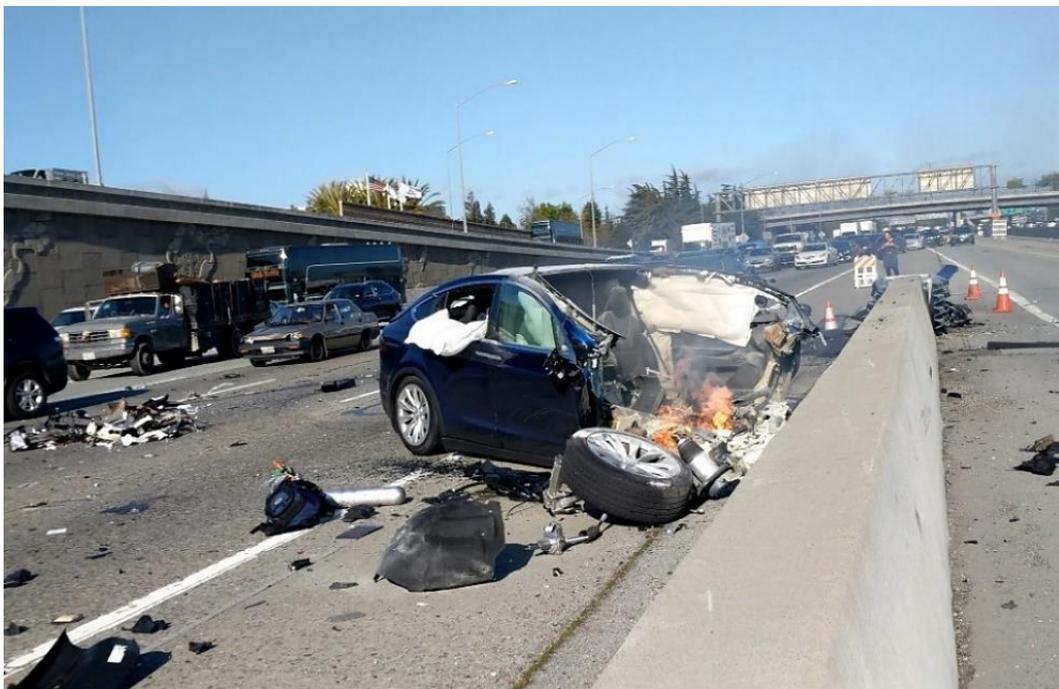
**1.5.1.1 Damage.** The SUV was extensively damaged in the crash (see figure 7). The front section (everything forward of the leading edges of the front doors) was destroyed and broken into fragments that spread across several traffic lanes at the US-101–SR-85 interchange. Separated components included the front drive motor, front suspension, fenders, and hood. The rear section, including the passenger compartment, sustained thermal damage from the postcrash fire.

**Figure 7.** Northbound view of the crash scene before the Tesla was engulfed in flames. (Source: witness S. Engleman)

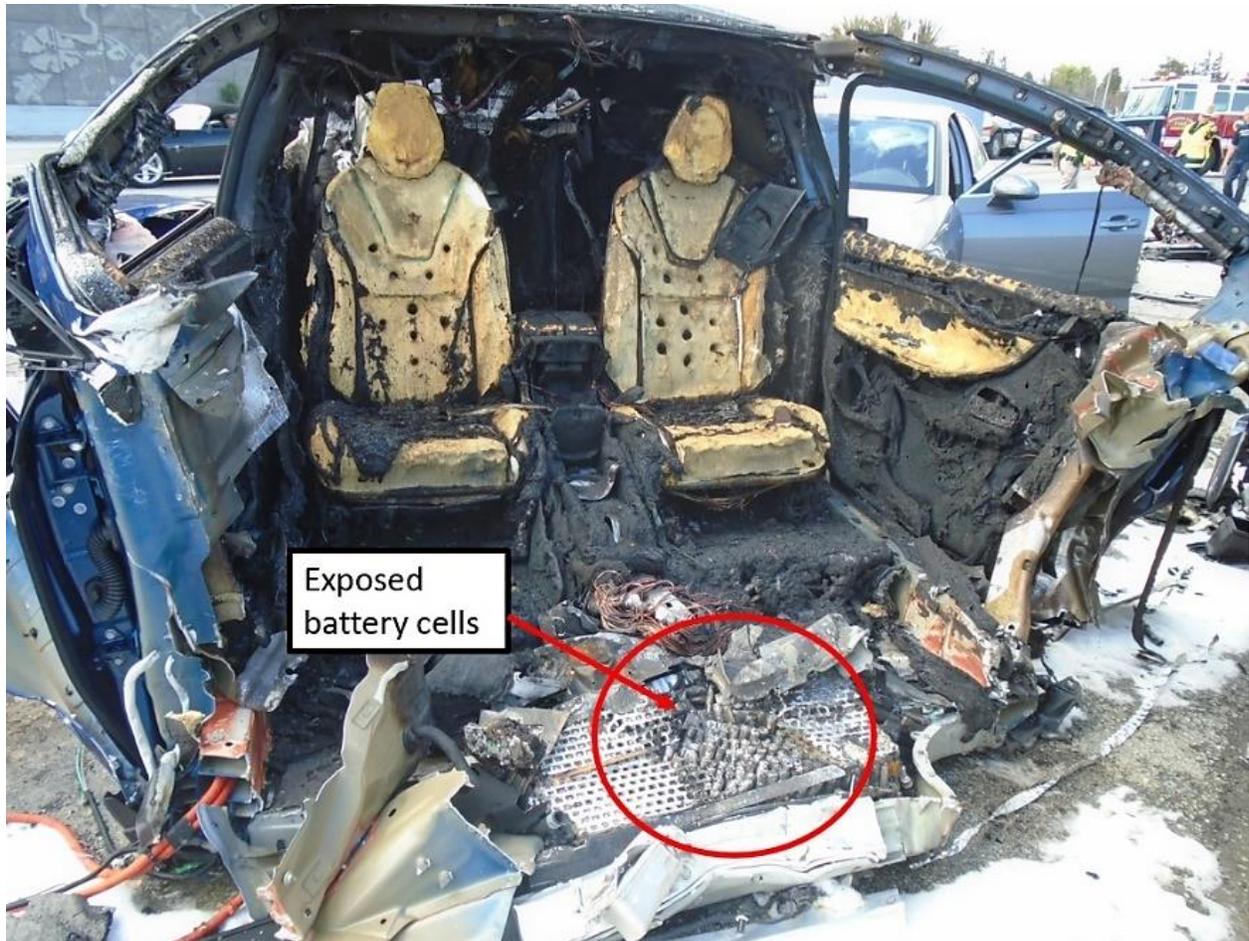
**1.5.1.2 Battery Damage.** The Tesla electric vehicle was powered by a 400-volt lithium-ion battery. The battery comprised about 8,500 vertically mounted and tightly packed battery cells, divided into 16 modules contained within an aluminum battery pack assembly, extending along the floor of the SUV. The battery pack was breached in the collision and a postcrash fire ensued. Examination of the battery pack found the front edge crushed rearward with the top surface twisted aft and upward, exposing individual battery cells (see figure 8).<sup>12</sup>

**Figure 8.** Interior view of the Tesla's rear section, with exposed battery cells from the lithium-ion battery (circled in red) in the floorboard. (Source: CHP)

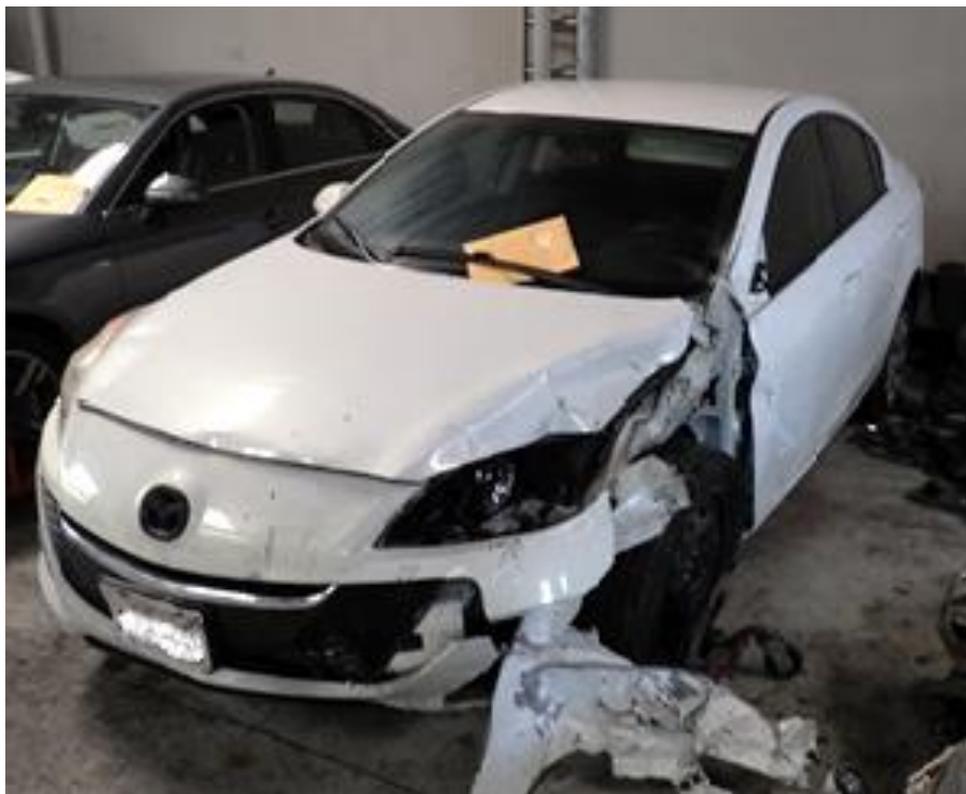
**1.5.2.1 Damage.** The 2010 Mazda 3 sustained damage concentrated in the area of the left fender, left front tire and wheel assembly, and driver's door (see figure 9).

**Figure 9.** Damage to left front, hood, and left side of the Mazda 3.

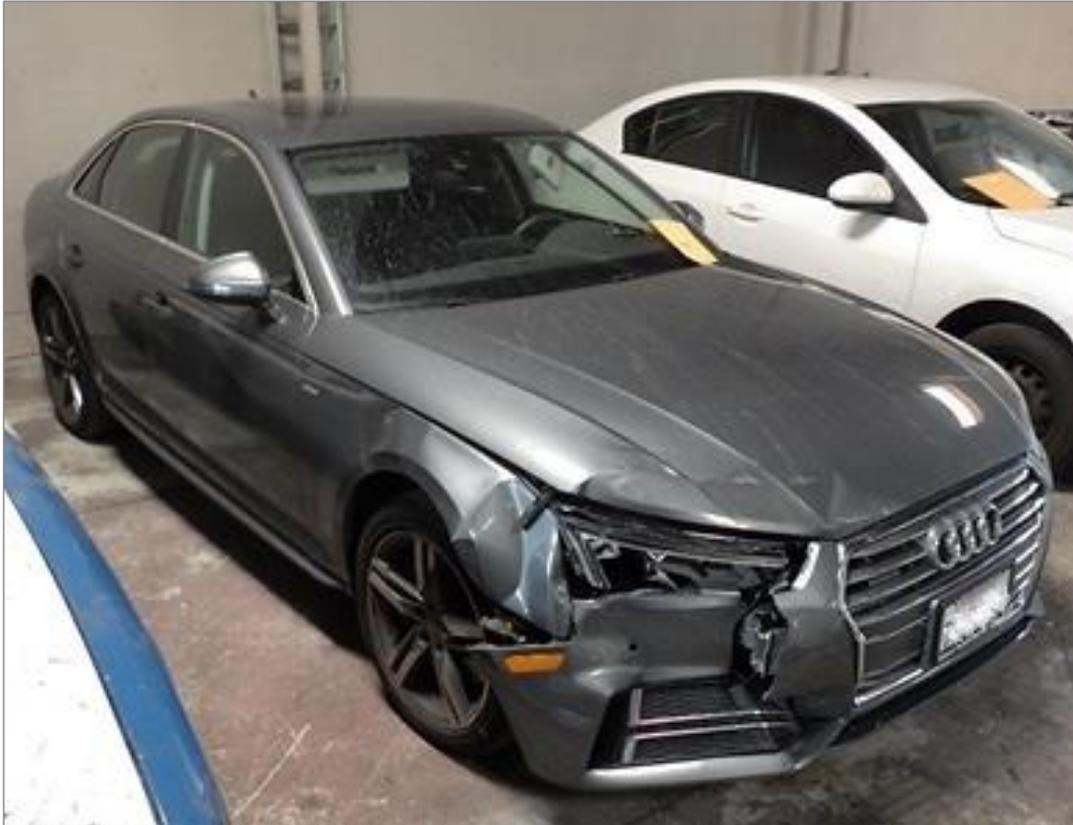
**1.5.3.1 Damage.** The 2017 Audi A4 sustained damage concentrated in the area of the right front bumper, headlamp, and hood (see figure 10).

**Figure 10.** Damage to right front of the Audi A4.

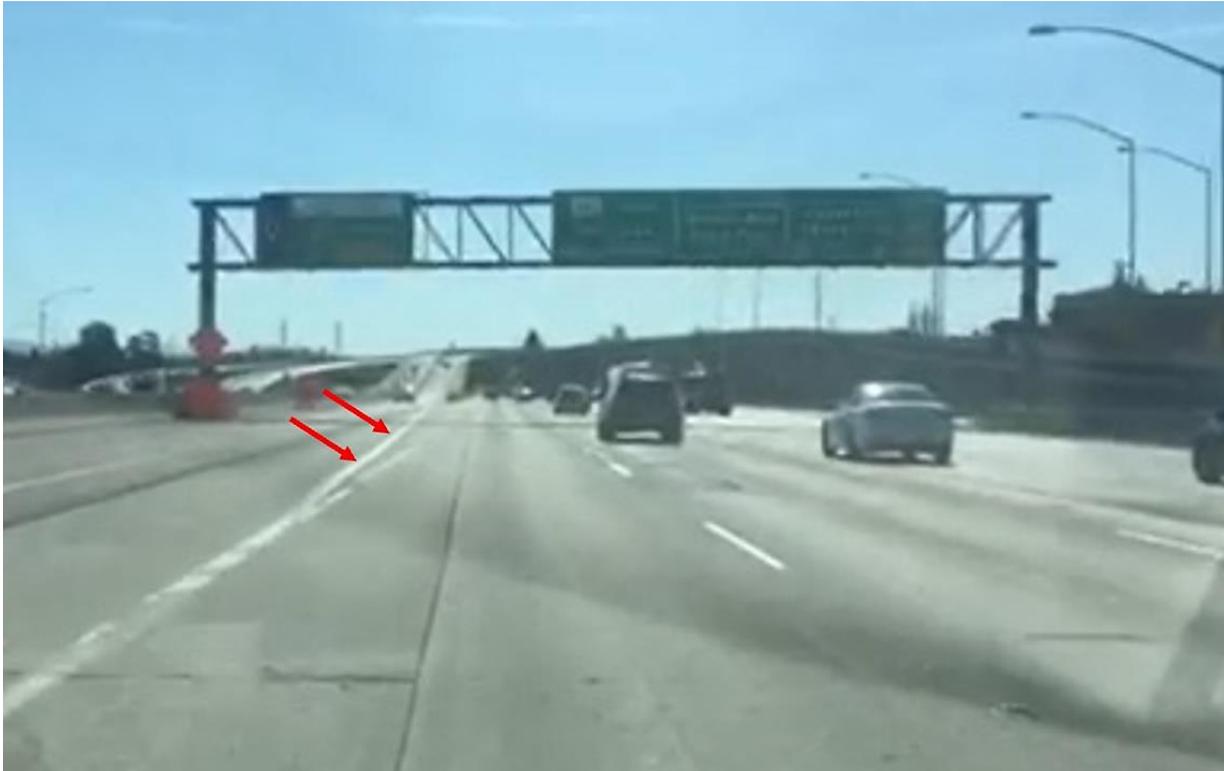
9:30 a.m. to approximate the lighting conditions (sun position) that had been present at the time of the collision. As shown in figure 13, the right edge line of the gore was worn and faded in the initial half of the gore. Since the crash, Caltrans has repainted the lane lines at the crash location.

**Figure 13.** Southbound US-101 view from a video drive-through at 685 feet from crash attenuator. The 8-inch-wide solid white line marking the left side of the gore area (designated with red arrows) was more prominent and visible than the right side of the gore. (Source: NTSB video drive-through, March 27, 2018)

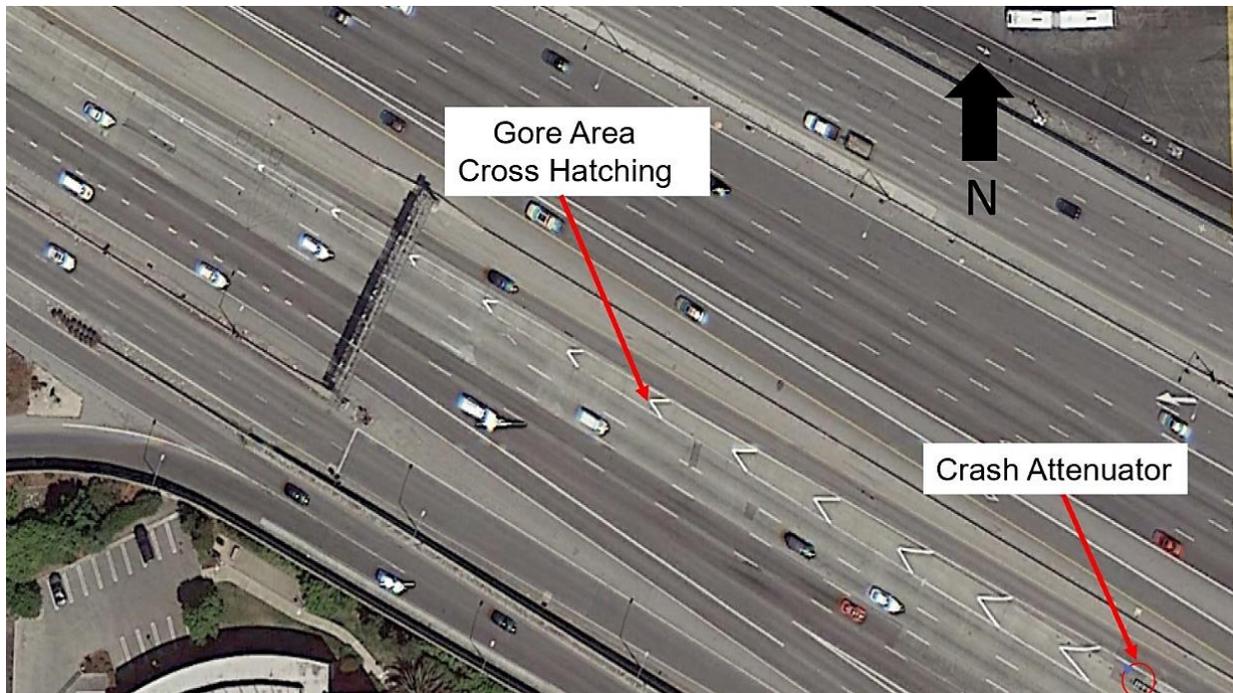
**Figure 14.** Aerial view of US-101 at the crash location, depicting chevrons (cross-hatching) added to the gore area in July 2018, 4 months after the crash. (Source: Google Earth, image date of August 8, 2018)

In July 2018, 4 months after the crash, Caltrans added chevron-shaped striping to the neutral area of the gore at the Mountain View crash location (see figure 14). The NTSB asked Tesla whether diagonal cross-hatching or chevron striping would have been effective in preventing the Tesla from entering the gore area. Tesla responded as follows:

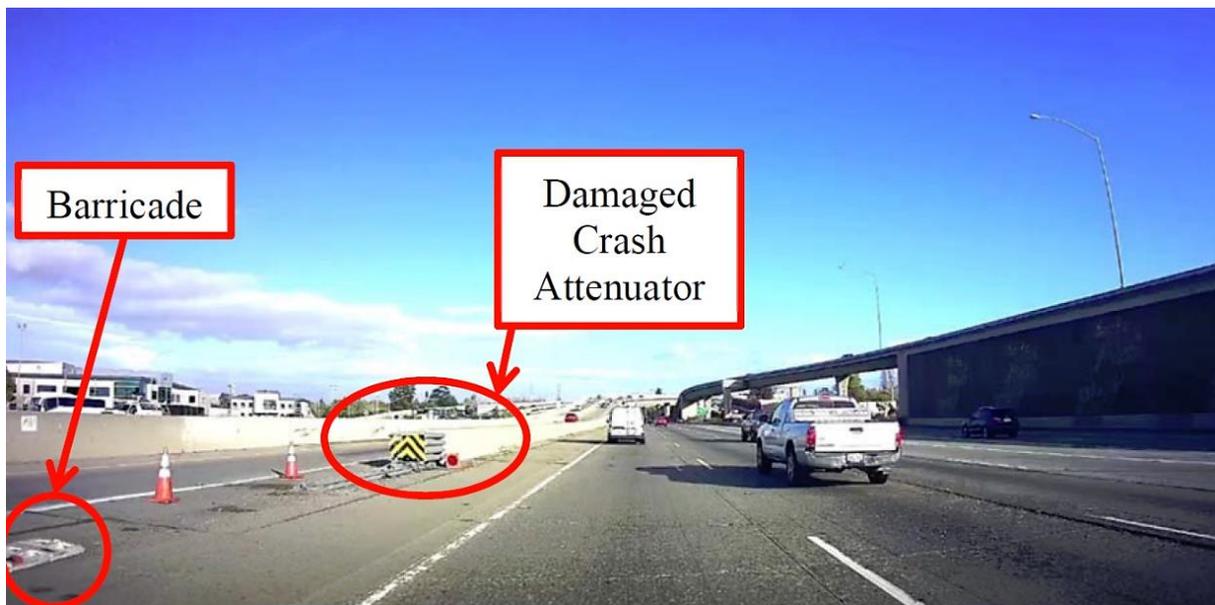
13. The crash attenuator was in a damaged and nonoperational condition at the time of the collision due to the California Highway Patrol's failure to report the damage following a previous crash and systemic problems with the California Department of Transportation's maintenance division in repairing traffic safety hardware in a timely manner.

The CHP responded to the March 12 crash but did not notify Caltrans of the damage to state property as required by policy and interagency operational agreements.<sup>37</sup> On March 20, 2018, two Caltrans maintenance workers patrolling the area discovered that the crash attenuator was damaged. Caltrans inspected the attenuator and determined that it was damaged beyond repair and had to be replaced with a new attenuator. No date was scheduled for the replacement because the Caltrans maintenance supervisor had to locate a replacement attenuator, and maintenance crews were required to be on 12-hour storm patrol shifts due to inclement weather. The maintenance supervisor directed that traffic cones and a Type 1 sawhorse-style plastic barricade be placed in advance of the damaged attenuator until it was replaced. Figure 15 depicts the precrash condition of the attenuator and the location of the displaced barricade and traffic cones.<sup>38</sup>

**Figure 15.** Southbound US-101 view depicting the precrash damaged condition of the crash attenuator, orange traffic cones, and a displaced Type 1 sawhorse-style barricade on March 22, 2018. (Source: CHP photo provided by passerby)

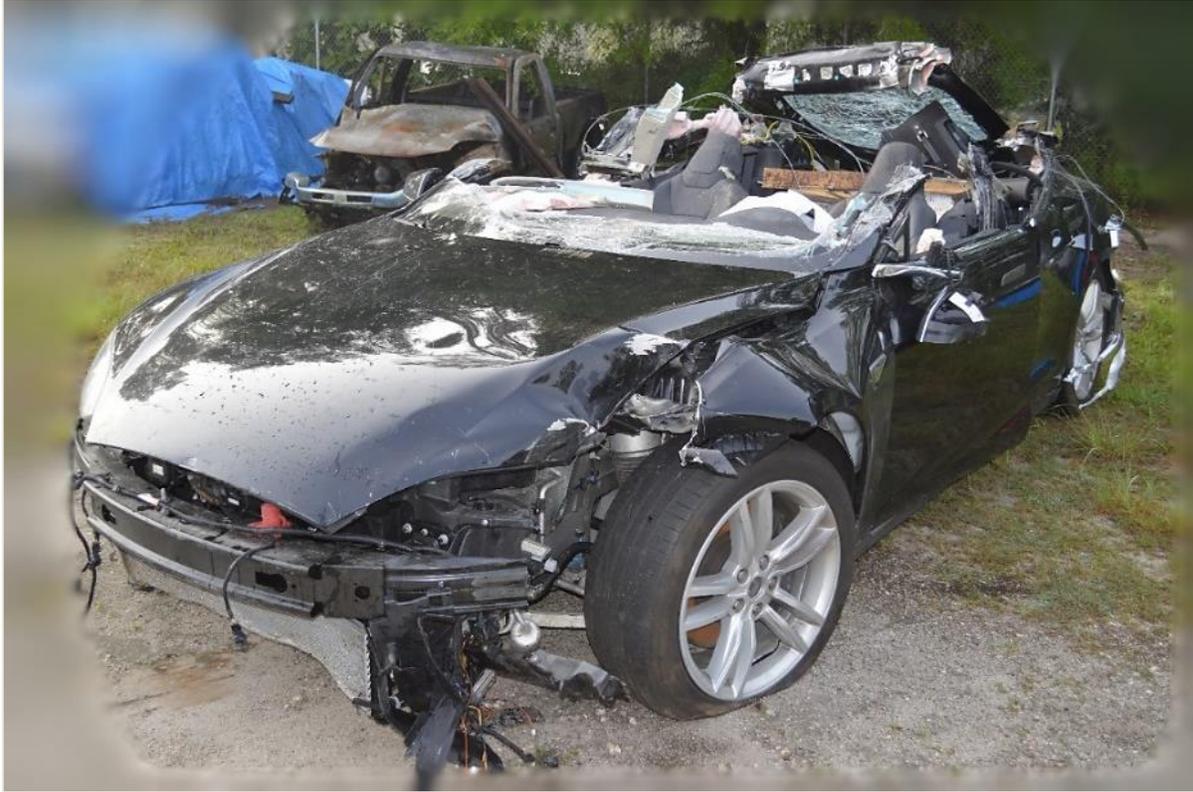
**Figure 16.** The 2015 Tesla after striking the side of a semitrailer in Williston, Florida.

The NTSB determined that the probable cause of the Williston crash was the truck driver's failure to yield the right of way to the car, combined with the car driver's inattention due to overreliance on vehicle automation, which resulted in the car driver's lack of reaction to the presence of the truck. Contributing to the car driver's overreliance on the vehicle automation was its operational design, which permitted his prolonged disengagement from the driving task and his use of the automation in ways inconsistent with guidance and warnings from the manufacturer.

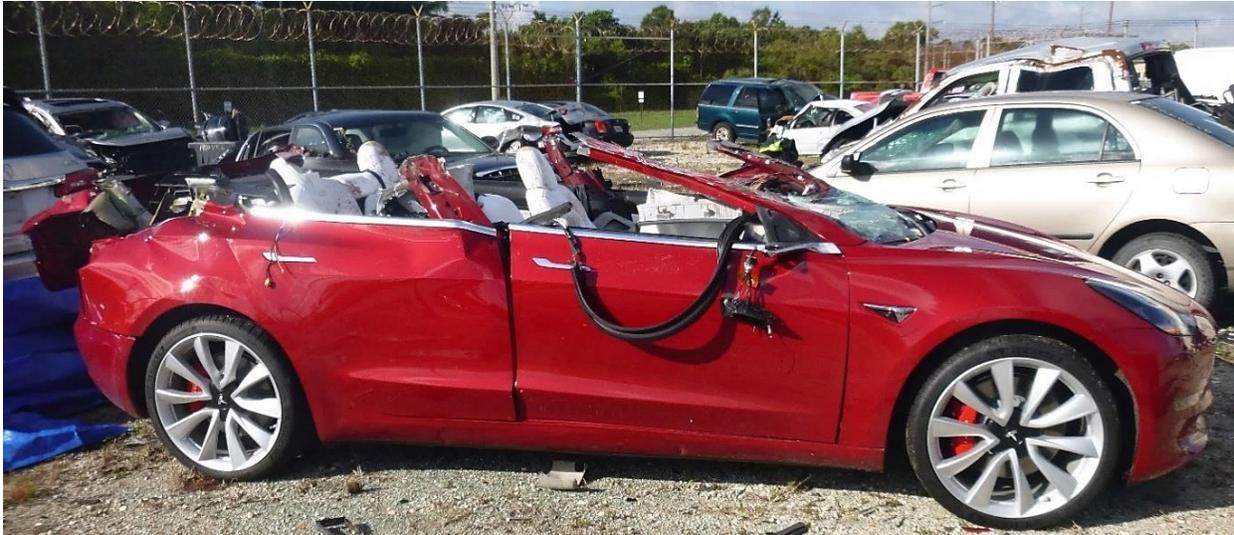
**Figure 18.** The 2018 Tesla after striking the side of a semitrailer in Delray Beach, Florida.

The NTSB determined that the probable cause of the Delray Beach crash was the truck driver's failure to yield the right of way to the car, combined with the car driver's inattention due to overreliance on automation, which resulted in his failure to react to the presence of the truck. Contributing to the crash was the operational design of Tesla's partial automation system, which permitted disengagement by the driver, and the company's failure to limit the use of the system to the conditions for which it was designed. Further contributing to the crash was the failure of NHTSA to develop a method of verifying manufacturers' incorporation of acceptable system safeguards for vehicles with Level 2 automation capabilities that limit the use of automated vehicle control systems to the conditions for which they were designed.
