HIGHWAY ACCIDENT REPORT

TWO-CAR COLLISION
SOUTHERN APPROACH
TO GOLDEN GATE BRIDGE
SAN FRANCISCO, CALIFORNIA
JULY 11, 1970

REPORT NUMBER: NTSB-HAR-71-5

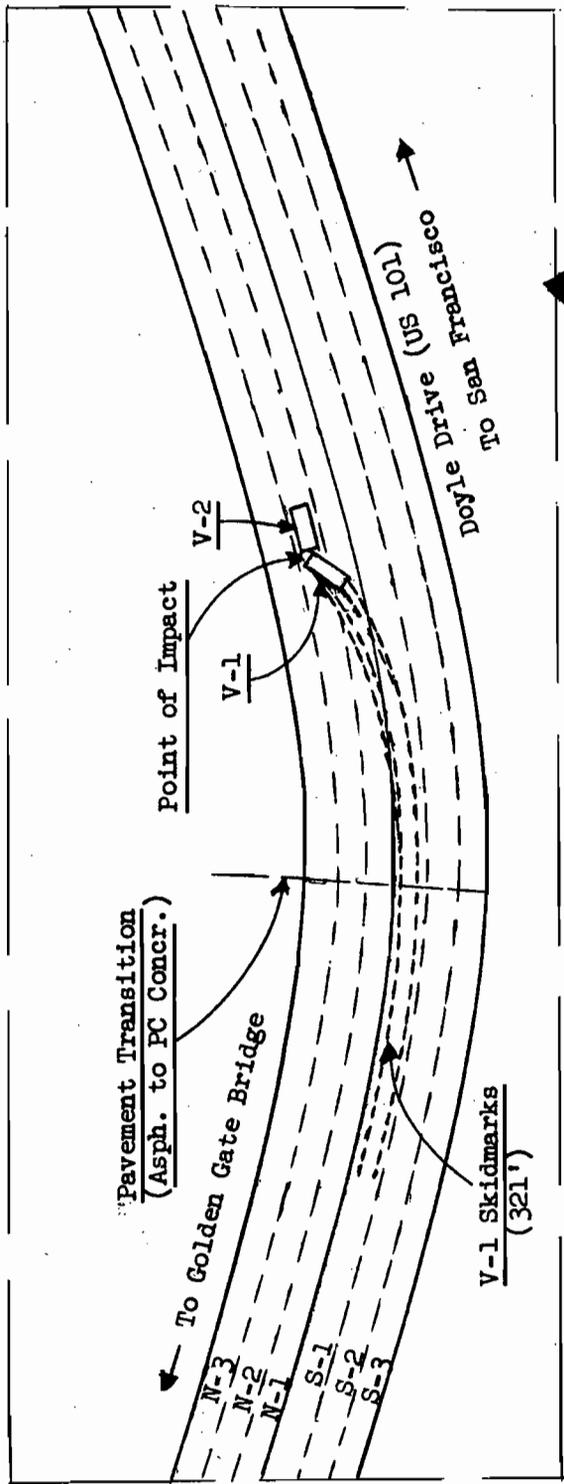
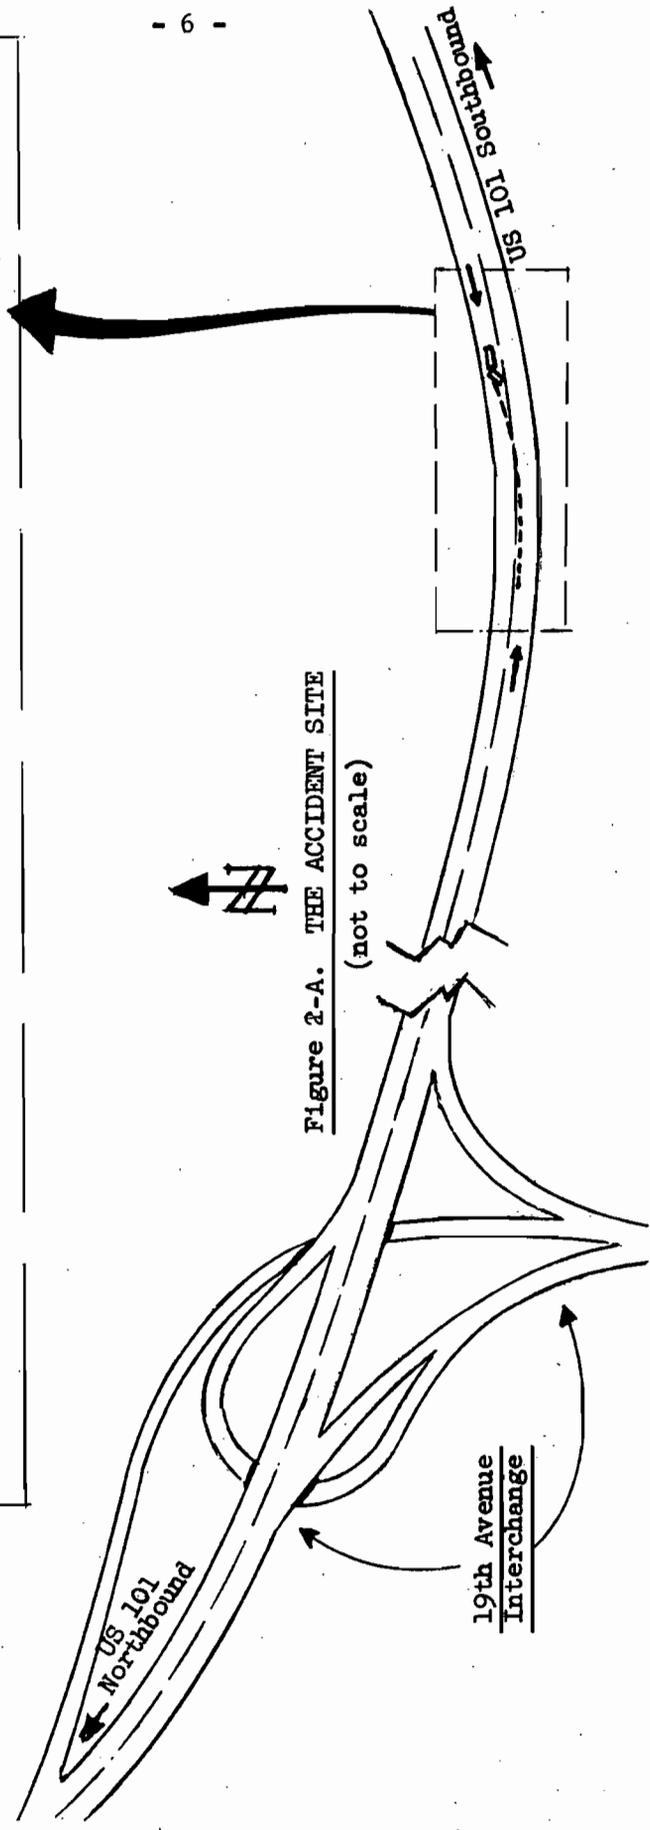
Figure 2-A. THE ACCIDENT SITE
(not to scale)

According to California Highway Patrol, the point of impact was identified by scrapes in the pavement in northbound lane N-2, 45 feet east of light standard D-340, and 2 feet north of the dividing line between lanes N-1 and N-2. Just east of this point was a black, single-wheel skidmark, 5 feet long, parallel to the lane dividing line. (See Figures 2-A, 2-B, and 3.)

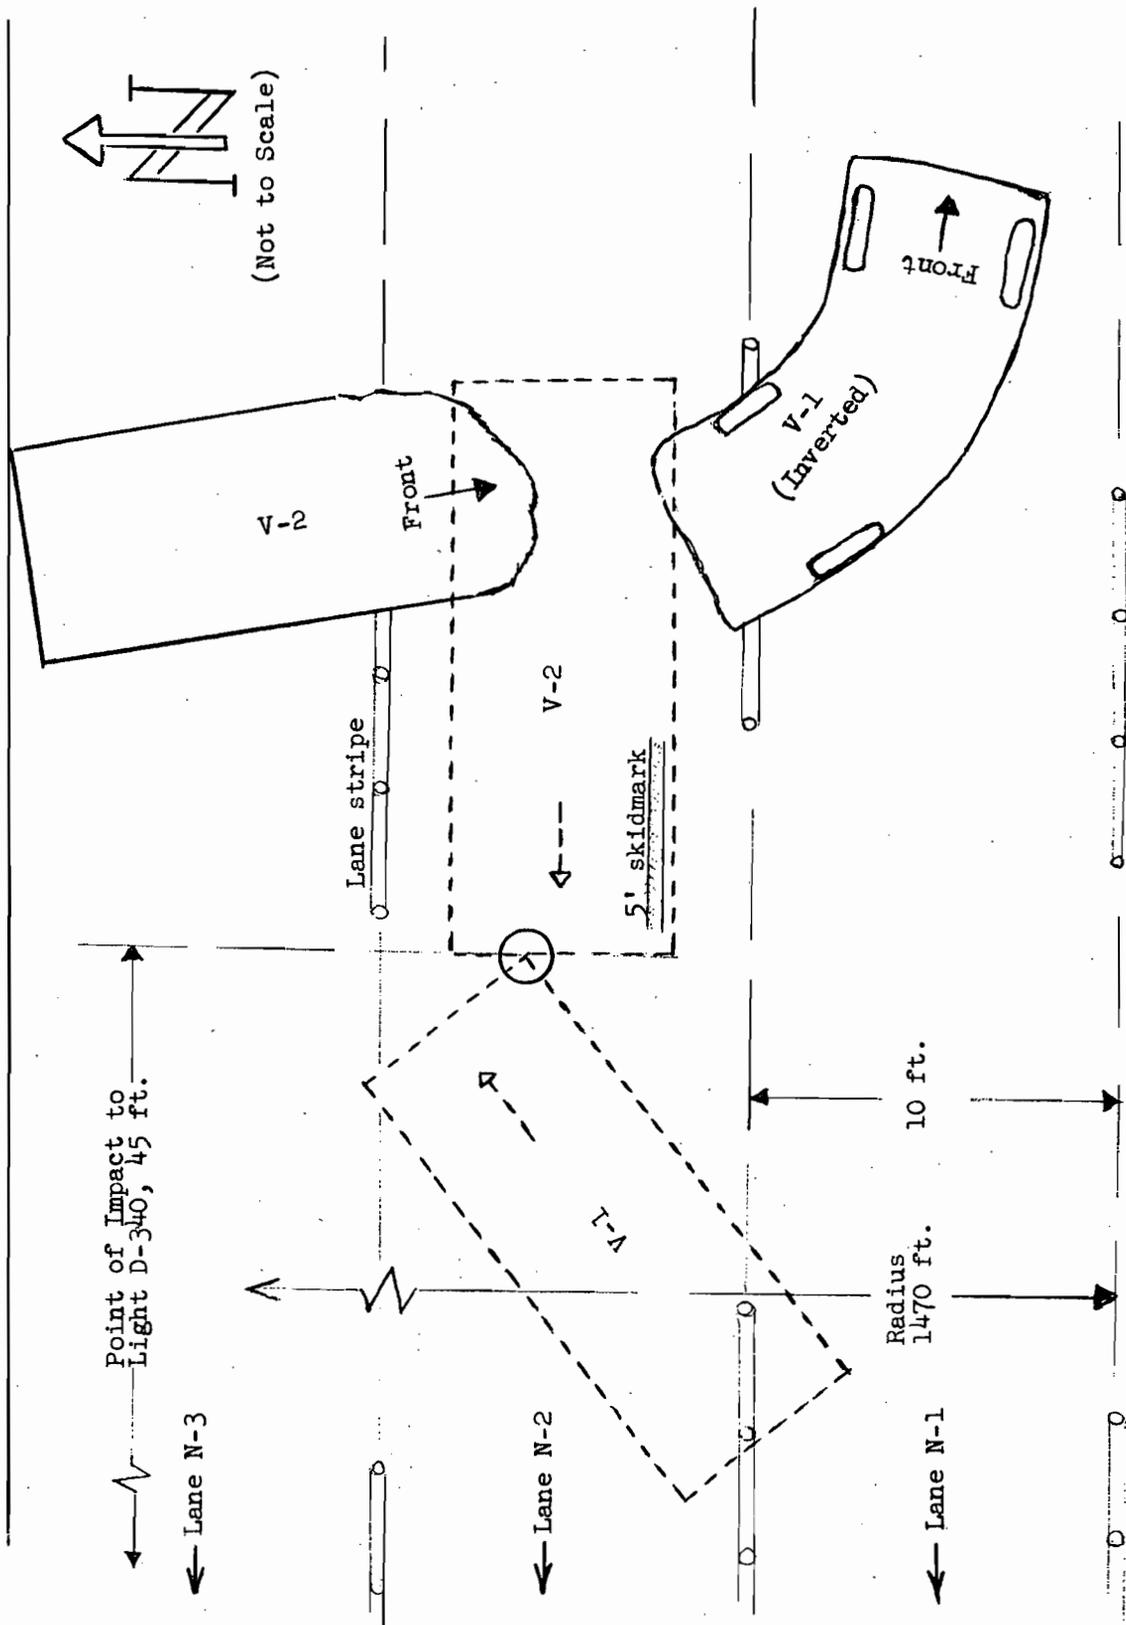
Figure 2-B. Approximate Point of Impact and Positions of Rest, V-1 (Porsche) and V-2 (Mustang)

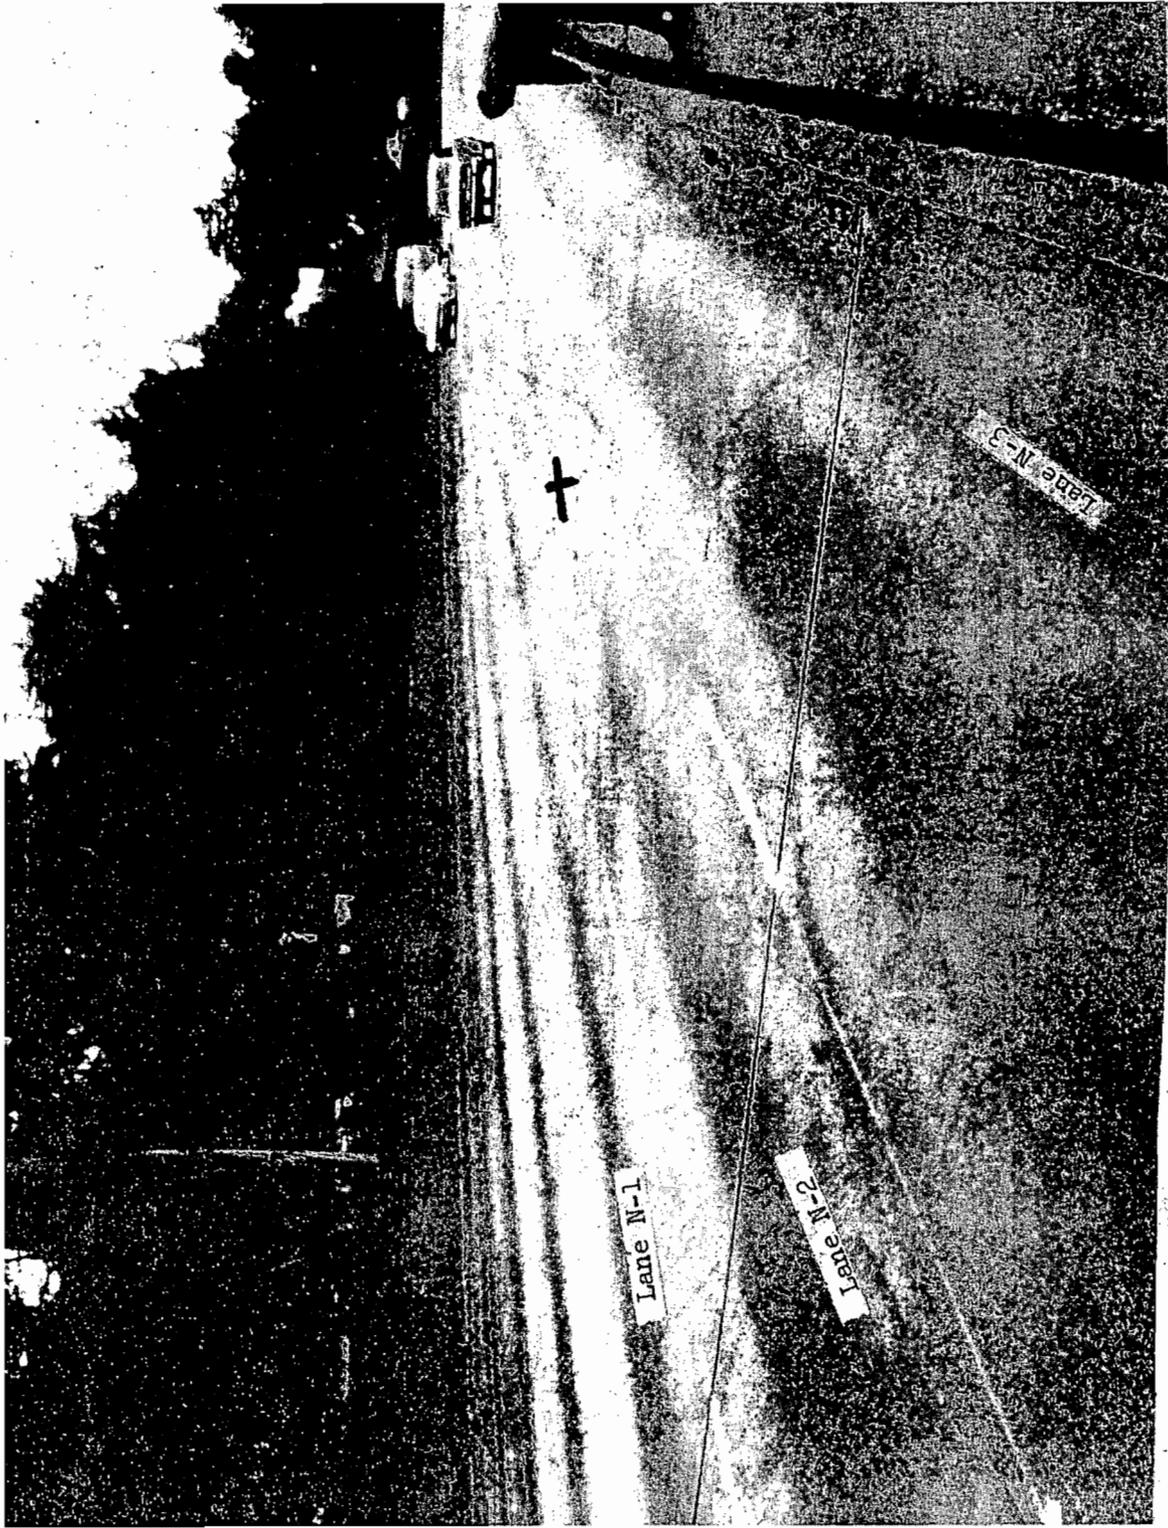
Figure 3. The Accident Site Looking Northbound. The Approximate Point of Impact is marked "X", in Lane N-2.

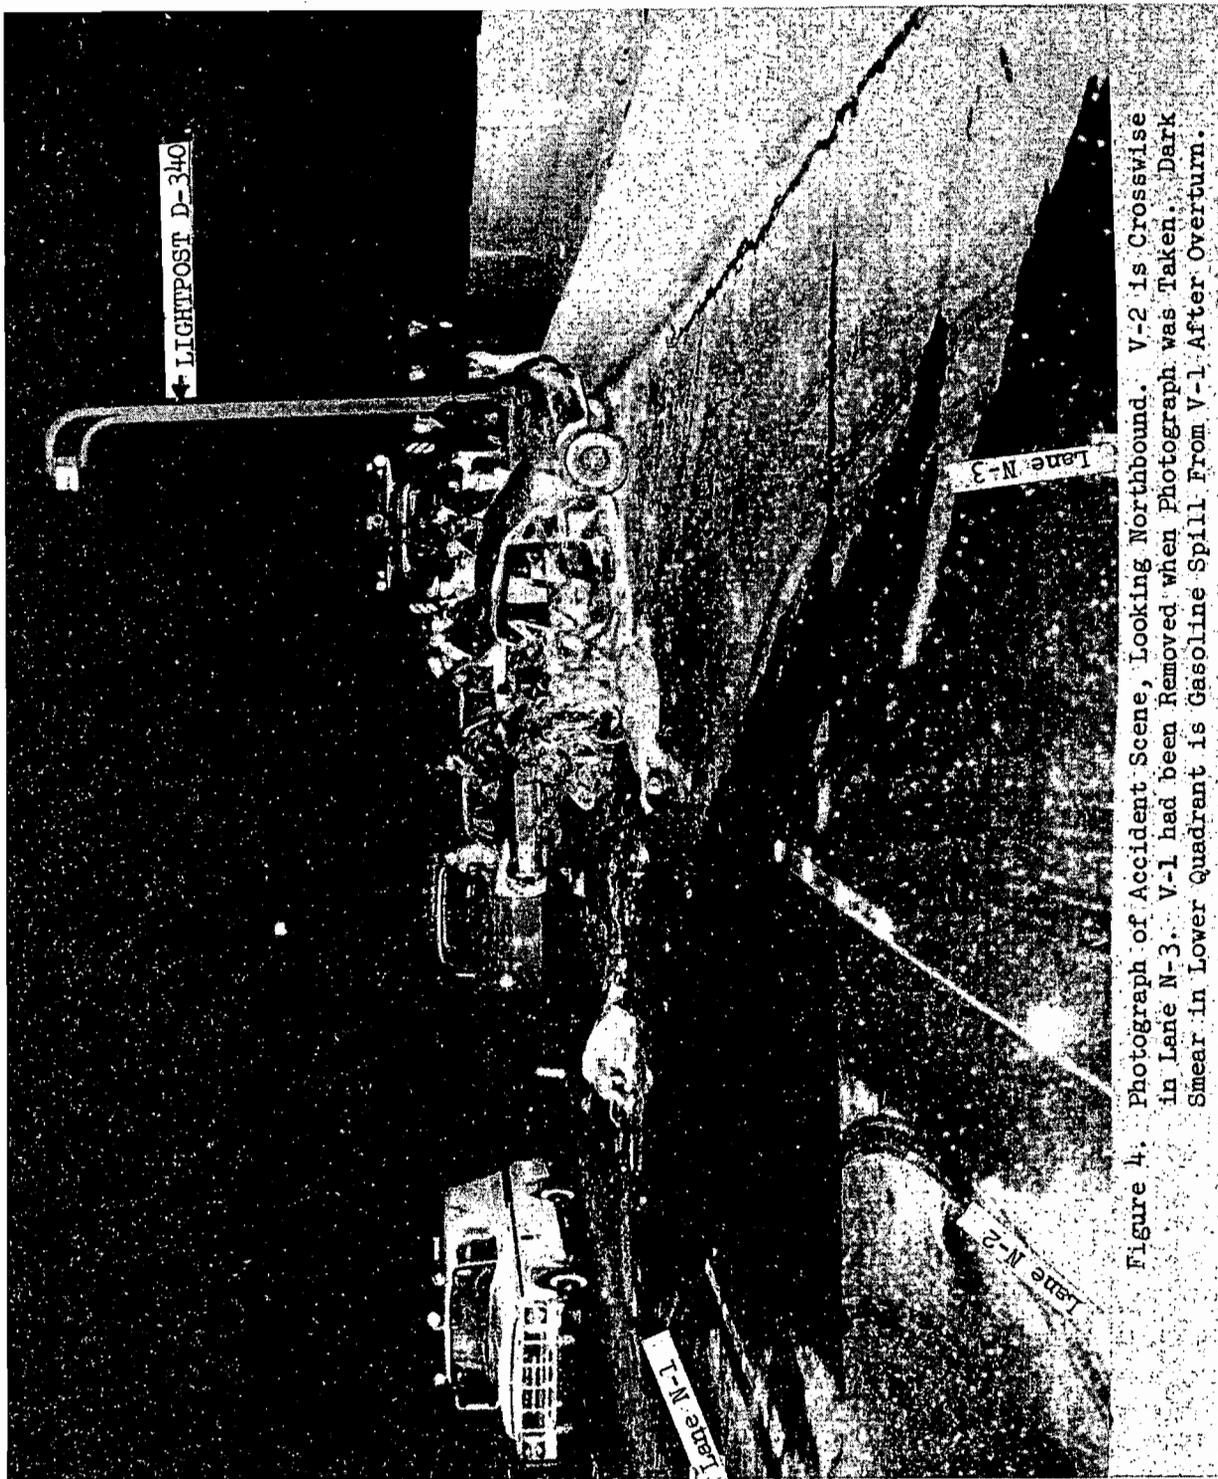
Vehicle 2, the Mustang, was found upright, almost perpendicular to the line of travel in lane N-3, its left rear tip against the highway sidewall and its right rear wheel about 8 feet east of the point of impact. All nine occupants were in the vehicle. (See Figure 4.)

Figure 4. Photograph of Accident Scene, Looking Northbound. V-2 is Crosswise in Lane N-3. V-1 had been Removed when Photograph was Taken. Dark Smear in Lower Quadrant is Gasoline Spill From V-1 After Overturn.
