HIGHWAY ACCIDENT REPORT

GREYHOUND BUS/MALONE FREIGHT LINES, INC.

TRUCK COLLISION

REPORT NUMBER: NTSB-HAR-73-5

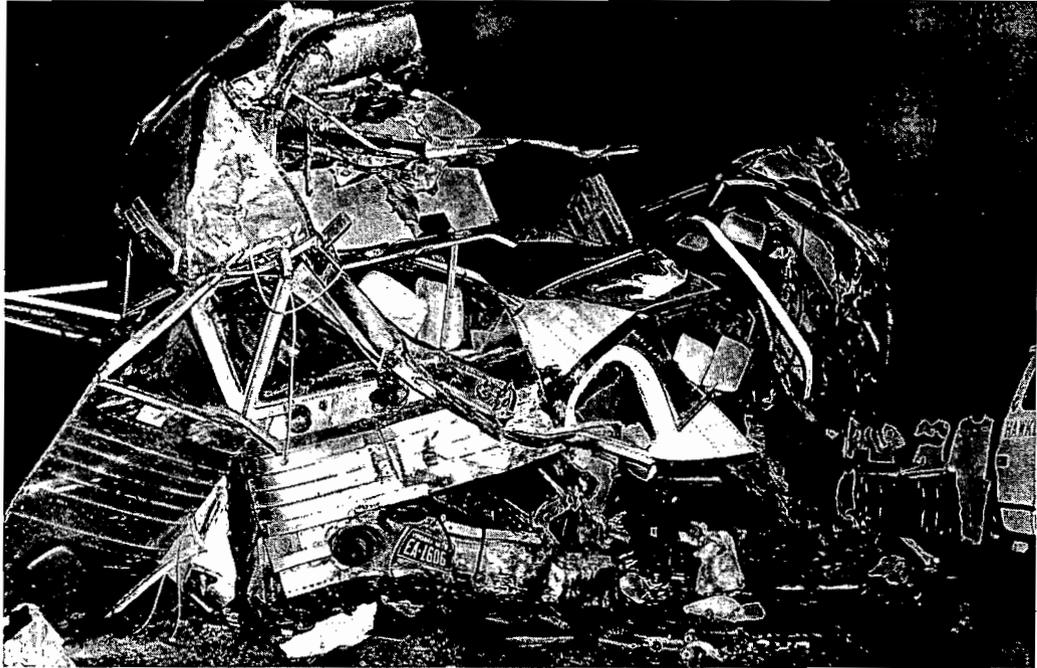
The Bus. The impact area included the left 38.4 inches of the front of the bus. Impact damage extended along the left side through the length of the bus. (See Figures 5, 6, and 7.) Some minor damage was incurred during rescue operations.

Figure 5. Damage to front of bus.

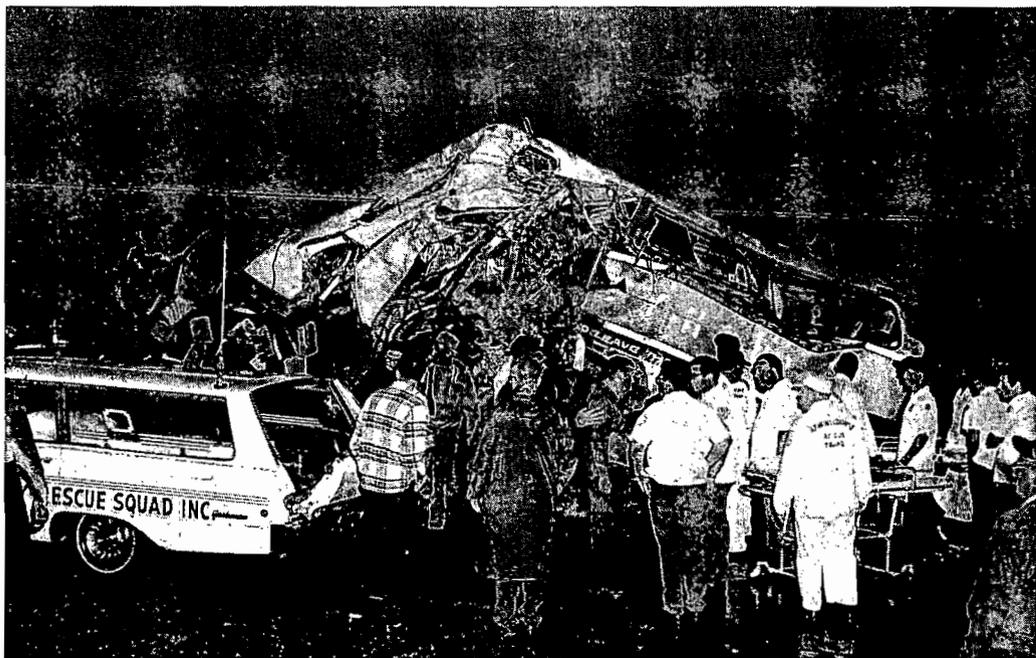
Figure 6. Damage to left side of bus.

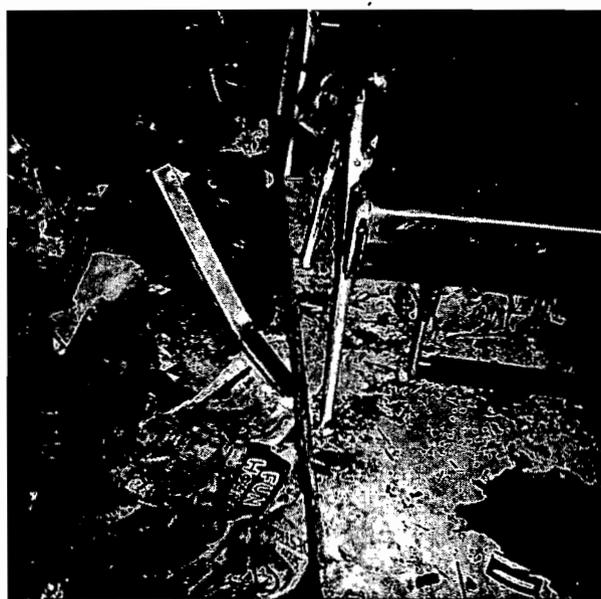
Figure 8. Seat leg, sheared at flange.

Another source of injury was the failure of some of the seats. Figure 8 shows a seat with the legs attached to the mounting flange. This seat probably was broken as a result of a passenger's striking it as the bus decelerated at impact. Some of the occupants in the rear section were trapped under and between seats that had broken or had been deformed in some manner. A broken seat not only permits a passenger to be thrown forward, but subjects him to possible injury by the seat to his rear which may come down on top of him. In the absence of suitable occupant restraints, it is desirable to contain the passenger in his seated position between the seats, since this provides some cushioning effect.

11. The failure and rotation of the seat structures after impact contributed to the ejection of and injuries to the passengers. At present, there is no specific requirement for the strength of the seats in the Code of Federal Regulations. (FMVSS 207 applies to seat anchorages.)

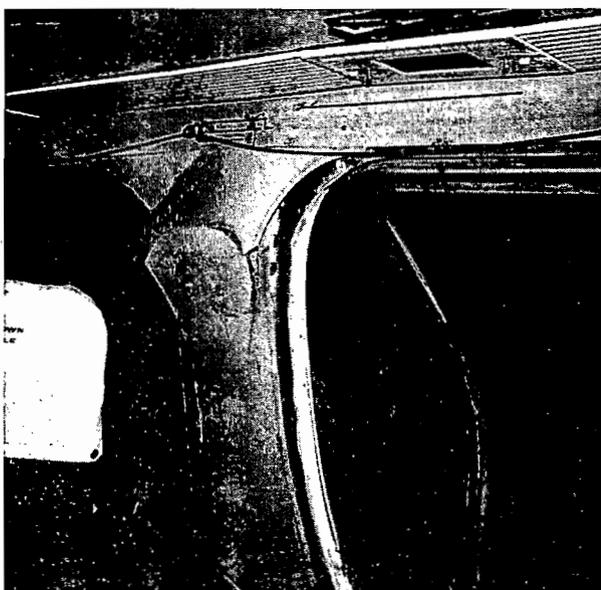
Figure 9. Split interior panel.

Passengers who remained inside the bus after impact were exposed to several obvious injury-producing sources. First, the fracturing and splitting of the interior panels (side and roof) resulted in exposed sharp edges, which caused some lacerations. It was not possible to determine whether a passenger contacted the split panel shown in Figure 9, but those seated in the immediate area suffered head injuries and lacerations. The location of this split in the panel at the head-height of a passenger would make contact very probable.

12. The fracturing and splitting of the interior panels and the failure of the seats created a hostile injury environment and contributed to the severity of the injuries.

3. The National Highway Traffic Safety Administration revise part S7.1 of its Proposed Rulemaking--Bus Passenger Seating and Crash Protection; Docket 73-3; Notice 1, to require impact protection for interior panels located in and around bus passenger windows. (Recommendation H-73-43)

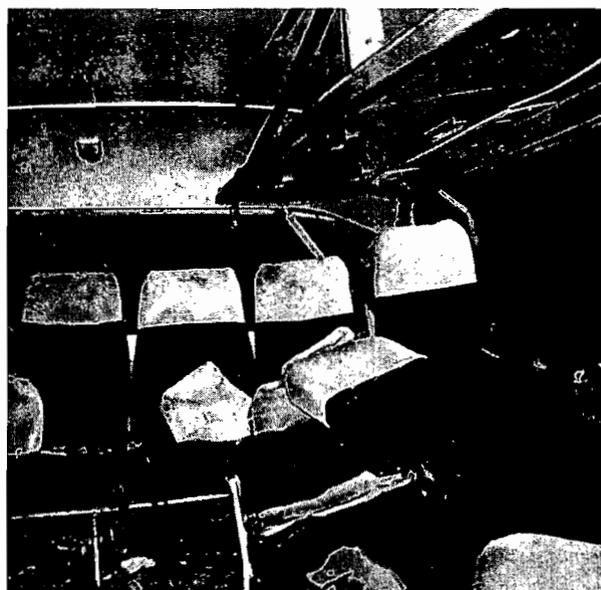
Figure 10. Interior of the rear section of bus, after collision.
