# HIGHWAY ACCIDENT REPORT

JESUS AYALA SCHOOLBUS-TYPE BUS  
RUN-OFF ROADWAY/DRAINAGE DITCH SUBMERGENCE

BLYTHE, CALIFORNIA

JANUARY 15, 1974

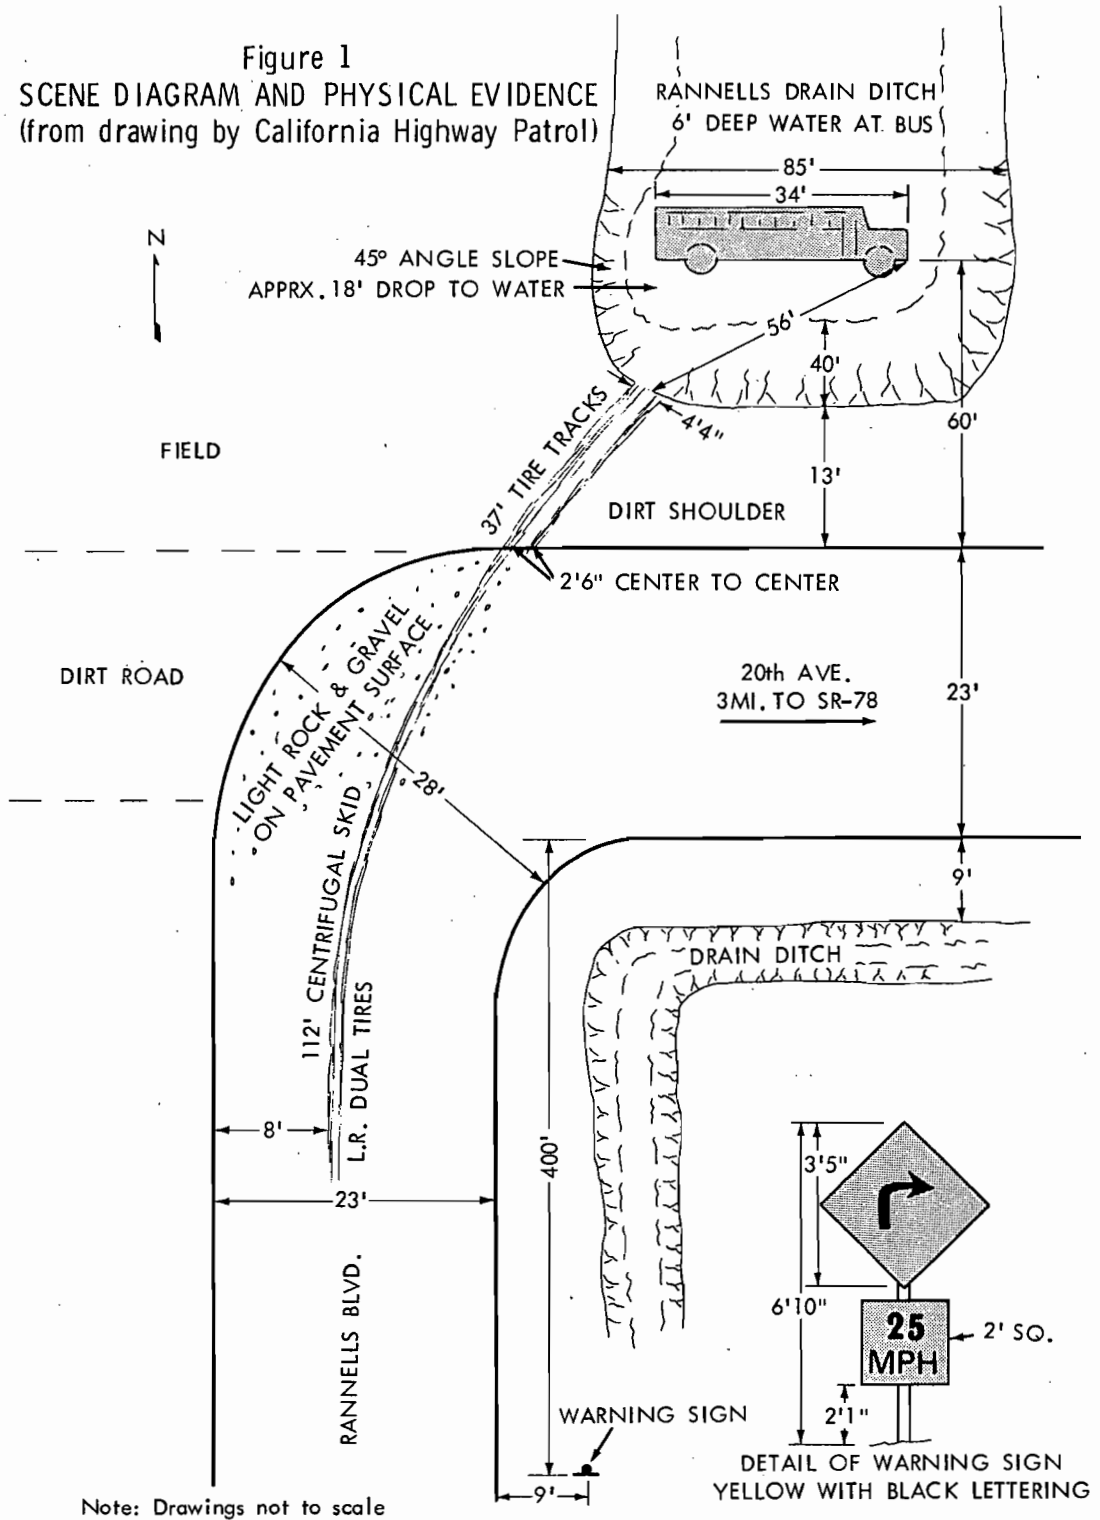
Figure 1  
SCENE DIAGRAM AND PHYSICAL EVIDENCE  
(from drawing by California Highway Patrol)

California. The bus had separated from a two-bus convoy and was en route to the High and Mighty Farms near the accident site. The bus was traveling in the middle of the 23-foot-wide street at 45 to 55 mph, a speed too high to negotiate the turn. A right turn warning sign in combination with a speed advisory sign, which was posted about 350 feet before the turn, warned of the turn and recommended a maximum speed of 20 mph. According to witnesses, as the bus approached the turn, the driver seemed to hesitate and then began to steer sharply to his right in an attempt to negotiate the turn. He did not apply the brakes nor did any witness describe an attempt to accelerate through the turn. The bus crossed the edge of the pavement on the far side of the road, about midway through the turn and traveled 37 feet diagonally across the dirt shoulder to the edge of an 85-foot-wide drainage ditch, which paralleled Rannels Boulevard. (See Figure 1.)

There were 112 feet of centrifugal skidmarks from the left rear dual tires of the bus. These skidmarks began at a point to the left of the center of the roadway about 75 feet from the point where the bus crossed the edge of the pavement. (See Figure 1.) These marks continued 37 feet further along and across the shoulder of the roadway to the edge of the drainage ditch. No precrash marks were reported along the side slope of the drainage ditch, which indicated that the bus vaulted from the top ledge to its final position in the water below. The final position of the front of the bus was 56 feet horizontally from the point where the bus vaulted from the edge of the ditch and 60 feet laterally from the edge of the road.
