**NATIONAL  
TRANSPORTATION  
SAFETY  
BOARD**

**HIGHWAY ACCIDENT REPORT**

**MULTIPLE -VEHICLE COLLISIONS**

**NEAR CORONA, CALIFORNIA**

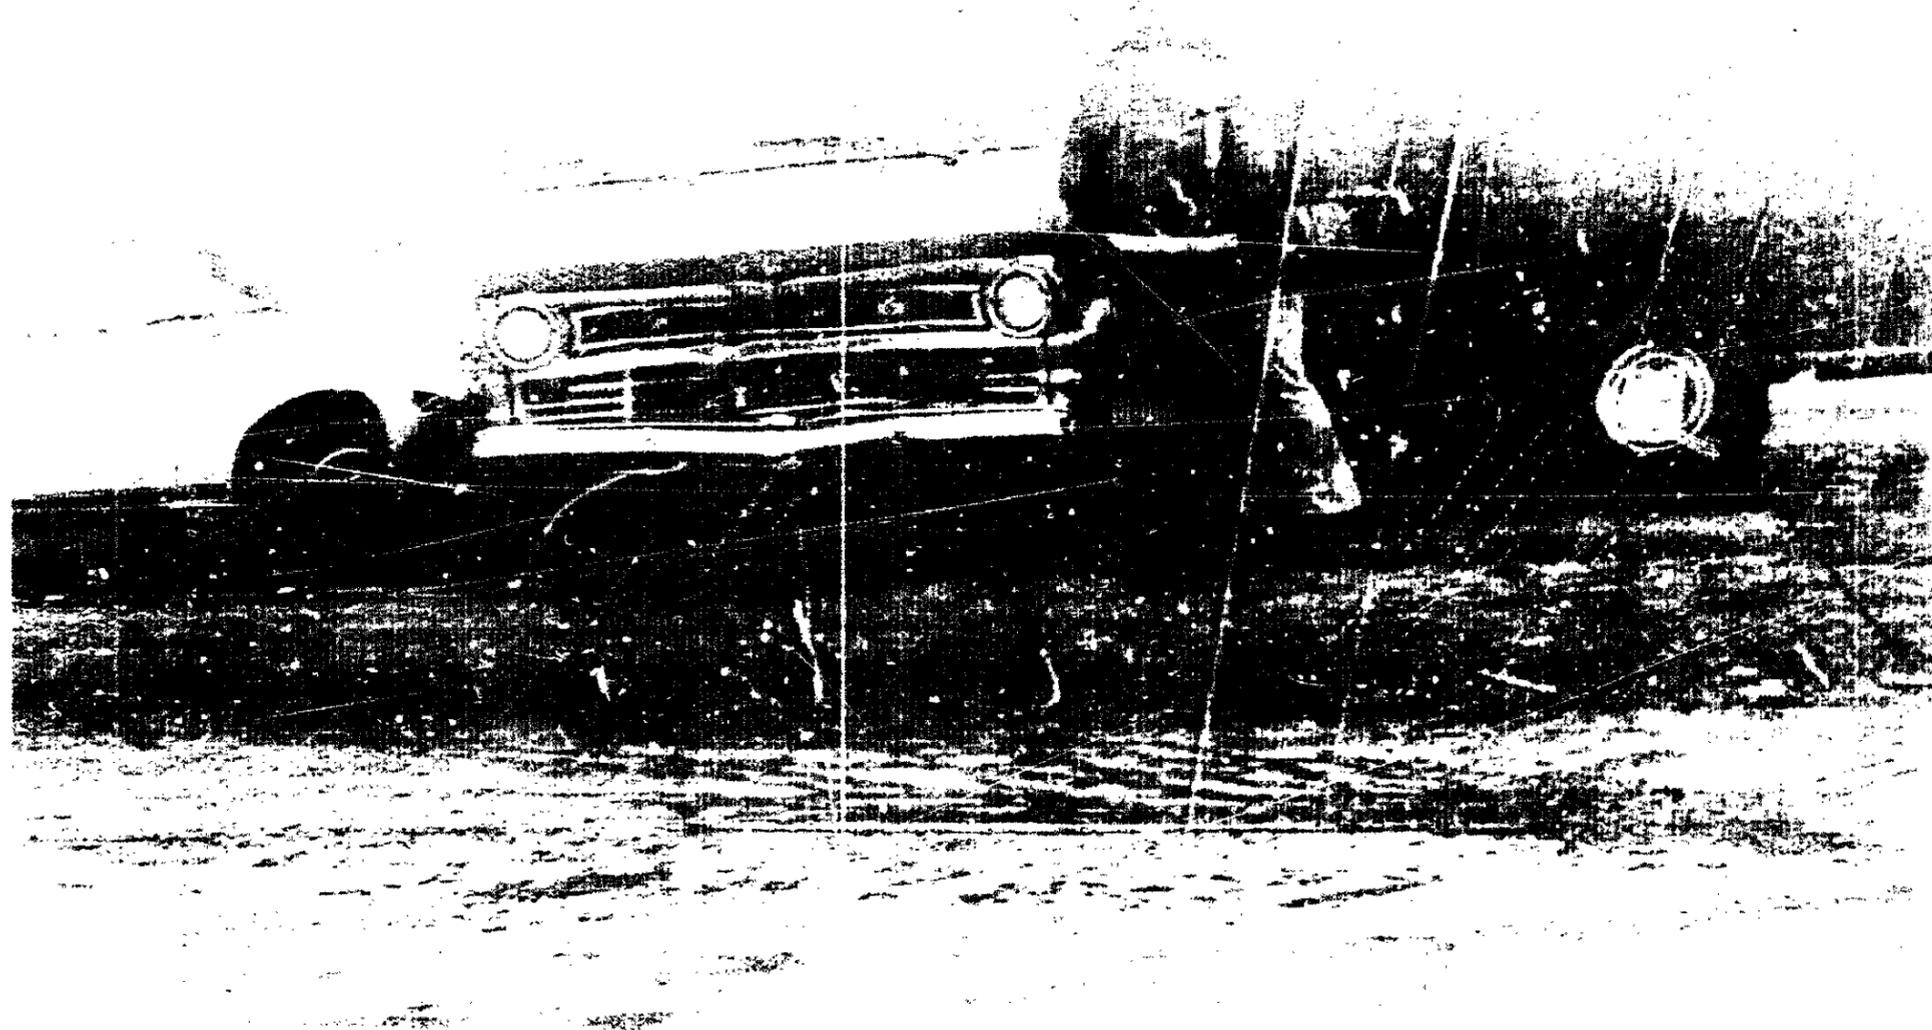
Figure 3. Damaged vehicles. Note different final stopping directions.
