SPECIAL INVESTIGATION

**UMTA PROTOTYPE BUS FIRE
NEAR PHOENIX, ARIZONA
MAY 13, 1975**

REPORT NUMBER: NTSB-HAR-75-8

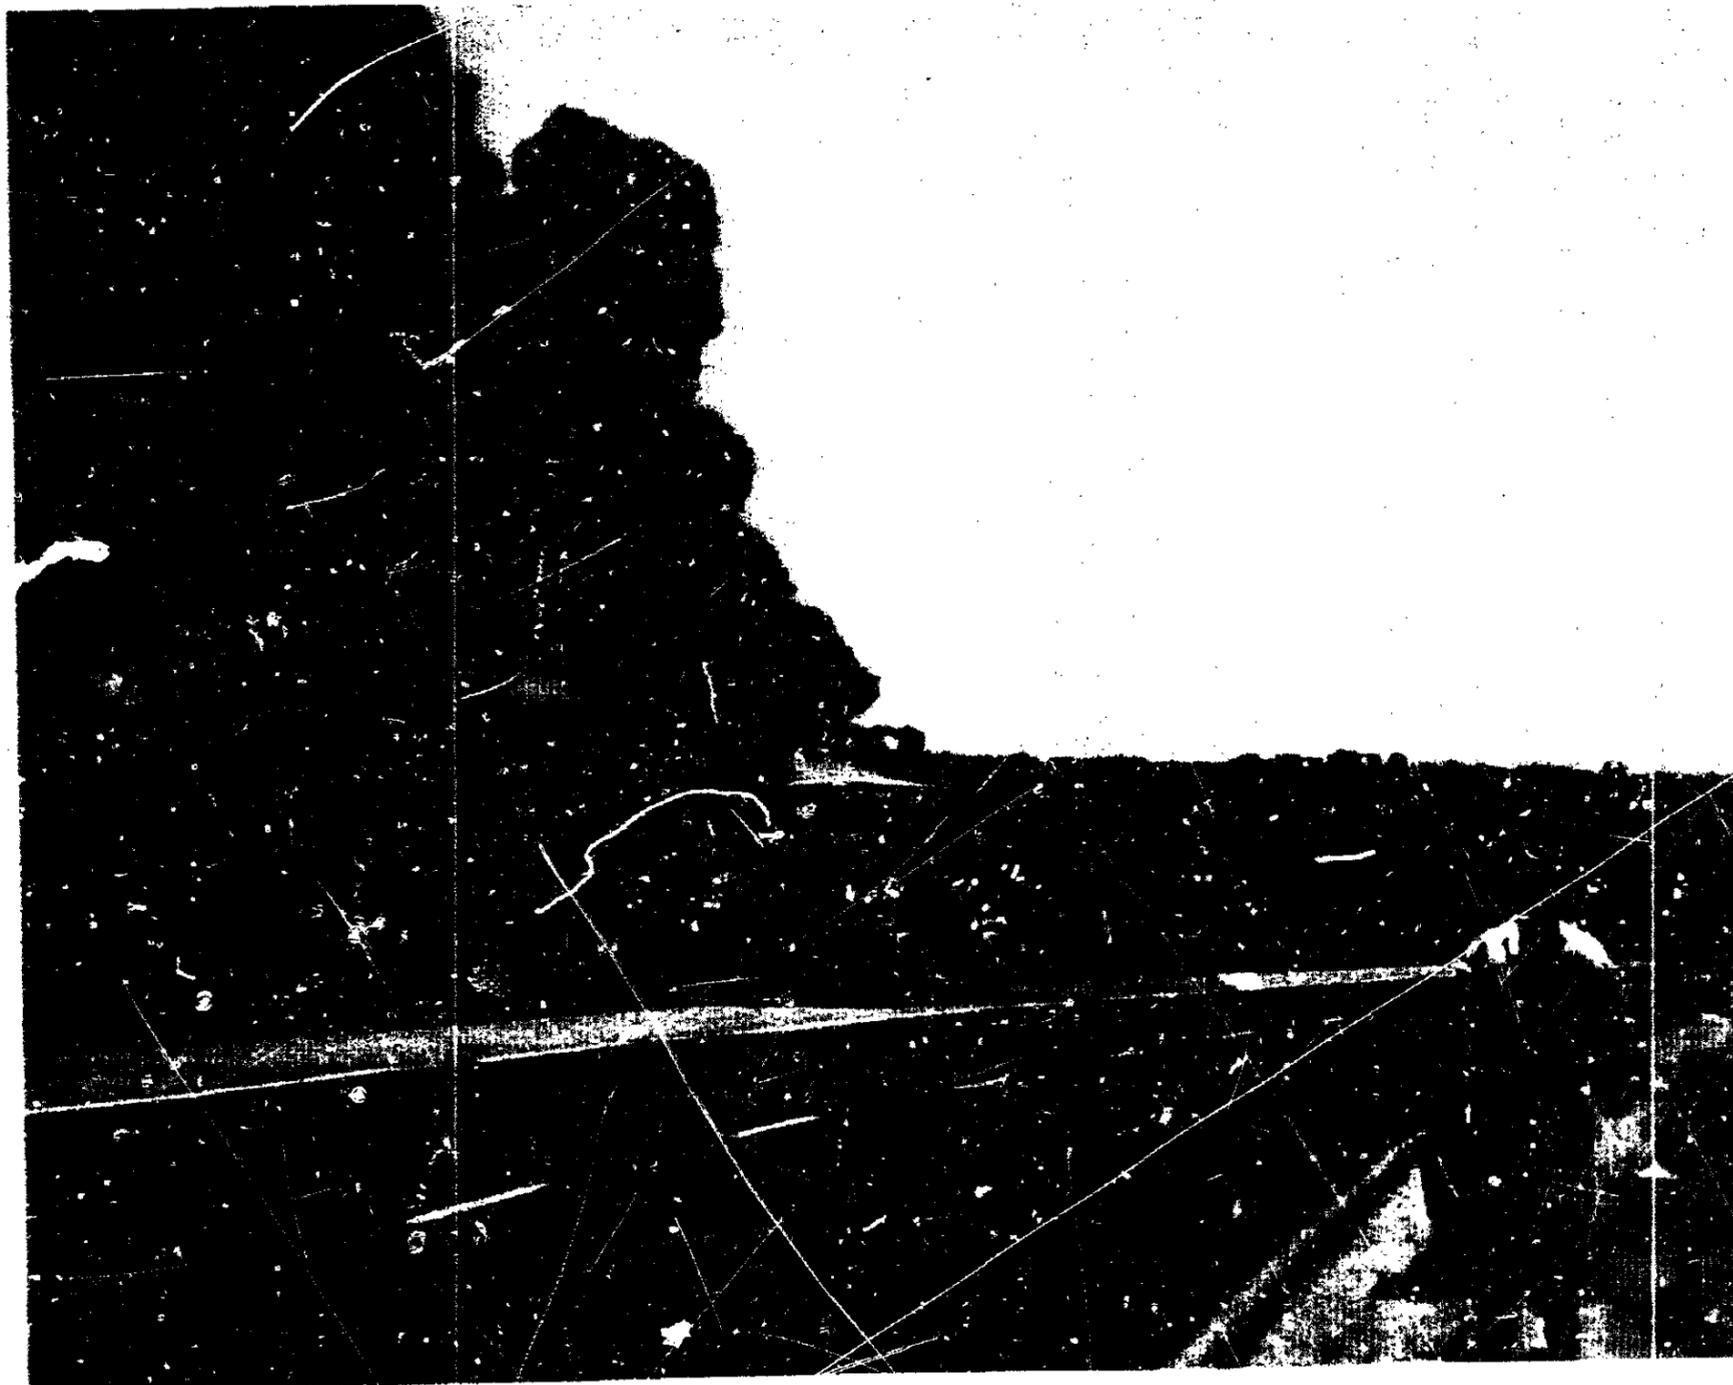
Figure No. 7. Initial Passenger Compartment Fire Involvement.

Light breezes caused the flames to travel around the fire wall. The flames ignited the sides, windows, and roof of the bus. (See Figure 7.) Fire also traveled through the air conditioning vents in the fire wall and into the passenger compartment.
