**NATIONAL  
TRANSPORTATION  
SAFETY  
BOARD**

**HIGHWAY ACCIDENT REPORT**

**SISKIYOU UNION HIGH SCHOOL  
DISTRICT SCHOOLBUS/AUTOMOBILE  
COLLISION AND ROLLOVER, 1-5,  
ASHLAND, OREGON  
MAY 9, 1975**

REPORT NUMBER: NTSB-HAR-76-1

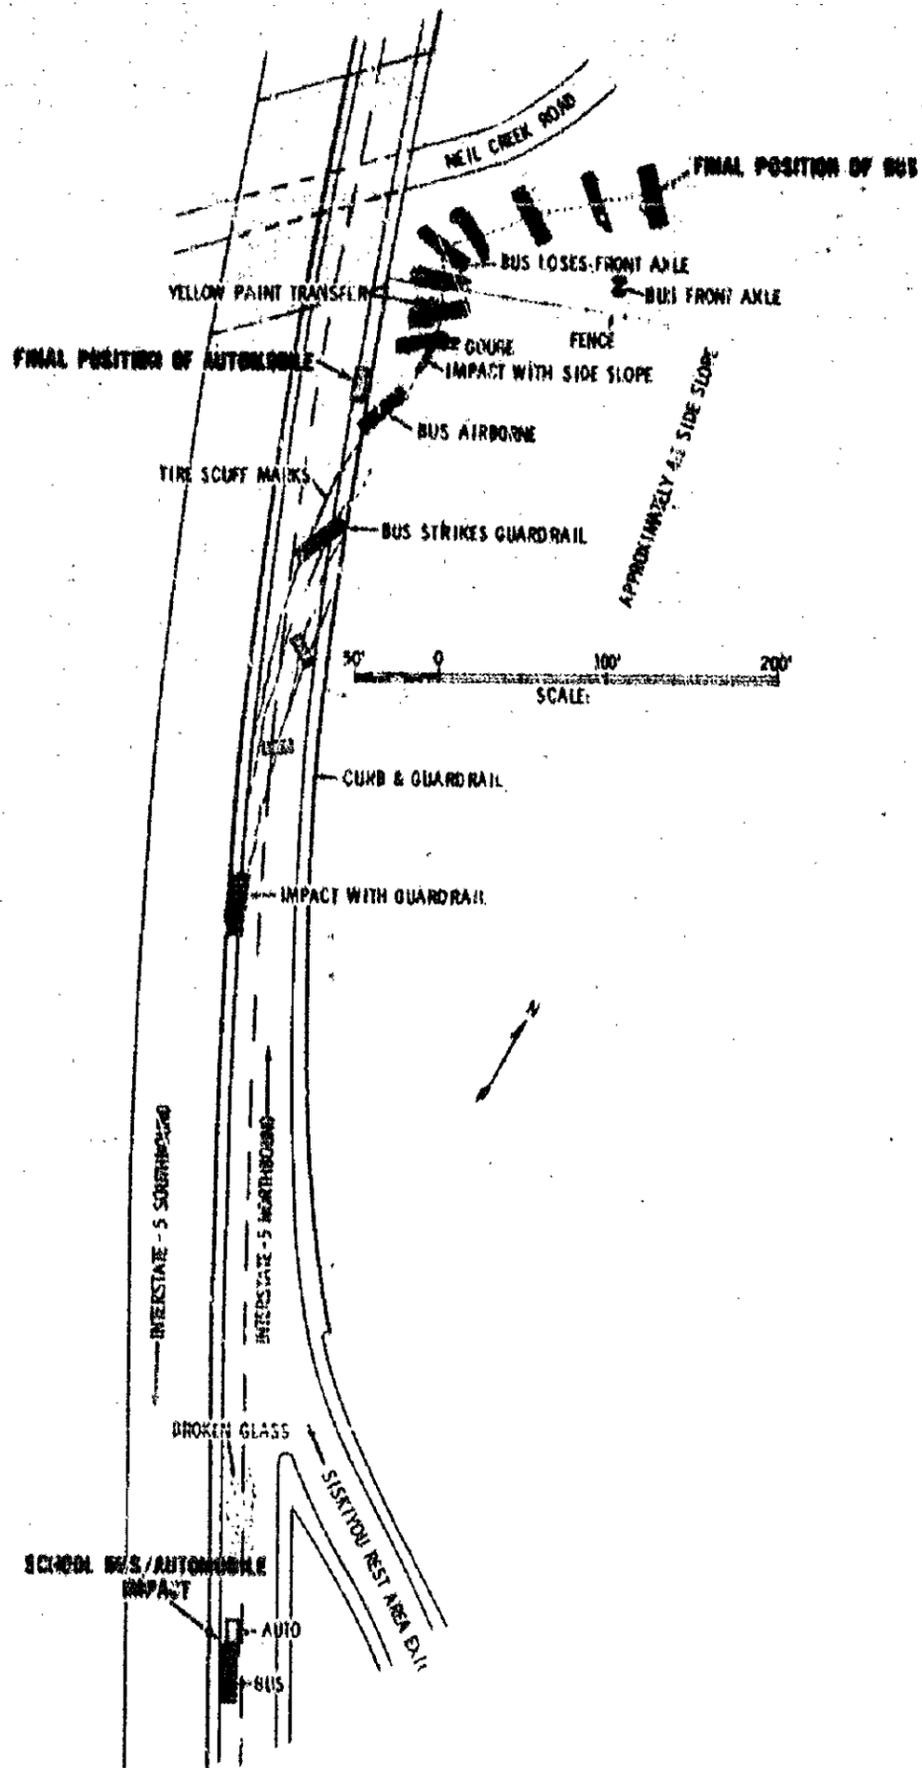
on the highway. The driver managed to steer the bus successfully through the curves. When the bus approached a rest area about 5 1/2 miles from the summit, (See Figure 1.) its speed is estimated to have been 70 mph. <sup>1/</sup>

Figure 1. Schoolbus/Automobile collision and Rollover, Ashland, Oregon, May 9, 1975

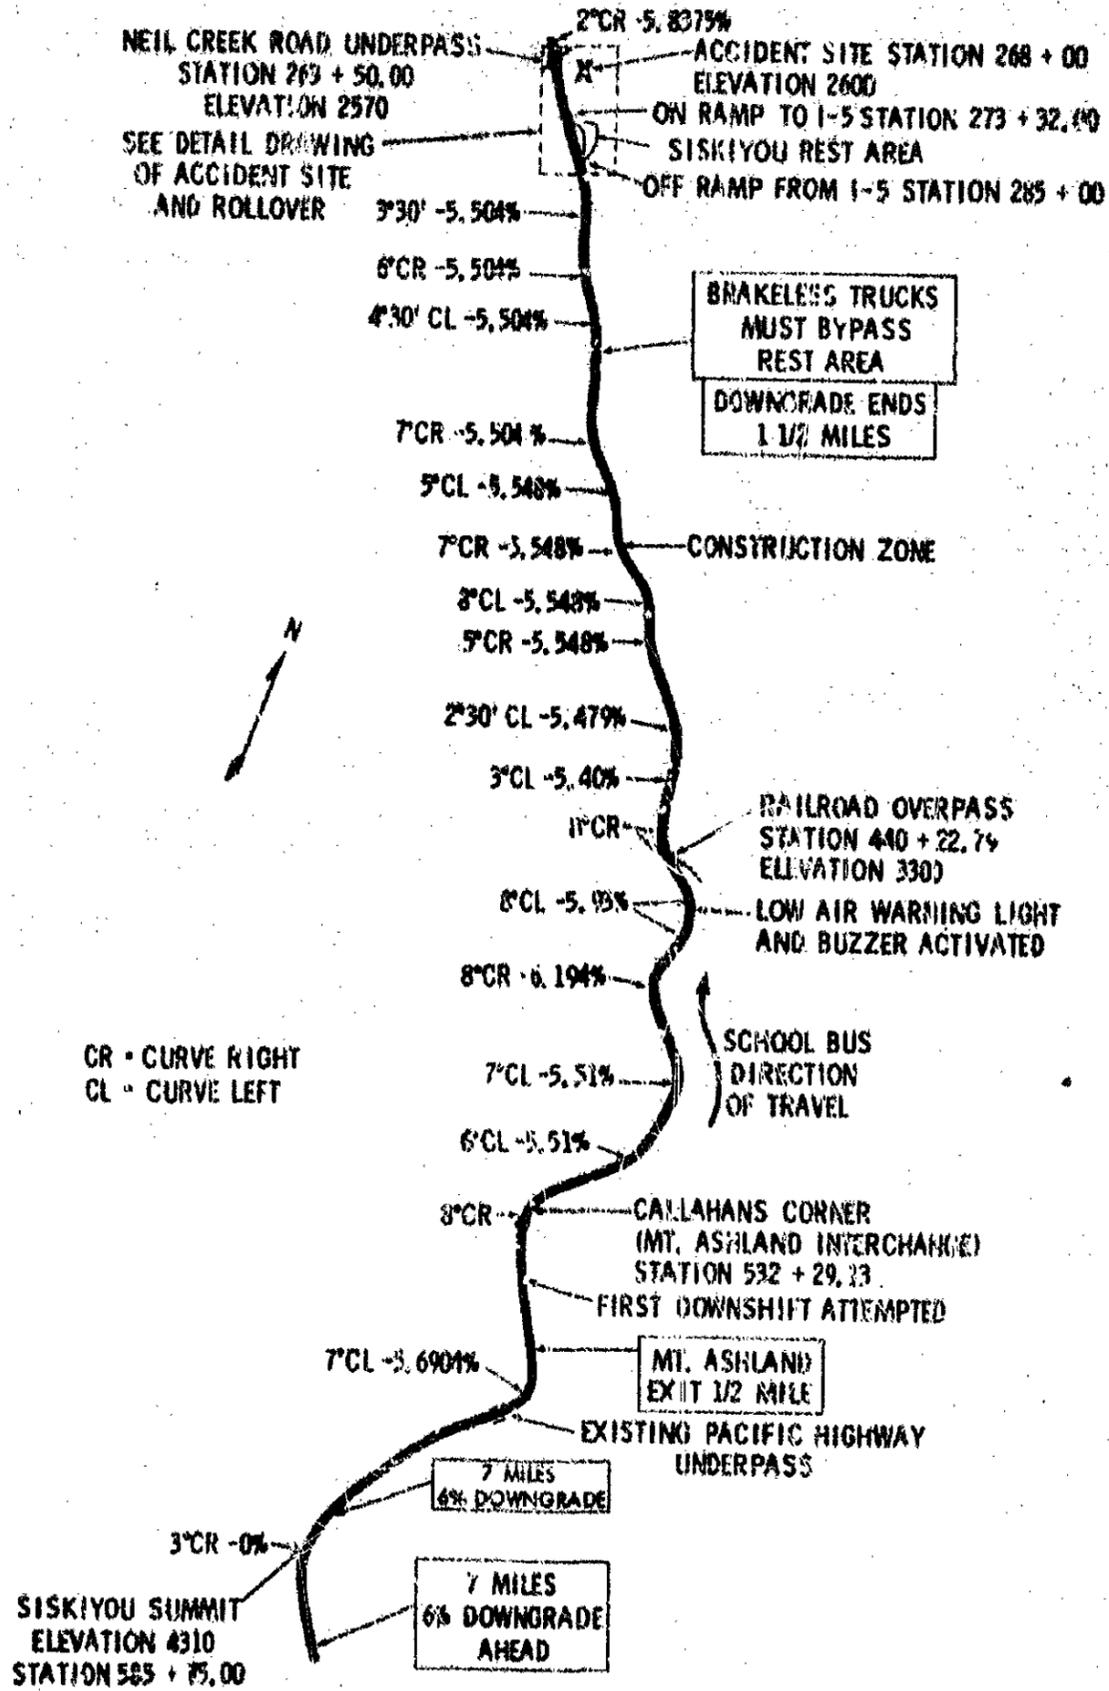
Figure 5. Northbound Interstate 5 from the Siskiyou Summit to the accident site.

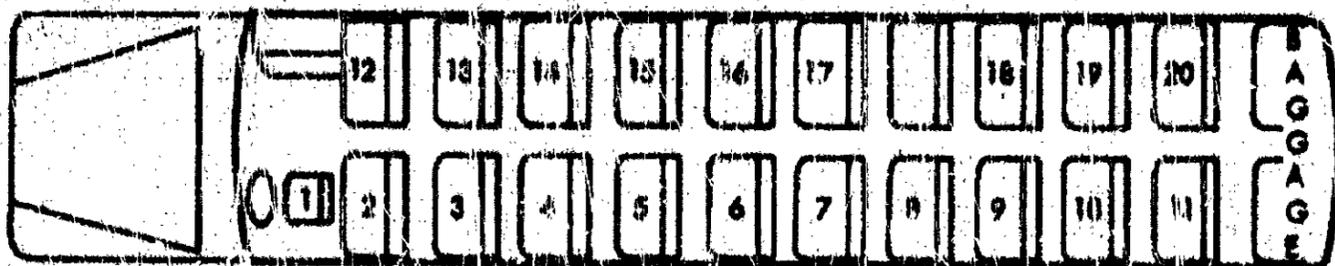
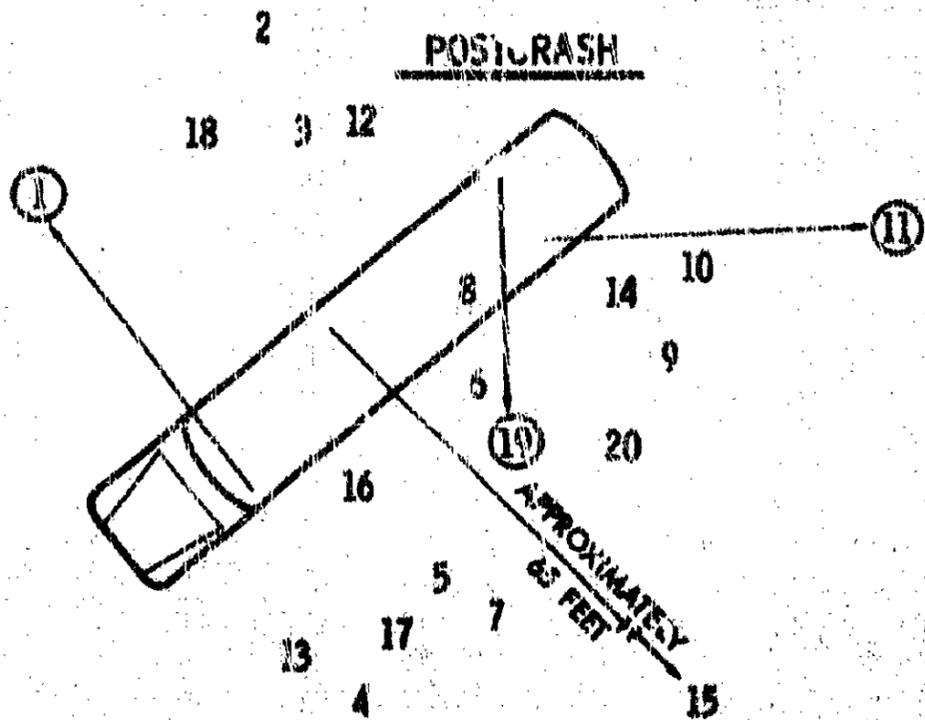
Figure 7. Precrash and postcrash positions of schoolbus occupants.
