HIGHWAY ACCIDENT REPORT

**SURTIGAS, S. A.,
TANK-SEMITRAILER OVERTURN,
EXPLOSION, AND FIRE**

NEAR EAGLE PASS, TEXAS

REPORT NUMBER : NTSB-HAR-76-4

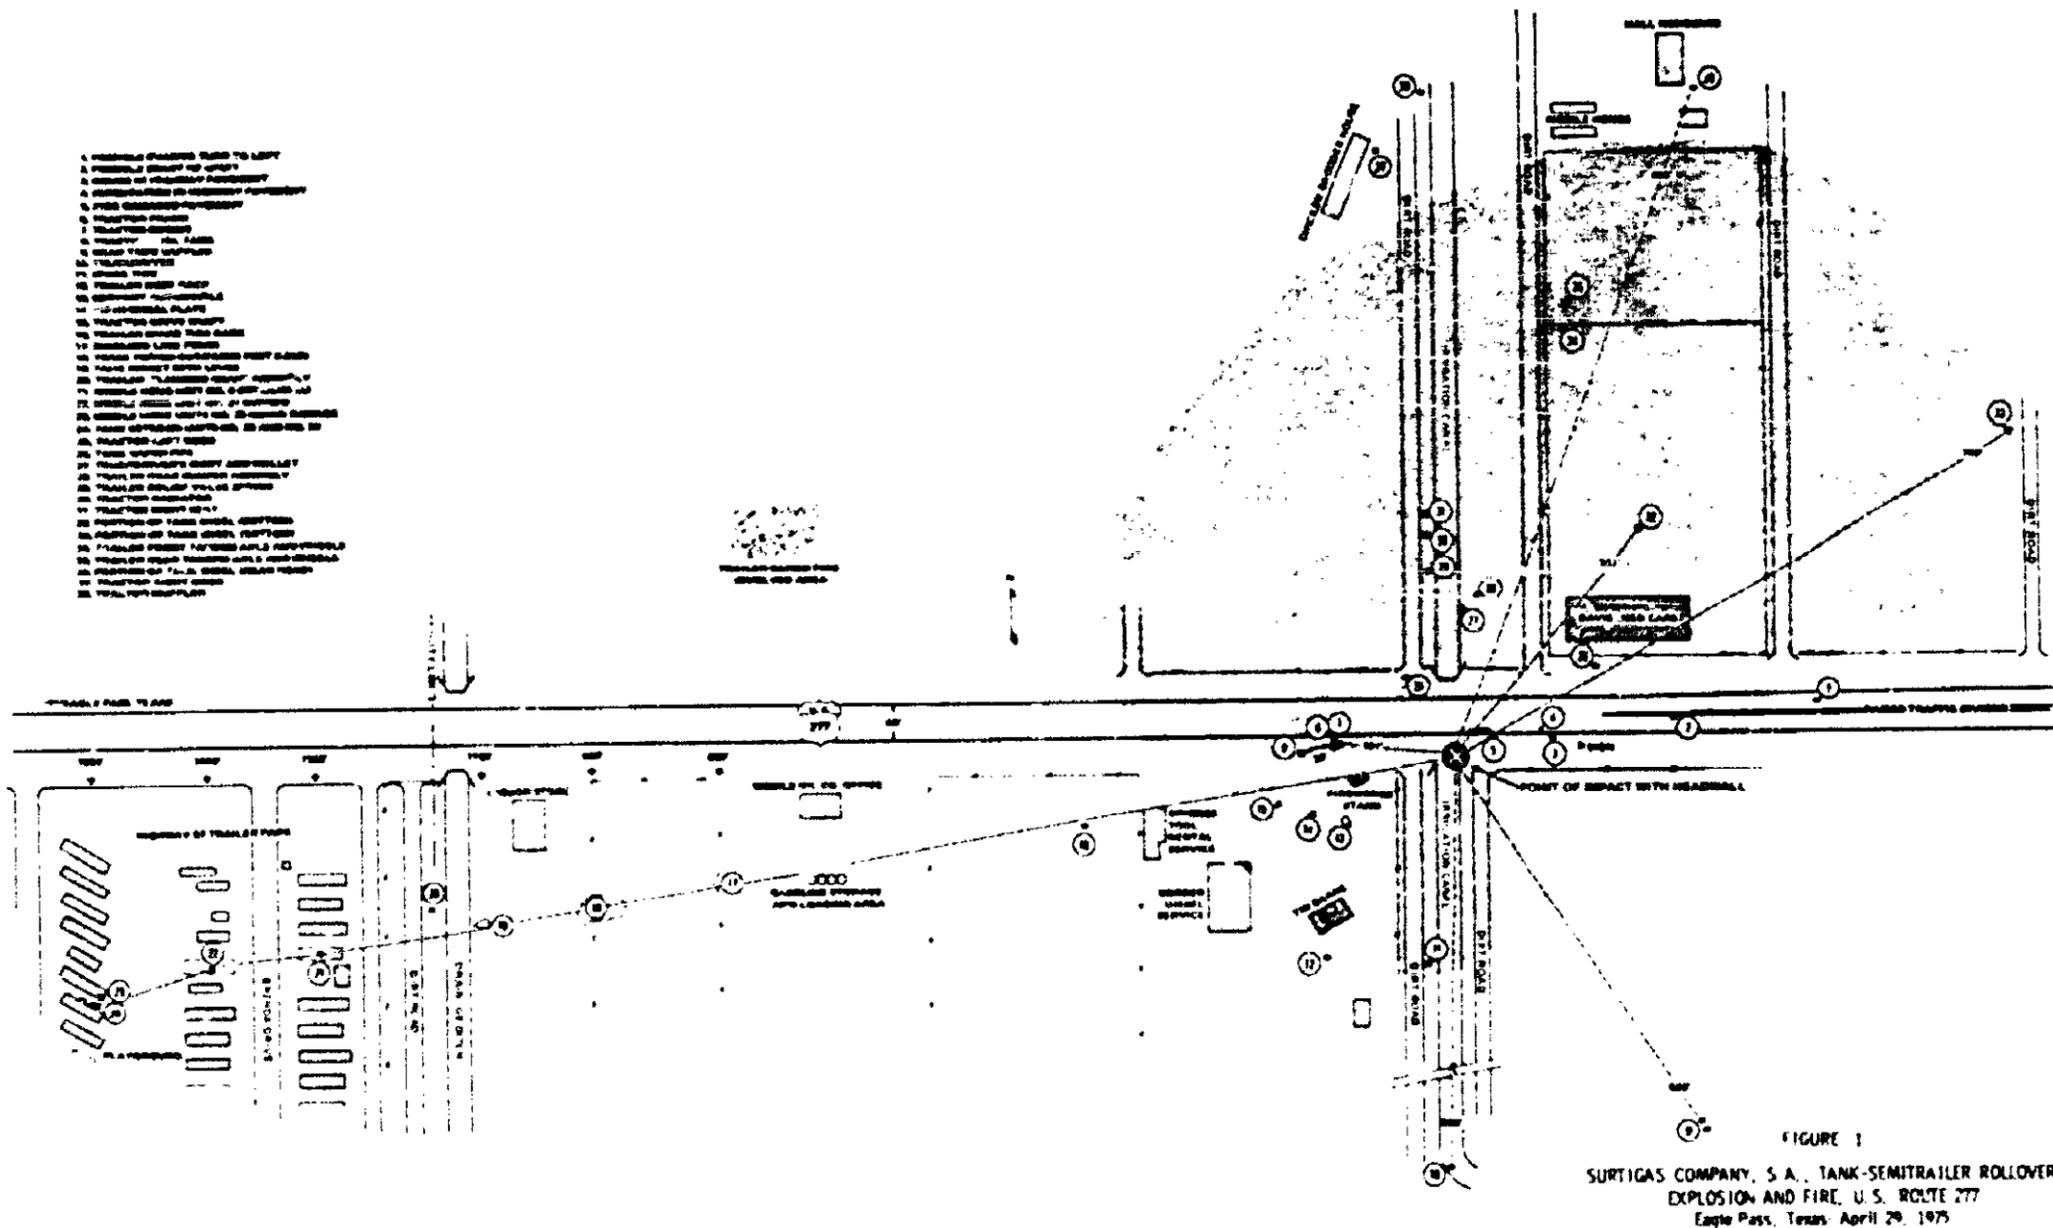
Figure 1. Accident site.

U.S. Route 277 was a two-lane, 40-foot-wide concrete roadway with a well-worn asphalt surface. (See Figure 1.) The eastbound and westbound lanes were divided by a double yellow centerline, which was also worn. The road crossed an irrigation canal at the accident site. Four hundred and thirty-one feet east of the irrigation canal, the roadway was intersected by U.S. Route 57. Near its intersection with Route 57, Route 277 widened and its lanes were separated by a raised concrete divider. There were 30-foot gravel and clay shoulders on each side of the roadway. The posted speed limit was 50 mph. The westbound truck approached the site on an average 1.70-percent downgrade. On the day of the accident, the visibility was 5 miles and the temperature was 80 degrees. Witnesses described traffic as light but steady.

The irrigation canal which ran north and south under the roadway had concrete headwalls 28 feet to the north and 29 feet to the south of the roadway's edge. The concrete headwalls were 17.5 feet long, 12 inches thick, and 23 inches high, and constructed of reinforced concrete. They were not protected by a barrier.

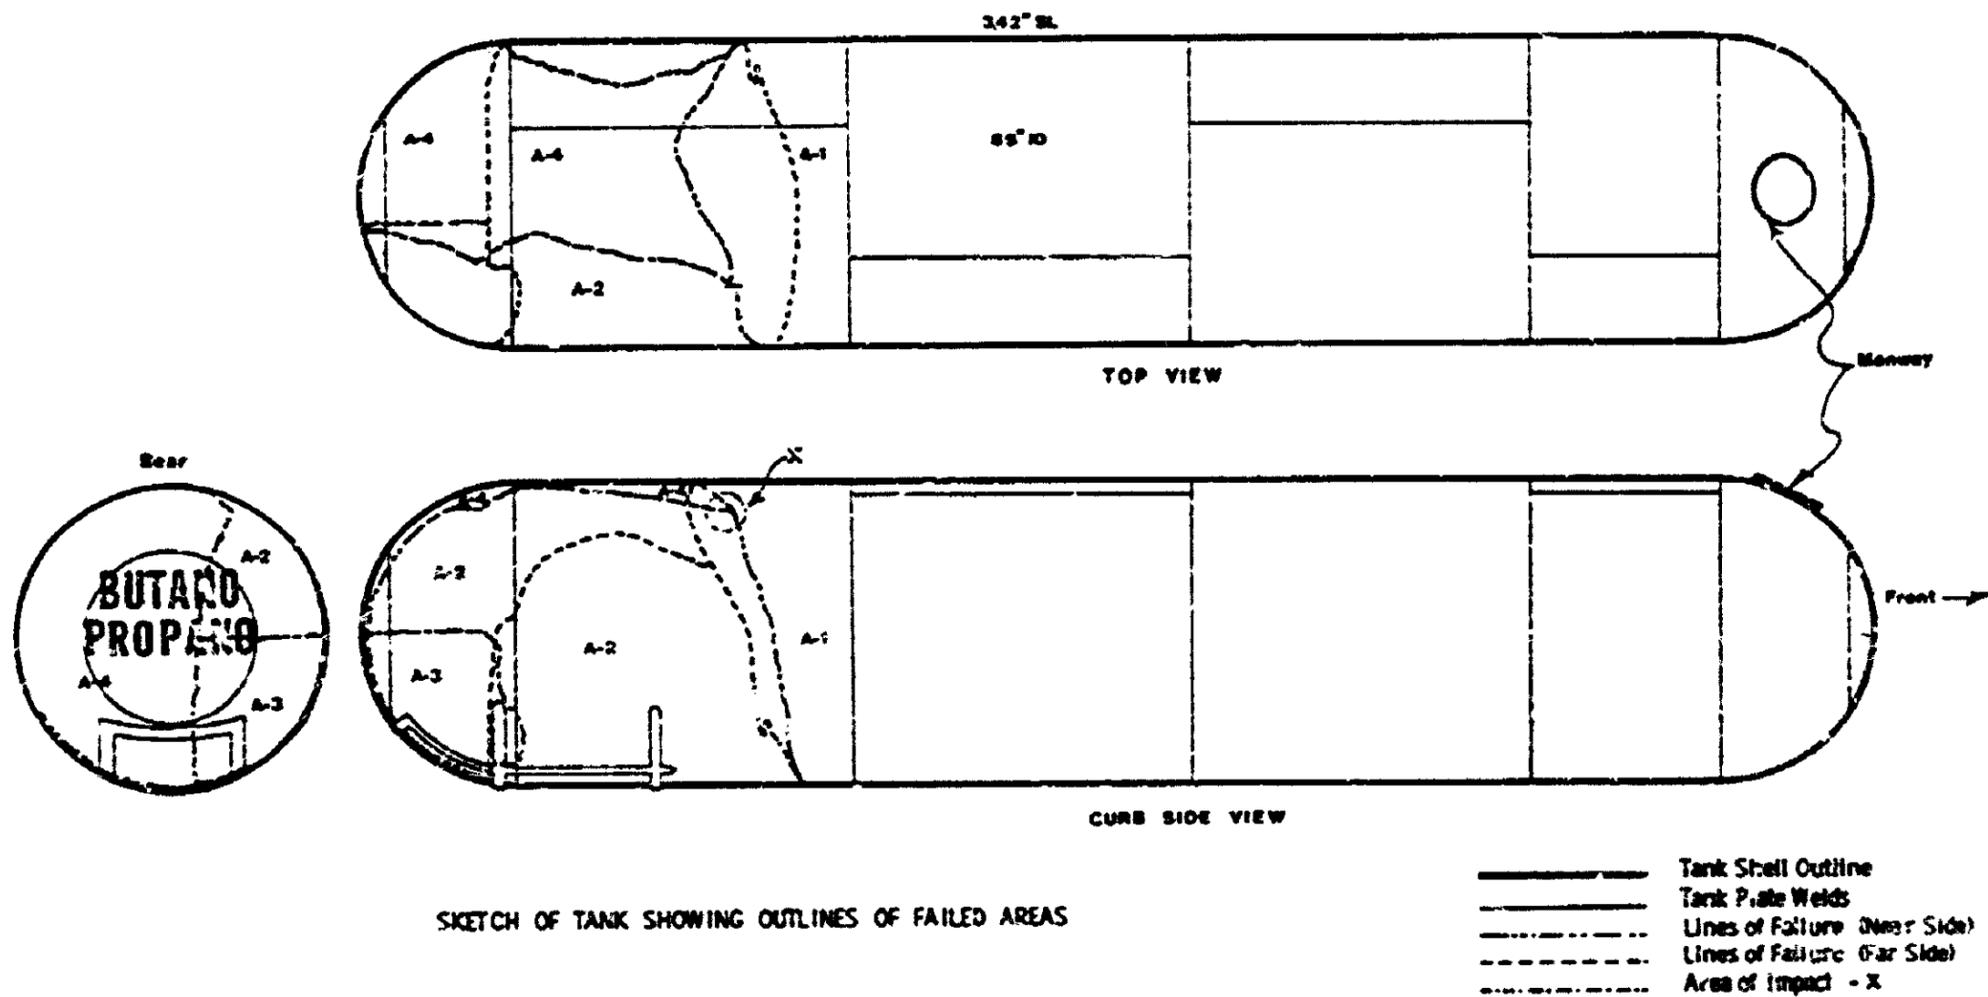
The open end of the forward section of the tank was deformed into an ellipse. (See Figure 4.) The edges of the failure area had a mechanically deformed, gouged, and stretched dent. The dent was located on the right side of the tank, 26 inches from the top longitudinal centerline and 22 feet 9 inches rearward of the front head-to-shell weld. At the point of impact, the shell material was gouged from an original thickness of 0.387 inches to 0.279 inches. The internal tank pressure of 87 psig combined with the impact load to cause a shear-type failure around the tank circumference. The pressure, acting upon the tank material at the point of initiation of the crack, produced the extensive spread of the initial crack and permitted the violent rupture and separation of major parts of the tank.

The Safety Board analyzed a sample of the metal from the suspected impact area, and found no evidence of a pre-existing crack. The analysis showed that the fracture appeared to be caused by an overload separation.

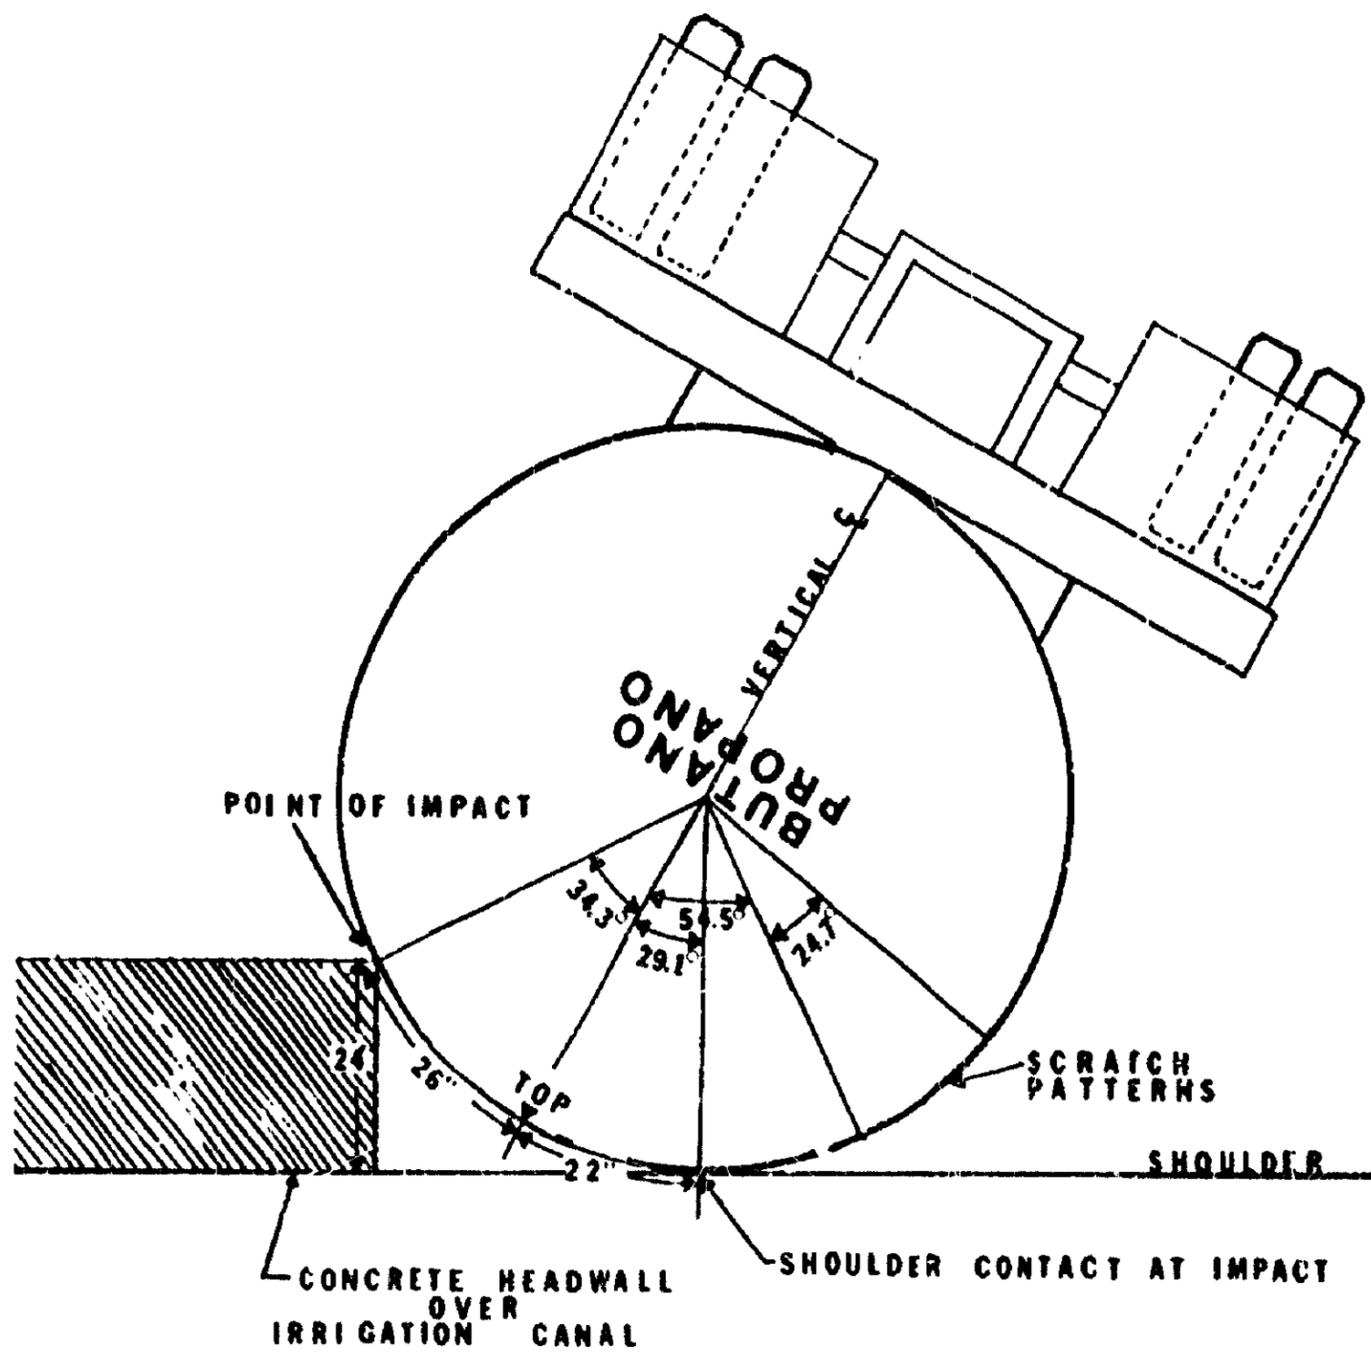
When the trailer separated from the tractor, the upsetting forces on the tractor were removed. The tractor dropped onto its right wheels, continued westward, and stopped opposite the headwall of the irrigation canal. The trailer rolled onto its left side and slid toward the concrete headwall and struck it. (See Figure 5.)

At impact, the tank shell was gouged severely and was forced into an elliptical shape. Impact forces also caused the tank to rotate counterclockwise about 40 to 50 degrees and to rebound to the south edge of the eastbound lane. The tank shell began to crack where it struck the headwall. The internal tank pressure of 87 psig combined with the impact load to cause a shear-type failure around the circumference of the tank.

FIGURE 5. CALCULATED ATTITUDE OF TANK-SEMITRAILER AT IMPACT WITH CONCRETE HEADWALL
