NATIONAL TRANSPORTATION SAFETY BOARD

HIGHWAY ACCIDENT REPORT

UNION OIL COMPANY OF CALIFORNIA,
TANK TRUCK AND FULL TRAILER
OVERTURN AND FIRE
SEATTLE, WASHINGTON

REPORT NUMBER: NTSB-HAR-76-7

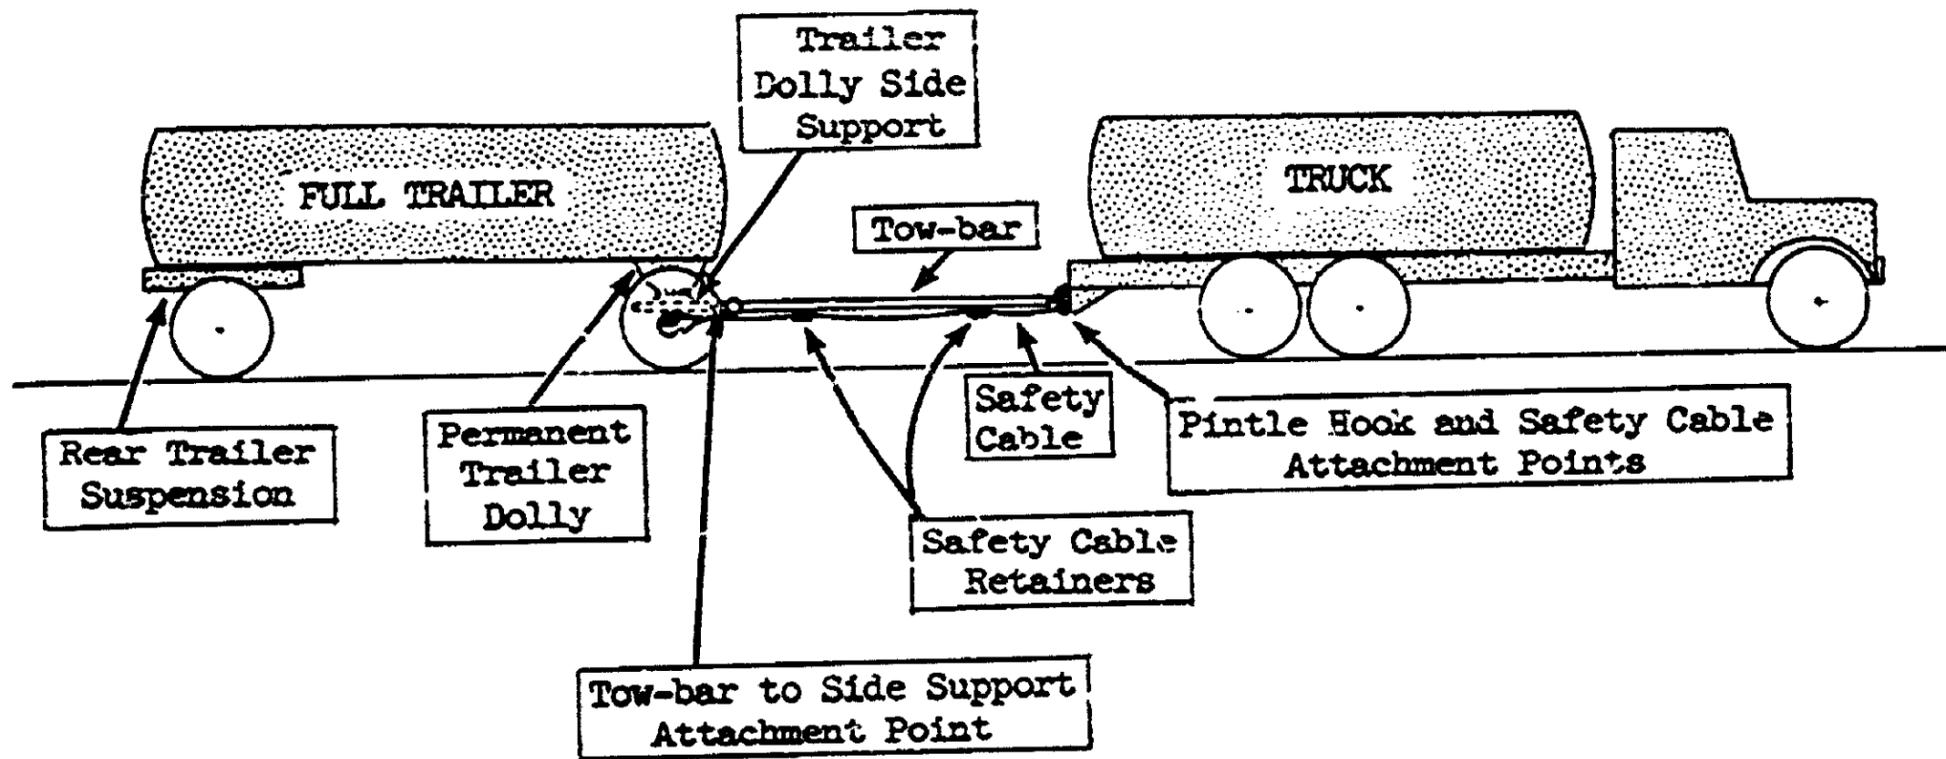
Figure 7. Diagram of truck and full trailer with tow-bar. Safety cable retained along lower left and right sides of tow-bar by short metal sleeves which are welded to the tow-bar rails.
