**STUDENT TRANSPORTATION LINES, INC.,
CHARTER BUS CLIMBING OF
BRIDGE RAIL AND OVERTURN**

NEAR MARTINEZ, CALIFORNIA

MAY 21, 1976

REPORT NUMBER: NTSB-HAR-77-2

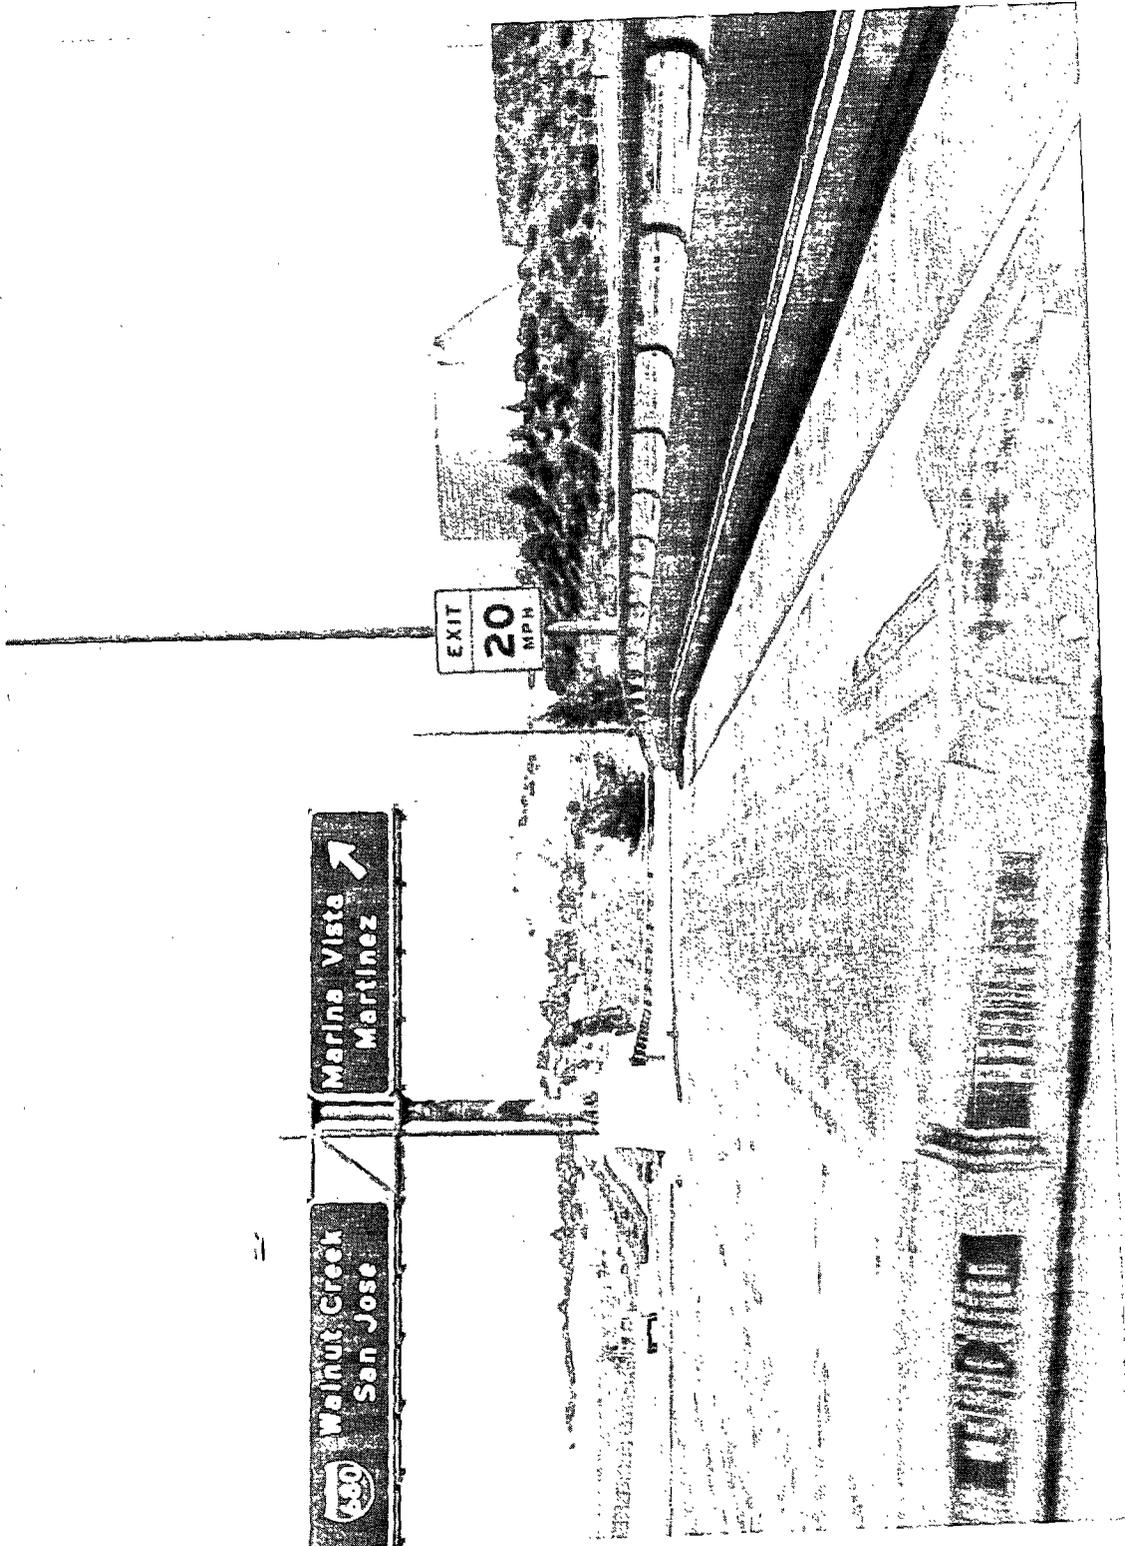
Figure 1. Approach to Marina Vista offramp showing the exit and 20-mph speed advisory signs and entrance to ramp.

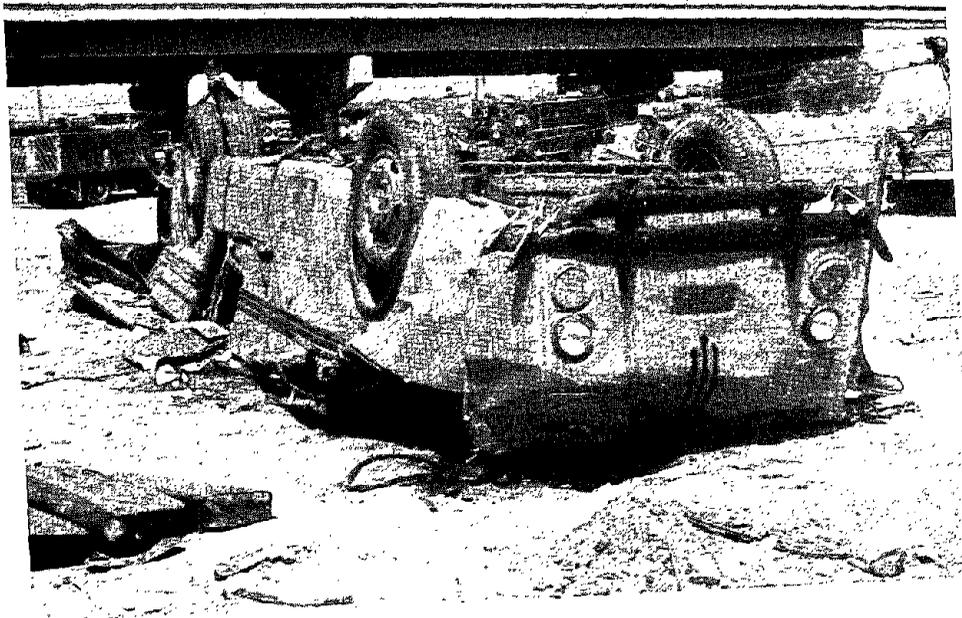
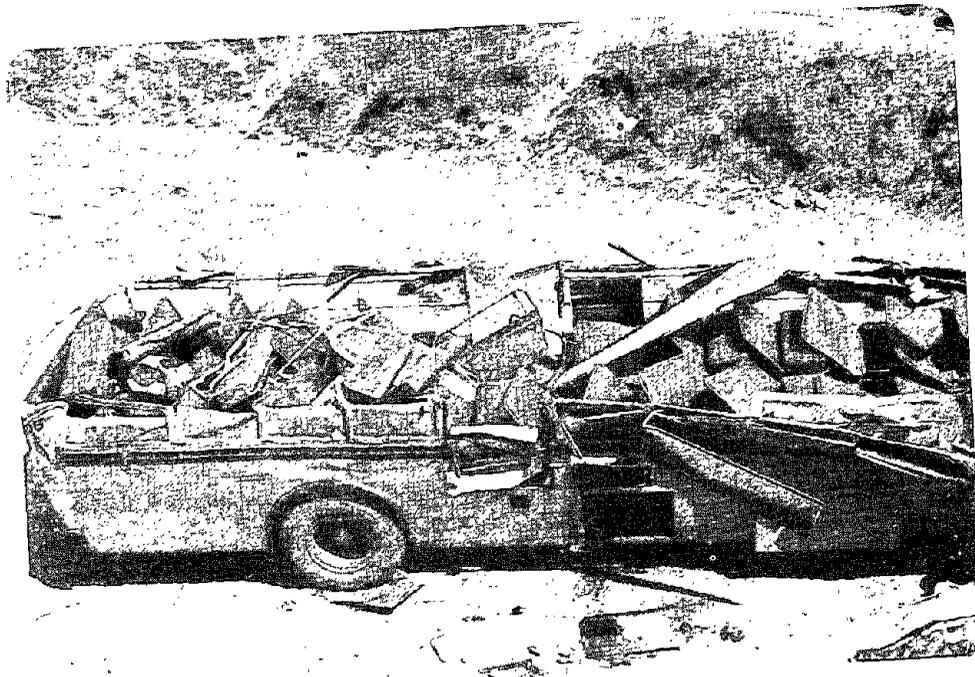
The bus was totally destroyed. (See figure 2.) The following is a description of only that vehicle damage pertinent to the reconstruction of the crash dynamics:

Figure 3. Damaged bus at the accident site. The roof was cut from bus during rescue efforts.

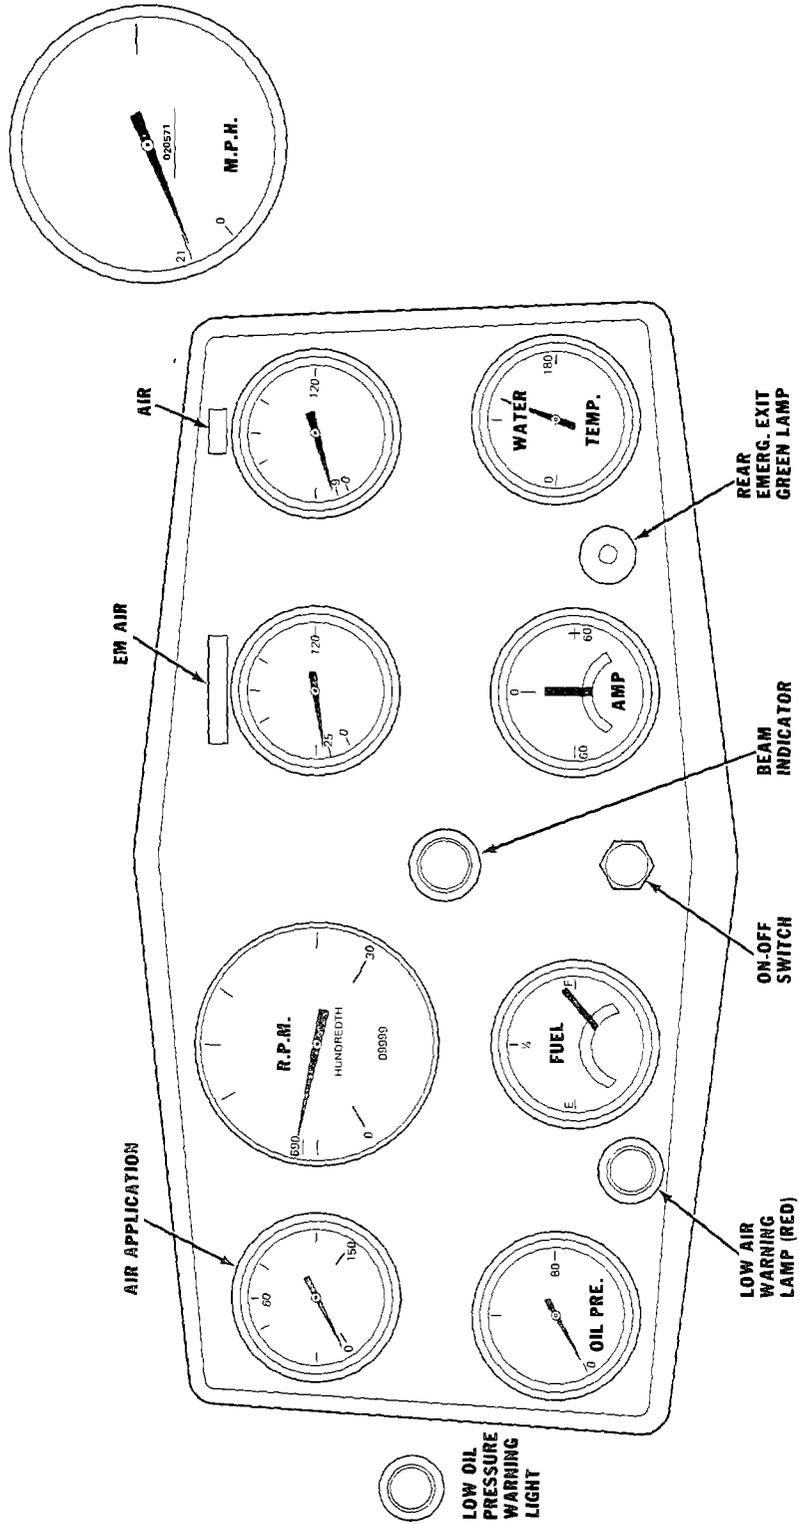
Figure 4. Diagram of instrument panel of accident bus.

Emergency Brake Air Gauge -- The emergency brake air gauge was located in the upper right center of the instrument panel to the right of the tachometer. This gauge registered the air pressure from 0 to 150 psi in the emergency airbrake reservoir and was independent of the service brake system. The gauge was not installed by the original manufacturer. The emergency airbrake system was activated by a lever on the right side of the steering column just below the steering wheel. The gauge was labeled with a plastic label with "EM Air" printed thereon and the word "air" was printed at the bottom of the dial.

Possibly, the driver did not react to the low service air pressure gauge reading because he thought that the center gauge (emergency air) was service air pressure. After air pressure had reduced to 35 psi, there would have been a gradual decrease in brake performance, and an experienced driver should have recognized it and responded to it. He had several opportunities to stop the bus safely after leaving the Vista Point and before entering the ramp. The air emergency system was available for use and could have stopped the bus. Sometime between belt failure and the post-crash inspection, the emergency airbrake system had been applied at least three times. The CHP test results with 100 psi original pressure indicated that the first application left 75 psi, the second left 56, and the third left 43 psi -- the exact amount found during the post-crash inspection. The driver testified that he was not aware of the location of the emergency air control. All of the vehicles he had driven previously had this control in the form of a switch on the dash and not a lever on the steering column. However, the same lever is used for trailer brakes in truck combinations and is found in many truck tractors. Since the driver had been driving the bus for more than 2 hours and since he had 20 years of experience driving airbraked vehicles, the Safety Board concludes that he should have been aware of the location of the lever and its use.
