NATIONAL TRANSPORTATION SAFETY BOARD

HIGHWAY ACCIDENT REPORT

**TRACTOR-SEMITRAILER/SCHOOLBUS
COLLISION AND OVERTURN**

REPORT NUMBER: NTSB-HAR-78-1

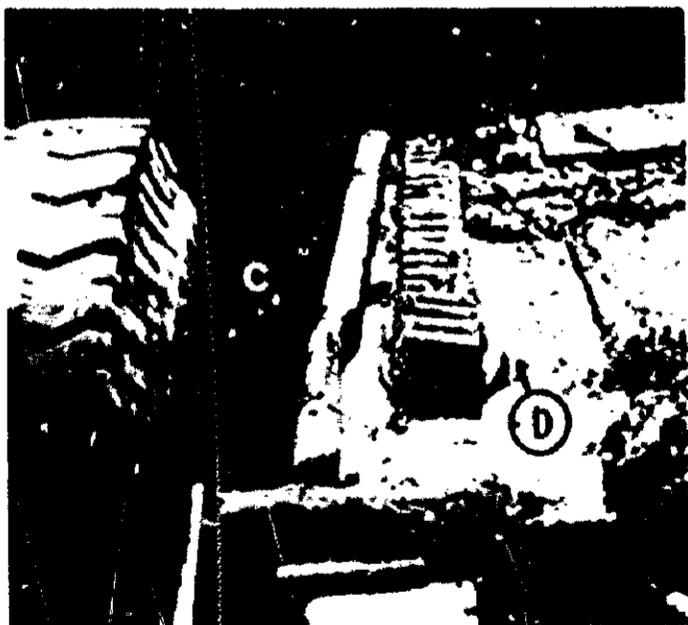
The upper part of the tractor frame-mounted sliding fifth wheel assembly separated from its lower components. Three teeth on the left side of the upper assembly showed evidence of extremely high loadings. The front tooth had sheared at its outboard end. The left side channel in which the upper slide plate moves fore and aft, had been deformed upward and inboard. (See figures 5 through 8.) Wear marks on the lower ratchet teeth indicate that the fifth wheel had been positioned 4 inches aft of the bogie axle centerline. The fifth wheel stop plate, mounted at the forward end of the assembly, failed at the attachment welds.

Figure 7. Left-side stationary rail of tractor-mounted fifth wheel assembly showing deformed sliding rail channel (C), and twisted fifth wheel positioning rail (D). (Lower component.)

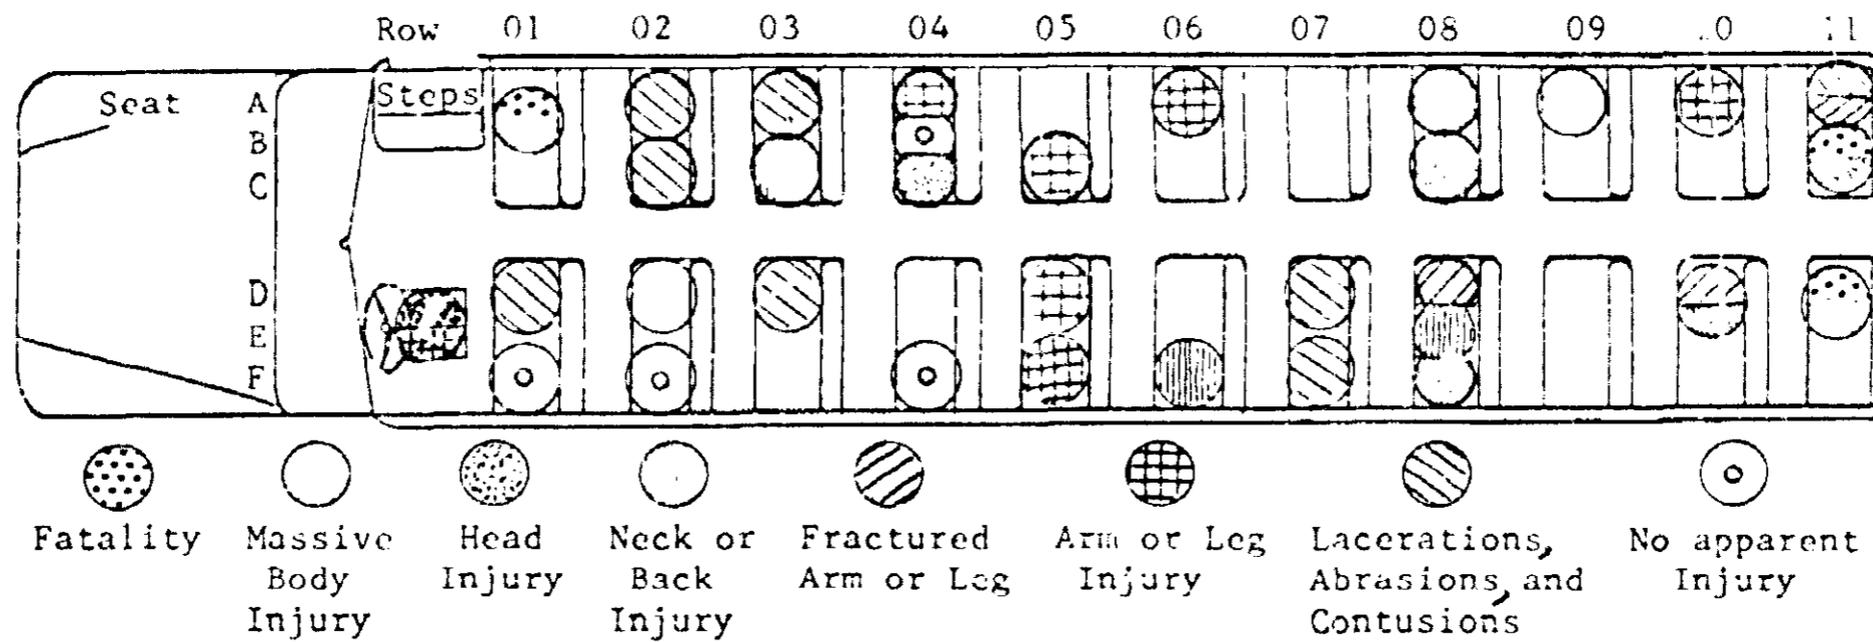
The seating arrangement of the schoolbus occupants is shown in figure 9. The schoolbus driver was using her seatbelt, which performed as intended during the accident. The bus was not equipped with seatbelts for the passengers nor were such restraints required. One passenger was ejected and was killed when the bus overturned and pinned the child under the right side of the bus. According to the coroner's report, two of the three occupants of the rearmost row of seats died as a result of their injuries. The third sustained a fractured wrist and lacerations.

Figure 9. Locations of bus occupants and indications of types of injuries.

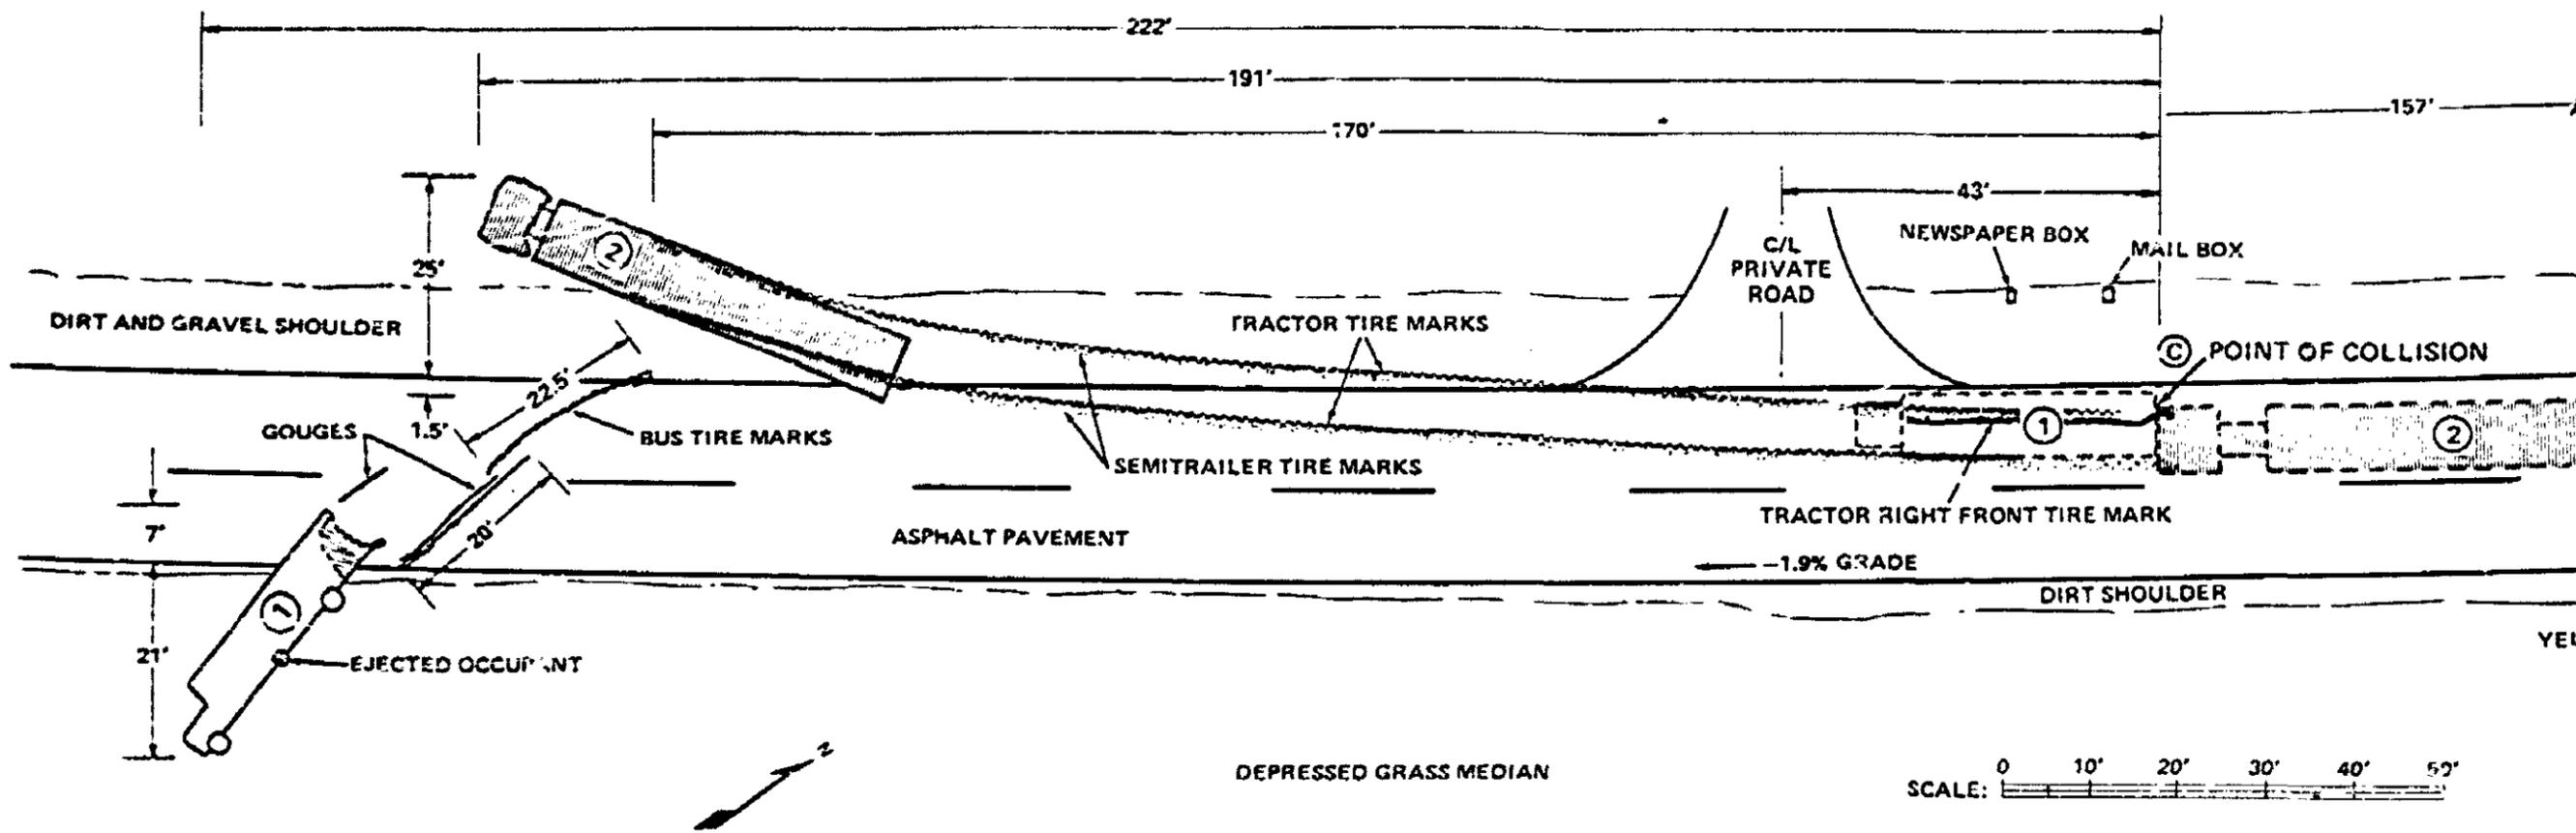
APPENDIX B. DIAGRAM OF COLLISION SITE.

The impact lifted the rear of the bus, driving it forward onto the shoulder. The bus was forced to the left across the southbound lane, overturned onto its right side, and stopped partially on the median and partly in the roadway about 222 feet from the point of impact. The tractor-semitrailer veered to the right, ran off the road, and stopped 191 feet from the point of impact. (See appendix B.)

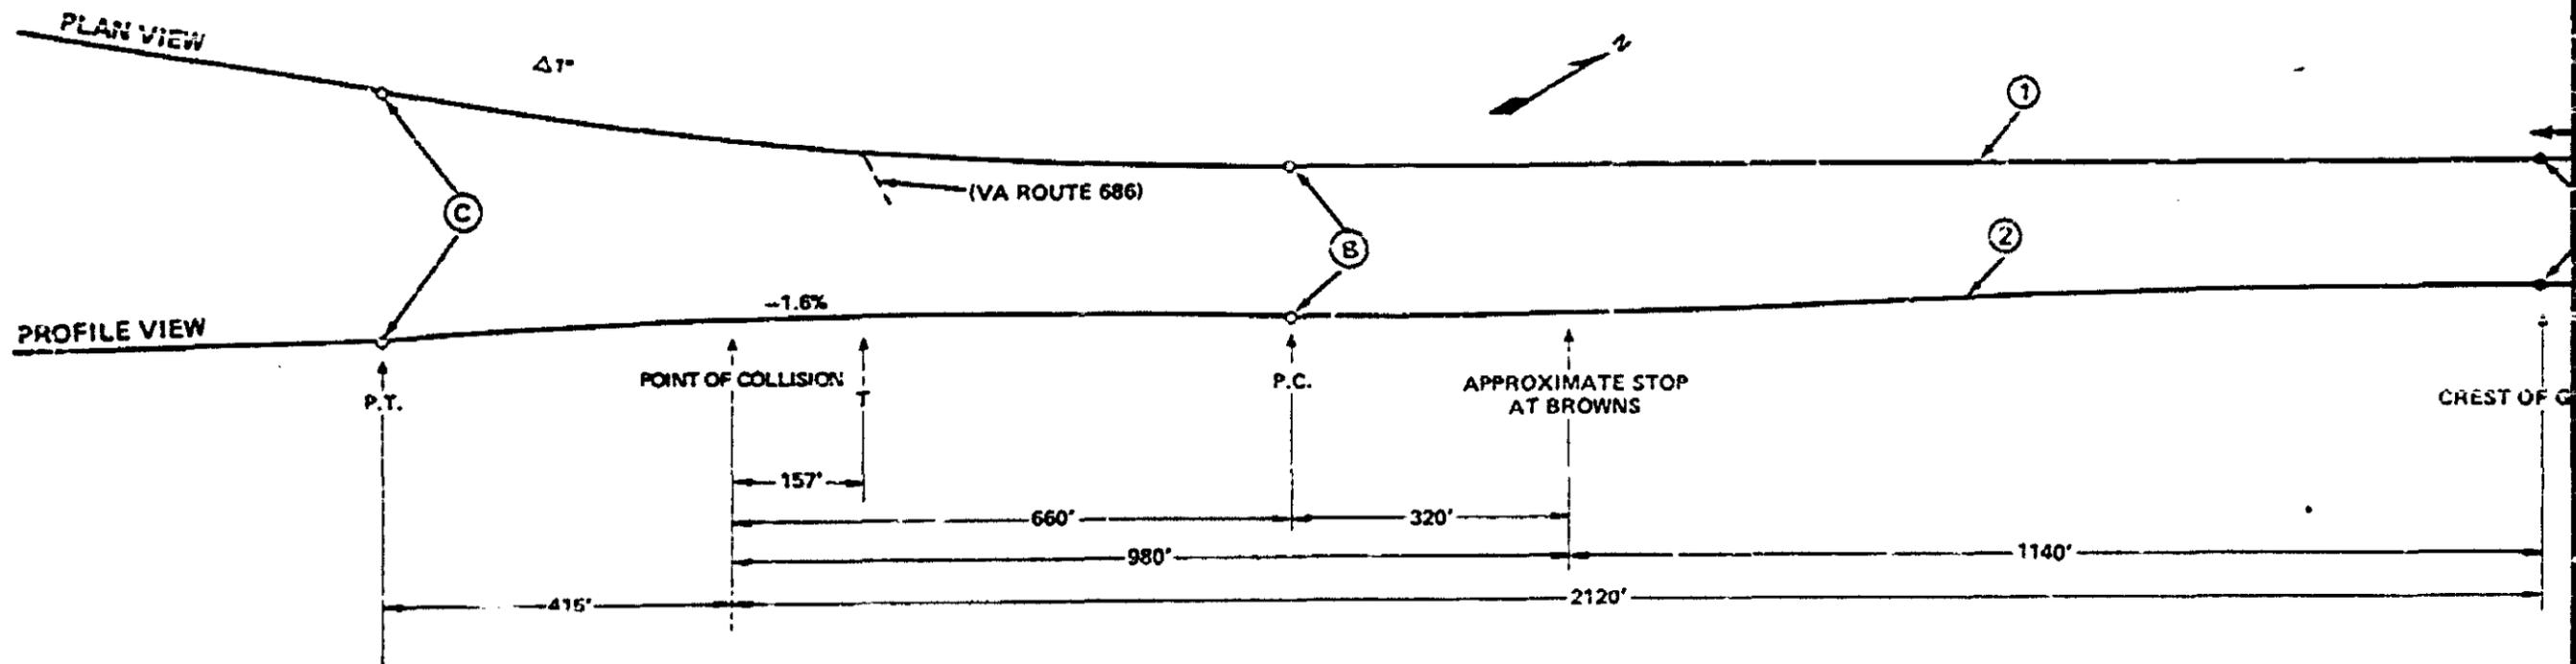
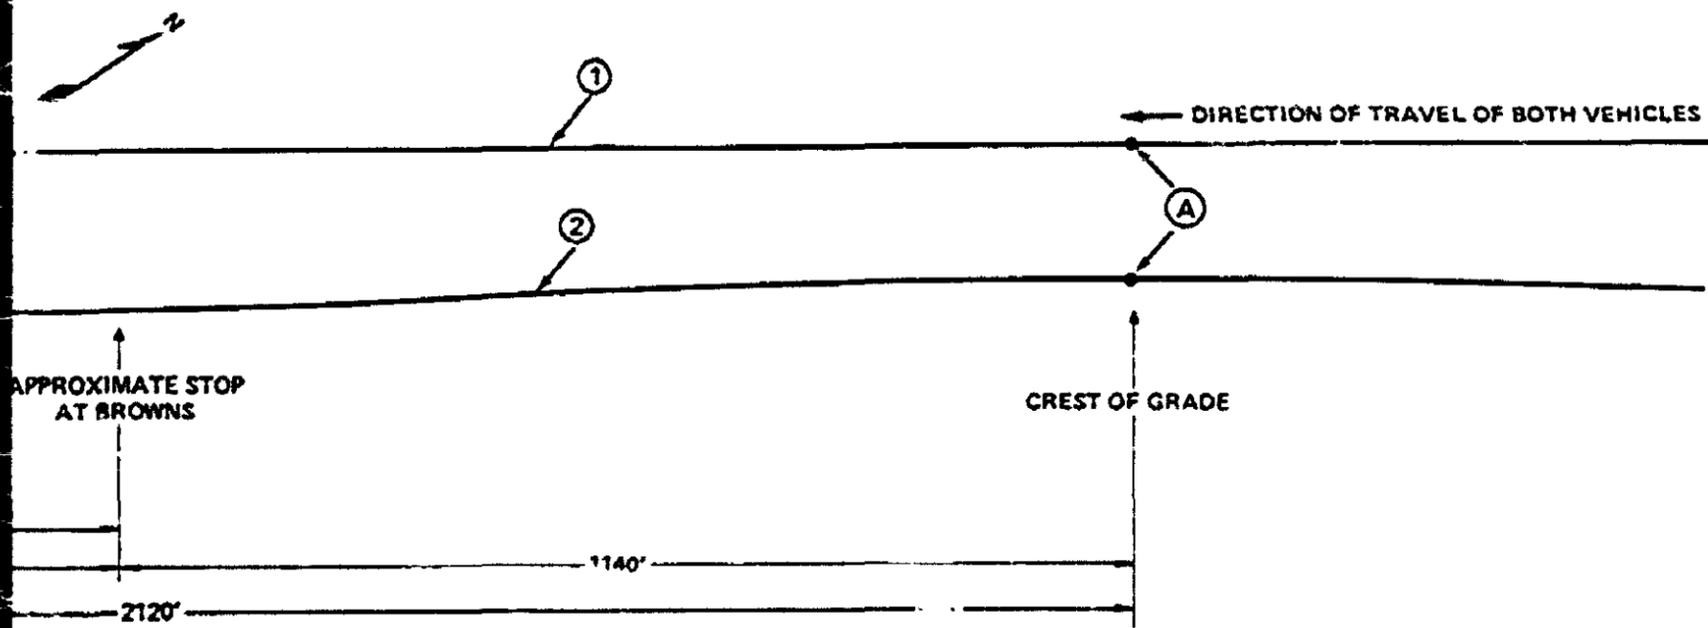
APPENDIX C. PLAN VIEW, CENTERLINE, AND PROFILE OF SOUTHBOUND LANE OF U.S. 29.

The collision occurred on a 1.6 percent downgrade. The downgrade began at a point 2,120 feet north of the point of collision, continued approximately 1,300 feet, leveled out, and began again about 450 feet north of the collision point. The right curve began 660 feet north of the point of collision. (See appendix C.)
