# NATIONAL TRANSPORTATION SAFETY BOARD

## HIGHWAY ACCIDENT REPORT

MIDAS MINI MOTOR HOME/ AUTOMOBILE COLLISION,  
U.S. ROUTE 69

REPORT NUMBER: NTSB MAR-78-2

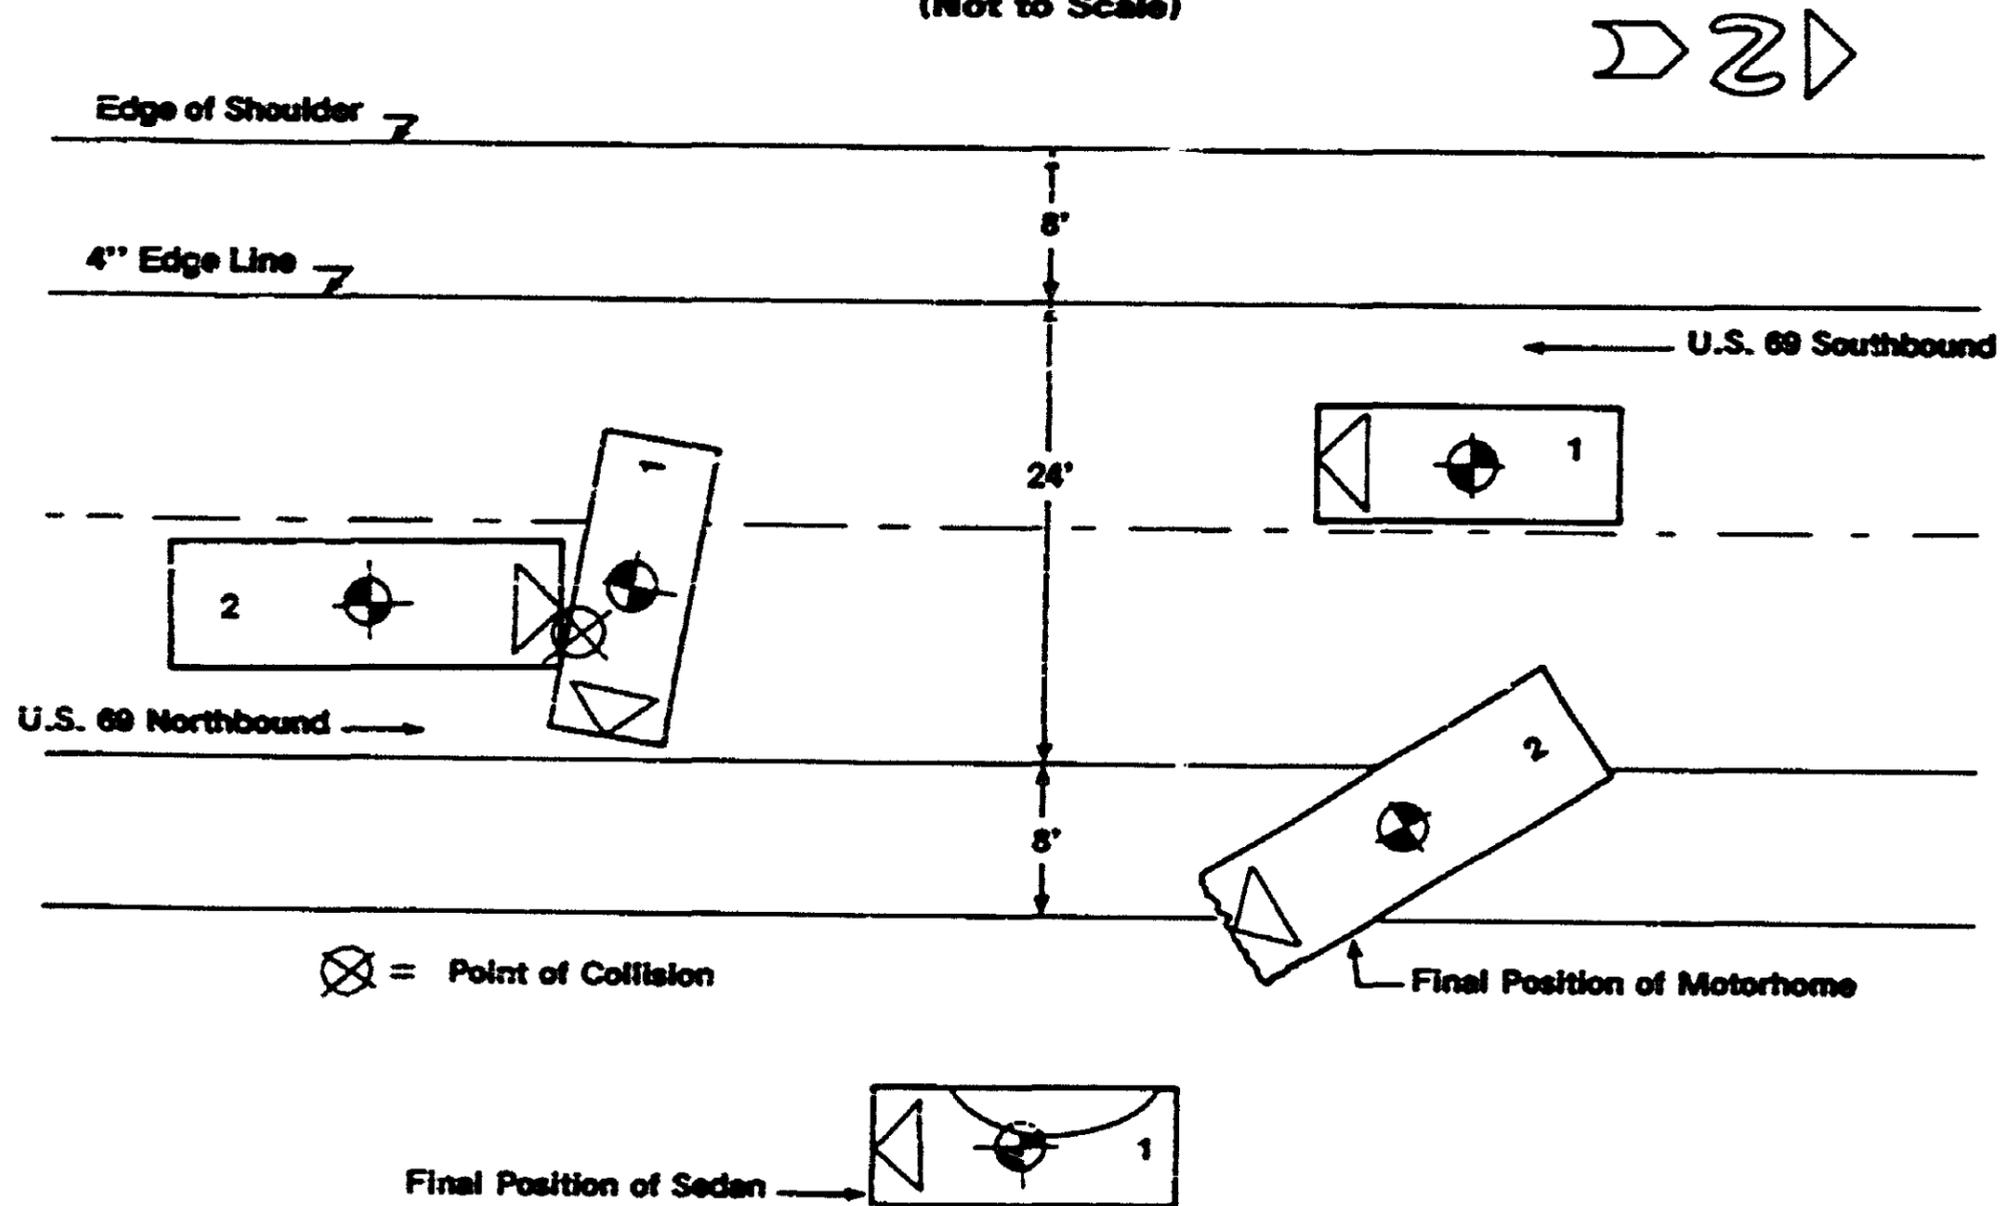
As the vehicles approached in a heavy rainfall and moderately strong winds, the sedan began to slide, rotated counterclockwise and crossed the centerline into the path of the motor home. Evidence indicated that the sedan's left and right front wheels crossed the centerline approximately 49 and 30 feet, respectively, north of the point of impact. There was no evidence to indicate that the motor home braked or skidded before impact although the driver did steer 2° to 5° to the right.

The front of the motor home struck and penetrated the right side of the sedan at a point 43 inches rearward of the front corner. Both vehicles immediately began to rotate clockwise toward the northeast. The sedan skidded sideways approximately 28 feet while rotating about 98° before coming to rest facing north on the east side slope of the highway. (See figure 1.) At the same time, the motor home rotated approximately 153°, slid approximately 57 feet, overturned onto its left side, and slid 4 feet before coming to rest facing southeast on the paved east shoulder of the road. Based on the physical evidence at the scene, it was calculated that the preimpact speed of the sedan was 37 mph and its impact speed was 33 mph. The preimpact and impact speed for the motor home were the same -- 45 mph. There were no immediate witnesses to the accident. A motorist 1/4 mile behind the motor home could only estimate the motor home's speed at 45 mph to 50 mph and verify that it was raining.

Figure 1. Diagram of collision between sedan (1) and motor home (2).

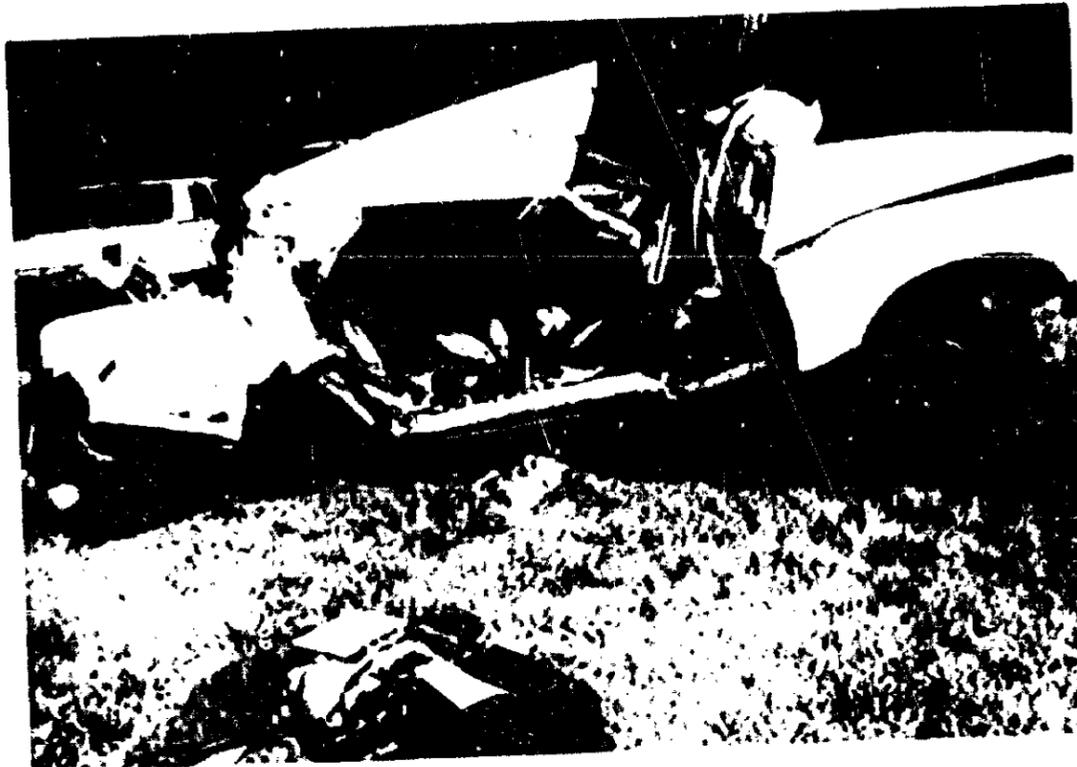
The two right-side doors were crushed inward to about the centerline of the vehicle. (See figure 4.) Some of the welds connecting the B-pillar and the right-front door hinges to the body failed at impact. The A, B, and C-pillars and the chassis frame rails were crushed laterally. The right-front corner of the roof and the top of the A-pillar were crushed to within 4 inches of the vehicle's centerline and the roof buckled upward. The front, rear, and side windows were broken. The vehicle's electrical system and engine could not be tested because of the crash damage.

Figure 4. Ford sedan, photographed from the right side.

The use of the available seatbelts by the occupants of the sedan would not have aided them in surviving the collision. Their major injuries were insured by the loss of cross-sectional integrity of the car body when the two right-side doors were crushed to the centerline of the vehicle and because the A and B pillars failed.

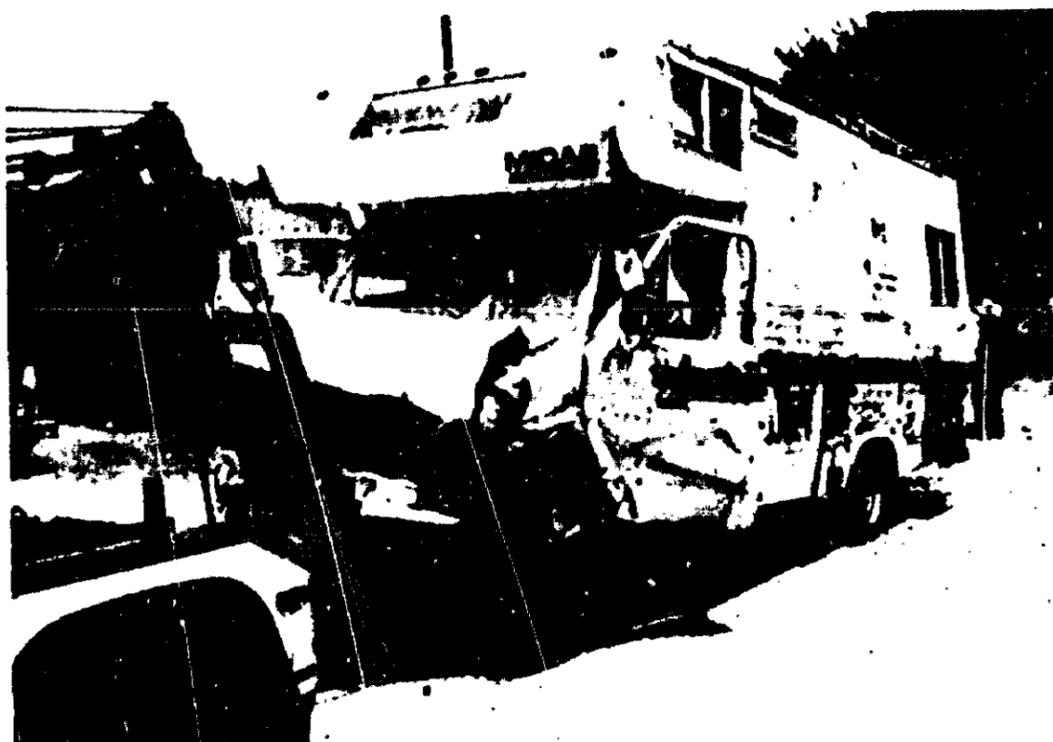
A postcrash inspection of the mechanical components of the motor home indicated that all of the tires had at least 4/32 inch of tread. All tires were inflated except for the left front which was flattened in the collision. The entire front of the motor home was compressed and pushed backward in an irregular pattern. (See figures 5 and 6.) The driver's door was open and pushed outward.

Figure 5. Midas Mini Motor Home, damaged cab and left-side door.

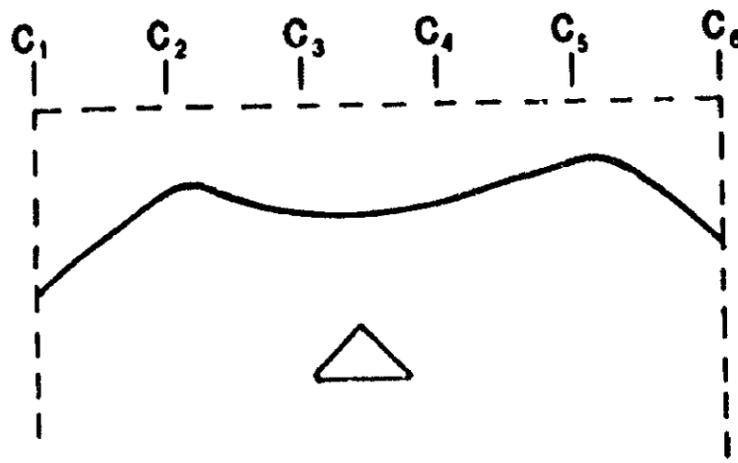
C <sub>1</sub> = 21.6''	C <sub>4</sub> = 10.8''
C <sub>2</sub> = 8.8''	C <sub>5</sub> = 6.8''
C <sub>3</sub> = 12.5''	C <sub>6</sub> = 16.3''

Figure 6. Motor home front end deformation diagram.

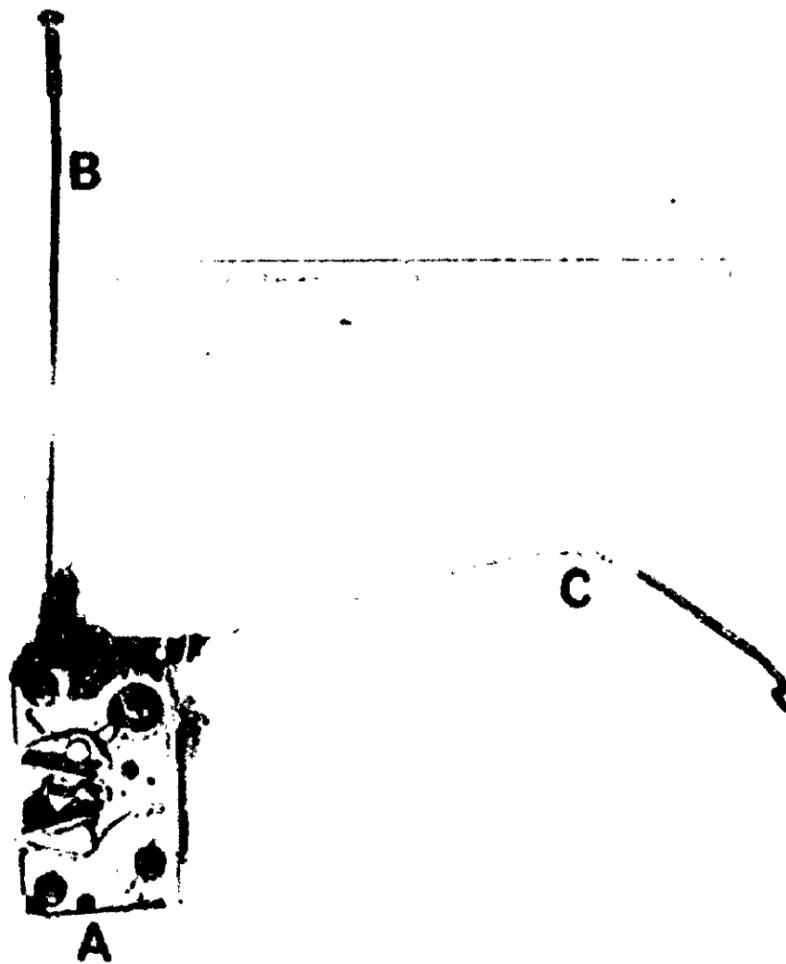
The left door's locking latch, manufactured by the Ford Motor Company, is typical of Ford automotive door latches. The striker enters the latch body and is captured in a slot formed by two rotating plates. Neither inspection nor operation of the door latch after the accident revealed any visible impairment of function. There was no obvious distortion of any part of the latch, except for the externally connected lever arm, which had a very slight twist. The actuating rod for the interior handle was bent and shortened by approximately 1 7/8 inches.

The original length of this rod was 12 3/4 inches and the distorted length was 10 7/8 inches. (See figure 7.)

Figure 7. Left door latch assembly from Midas Mini Motor Home.  
A. Latch assembly.  
B. Door lock control rod and knob.  
C. Link assembly door latch remote control rod.

The shortening of this rod through bowing produced the same action as moving the door handle to actuate the rod and open the latch. The latch opened and was held open permitting the door to open. While the motor home was rotating clockwise, the unlatched door was held closed by centrifugal force. As the motor home overturned onto its left side, the unrestrained driver fell against the unlatched door; the door opened and he fell through the partially open door of the motor home and was crushed.

Inspection and operation of the door latch mechanism by the NHTSA and Safety Board investigators found no impairment. There was no obvious distortion of any part of the latch, with the exception of the inner handle link assembly door latch remote control, which had been bent, shortening it approximately 1 7/8 inches.

"Inform its members of the details of the unwanted actuation of the door latch and encourage them to consider ways to prevent such failures in the manufacture of future door-latch assemblies. (Class I, Urgent Action) (H-78-18)"

Revise FMVSS 206 to require performance tests on door latch assemblies rather than the nondynamic, laboratory tests as described in the Society of Automotive Engineers' Recommended Practice, SAE J839b. (Class II, Priority Action) (H-78-15)

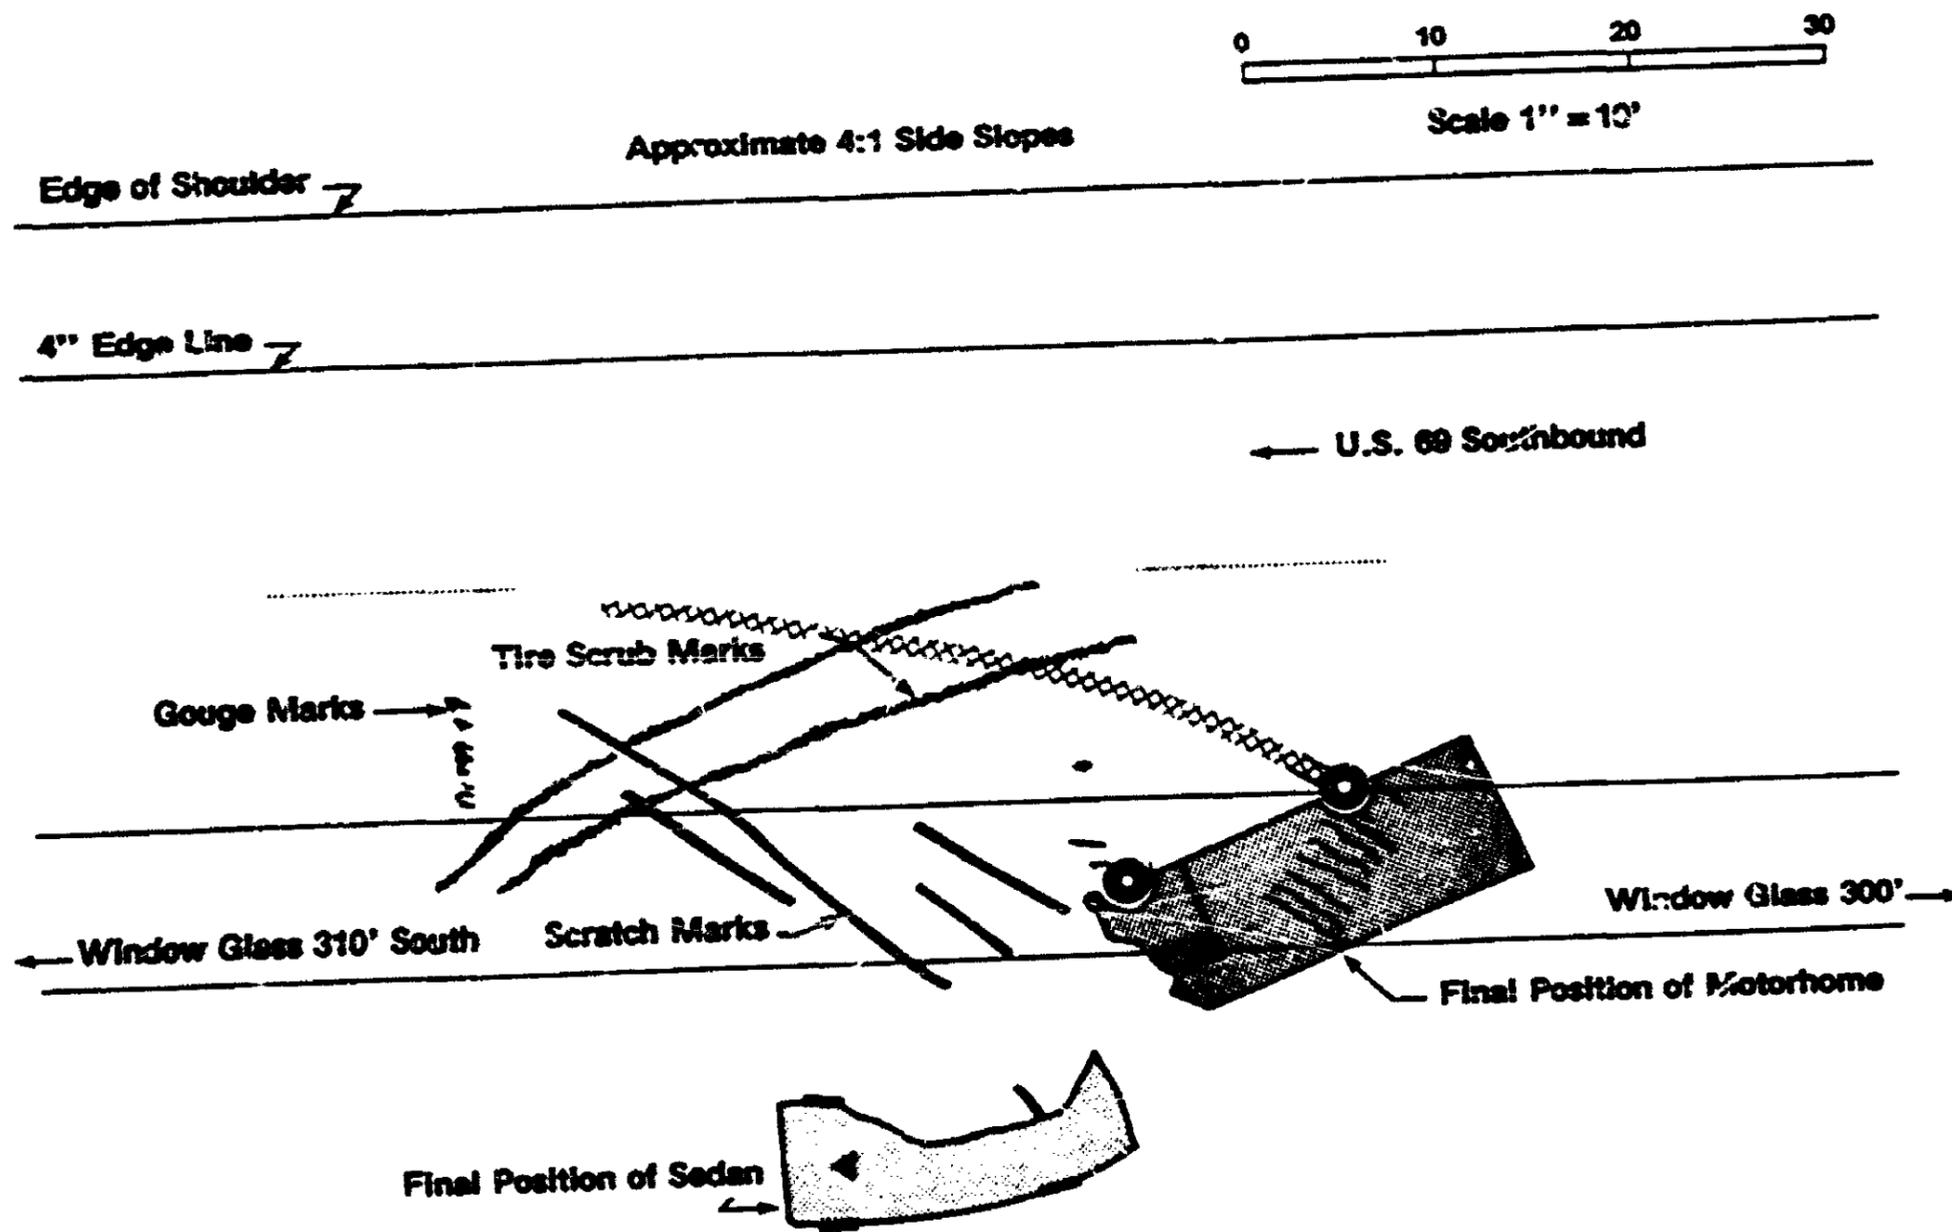
Figure 8. Postcrash diagram.

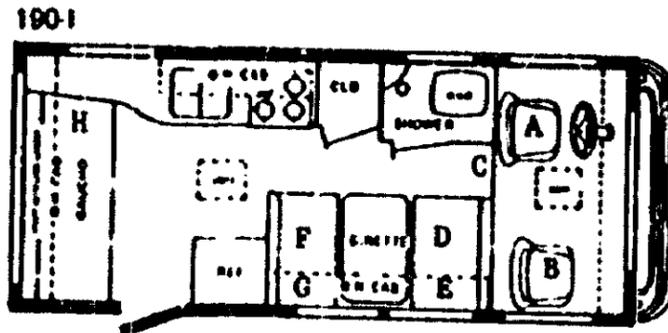
SEATED POSITIONS AND INJURIES OF  
OCCUPANTS OF HIDAS MINI MOTOR HOME

<u>Seated Position</u>	<u>Occupants</u>	<u>Injuries</u>
A. Driver	41-year-old male	respiratory failure due to multiple interthoracic injuries also had scalp lacerations

B. Right front	12-year-old female	skull and cerebral injuries (AIS-6) <sup>1/</sup>
C. Kneeling behind and between A and B	31-year-old female	head concussion with loss consciousness and laceration on left leg (AIS-?)

D. Left forward table seat facing to the rear	5-year-old female	fractured distal left tibia (AIS-?)
E. Right forward table seat facing to the rear	9-year-old female	laceration to left wrist (AIS-2)

F. Left rear table seat facing forward	65-year-old female	left arm contusion, distention of abdomen, fracture right femur and lacerations (AIS-2)
G. Right rear table seat facing forward	55-year-old male	fractured left right finger, spinal injury, puncture wound right arm, laceration of chin (AIS-2)

H. Rear benchseat	27-year-old male	fractured mandible, 2-inch scalp laceration, and avulsion of several teeth (AIS-2)
