HIGHWAY ACCIDENT REPORT

KOHLER COMPANY
TRACTOR-SEMITRAILER/PICKUP TRUCK
COLLISION, N.C. ROUTE 228
NEAR MARION, NORTH CAROLINA
JANUARY 25, 1978

1. Report No. NTSB-HAR-78-6	2. Government Accession No.	3. Recipient's Catalog No.	
4. Title and Subtitle Highway Accident Report - Kohler Company Tractor-Semitrailer/Pickup Truck Collision, N.C. Route 226, Near Marion, North Carolina, January 25, 1978		5. Report Date September 21, 1978

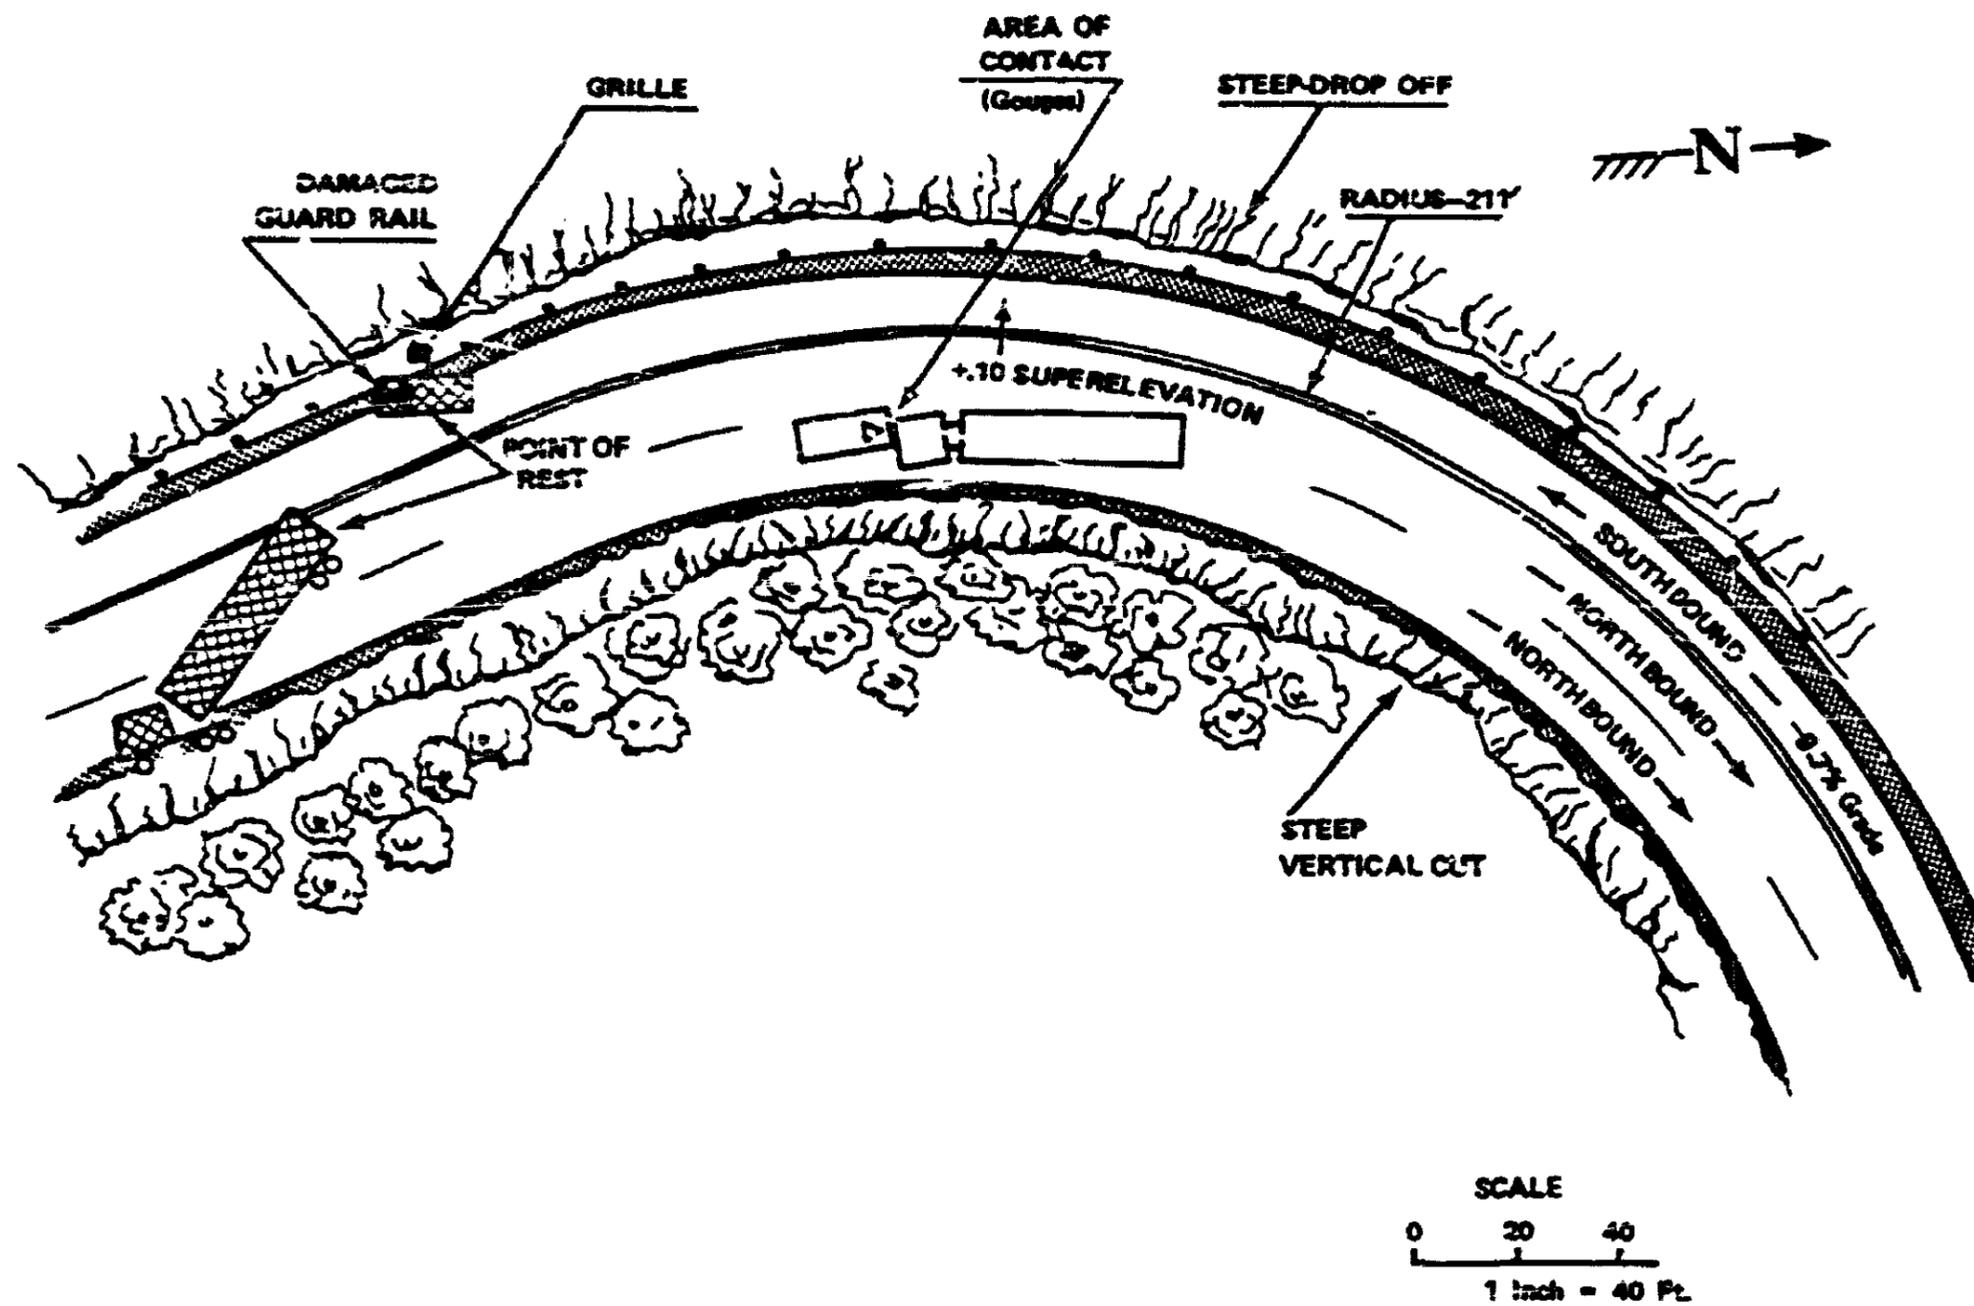
About 10:00 a.m., after the truck had traveled about 10 miles, it began to descend a 4-mile-long, steep winding grade on North Carolina Route 226, near Marion, North Carolina. The driver stated that he began descending the grade at 20 to 25 mph. After driving through the first few curves, he looked through his rearview mirror and noticed that the trailer brakes were smoking. He tried to slow the vehicle and intended to pull off the road, but the brakes were not effective, and the truck began to accelerate. The driver stated that, since he knew he could not make it all the way down the grade, and he did not want to drive off the ledge down a steep embankment on the right, he steered to the left across the centerline into the northbound lanes. He intended to stop the truck by scraping it against the steep vertical cut on the east side of the road. At this point, the truck had descended 1.1 mile of the hill and was traveling 35 to 40 mph. After the truckdriver steered across the centerline and into the northbound lane, it collided head on with a pickup truck. Neither driver could see the other's vehicle, because each approached the other at a 211-ft radius, blind curve.

After colliding with the pickup, the tractor struck the steep vertical cut on the east side of the road, and the tractor and trailer turned over onto the right side and came to rest on the roadway. The pickup truck rotated clockwise 185° and was driven back 85 ft in a southwesterly direction. There it struck and came to rest against the guardrail on the west side of the road. (See figure 1.) A passenger in the pickup truck was killed; both drivers and a second passenger of the pickup truck were injured.

Figure 1. Diagram of accident.
 Vehicle positions are approximate.
