HIGHWAY ACCIDENT REPORT

**OSTERKAMP TRUCKING, INC.,
TRUCK/FULL TRAILER AND
DODGE VAN COLLISION, U.S. 91
NEAR SCIPIO, UTAH**

AUGUST 26, 1977

1. Report No. NTSB-HAR-79-1	2. Government Accession No.	3. Report Number PB293501
4. Title and Subtitle Highway Accident Report - Caterkamp Trucking Inc., Truck/Full Trailer and Dodge Van Collision, U.S. 91, near Scipio, Utah, August 26, 1977	5. Report Date February 22, 1979

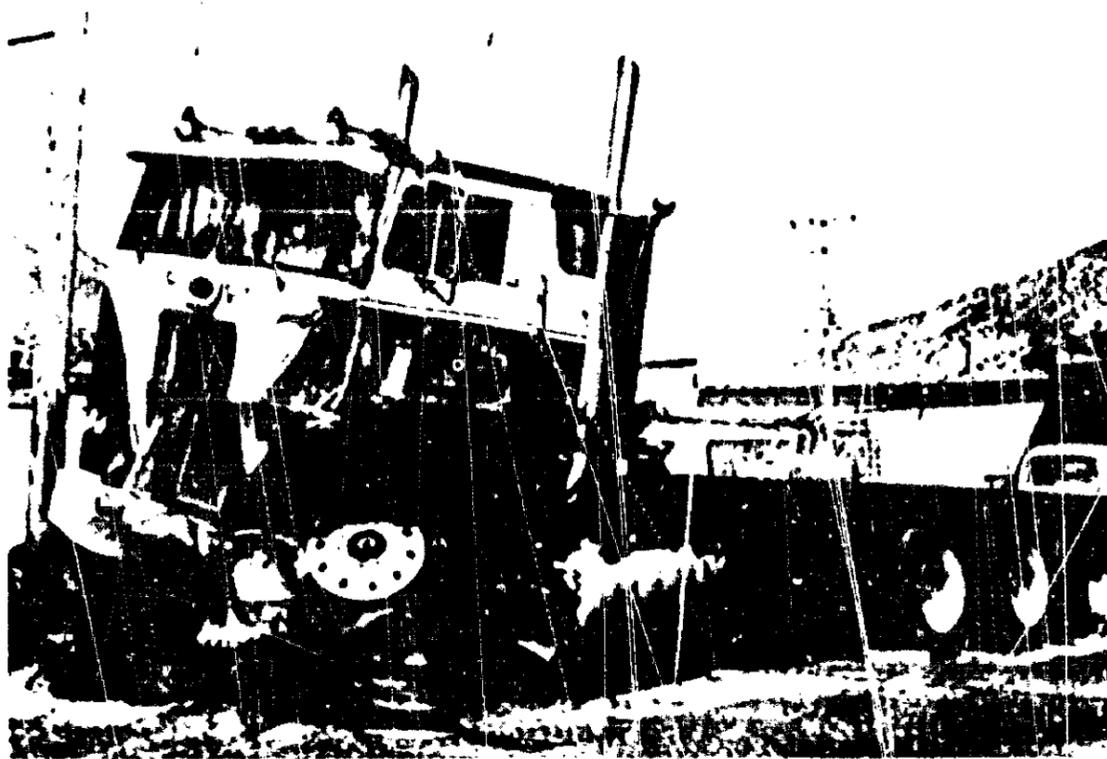
Major impact damage was to the left front corner of the truck (see figure 2) and front of the van (see figure 3).

Figure 2. Damage to the truck.

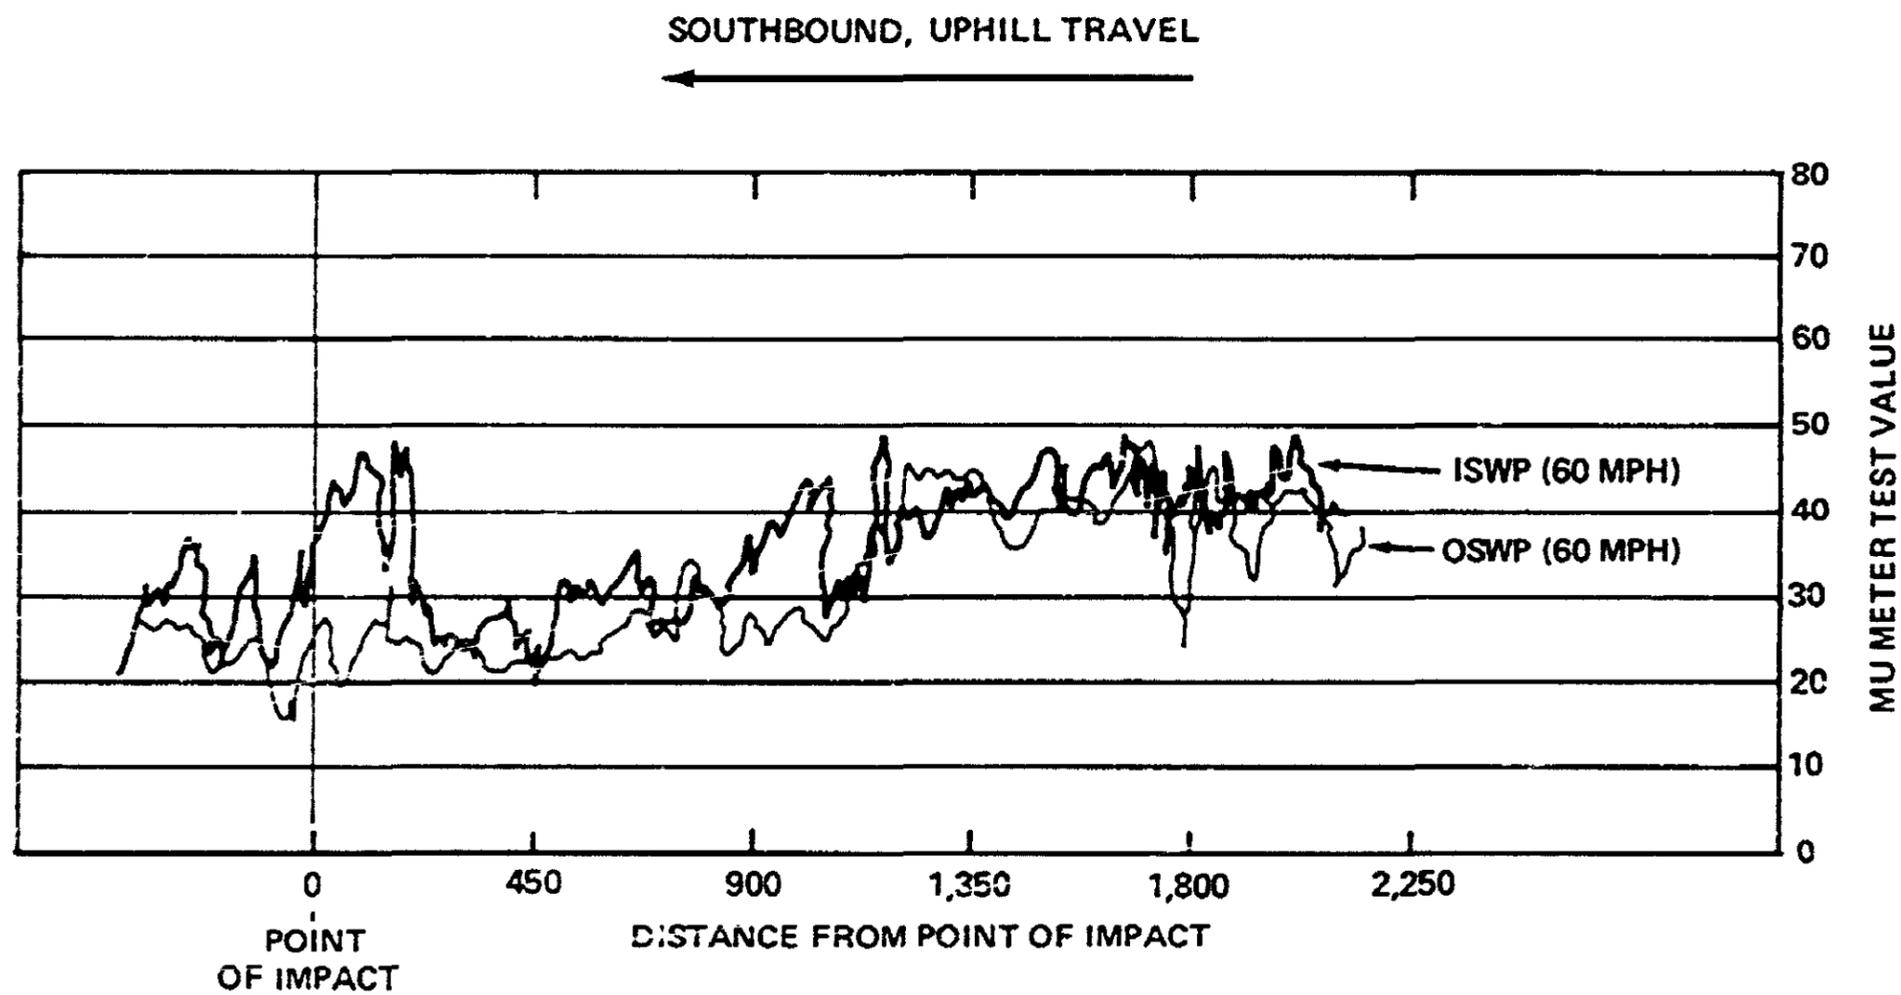
Figure 5. Mu Meter skid numbers for the inside and outside wheel paths of the southbound lane as measured on October 18, 1977.

Nonstandard Mu meter tests were also conducted on the southbound inside and outside wheel paths at test speeds of 60 mph. A continuous Mu number record for these tests (see figure 5, page 7) demonstrated that the frictional quality became progressively lower as the Mu meter trailer climbed the grade. Also, an alternating pattern of a wide departure in friction values between the two wheel paths followed by a merging of these values began about 1,000 feet before impact. This progressively decreasing and split coefficient of friction condition was suspected to have even more capability to impair vehicle stability. Theoretically, as a result of this pattern, the tires of a vehicle on the outside wheel path could alternately lose and regain traction in relation to the tires along the inside wheel path. However, this possibility could not be fully evaluated through an examination of existing research.
