NATIONAL TRANSPORTATION SAFETY BOARD

HIGHWAY ACCIDENT REPORT

OVERTURN OF A
YPSILANTI, MICHIGAN, BOYS CLUB BUS,
ON I-75, NEAR TIFTON, GEORGIA
APRIL 11, 1978

1. Report No. NHSB-HAR-79-2	2. Government Accession No.	3. Report Number PB294004	
4. Title and Subtitle Highway Accident Report - Overturn of a Ypsilanti, Michigan, Boys Club Bus, I-75, Near Tifton, Georgia, April 11, 1978.		5. Report Date March 8, 1979	6. Performing Organization Code

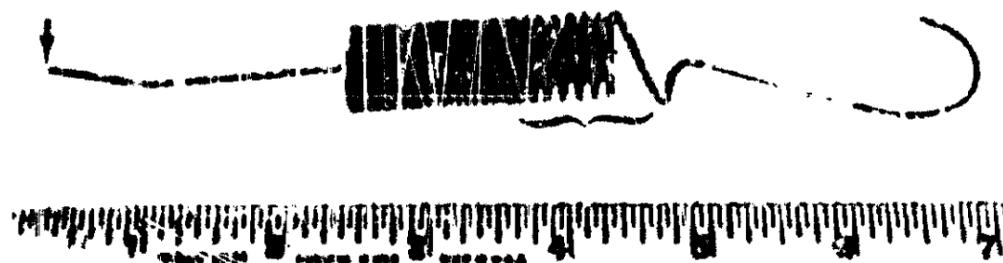
Figure 12. Overall view of the carburetor return spring. Arrow locates fracture and bracket denotes extended coils.

Accelerator return spring. -- The National Transportation Safety Board's Metallurgical Laboratory analyzed the fractured accelerator return spring. The analysis indicated that the spring had fractured transversely in an area used for the attachment of one end. (See figure 12.) This area appeared to be where the spring wire began to bend, forming a hook similar to that on the other end. (See figure 13.)

Analysis of the fractured spring indicates that the complete fracture was imminent on continuing fatigue cycles and probably failed as a result of fatigue stresses. The primary stress promoting the fatigue was bending or tension, or both, produced during extension of the spring. Extension of some of the coils suggest that the spring was manually stretched.
