NATIONAL TRANSPORTATION SAFETY BOARD

HIGHWAY ACCIDENT REPORT

OVERTURN OF
ROSS AMBULANCE SERVICE AMBULANCE
STATE ROUTE 116
LITTLETON, NEW HAMPSHIRE
AUGUST 22, 1978

ROSS AMBULANCE SERVICE
AMBULANCE OVERTURN
STATE ROUTE 116
LITTLETON, NEW HAMPSHIRE
AUGUST 22, 1978

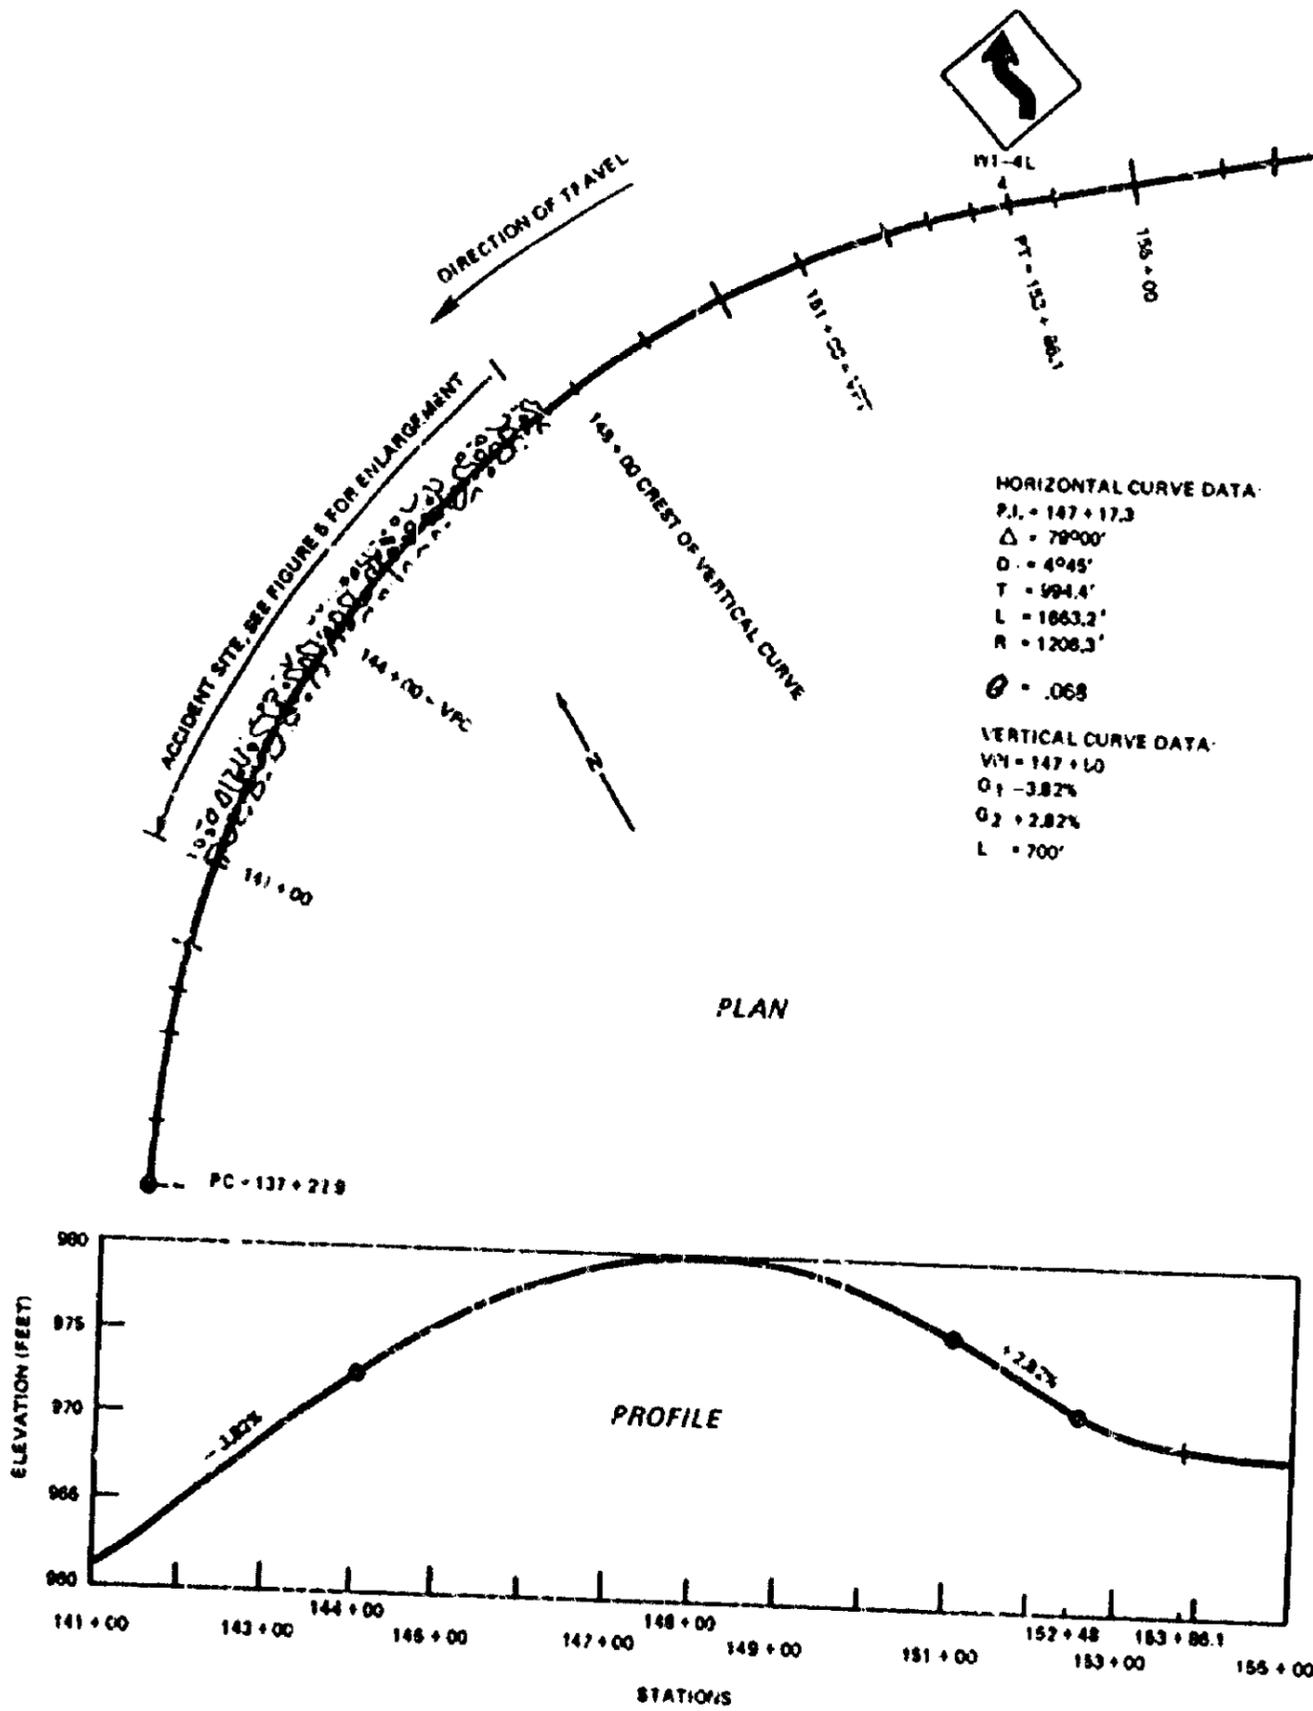
The posted speed limit was 50 mph. A reverse curve warning sign was located at the beginning of the horizontal curve. (See figure 4.) The horizontal alignment at the accident site was a 1,206-foot radius curve, 1,663 feet in length. It curved to the left in the direction of travel of the ambulance. The superelevation throughout the accident site averaged 0.049 ft/ft for both lanes of traffic. Superimposed over a portion of the horizontal curve was a 700-foot-long vertical curve. In the westbound direction it connected a 2.82 percent upgrade to a 3.82 percent downgrade. It was estimated that the coefficient of friction for the dry pavement was 0.70. (See figure 4.)

Figure 4. Alignment, profile and signing of New Hampshire Route 116 at accident site.

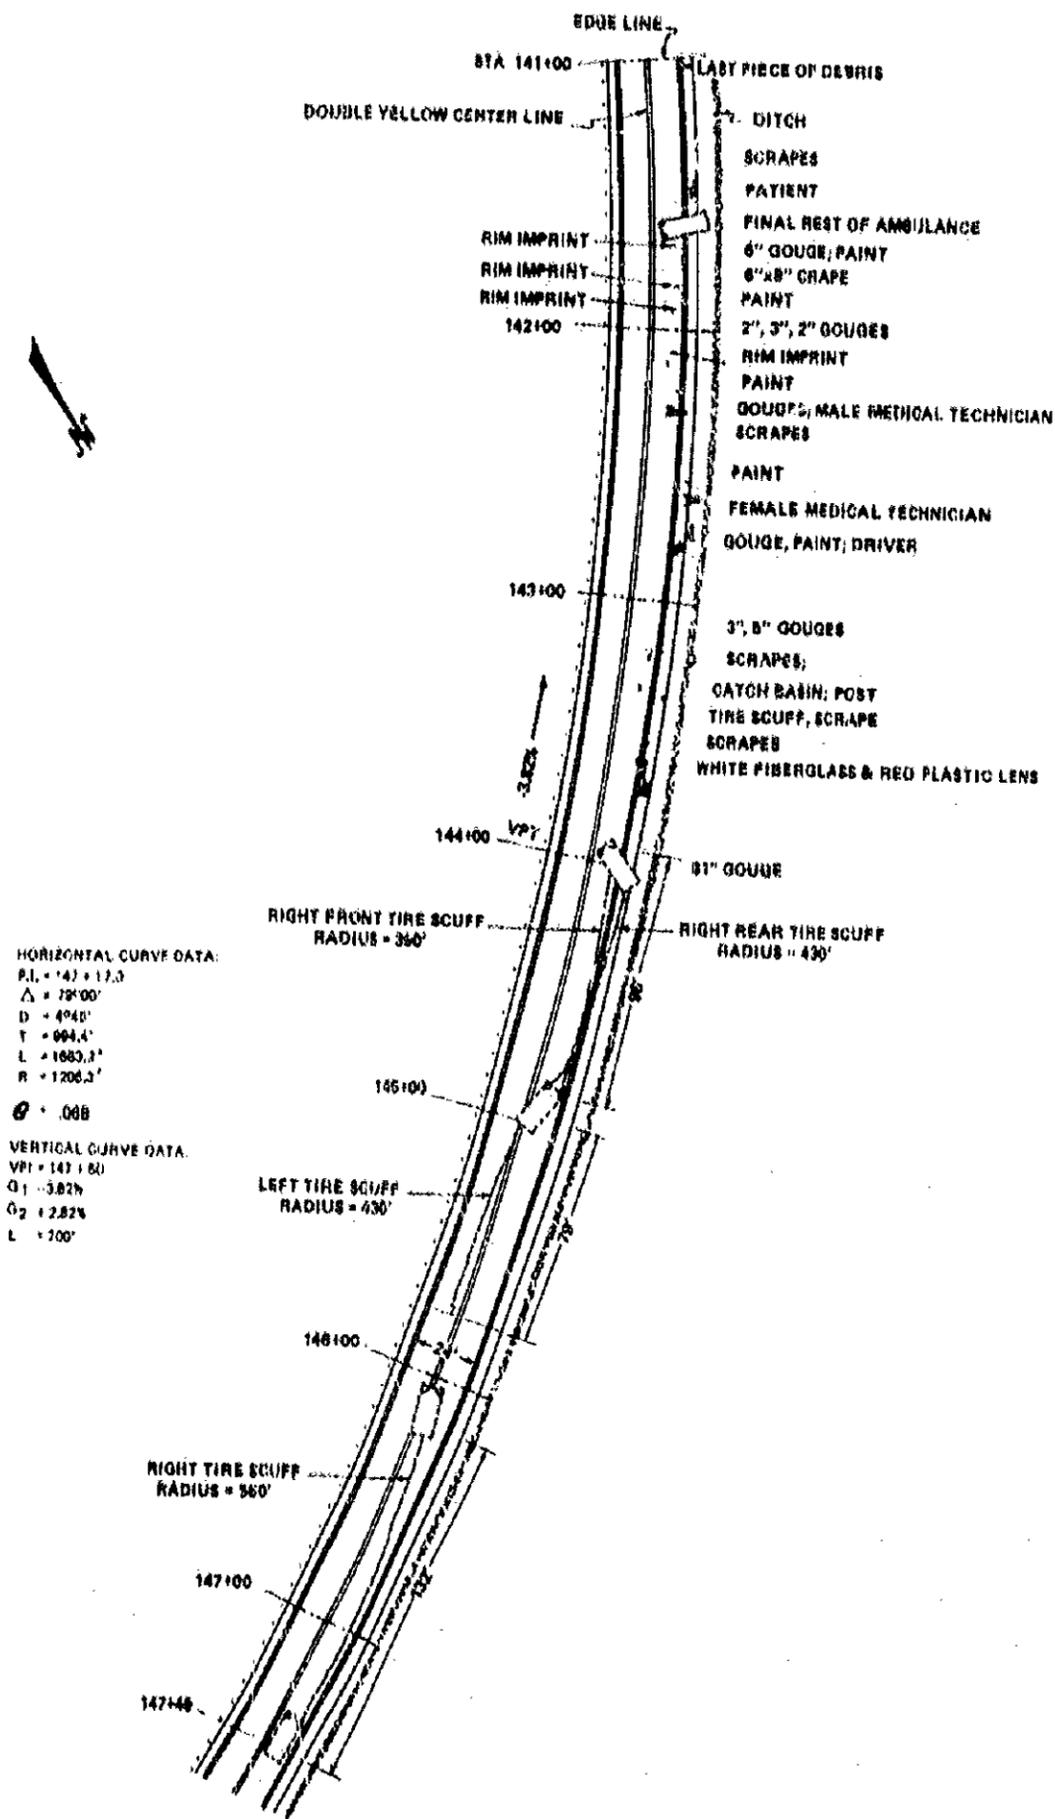
leftward turning tire scuff was 550 feet. (See figure 5.) After a gap of 41 feet, a single, rightward-curving tire scuff mark began in the eastbound lane. It continued for 79 feet at a radius of 430 feet. It ended in the westbound lane. After another gap of 11 feet, two tire scuff marks began in the westbound lane, with narrow cross striations. The striations increased in width to their end, or 96 feet from their beginning. The radii of the leftward-turning tire scuff marks were 430 feet and 390 feet, respectively. The last 8 feet of one scuff mark contained a deep, 81-inch-long gouge. The gouge was 4 inches wide at its widest point.

Figure 5. Wreckage distribution, tire marks, and horizontal alignment at accident site.

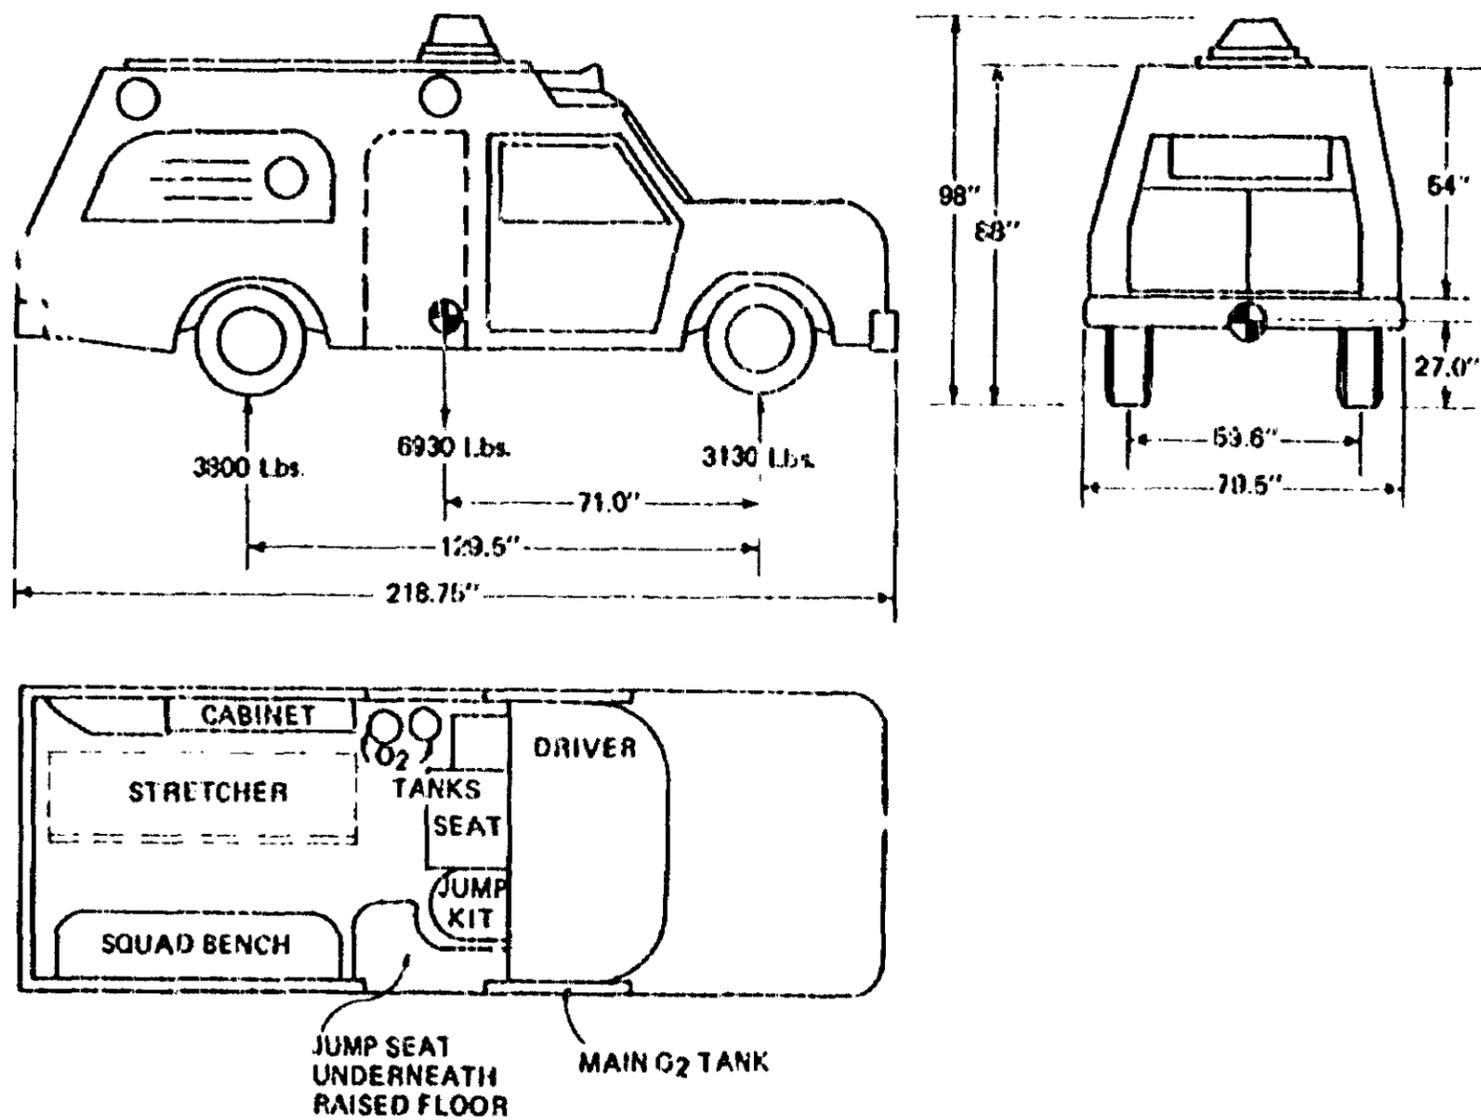
To calculate the critical cornering speed of the ambulance, it was necessary to determine its center of gravity. Because of the severe deformation of the accident vehicle, measurements were made of a similar vehicle, a 1975 Chevrolet Suburban Van, VIN CCY165F171485 which also had been modified by Yankee Coach, Inc., substantially in the same manner as the ambulance. It was calculated that the center of gravity of this vehicle was 71 inches to the rear of the front axle and 27 inches above the ground level. These calculations suggested that the modification moved the center of gravity rearward 6 inches without raising it significantly. (See figure 6.)

Figure 6. Drawing of a Suburban Custom 10 van conversion showing dimensions.
