# NATIONAL TRANSPORTATION SAFETY BOARD

## HIGHWAY ACCIDENT REPORT

STATIONWAGON PENETRATION OF  
BRIDGERAIL, I-10  
NEAR ALHAMBRA, CALIFORNIA  
NOVEMBER 11, 1978

NTSB-HAR-79-5

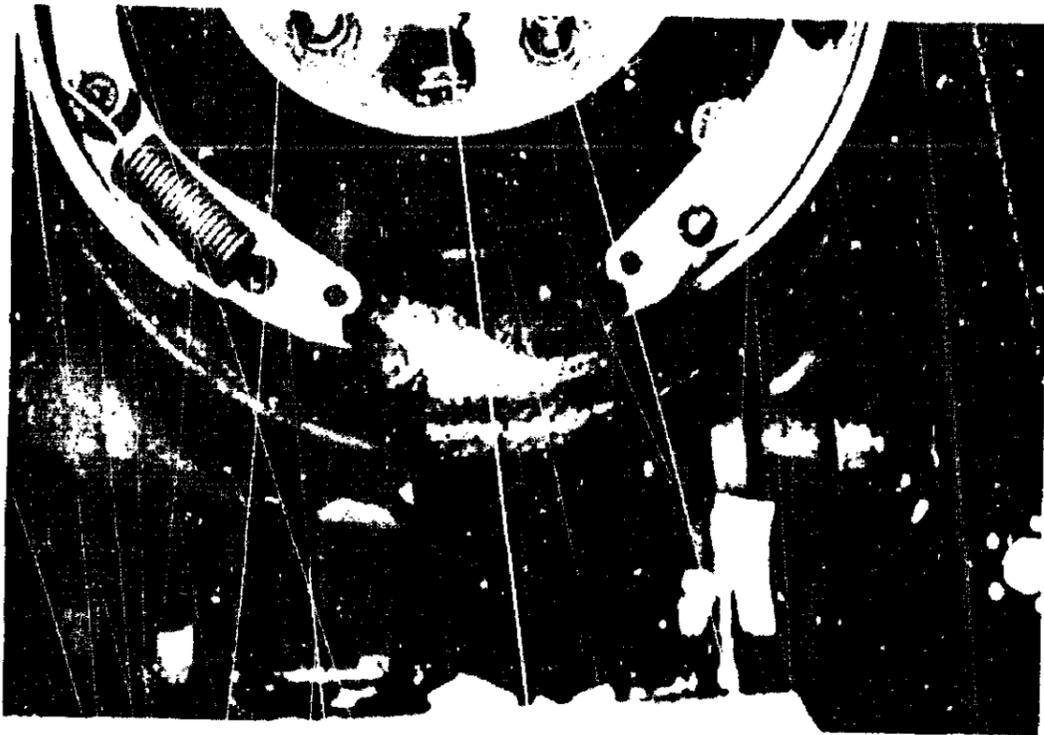
2. The star wheel brake-adjusting assembly and self-adjusting linkage at the left-rear wheel was disconnected and lying loose inside the brake drum. (See figures 2 and 3.) The brake drum was scored.
3. The hydraulic brake system trouble warning light was disconnected.
4. The mechanical parking brake was out of adjustment and provided no braking torque to the rear wheels.
5. Two adjacent tread grooves on each rear tire were less than 1/32 inch in depth. <sup>2/</sup> The remaining four tread grooves on the right rear tire were between 5/32 and 6/32 inch in depth and the four remaining grooves on the left rear were between 2/32 and 6/32 inch.
6. Tire air pressure at the left rear wheel, which was the only tire that remained inflated, was 20 psi. The pressure recommended by the manufacturer for the rear tires was 32 psi.

Figure 2. View of lower section of left rear wheel brakes showing absence of brake adjustment mechanism.

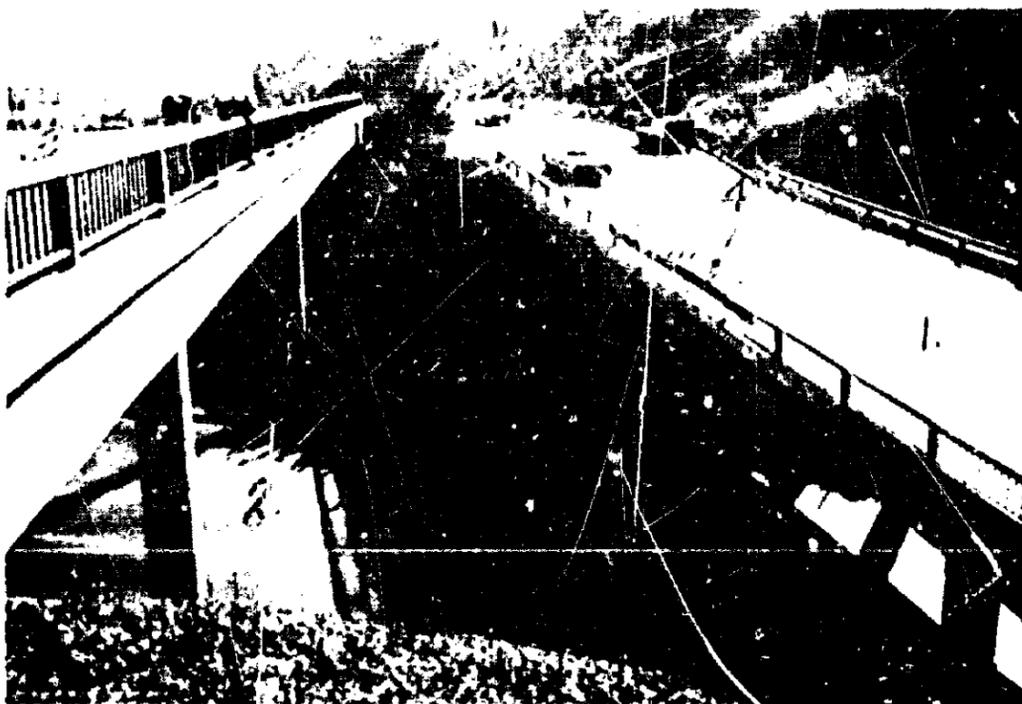
Figure 8. Southbound view of crash site.

1. Ramona Boulevard Bridge Overpass.
2. Ramona Boulevard.
3. Route 7 (Long Beach Freeway).
4. Temporary barrier where stationwagon crashed through bridge railing.

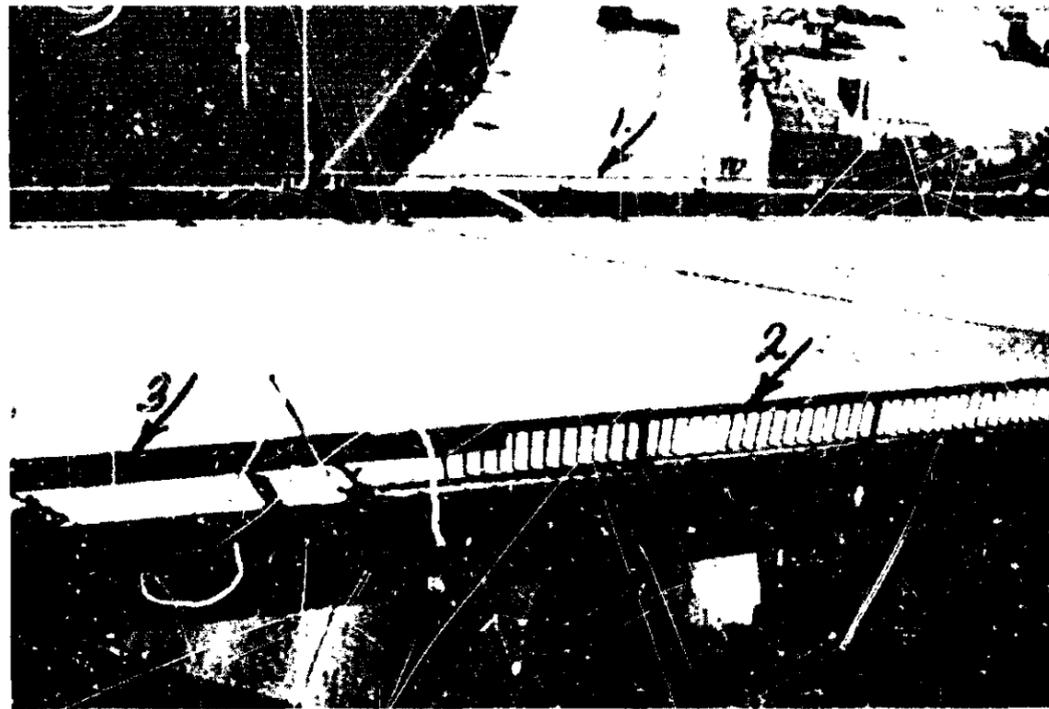
The bridge overpass is elevated 22 feet above Ramona Boulevard and has a 6 percent grade. It is bordered on the left by a 9-inch concrete curb and a steel, panel-type bridgerail, and on the right by a California type-9 barrier rail. (See figures 9 and 10.) Originally both sides of the overpass had concrete curbing and the steel, panel-type bridgerail; but in 1973 when the overpass was widened 11 feet on the right, the right-side curbing and bridgerail were removed and replaced with the California type-9 barrier rail.

Figure 9. Ramona Boulevard Overpass  
Arrow 1 - California Type-9 Barrier Rail.  
Arrow 2 - Panel-Type Bridgerail.  
Arrow 3 - Temporary barrier where stationwagon  
crashed through bridgerail.

"Establish a policy and program consistent with Federal Highway Administration guidelines and safety standards that will provide for upgrading substandard bridgerailing that has been crash-damaged. (Class II, Priority Action) (H-79-37)

"Establish a program to retrofit, on a priority basis, bridgerailing that does not meet Federal performance guidelines, which provide that bridgerailings be designed to minimize severity of impact, retain the vehicle, redirect the vehicle so that it will move parallel to the roadway, and minimize danger to traffic below. (Class II, Priority Action) (H-79-39)"

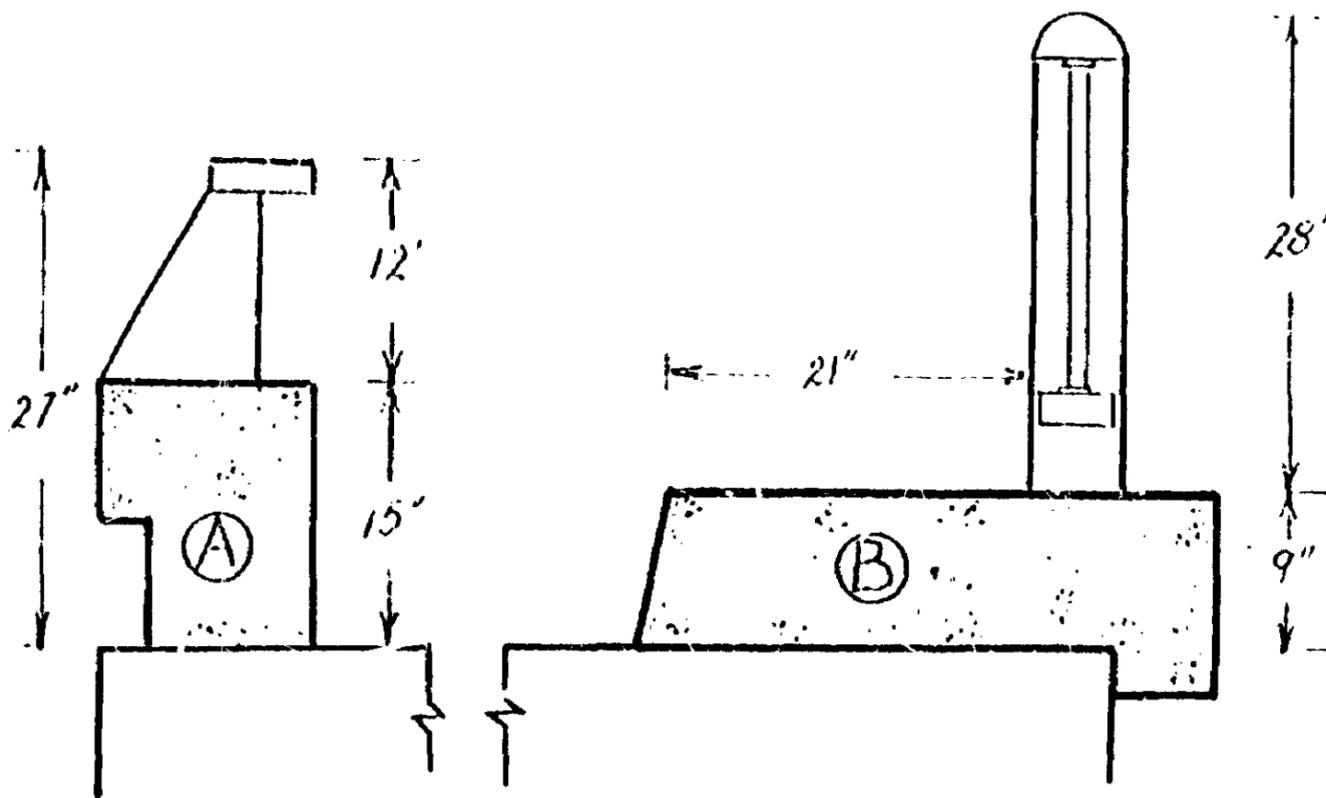
Figure 10. A - California "Type-9" Barrier Rail  
B - Panel-Type Bridgerail.

In a report sponsored by the FHWA, <sup>9/</sup> bridgerailing similar to that used at the accident site was cited as "...older bridgerailing installations that do not perform satisfactorily..." A photograph of an accident scene where a vehicle crashed through panel-type bridgerail and had landed on the roadway below was used as an illustration. A chart in this publication rated panel-type bridgerail as "P" for poor.

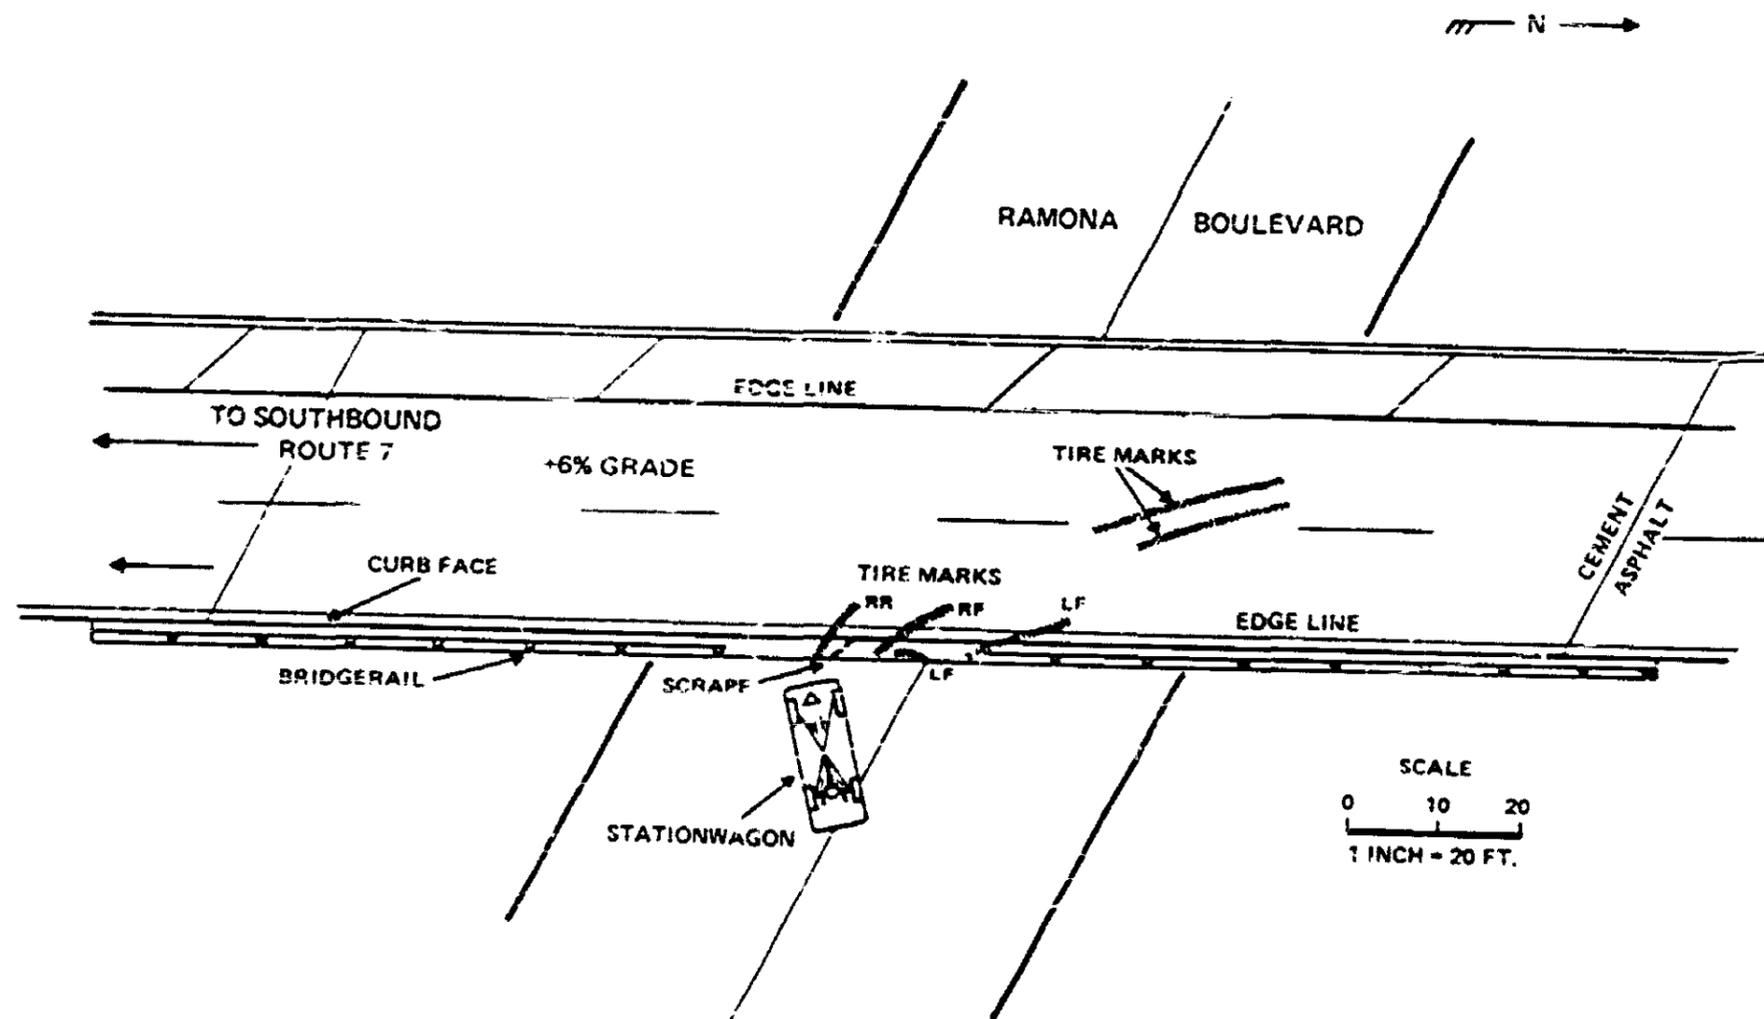
Figure 11. Accident scene diagram.

When the stationwagon struck the bridgerail, three bridgerail posts and three 10-foot sections of bridgerail were torn out. Tire scuff marks attributed to the stationwagon were found on the roadway, on the curb facing, and on top of the curb. (See figure 11.) Other tire marks and paint transfers not related to this crash were evident on both sides of the bridge overpass.

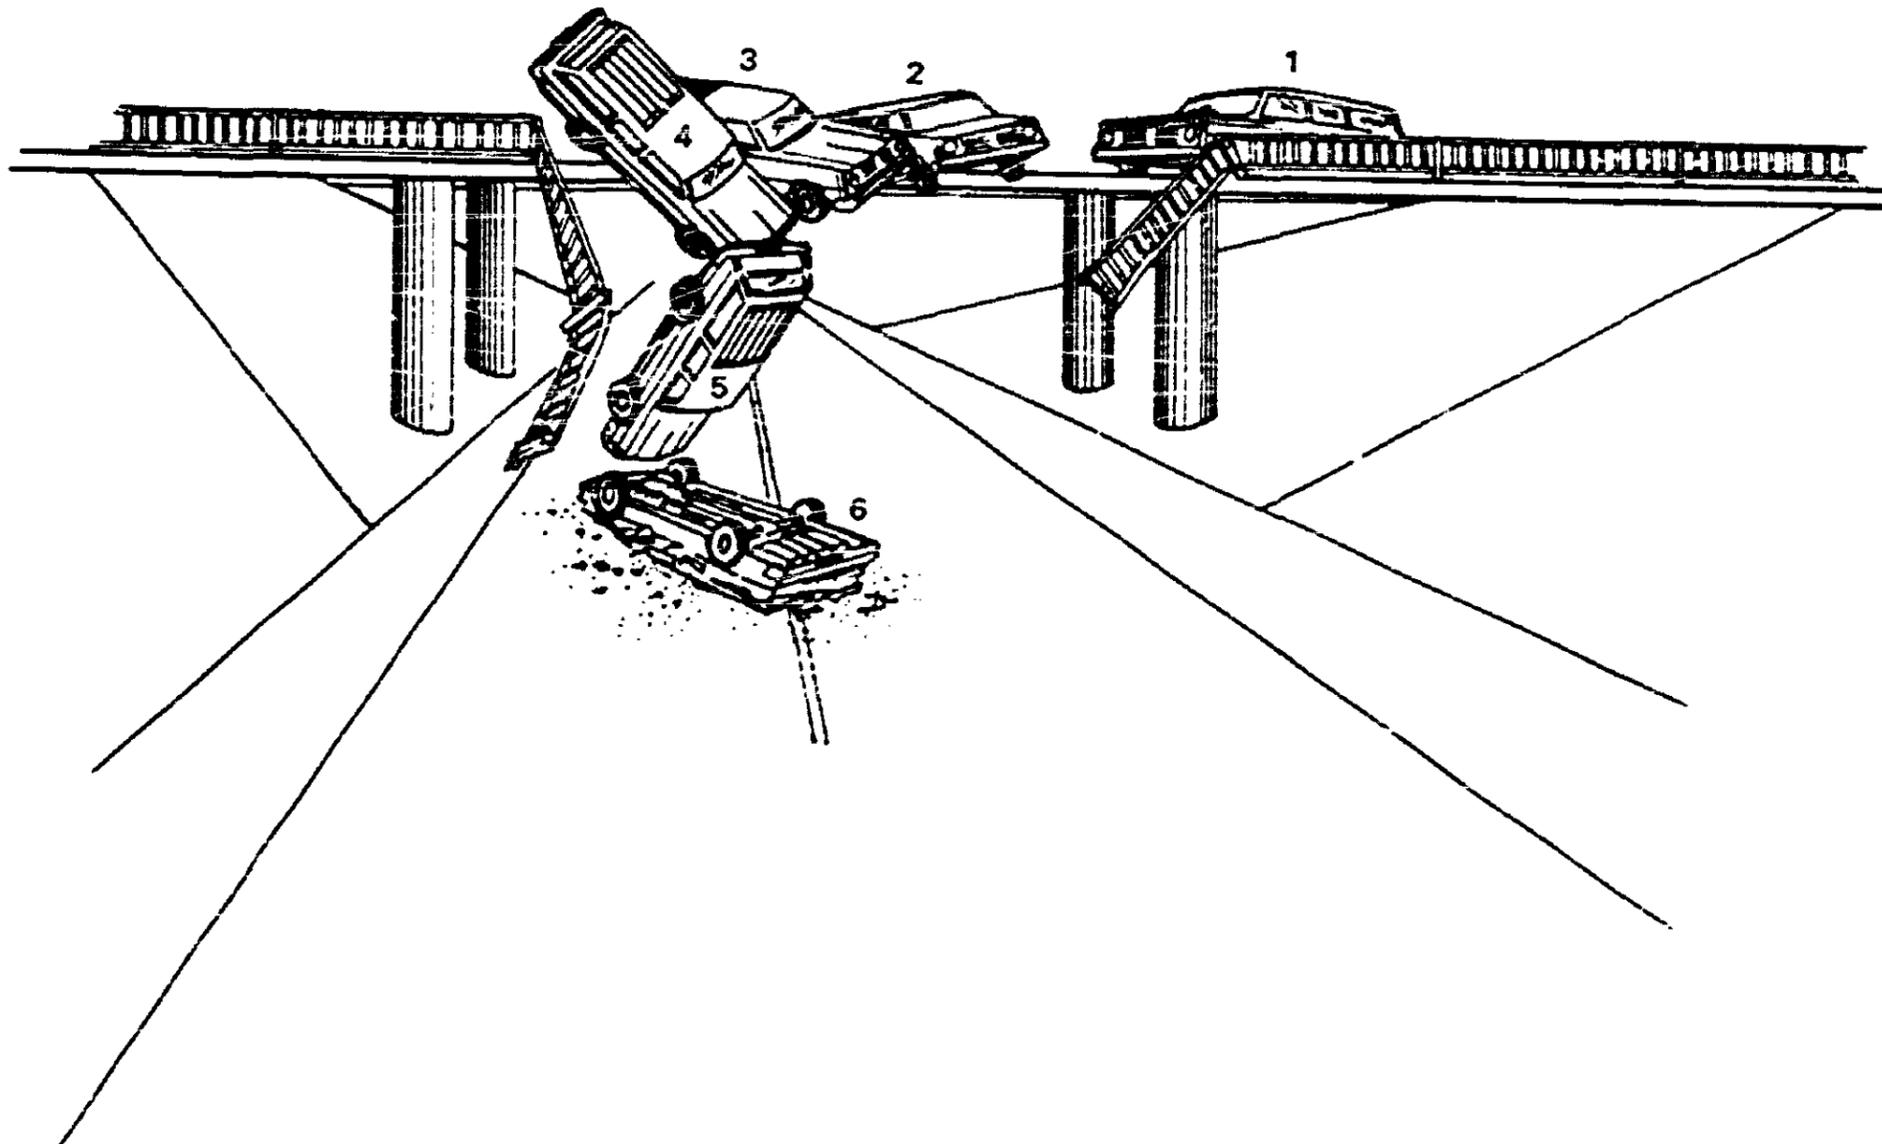
before breaking away "snagged" the vehicle when the post became embedded against the front edge of the lower control arm of the right-front wheel, which is between the chassis frame and the right-front wheel. The already counterclockwise rotation of the stationwagon, which began with the initial contact between the left front and the bridgerail was accelerated as it pivoted about 90° on that post and crashed through two more sections of bridgerail before falling 22 feet to the roadway below. An approximation of the rotation, pitch, and roll sequence of the stationwagon as it crashed through the bridgerail and fell to the roadway below is illustrated in figure 12.

Figure 12. Estimate of vehicle attitude during the crash sequence from  
(1) initial contact with bridge rail, to (6) place of final rest.
