**NATIONAL
TRANSPORTATION
SAFETY
BOARD**

HIGHWAY ACCIDENT REPORT

LOPD COURIER PICKUP TRUCK
FIXED OBJECT COLLISION
PATUXENT ROAD
NEAR CROFTON, MARYLAND
APRIL 23 1979

1. Report No. NTSB-HAR-79-6		2. Government Accession No.		3. Report Number PH 300545	
4. Title and Subtitle Highway Accident Report - Ford Courier Pickup Truck, Fixed-Object Collision, Patuxent Road near Crofton, Maryland, April 23, 1979				5. Report Date September 6, 1979

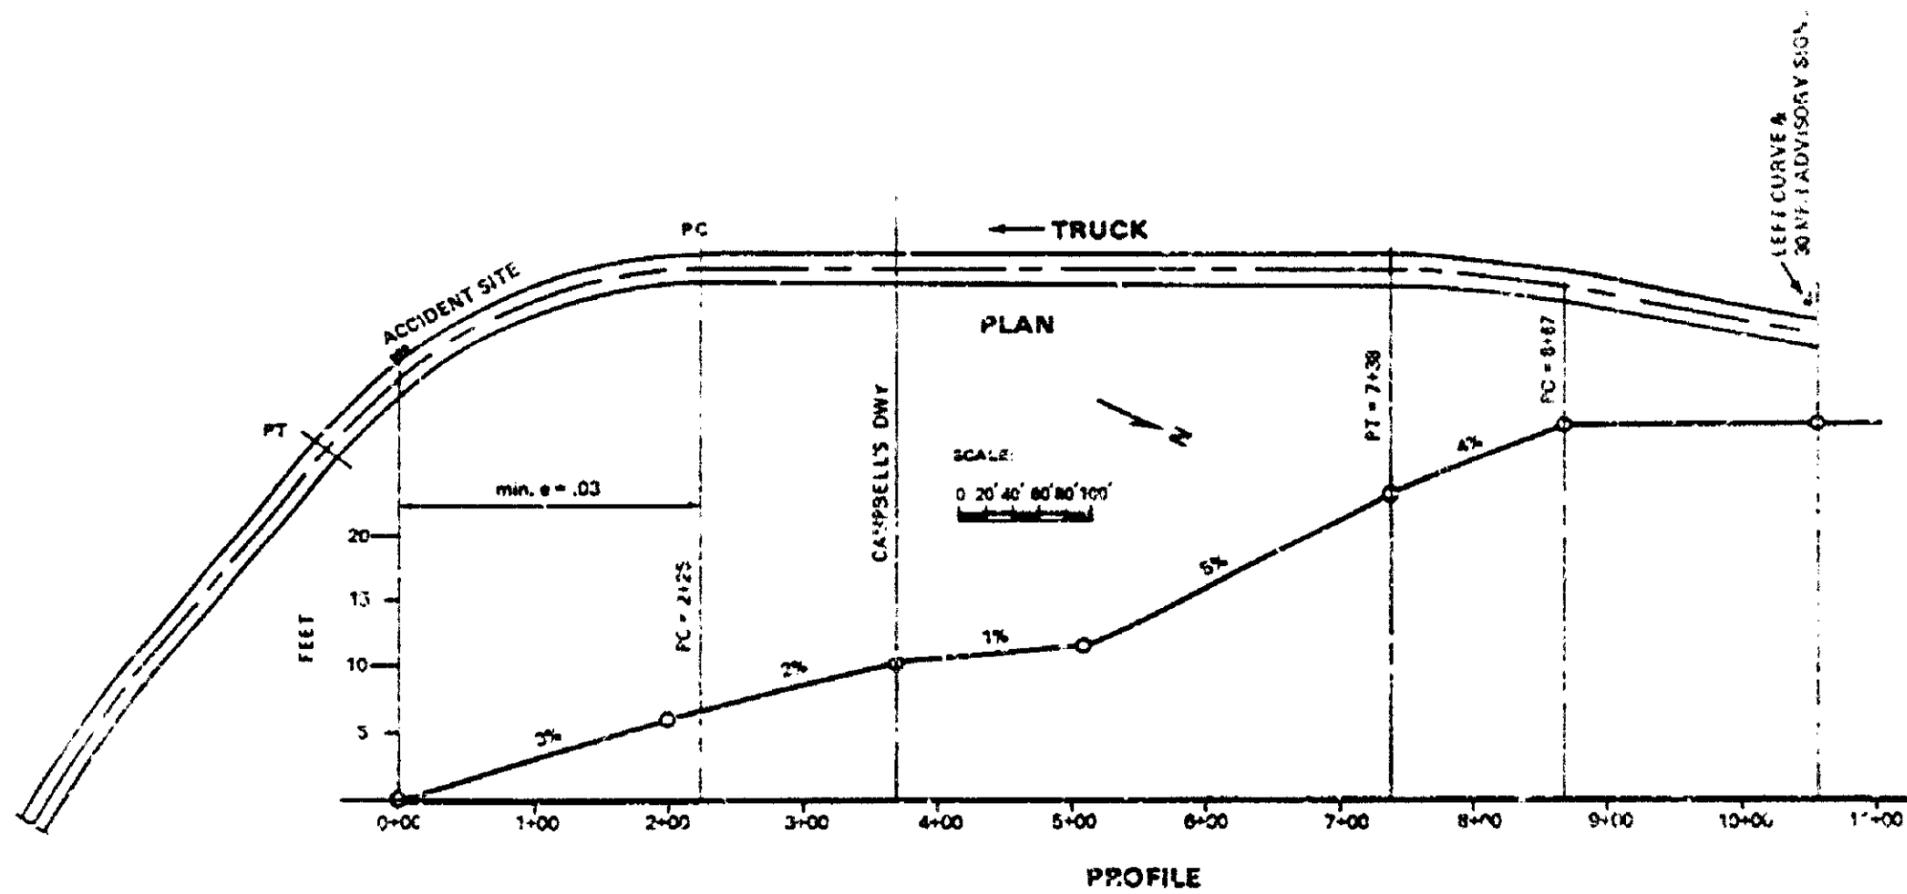
Figure 3. Plan and Profile of Accident Site.

The curve on which the accident occurred has a radius of 350 feet and an average superelevation of about 0.035 feet/foot where the truck left the scuff marks. In 1977, the road had been resurfaced with asphalt. The pavement was 22 feet wide and the highway right-of-way was 39 feet wide, leaving a 4-foot-wide area on each side of the road for highway use. A dirt shoulder/drainage ditch was located in this area and trees and utility poles bordered the right-of-way; there were no street lights. The reflectorized white edgelines were in good condition and located 1 foot from the edge of the pavement, thereby providing 10-foot-wide lanes. The double yellow centerline was in poor condition throughout the curve. (See Figure 4.)
