Highway Accident Report: Cross-Median,
Multiple-Vehicle Collision and Fire,
State Route 2, Near Cleveland, Ohio, May 6, 1979

1. Report No. NTSB-HAR-79-7		2. Government Accession No.		3. Publication No. PB300914	
4. Title and Subtitle Highway Accident Report — Multiple Vehicle Collision and Fire, State Route 2, Near Cleveland, Ohio, May 6, 1979				5. Report Date September 20, 1979

CROSS MEDIAN MULTIPLE VEHICLE COLLISION AND FIRE
STATE ROUTE 2, NEAR CLEVELAND, OHIO
MAY 6, 1979

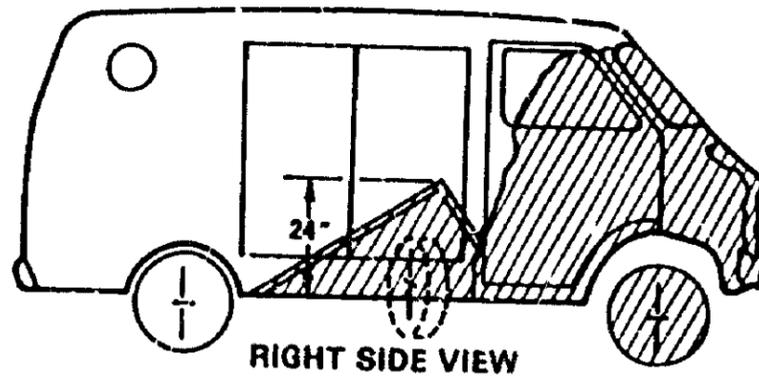
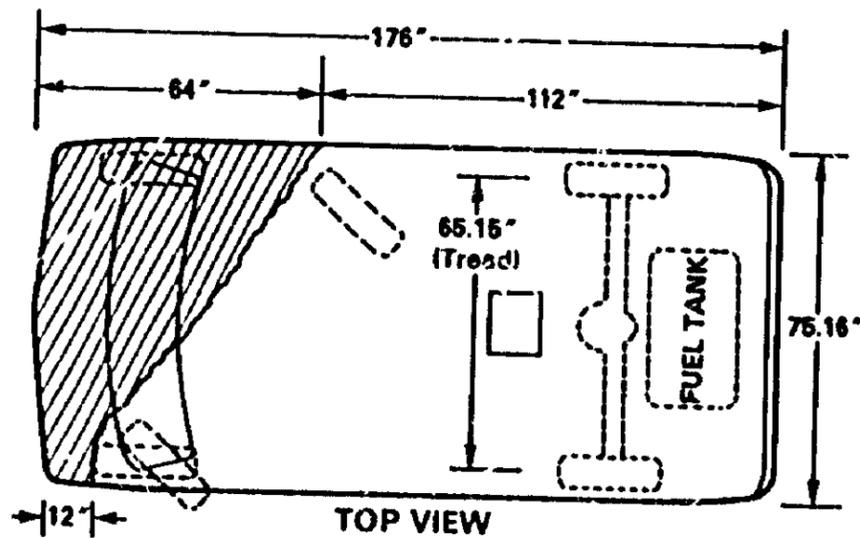
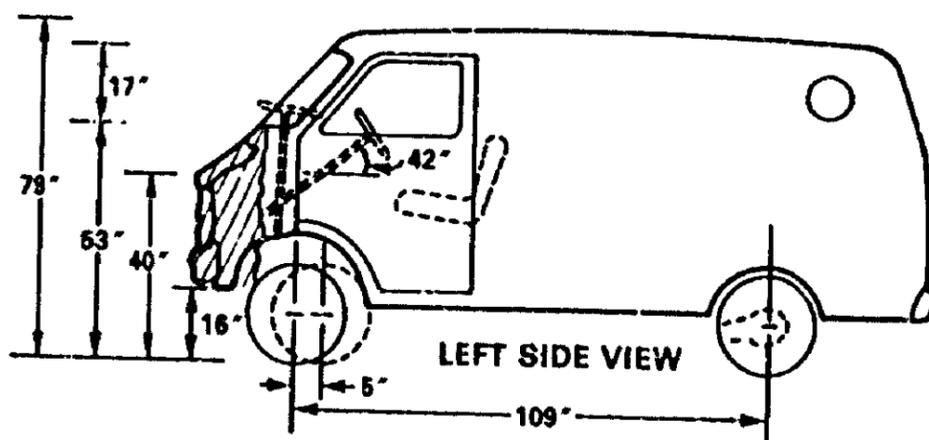
VEHICLE DAMAGE DIAGRAM
1976 DODGE VAN
VIN B21BE6V097531
(Not to Scale)

The Van. The postcrash inspection of the van indicated that the front end components were deformed rearward; the most significant deformation was on the right front. All flammable interior and external components were destroyed by fire. The left front tire was cut and deflated, the right side tie rod sleeve was found to be fractured, and the fuel tank had been punctured and was empty.

Note: Entire vehicle damaged by fire except for lower left side outside components
