Highway Accident Report - Multiple-Vehicle  
Collision in a Construction Zone, U.S. Interstate 80  
Near Laramie, Wyoming, August 22, 1979

(U.S.) National Transportation Safety Board, Washington, DC

1. Report No. NTSB-HAR-80-1		2. Government Accession No.		3. Recipient's Catalog No. <b>PB 80 148794</b>	
4. Title and Subtitle Highway Accident Report-- Multiple-Vehicle Collision in a Construction Zone, U.S. Interstate 80, near Laramie, Wyoming, August 22, 1979		5. Report Date February 7, 1980		6. Performing Organization Code

MULTIPLE-VEHICLE COLLISION  
IN A CONSTRUCTION ZONE  
U.S. INTERSTATE 80, NEAR LARAMIE, WYOMING  
AUGUST 22, 1979

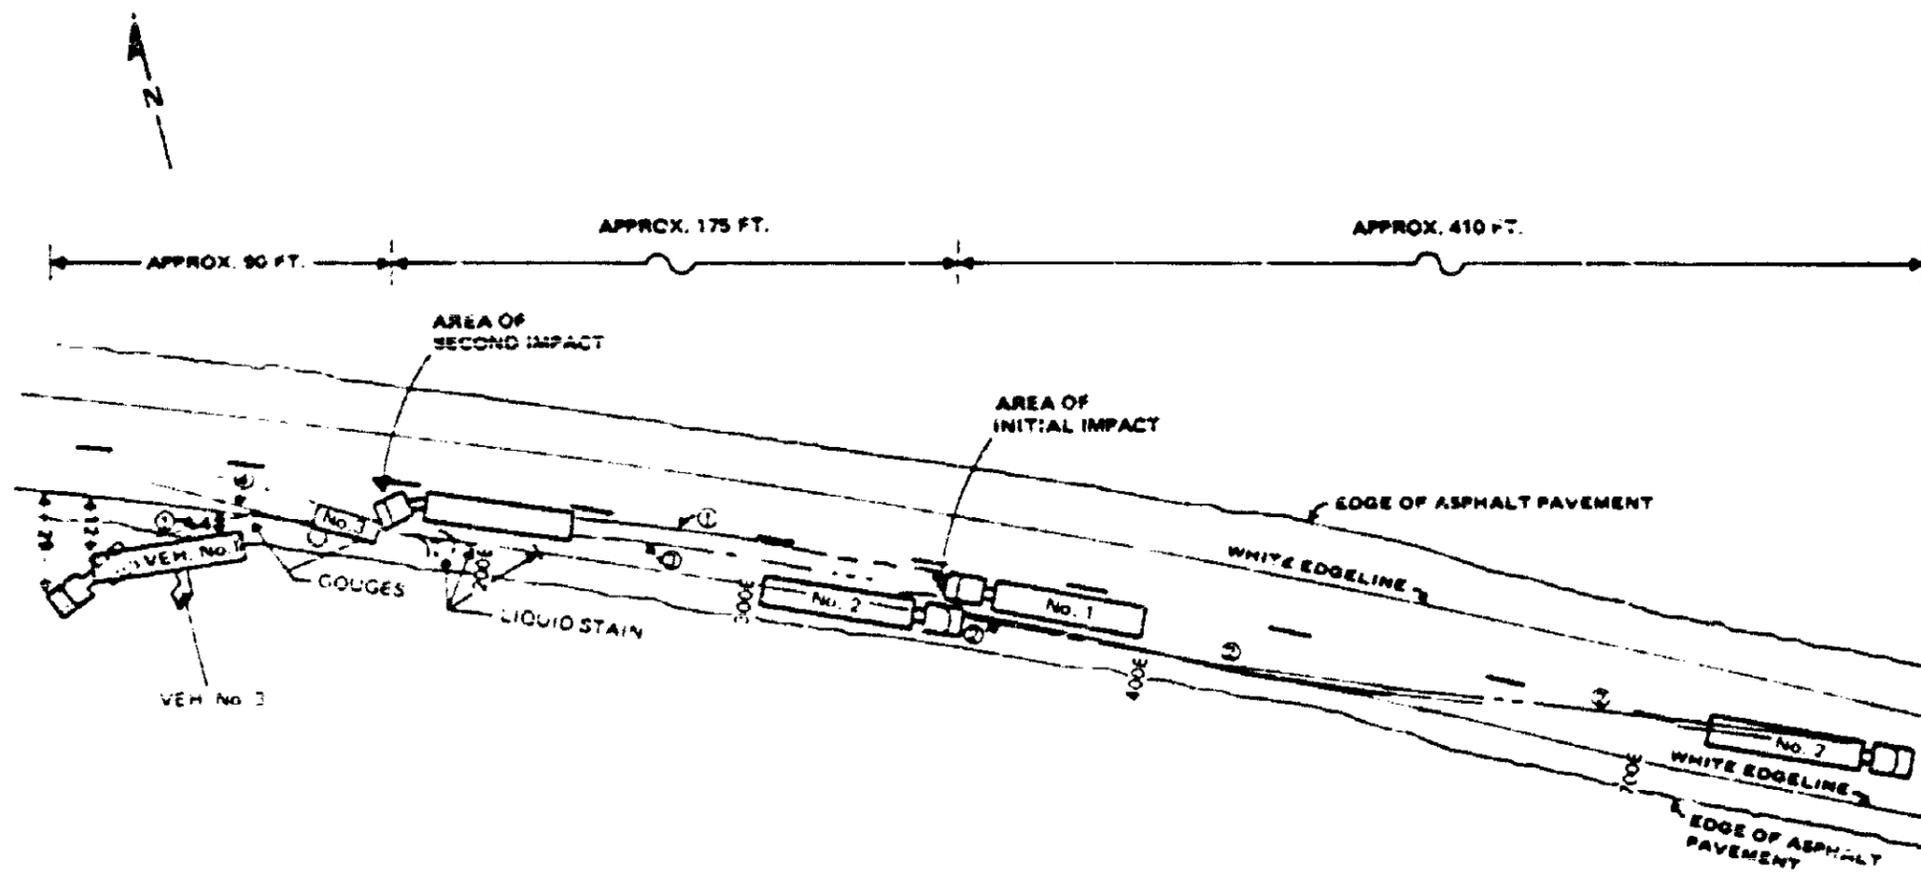
Figure 1.—Plan view of accident site.

The westbound truck struck the left driving wheels of the tractor of the eastbound truck, sideswiped the refrigerated semitrailer, hit the left-rear wheels of the semitrailer, and collided head-on with the motor home which had been following the eastbound truck in the eastbound lane. (See figure 1.) The driver and codriver of the westbound truck were killed. Six of the seven persons in the motor home were ejected and killed; one person was partially ejected and seriously injured. The two persons in the eastbound truck were not injured.

After the westbound truck struck the motor home, it came to rest off the road adjacent to the eastbound lane. Its right-rear semitrailer tire was 4 feet from the eastbound lane edgeline and the right-rear tractor bogie tire was 12 feet from this edgeline. (See figure 1.) The right-front wheel of the tractor was 27 feet from the eastbound lane edgeline. The right-rear corner of the semitrailer came to rest about 39 feet 6 inches from the point of impact with the motor home. The motor home came to rest adjacent to the left side of the semitrailer on the south side of the road. The motor home was located 16 feet from the left front of the semitrailer and 16 feet from the left rear of the semitrailer. The motor home's skidmarks measured 62.5 feet for the right tires and 54.8 feet for the left tires.

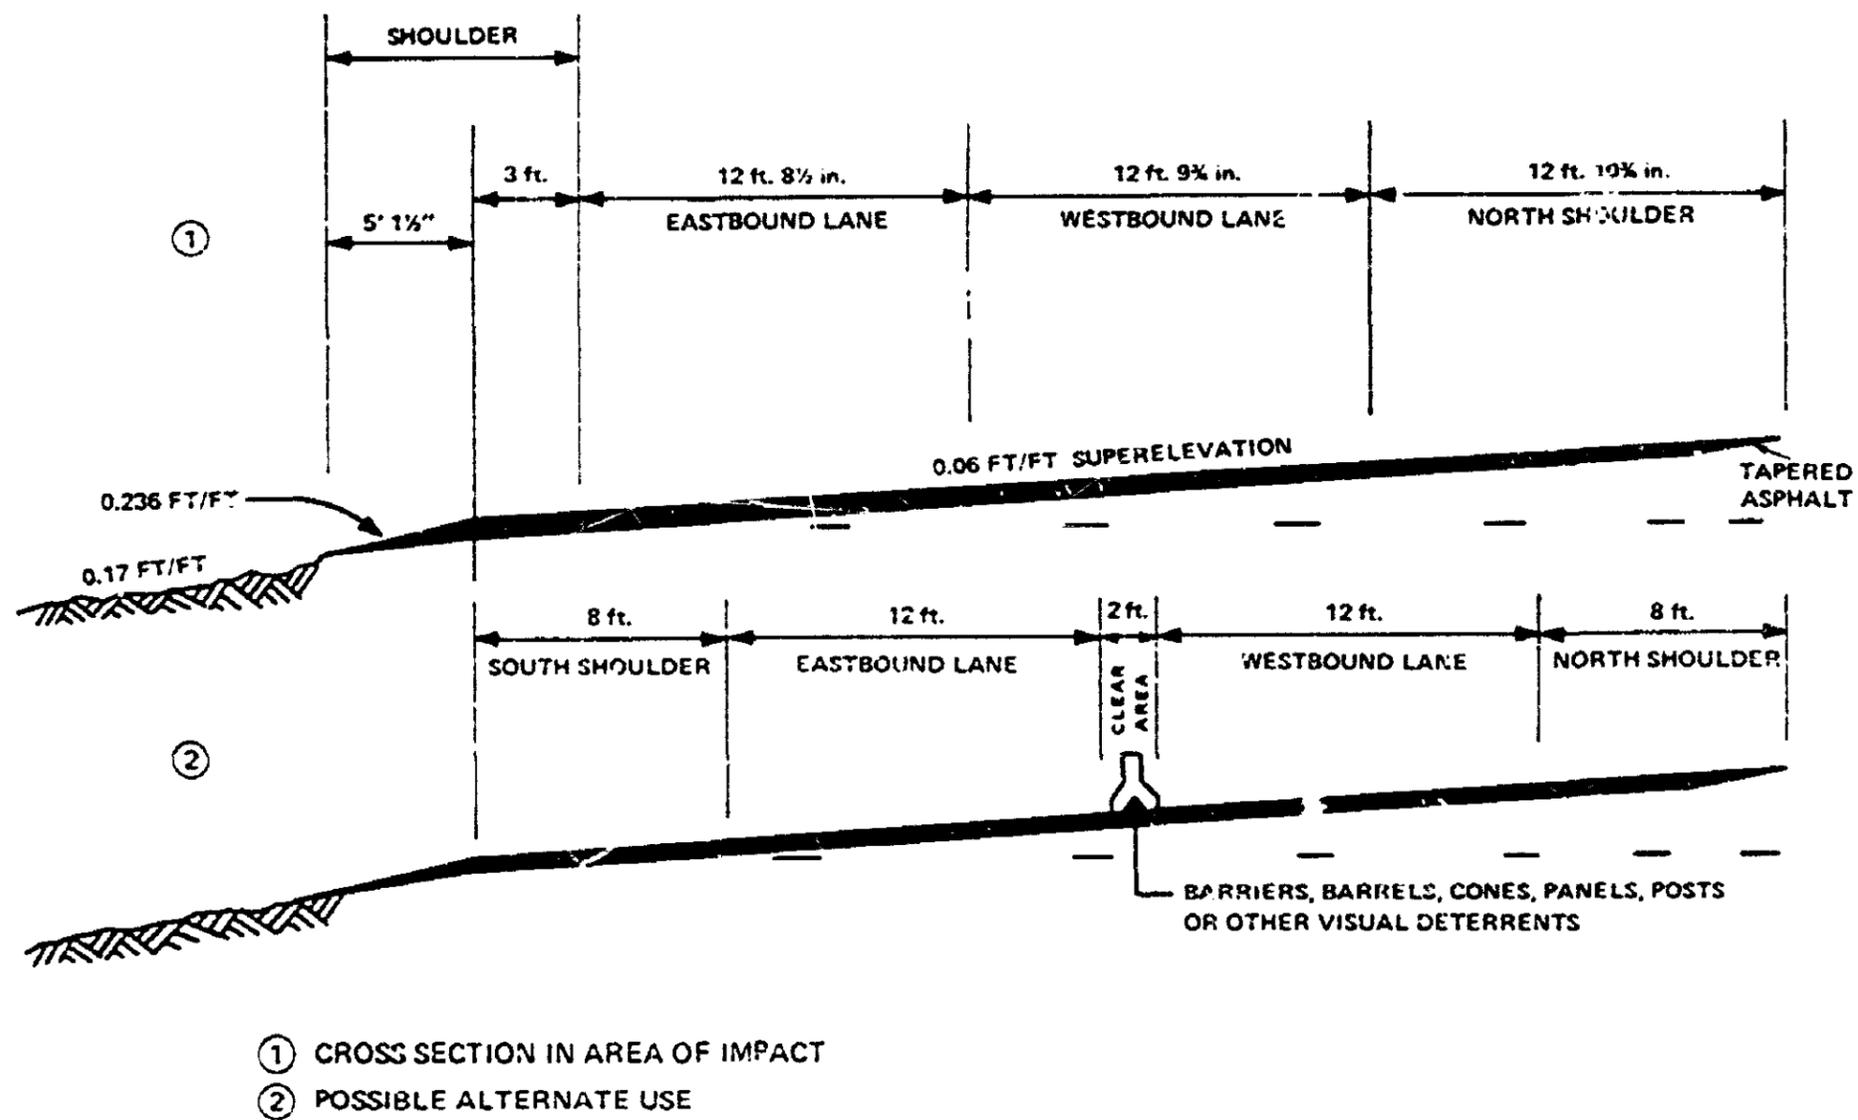
Figure 3.--Cross-section view of roadway at accident site.

Both eastbound and westbound traffic had been routed onto the westbound lanes, creating a two-lane, two-way traffic pattern. The temporary eastbound lane was 12 feet 8 inches wide, and the temporary westbound lane was 12 feet 10 inches wide. The shoulder for eastbound traffic was 8 feet 1 inch wide, and the westbound shoulder was 12 feet 11 inches wide. The first 3 feet of the eastbound shoulder had a 0.035 foot/per foot (ft/ft) slope. The next 3 feet had a 0.236 ft/ft slope. The roadway superelevation was about 0.06 ft/ft. (See figure 3.) Only the first 3 feet of the eastbound shoulder appeared to be usable to traffic; the rest of the shoulder appeared too steep for safe use. Adjacent to the paved shoulder was a rock-strewn median which was not conducive to safe travel. (See figure 4.)

Shoulder slopes that drain away from the paved surface on the outside of well superelevated sections should be designed to avoid too great a cross slope break. For example, use of a 1 inch per foot shoulder cross slope in a section with pavement superelevation of 0.08 foot per foot results in a 0.16 foot per foot algebraic difference in the pavement and shoulder grades at the high edge of pavement. Grade breaks of this order are hazardous and should not be permitted.

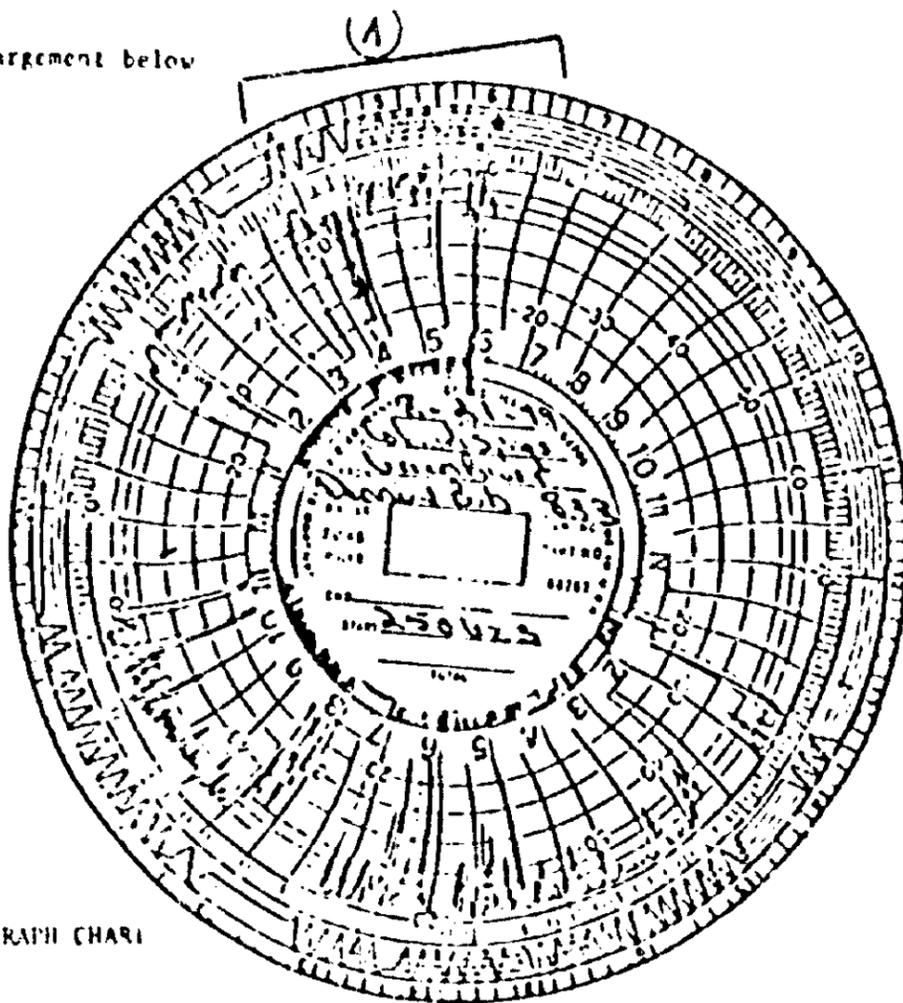
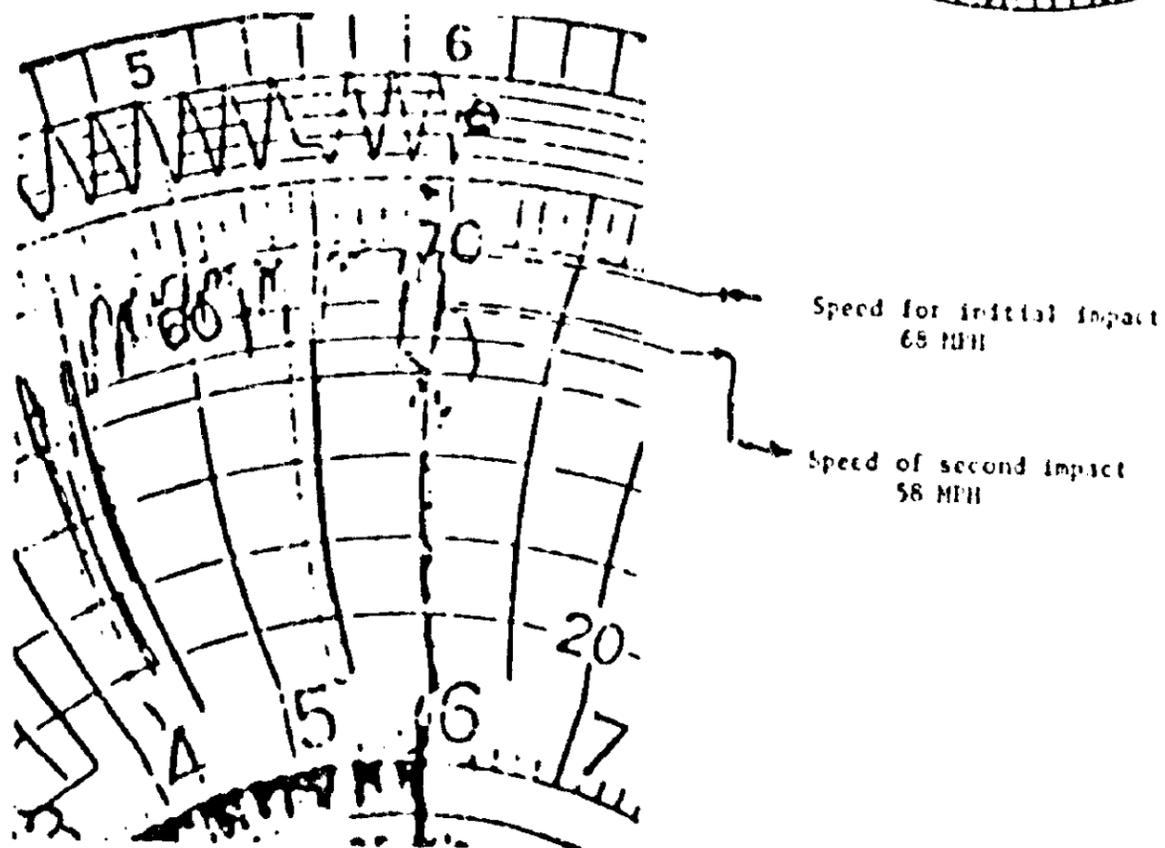
Figure 7.--Face of tachograph chart from westbound truck.

The tachograph in the westbound truck was examined after the accident. It was determined that the tachograph was operating at the time of the accident. The chart recorded speeds as high as 68 mph during its trip through Wyoming and Colorado. It registered the vehicle's speed at 68 mph when the westbound truck struck the eastbound truck, and at 58 mph when the westbound truck struck the motor home. (See figure 7.) The tachograph recorded the time of departure from Laporte at 7:30 p.m. on August 21. The tachograph showed the vehicle en route from 7:30 p.m. until 11 p.m. The cargo was unloaded at the terminal at Colorado Springs from 11 p.m. on August 21 until 1:30 a.m. on August 22. The tachograph shows the vehicle en route from Colorado Springs at 1:30 a.m., a stop at 3:15 a.m. until 3:45 a.m., and a brief stop at 5:20 a.m. The tachograph read 6 a.m. when it ceased operation. The Safety Board was unable to reconcile or explain the difference in the time the recordings stopped on the tachograph chart and the time of the accident established by the Wyoming Highway Patrol.

1. The westbound truck struck the eastbound truck and the motor home at speeds of 68 and 58 mph, respectively.
2. Before impact, the motor home was traveling at an average speed of 38 mph. The motor home had decelerated to a speed of 12 mph by the time it was struck by the westbound truck.
3. The westbound truck was completely within the eastbound lane when it struck the eastbound truck and the motor home.
4. The driver of the westbound truck was fatigued due to the length of time on duty, involving tire repairs, unloading cargo, and prolonged driving before the accident.
