HIGHWAY ACCIDENT REPORT

CENTRAL TEXAS BUS LINES, INC.,
CHARTER BUS, STATE ROUTE 7
NEAR JASPER, ARKANSAS
JUNE 5, 1980

NTSB-HAR-81-1

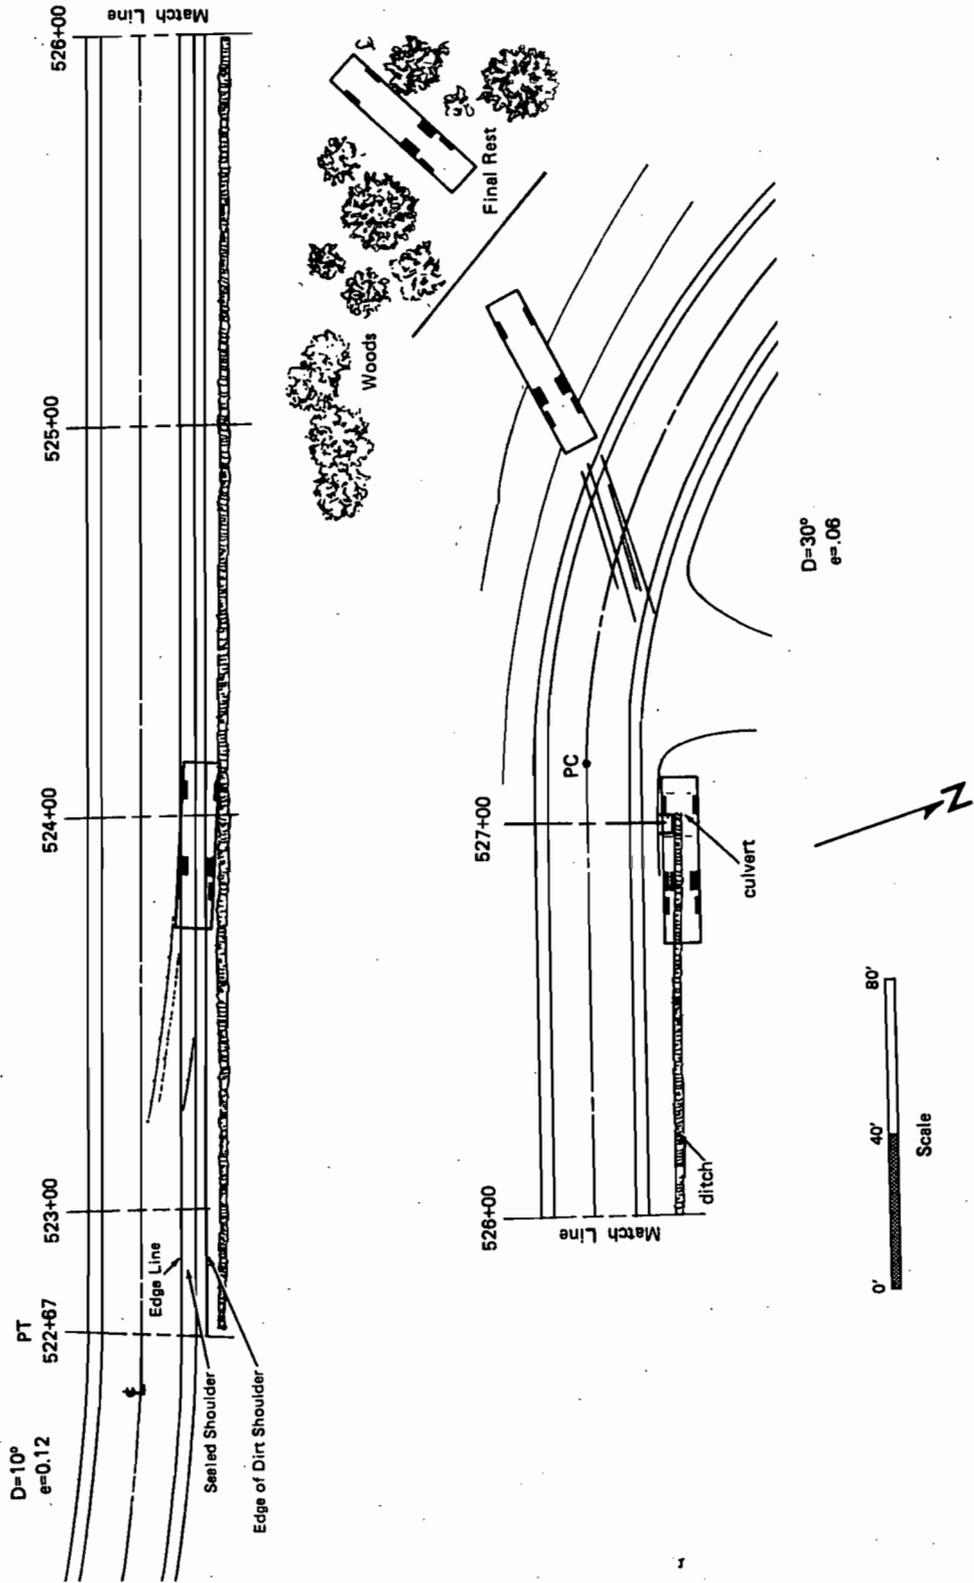
Figure 1.--Plan of accident site.

About 2 miles north of the hillcrest, the bus entered a 0.2-mile-long construction zone. The construction zone began with a 10-degree right curve followed by a straight section which was followed by a 10-degree left curve. A runaway vehicle escape ramp was being constructed on the straight section of the existing roadway, and the traveled way had been realigned to the west of and roughly parallel to the escape ramp. The bus traversed the construction zone but failed to negotiate the 10-degree left curve and ran off the right pavement edge into a drainage ditch which paralleled the road. A steep hillside with several rock outcroppings formed the right bank of the ditch, and as the right wheels of the bus entered the ditch, the bus tipped and its right side began scraping along the hillside. The bus continued forward for about 280 feet. (See figure 1.)

About 120 feet north of where it first contacted the hillside, the right-side window area struck a large rock outcropping. The bus then struck and mounted a 3-foot-high berm located at a concrete culvert headwall, and the busdriver and two passengers were ejected. The impact redirected the bus diagonally to the left across the pavement and off the left pavement edge. Two more passengers were ejected during this travel. The bus launched into a vault as the roadside terrain descended rapidly. The front of the bus struck several trees with bole diameters ranging from 9 to 13 inches. Two of these trees were sheared; three were uprooted. The bus came to rest (see figure 2) with its front against a large rock about 38 feet below pavement level where several more passengers were ejected.

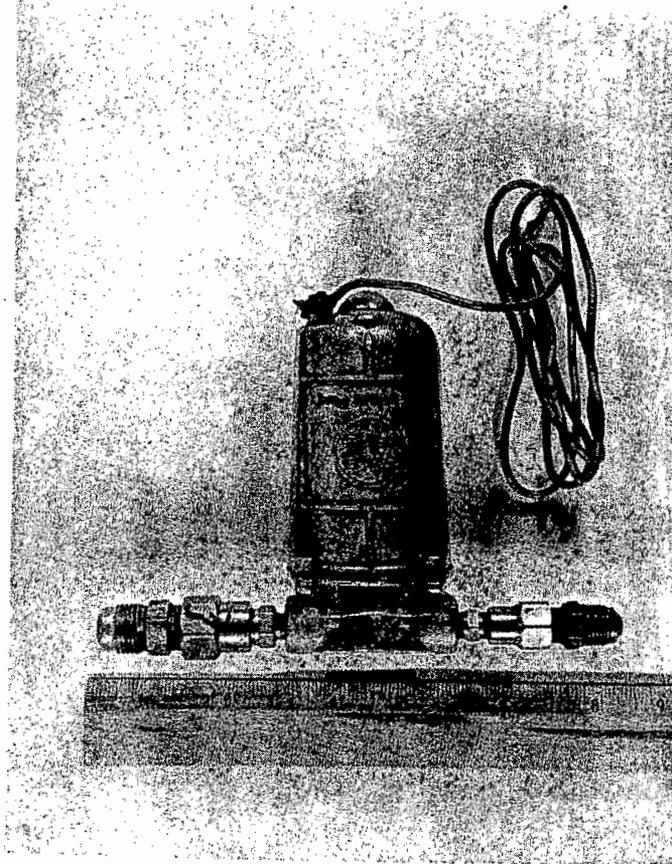
Fuel Pump.--The nonstandard fuel pump installed in Oklahoma was an electric centrifugal pump which had a constant flow rate of 22 gallons per hour at 1 psi and an outlet pressure of 4 to 8 psi. (See figure 3.) It had been installed so as to bypass the original equipment diesel fuel pump which had a broken shaft. The replacement fuel pump was the type normally used for gasoline automobile engines. The original equipment diesel fuel pump was a speed-sensitive, vacuum-mechanical, positive-displacement pump with a 110 to 115 gallon per hour flow rate and an outlet pressure of 70 psi at 2,100 rpm.

Figure 3.--Nonstandard electric fuel pump and attaching hardware used on accident vehicle.

The original fuel pump on the bus was a speed-sensitive, positive-displacement pump that increased fuel volume and pressure to accommodate increased engine loads and speeds. The small electric replacement fuel pump had only 20 percent of this fuel flow capability and could not supply sufficient fuel to the engine.

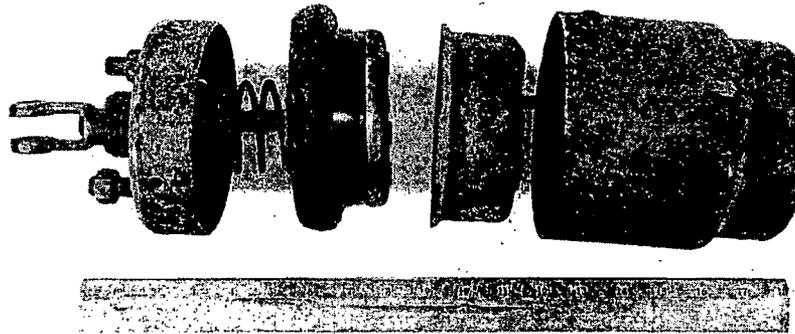
5. The right front-axle rotochamber was leaking air, but brake application occurred when air was applied. There was a 0.1-inch tear in the rotochamber diaphragm. (See figures 6, 7, and 8.)

Figure 6.--Brake actuator from the right front-axle rotochamber.

The type-16 air rotochamber mounted at the right-front wheel of the bus leaked when the airbrake system was charged from 60 to 120 psi during field inspection of the bus. With brakes applied, shoe to drum contact was noted, and the brake slack adjustment was within specifications. To assess the effect of air leakage on the rotochamber's performance, the rotochamber was removed for independent laboratory testing. The Approved Engineering Test Laboratories (AETL) reported its output force tests on the right-front rotochamber, with the actuator set at the 1-inch stroke position as it had been on the bus, to be as follows:

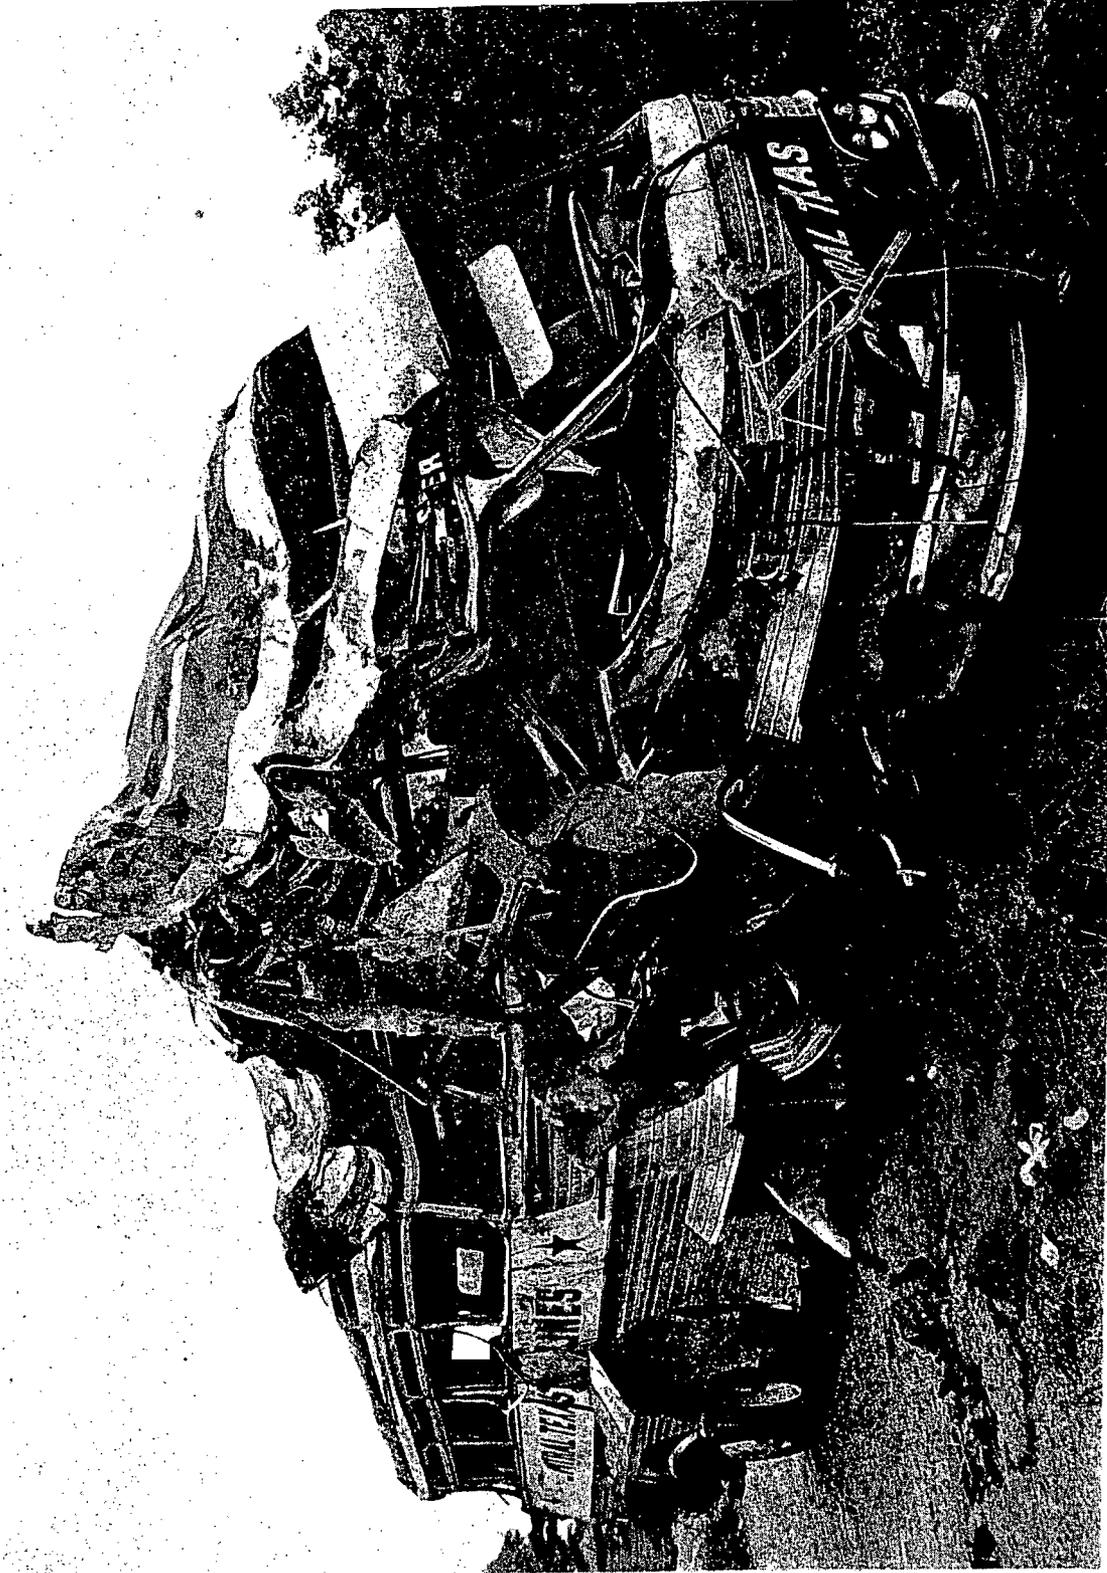
Figure 9.-- Right-side vehicle damage.

The front of the bus was crushed rearward and was skewed to the right. The right-front corner was crushed about 4.5 feet rearward. Several panels in the right-front area and both windshields were missing. The right-forward roof structure was displaced about 2 feet inboard and rearward. The center-front and right side of the bus had several semicircular imprints. (See figure 9.)

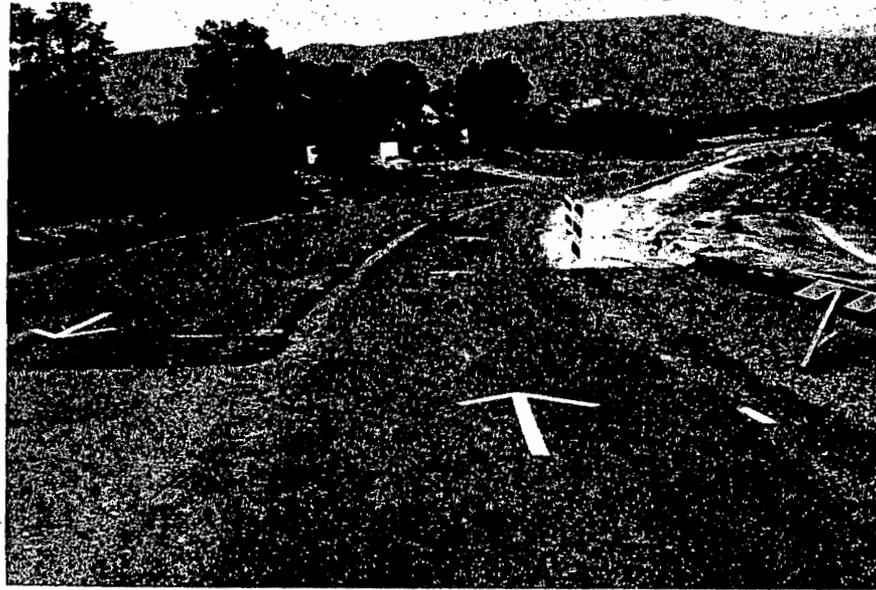
Figure 11.--Transition from existing alignment to new alignments. Pavement on right had been removed for construction of escape ramp.

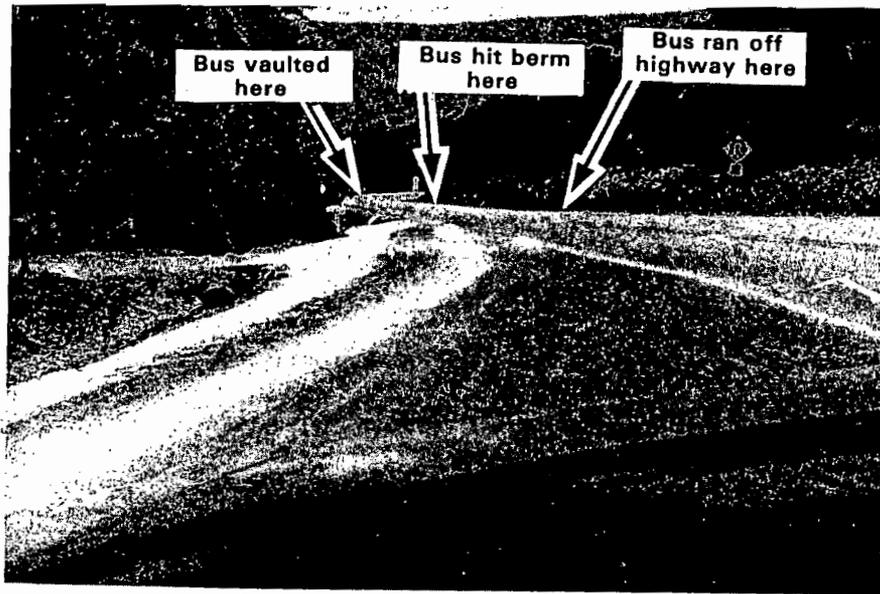
Figure 12.--Transition from new alignment to existing alignment. The hill symbol sign was installed after the accident, replacing a hill message sign which was struck by the bus.
