HIGHWAY ACCIDENT REPORT: COLLISION OF NORTH AMERICAN VAN LINES  
TRACTOR-SEMITRAILER AND FORD VAN IN CONSTRUCTION ZONE, OHIO  
TURNPIKE NEAR CLEVELAND, OHIO, JULY 22, 1981.

1. Report No. NTSB-HAR-82-1	2. Government Accession No. PB82-916201	3. Recipient's Catalog No.	
4. Title and Subtitle Highway Accident Report--Collision of North American Van Lines Tractor-Semitrailer and Ford Van in Construction Zone, Ohio Turnpike, near Cleveland, Ohio, July 22, 1981		5. Report Date March 24, 1982

**COLLISION OF  
NORTH AMERICAN VAN LINES TRACTOR-SEMITRAILER  
AND FORD VAN  
IN CONSTRUCTION ZONE, OHIO TURNPIKE  
NEAR CLEVELAND, OHIO,  
JULY 22, 1981**

The National Transportation Safety Board determines that the probable cause of this accident was the failure of the van driver to maintain his vehicle within the proper traffic lane. Contributing to the cause of the accident was the lack of positive separation of opposing traffic in the construction work zone.

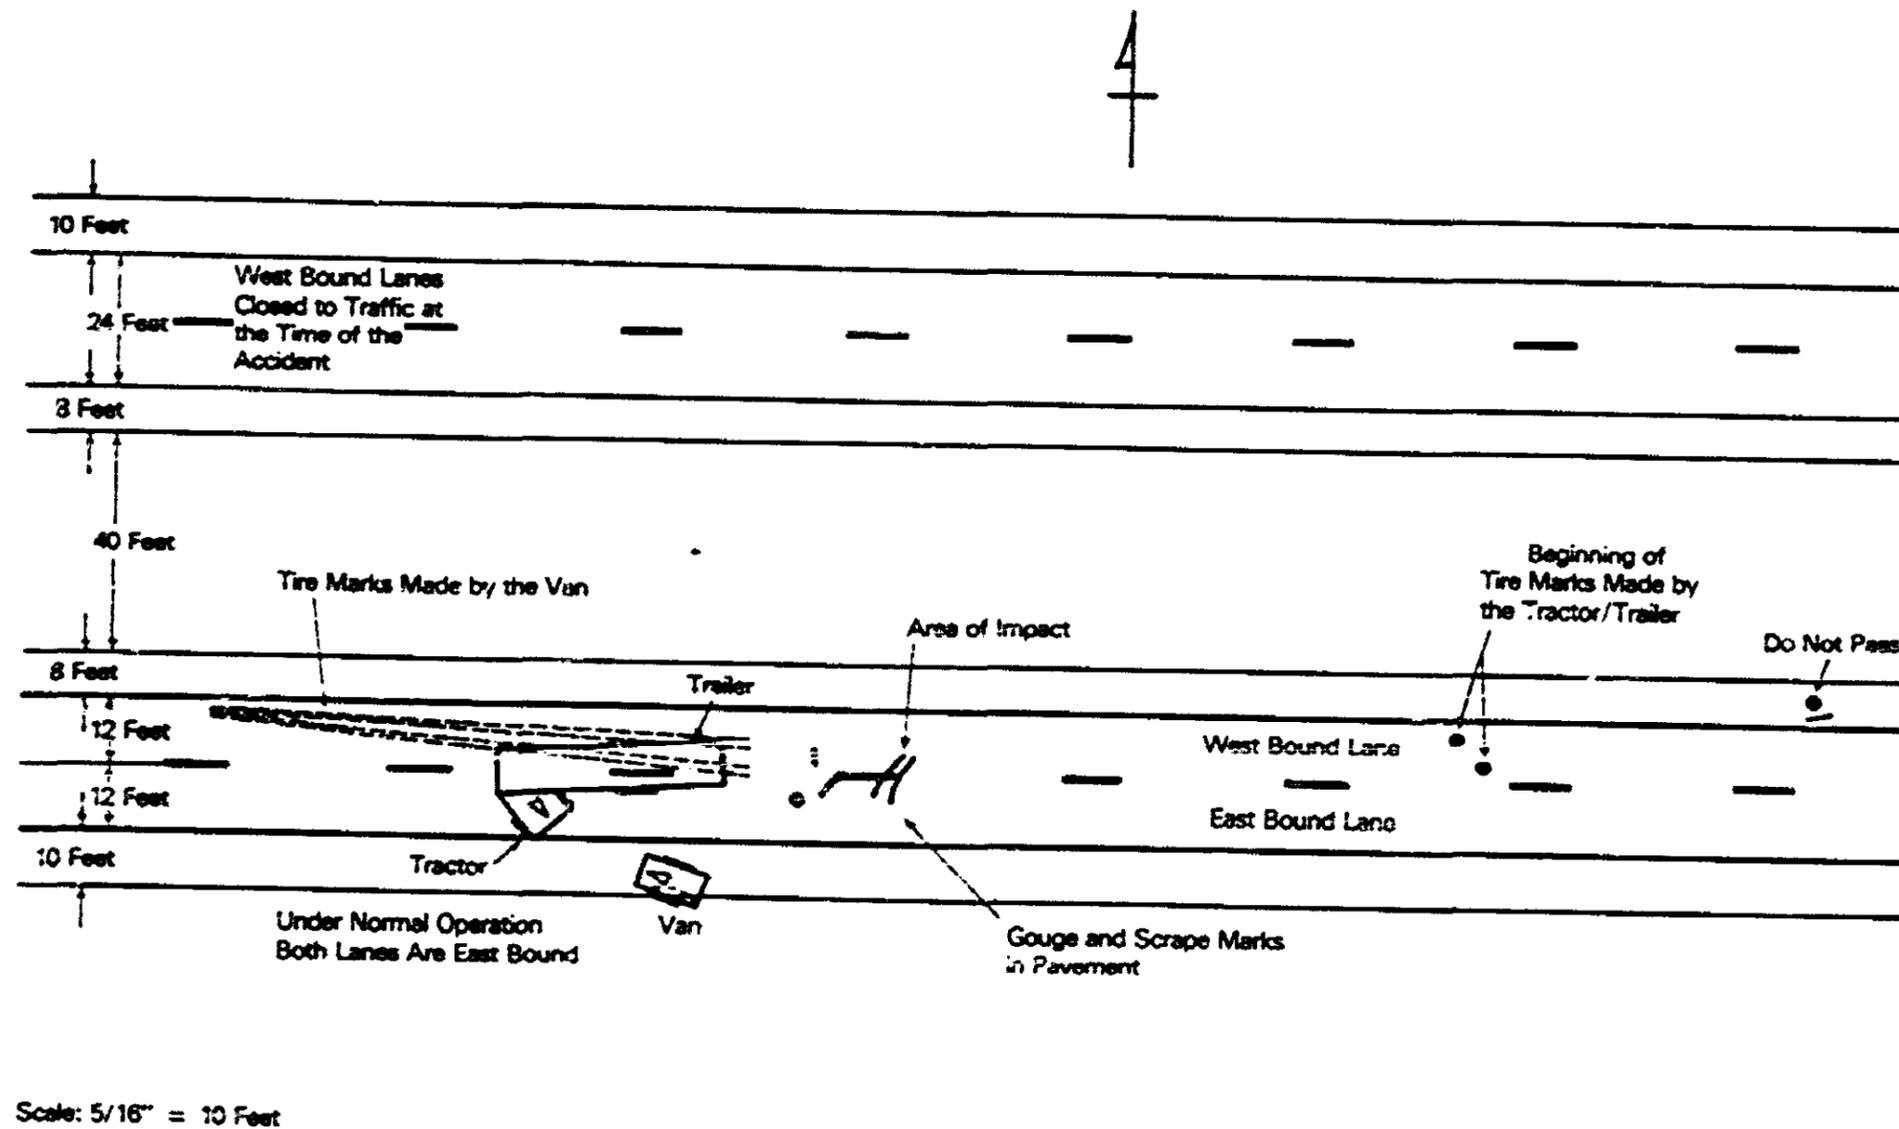
Figure 1.—Plan view of accident site.

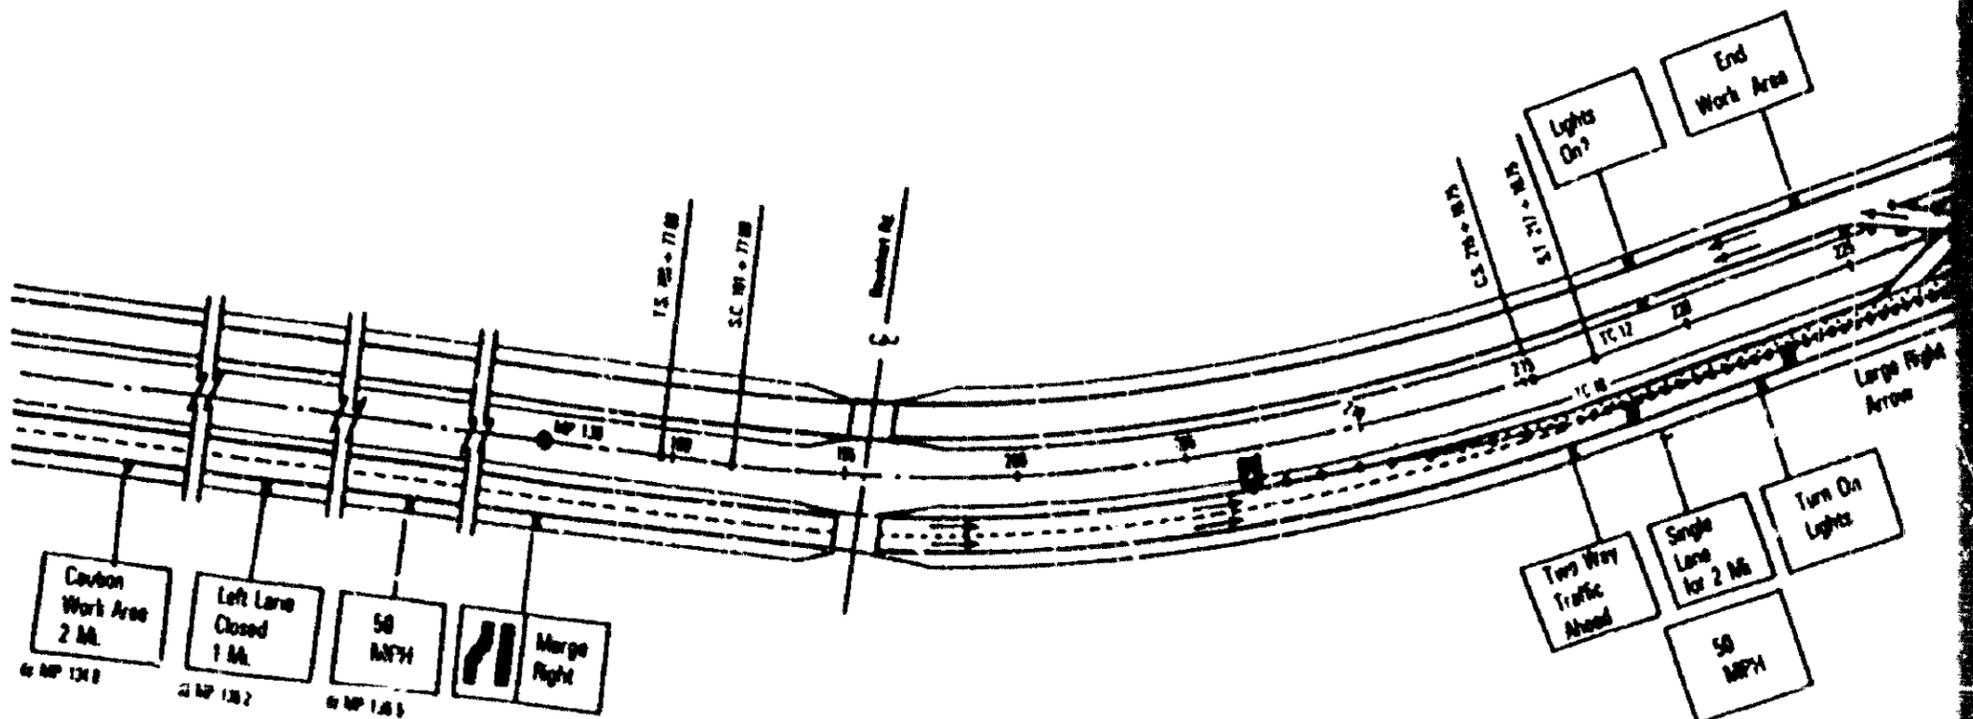
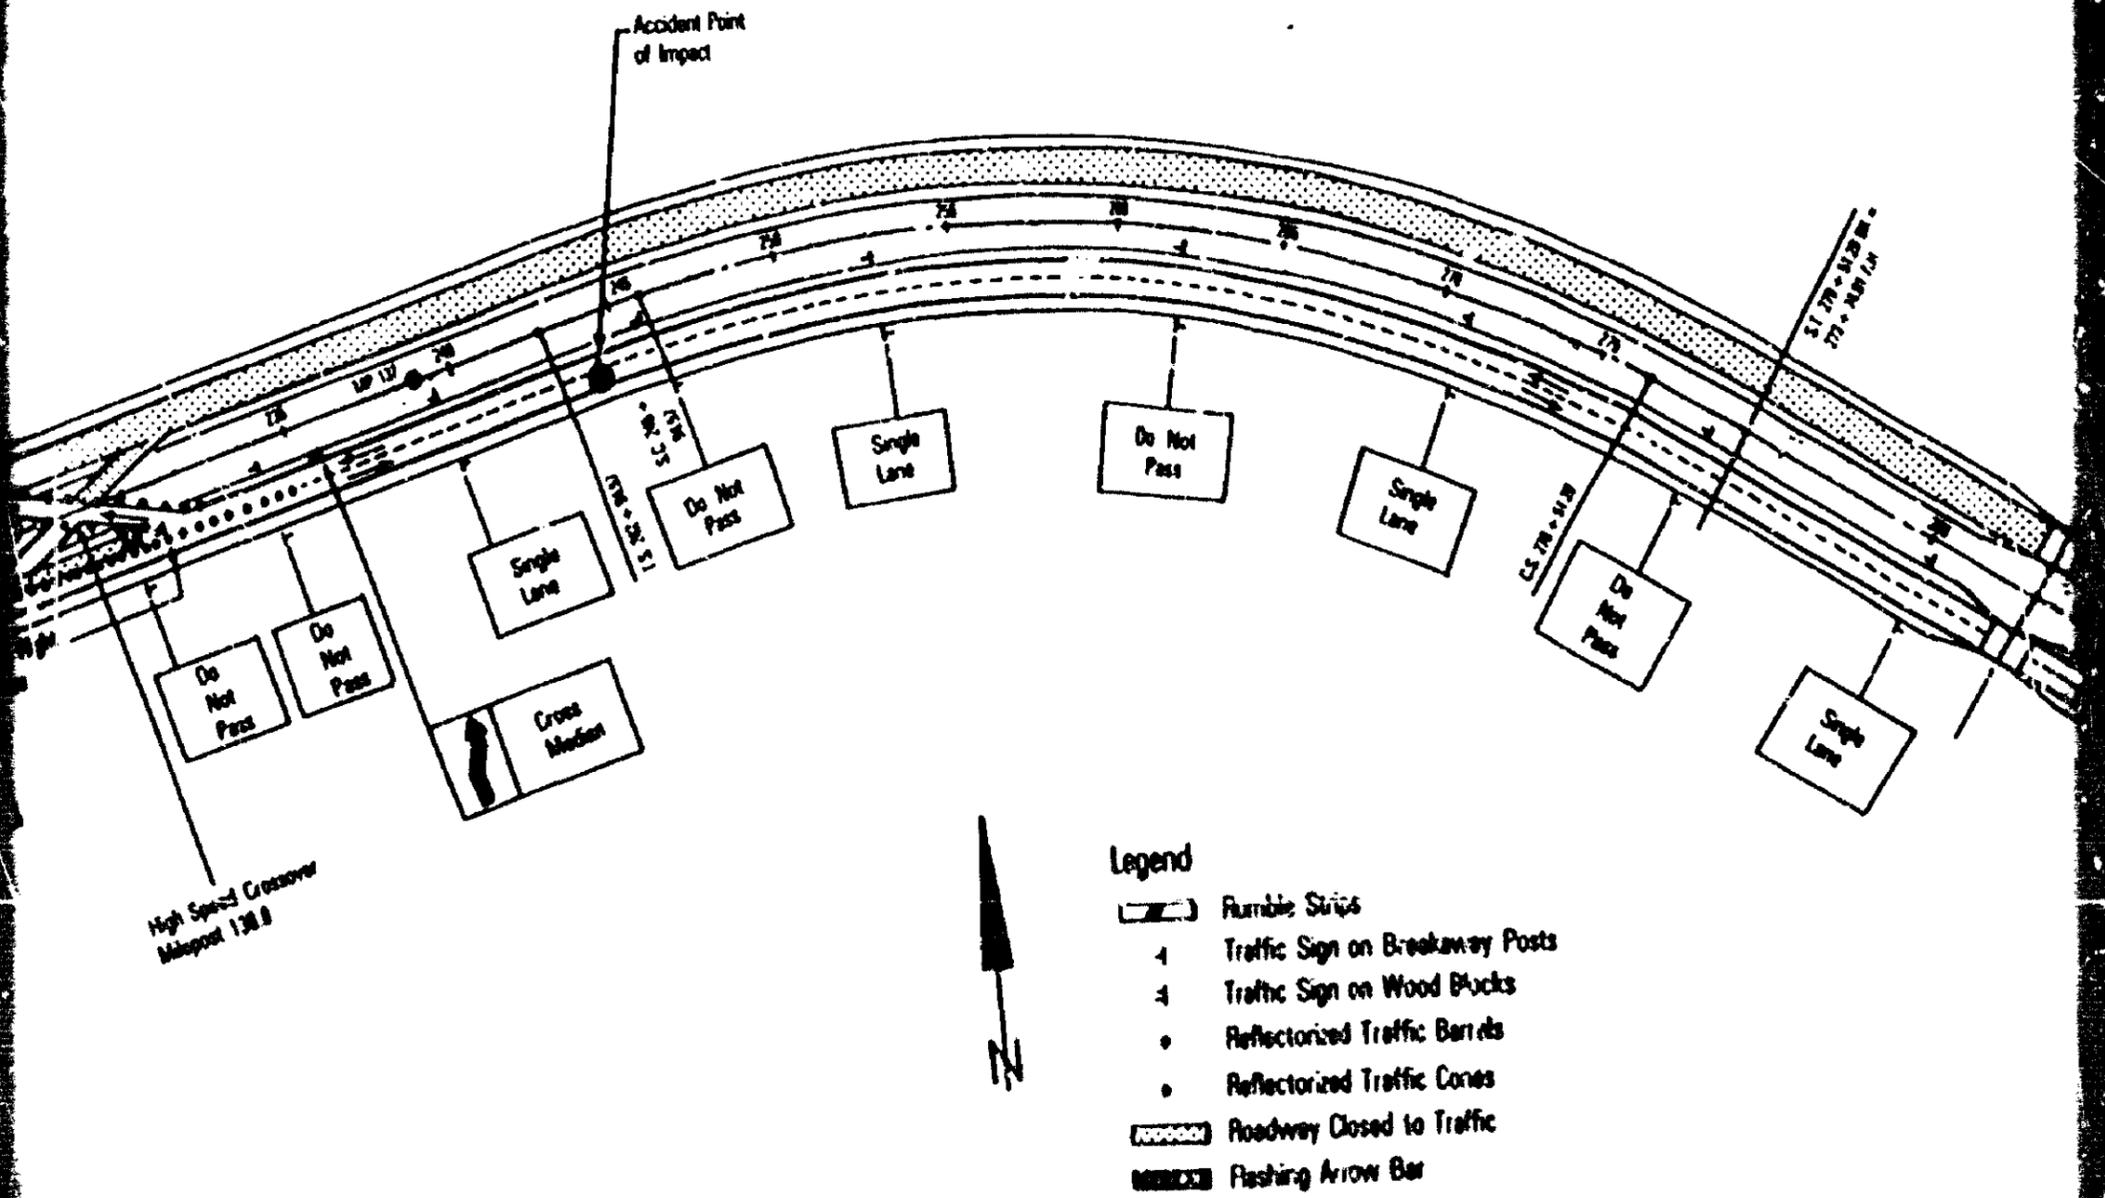
FIGURE 6.—PLAN VIEW OF

The accident occurred about 0.2 mile past milepost 137 and 120 feet into a 1°30'-spiral horizontal right-hand curve in the eastbound direction. The eastbound travel lane had a grade of +0.147 percent and superelevation varying from 3/16 to 7/16 inch per foot. The pavement markings in this area consisted of a white dashed lane line for the centerline. (See figure 6.)

There was no positive separation of the eastbound lanes in the construction zone to insure that two-way opposing traffic would remain within their proper lane. If positive separation, such as barriers, drums, cones, or vertical panels, were not feasible, then temporary striping should have been used in conjunction with appropriate warning signs and delineation devices to clearly indicate the required vehicle path. The Ohio Turnpike Commission opted to use dashed lane lines and complementary warning signs in the construction zone. The use of dashed lane lines may not have alerted the driver that he was in a temporary two-way opposing traffic situation, especially during early morning hours. The same type of pavement markings were being used as a lane division line on the divided highway prior to the construction zone.

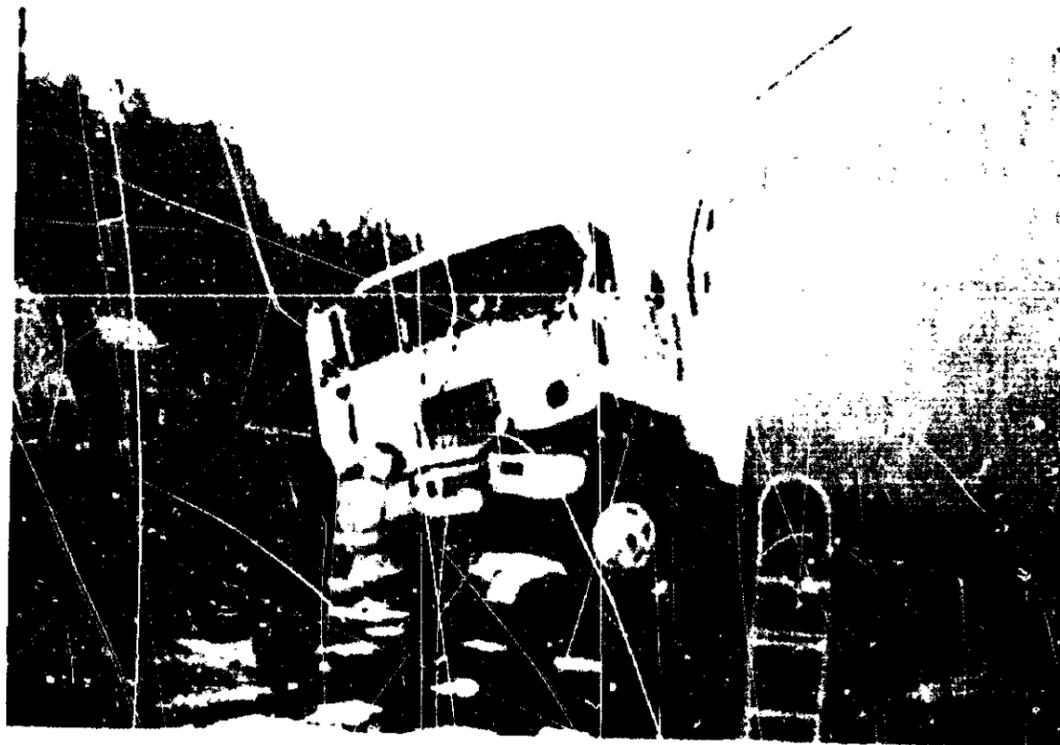
front headlamp glass were missing. Both ends of the tractor's front bumper were deformed rearward. (See figure 5.)

Figure 5.--Jackknifed condition of tractor-semitrailer.
