# NATIONAL TRANSPORTATION SAFETY BOARD

## HIGHWAY ACCIDENT REPORT

HERMAN DUVALI TRACTOR-POLE SEMITRAILER/  
S.L.&B ACADEMY, INC., SCHOOLBUS COLLISION  
U.S. ROUTE 45, NEAR WAYNESBORO, MISSISSIPPI  
OCTOBER 12, 1981

NTSB-HAR-82-2

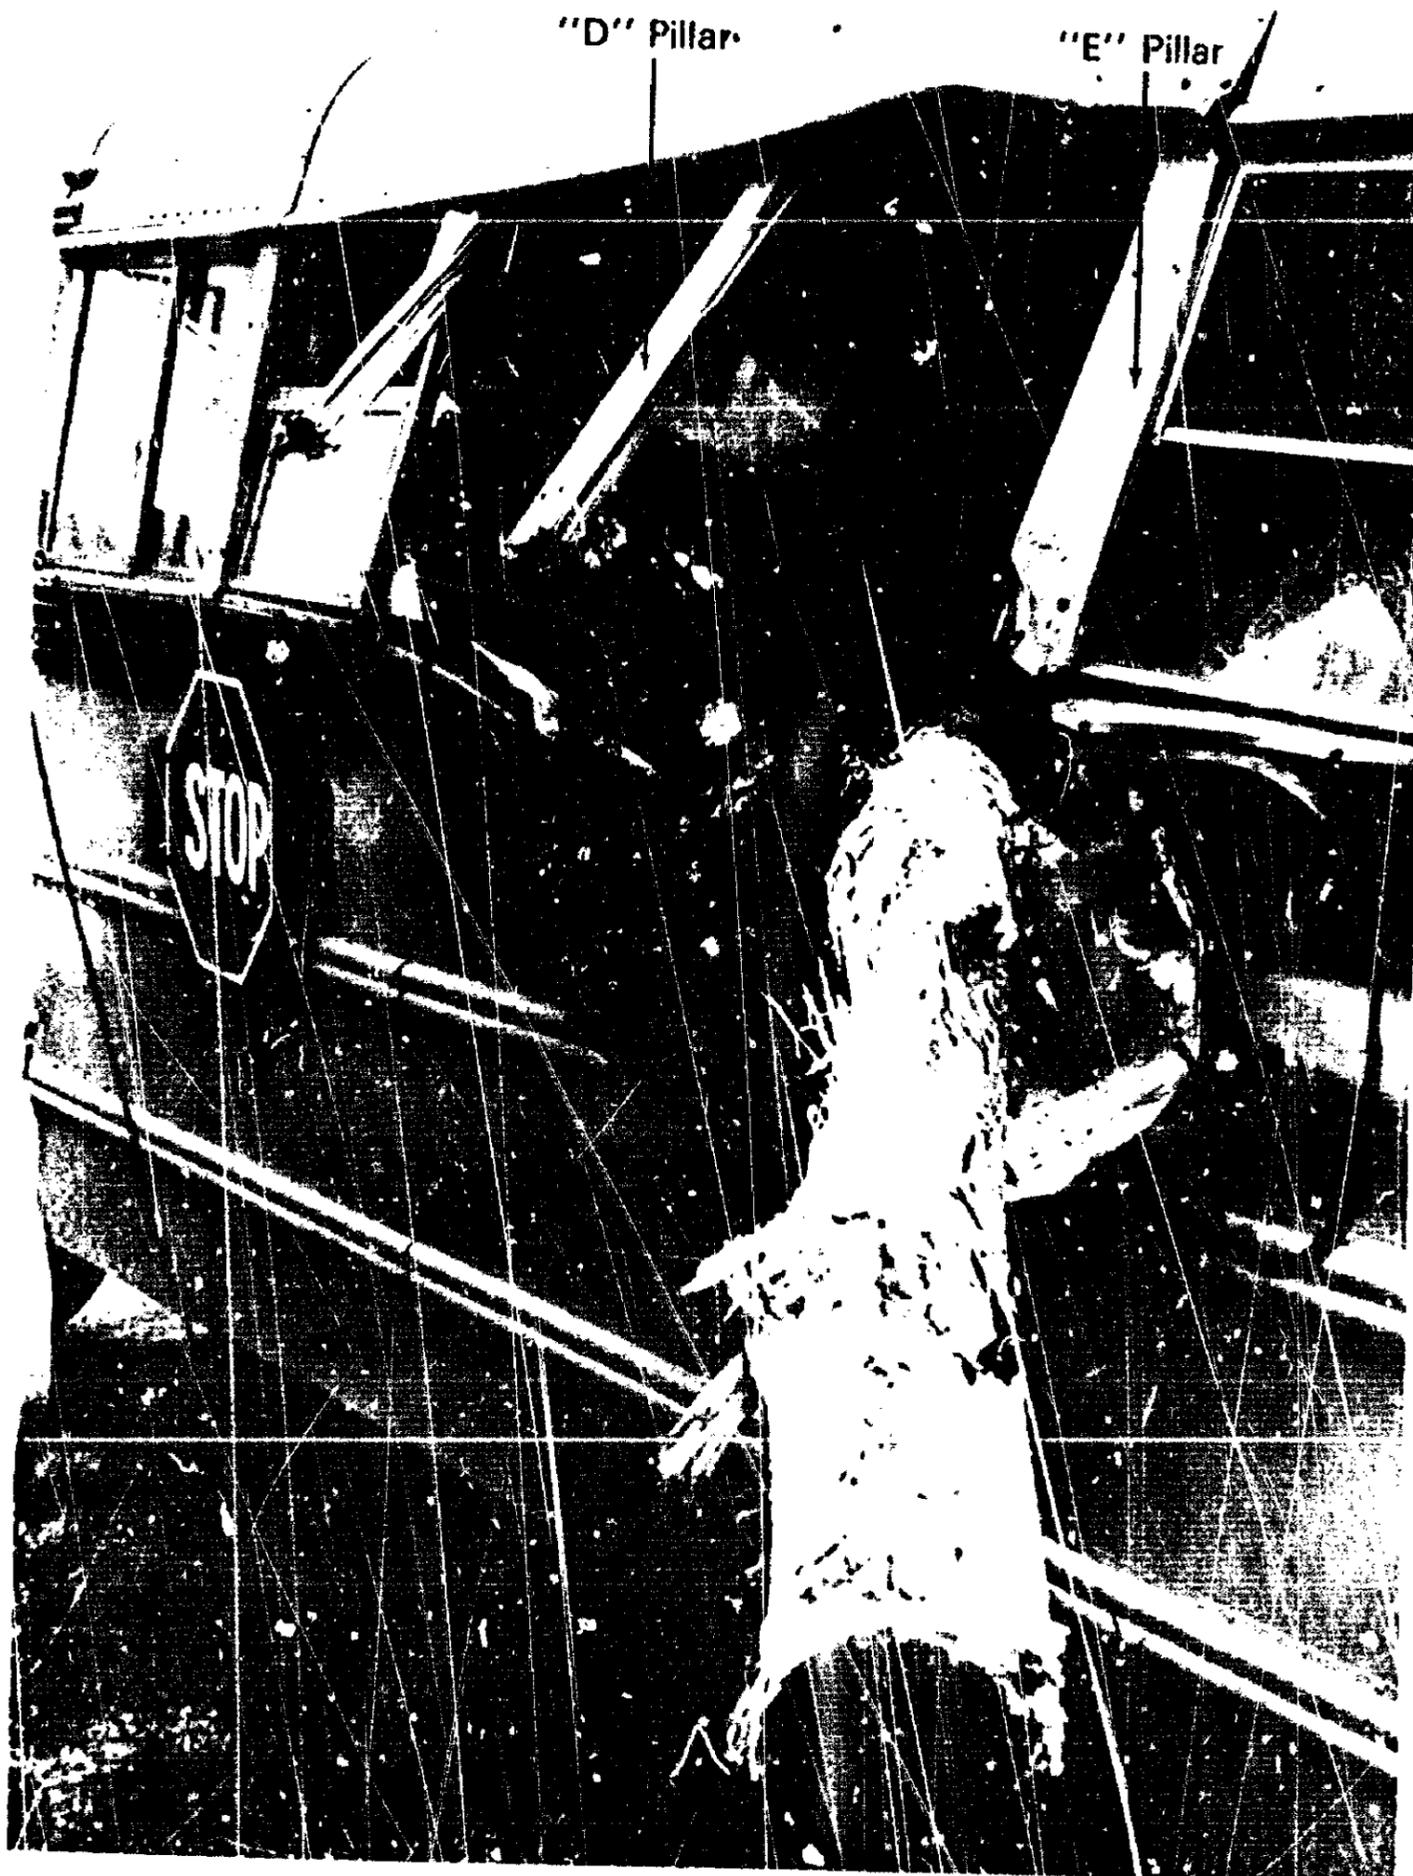
At least three logs on the truck were struck by the schoolbus; they penetrated the right windshield and passenger loading door area of the schoolbus, and one exited the left side in the area of the third passenger seat from the front. (See figure 3.)

Figure 3.—Log penetration from the right side of the bus.

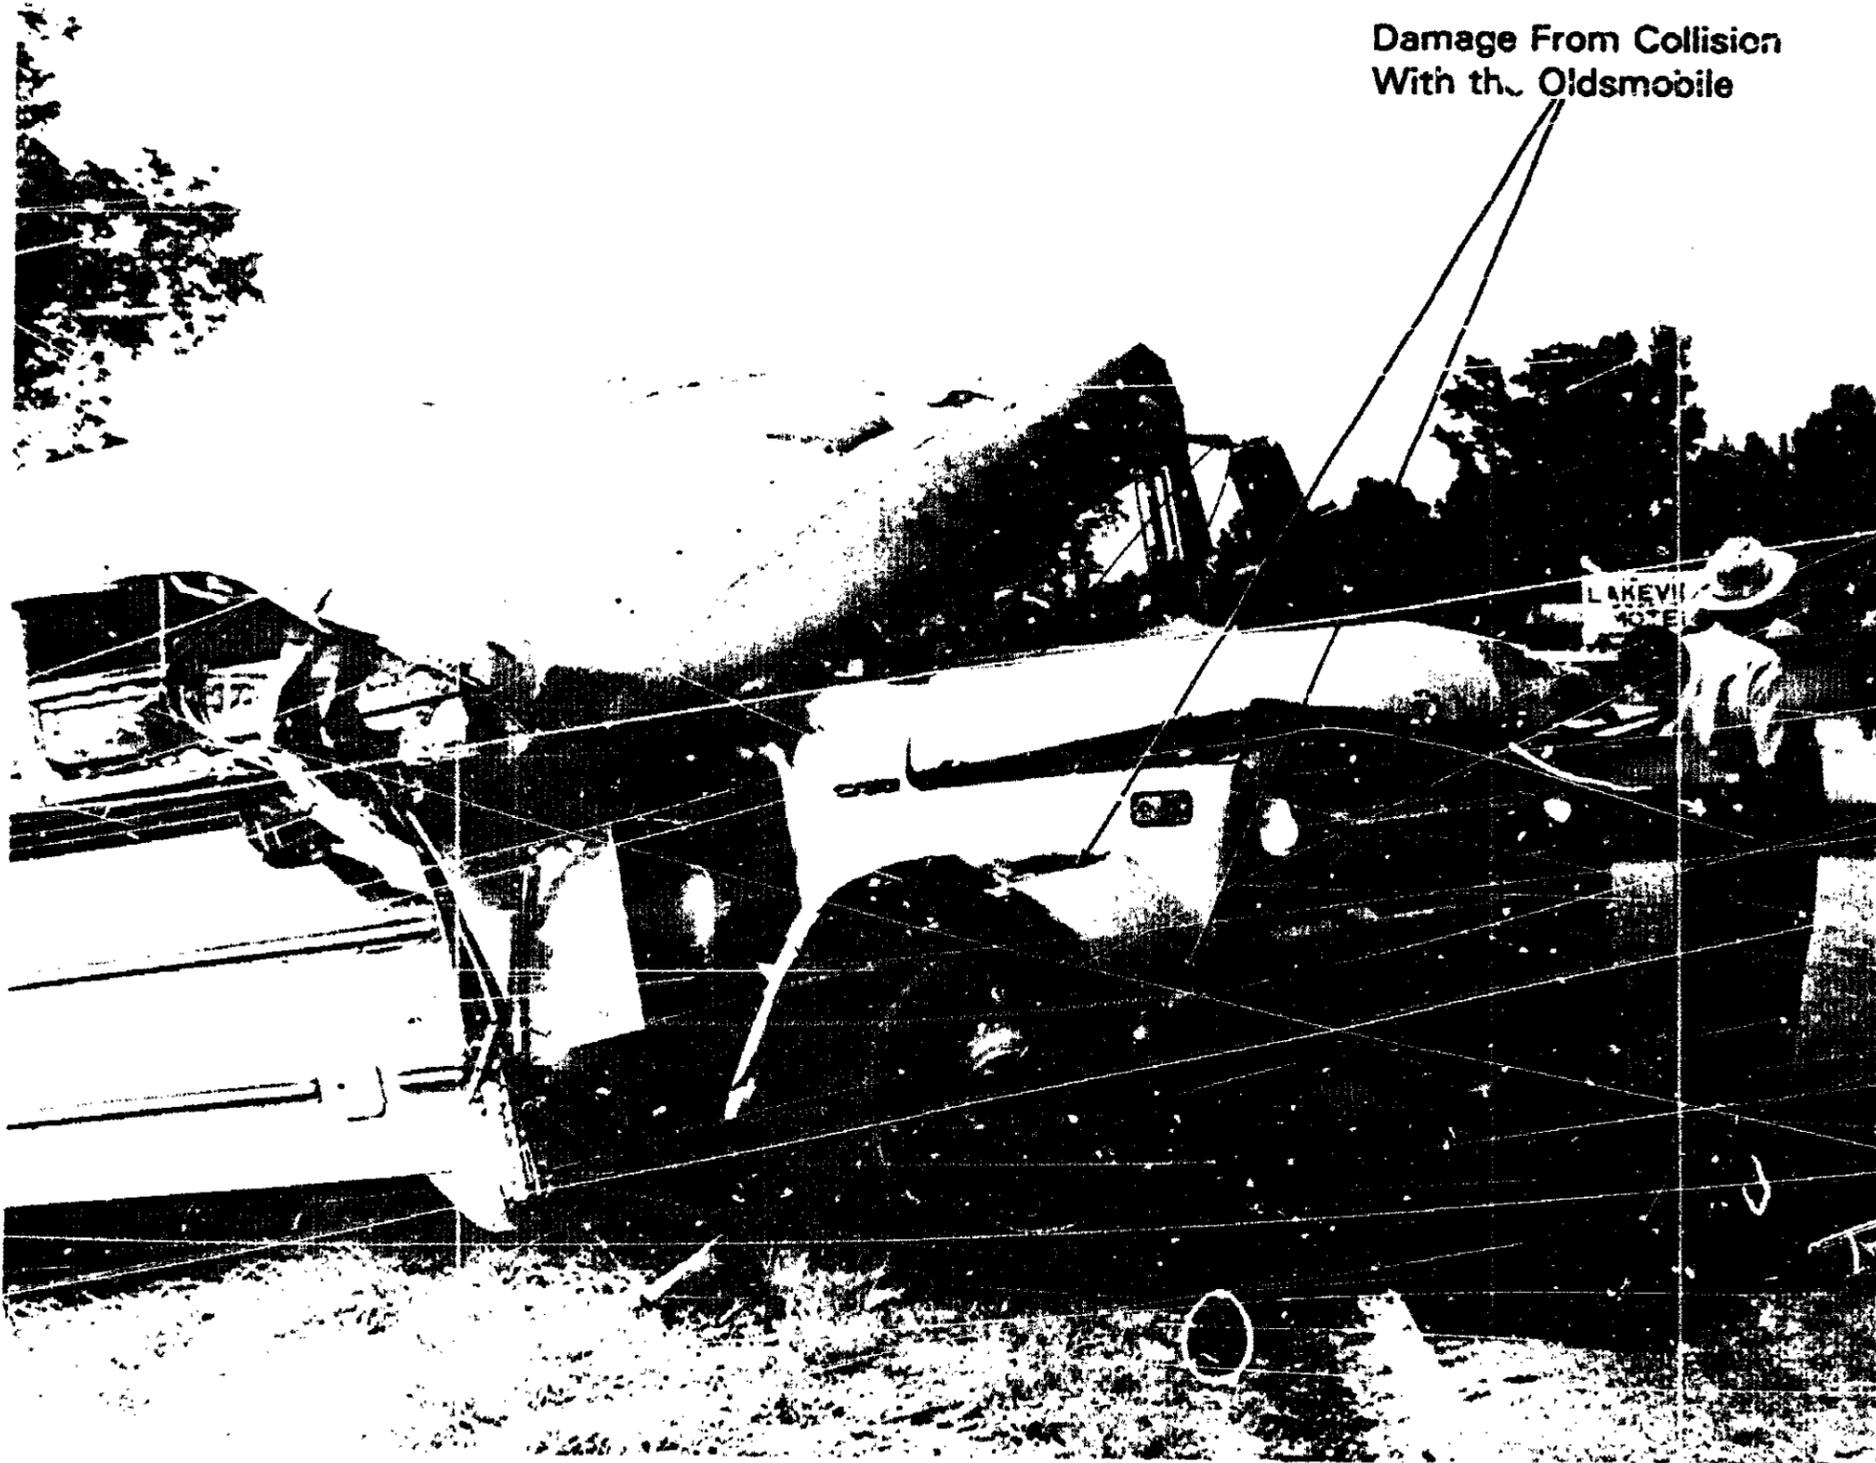
After the initial impact the schoolbus swerved to the right, struck the front bumper of an eastbound automobile, which was stopped at the intersection on Industrial Park Road and passed across the front of the automobile in a "sideswiping" type action. The bus then left the roadway at the southwest quadrant of the intersection, crossed a grassy area and a private driveway, and struck and overrode a utility pole, which splintered as a result of the impact. The bus continued an additional 102 feet while swerving left before stopping facing east with its front end at the west edge of the pavement on U.S. 45. (See figure 4.)

Figure 4.—Right front of the bus at its final rest position.

When the truck stopped, live electrical wires fell across the truck and along the ground. (See figure 4.) Two power company employees, who were in the area, arrived on the scene within 1 minute after the accident and shut off power to the electrical lines.

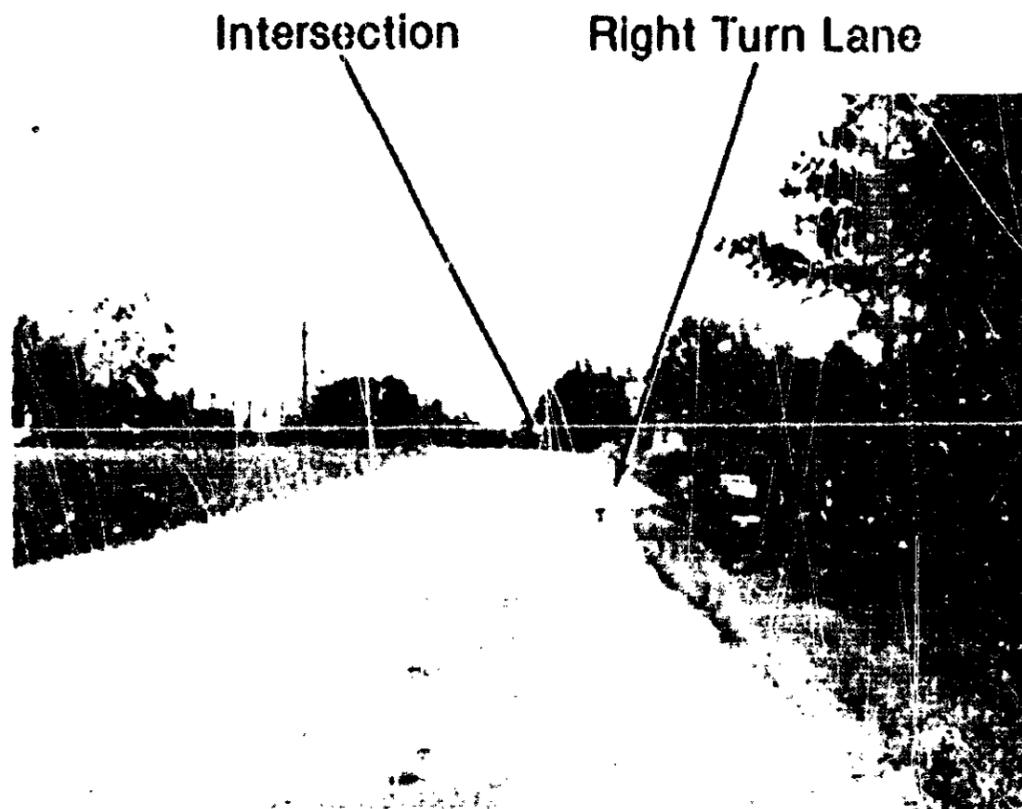
Approaching the intersection from the north, U.S. Route 45 has a grade of 0.77 percent positive to the south and a typical crown of 0.01-foot per foot. Pavement striping consists of solid white edge lines along both edges of the pavement and a single broken yellow center stripe. There is no break in the west edgeline for the turn lane and no lines at the west edge of the turn lane. (See figure 11.)

Figure 11.—U.S. Route 45 looking south toward the intersection.

Install appropriate advance warning signs to alert motorists of the potential hazard from turning trucks loaded with logs or other objects with extensive rear overhang at the intersection of U.S. Route 45 and Industrial Park Road and at all other intersections within the State of Mississippi where a similar hazards may exist. (Class II, Priority Action) (H-82-10)
