Highway Accident Report - Pacific Intermountain  
Express Tractor Cargo Tank Semitrailer Eagle/  
F. B. Truck Lines, Inc., Tractor Lowboy  
Semitrailer Collision and Fire, U.S. Route 50  
Near Canon City, Colorado, November 14, 1981

(U.S.) National Transportation Safety Board  
Washington, DC

22 Jun 82

1. Report No. NTSB-HAR-82-3		2. Government Accession No. PB82-916203		3. Recipient's Catalog No.	
4. Title and Subtitle Highway Accident Report—Pacific Intermountain Express Tractor Cargo Tank Semitrailer/Eagle F.B. Truck Lines, Inc. Tractor Lowboy Semitrailer, Collision and Fire, U.S. Route 50, Near Canon City, Colorado, November 14, 1981.				5. Report Date June 22, 1982

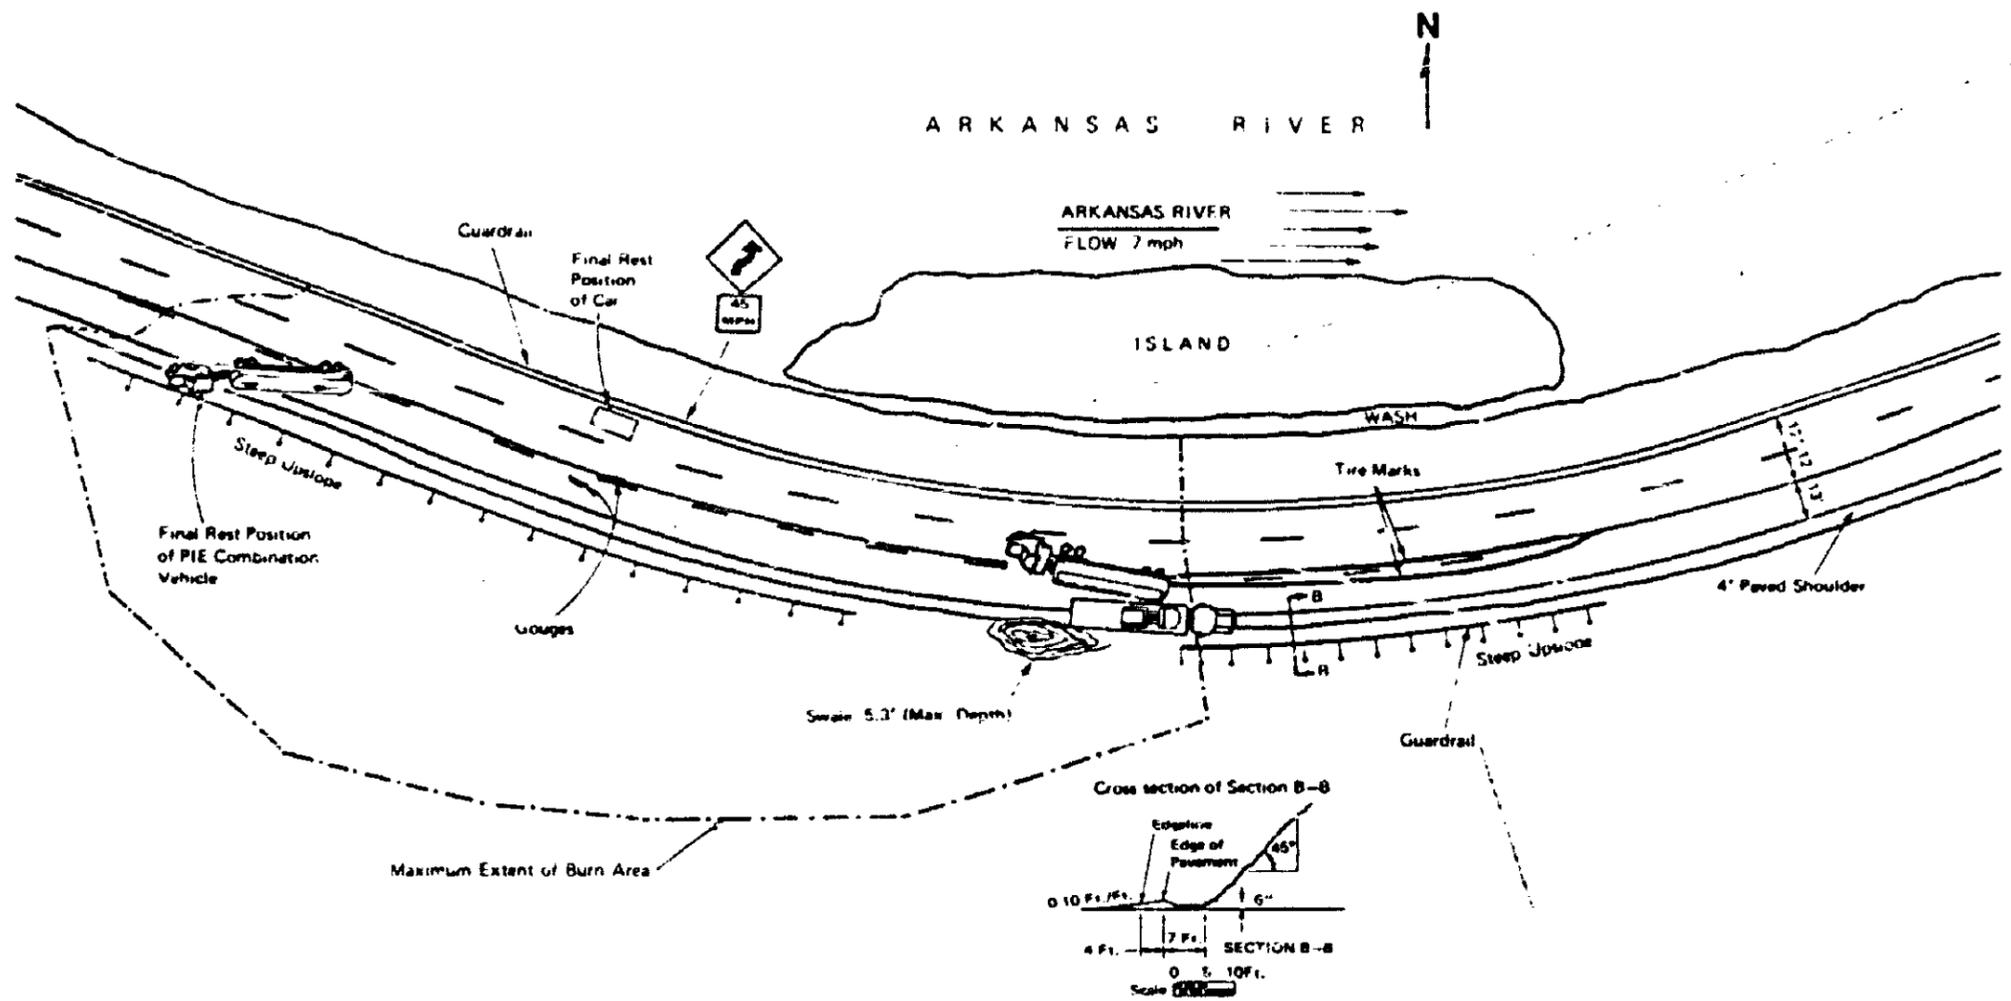
Figure 1.--Plan view of accident site on U.S. Route 50.

Safety Board investigators observed tire marks, scrapes, and gouges in the pavement surface at the accident site. Circular gouges burned into the pavement by the PIE semitrailer wheels indicated the semitrailer's final position after the impact and fire. The Colorado State Patrol (CSP) stated that the passenger car came to rest in the right westbound lane and that the Eagle combination vehicle came to rest on the edgeline of the eastbound lane, about 192 feet east of the position where the passenger car came to rest. The CSP also observed tire marks in the eastbound lane (see figure 10). The marks started 122 feet into the accident curve and then continued about 142 feet in the direction of the accident site. The radius of curvature for the tire marks was determined to be 626 feet. The D9H tractor was found with the left wheel track on the lowboy semitrailer and the right wheel track resting on the eastbound soft shoulder. About 10 feet behind the final position of the D9H tractor, a circular section of the pavement on the edge of the eastbound lane was missing.

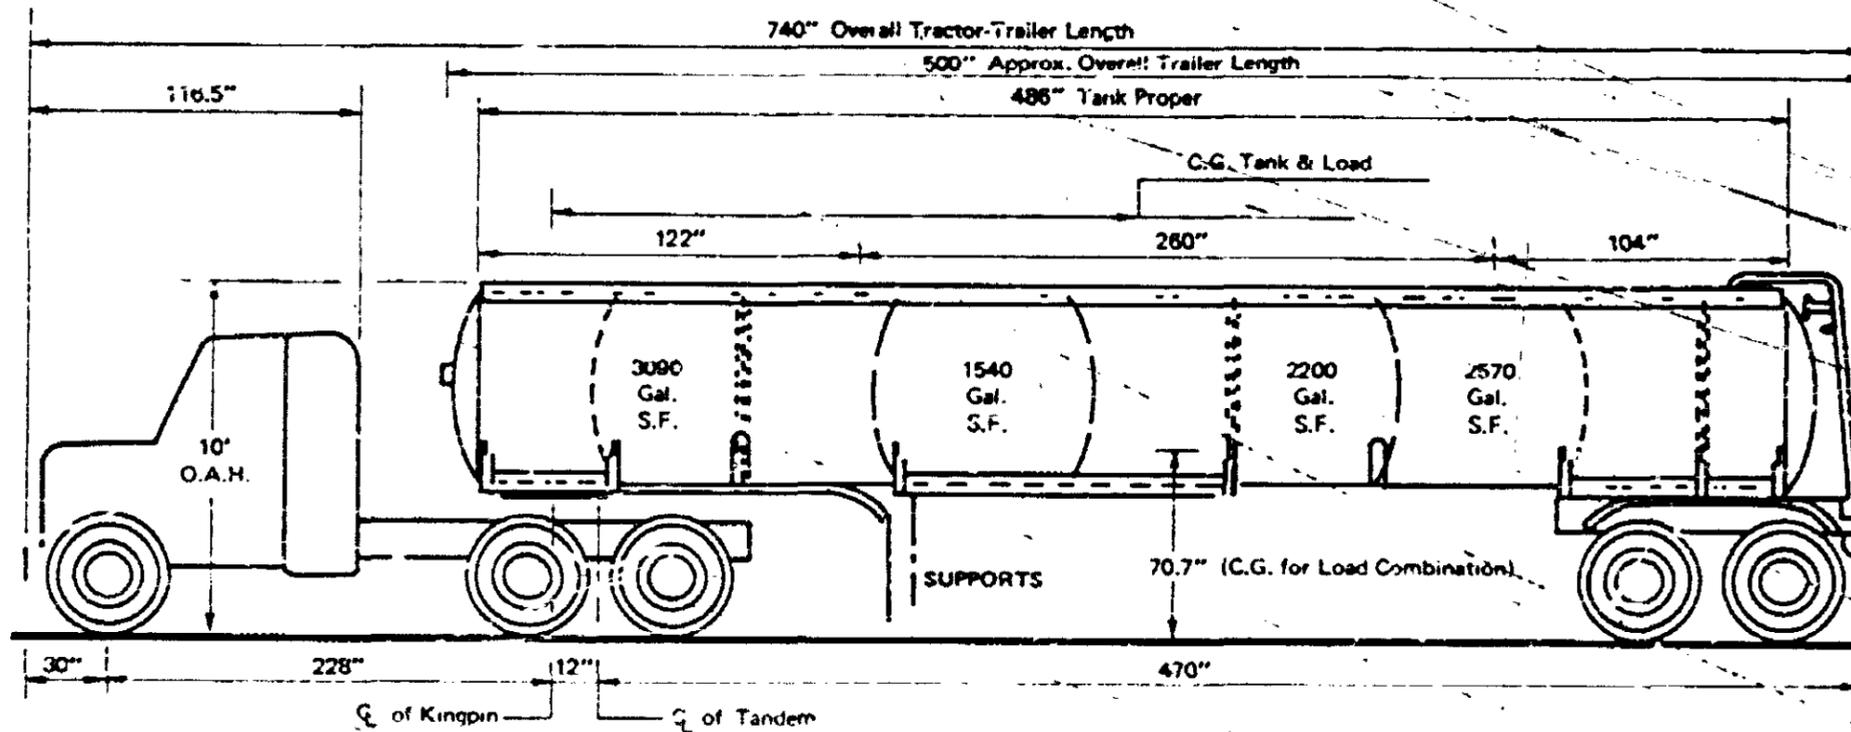
Figure 3.—PIE combination vehicle.

The PIE combination vehicle was essentially destroyed. The tractor cab, all interior components, the right side saddle tank, and the aluminum shell of the cargo tank were consumed in the fire. The only remains of the semitrailer was the rear dual tandem axle assembly. The kingpin and upper coupler plate were still attached to the tractor's fifth wheel. The right side aluminum frame rail of the tractor was bent into an "L" configuration (about a 75° angle). The left side frame rail was consumed by fire. The tractor's engine and transmission were not damaged internally. The shift cover plate was removed, and it was determined that the transmission was in ninth gear. However, Safety Board investigators could not verify whether the position of the transmission shifter had been altered during rescue or wreckage removal operations. The slack adjustments for the service brakes of the combination vehicle were not measured because of the excessive fire damage to all brake components.

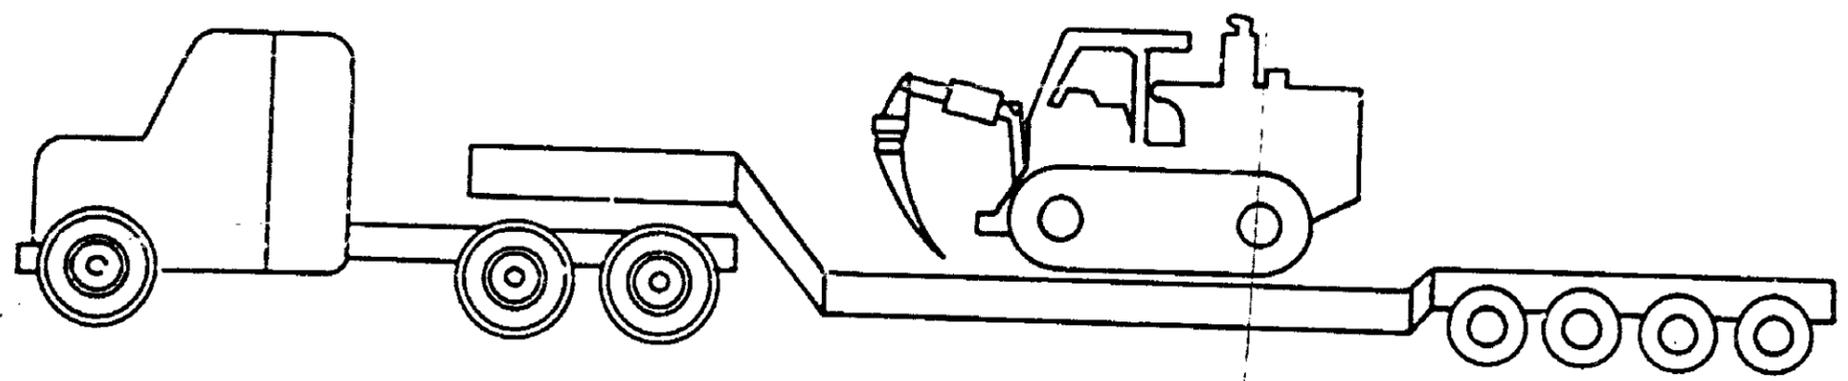
Figure 4.--Eagle combination vehicle.

Eagle Combination Vehicle.--The Eagle combination vehicle consisted of a 1979 Freightliner conventional tractor and a lowboy semitrailer. The tractor-semi-trailer was owned by Ray Withers of Pearl, Mississippi, and was operating under the interstate authority of Eagle/F.B. (EFB) Truck Lines, Inc., in Birmingham, Alabama. The three-axle tractor was equipped with a sleeper berth, a 13-speed Fuller road ranger transmission, 11x24.5 Kelly Springfield radial tires, and conventional mechanical air brakes on all axles. A type-1 occupant restraint was installed in the driver's seat.

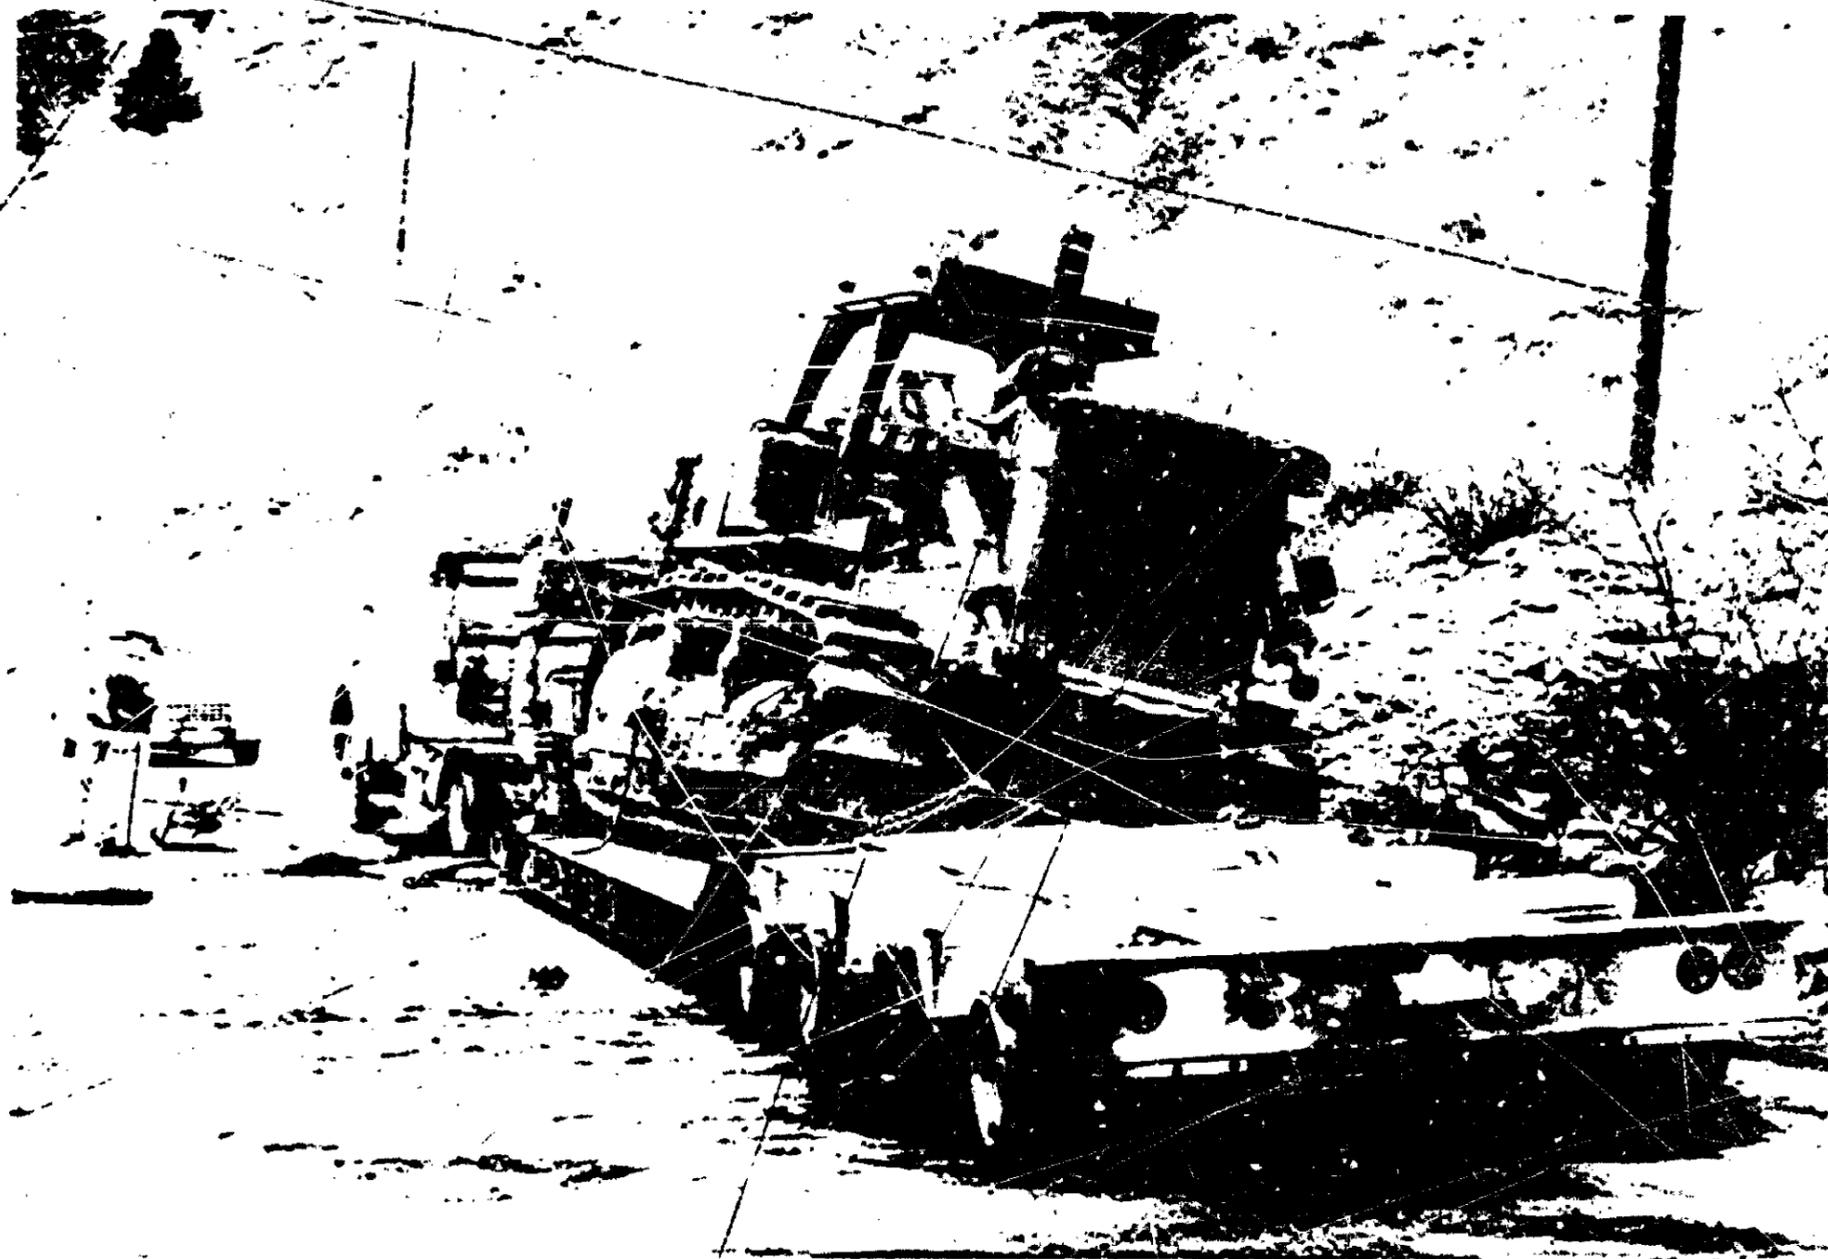
The Eagle combination vehicle was damaged in the postcrash fire. The tractor cab and front end components sustained relatively minor thermal and impact damage. The plastic bug screen, interior upholstery, tractor cab top, and rear fiberglass panels were scorched and charred from excessive heat exposure. Minor indentations were observed on the tractor's left sideview mirror and handrails. (See figure 5.) Components rearward of the sleeper berth sustained extensive heat and fire damage. All rubber and low melting point materials (the tires, suspension bushings, plastic hoses, brake chamber, and diaphragms) were destroyed in the fire. The lowboy semitrailer also was charred extensively, and all 16 tires were consumed in the fire. However, no structural or impact damage was observed on the semitrailer. (See figure 6.)

Figure 6.--Condition of Eagle combination vehicle after impact and fire.

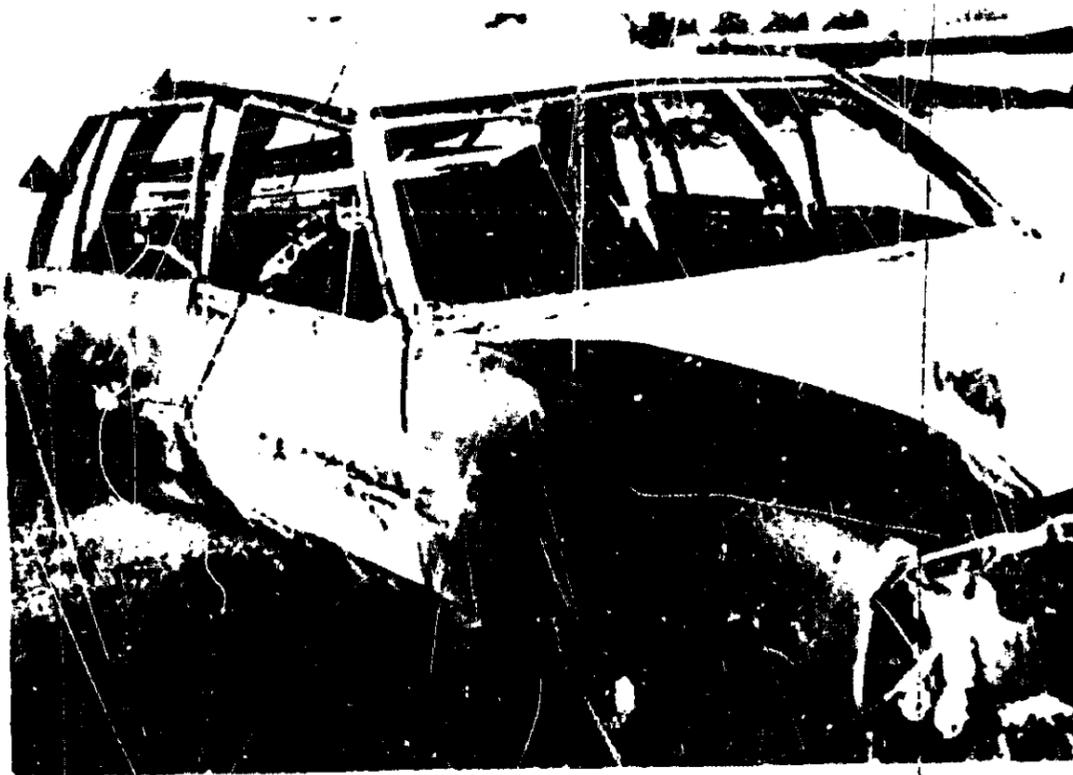
Passenger Car.--The accident passenger car was a 1981 Chevrolet Caprice Classic 4-door sedan equipped with a diesel engine and occupant restraints for all seated positions. All combustible plastic and aluminum materials on the car were destroyed. The engine compartment was gutted completely, with all engine accessories consumed in the fire. The roof, body quarterpanels, hood, and trunk were buckled and distorted from excessive heat damage. The passenger compartment also was totally destroyed, and all of the vehicle's tires were consumed in the fire. There was no apparent impact damage to the vehicle. However, the trunk and hood had been forced open during the rescue operation. (See figure 8.)

Figure 8.--Postfire condition of the passenger car involved in accident.

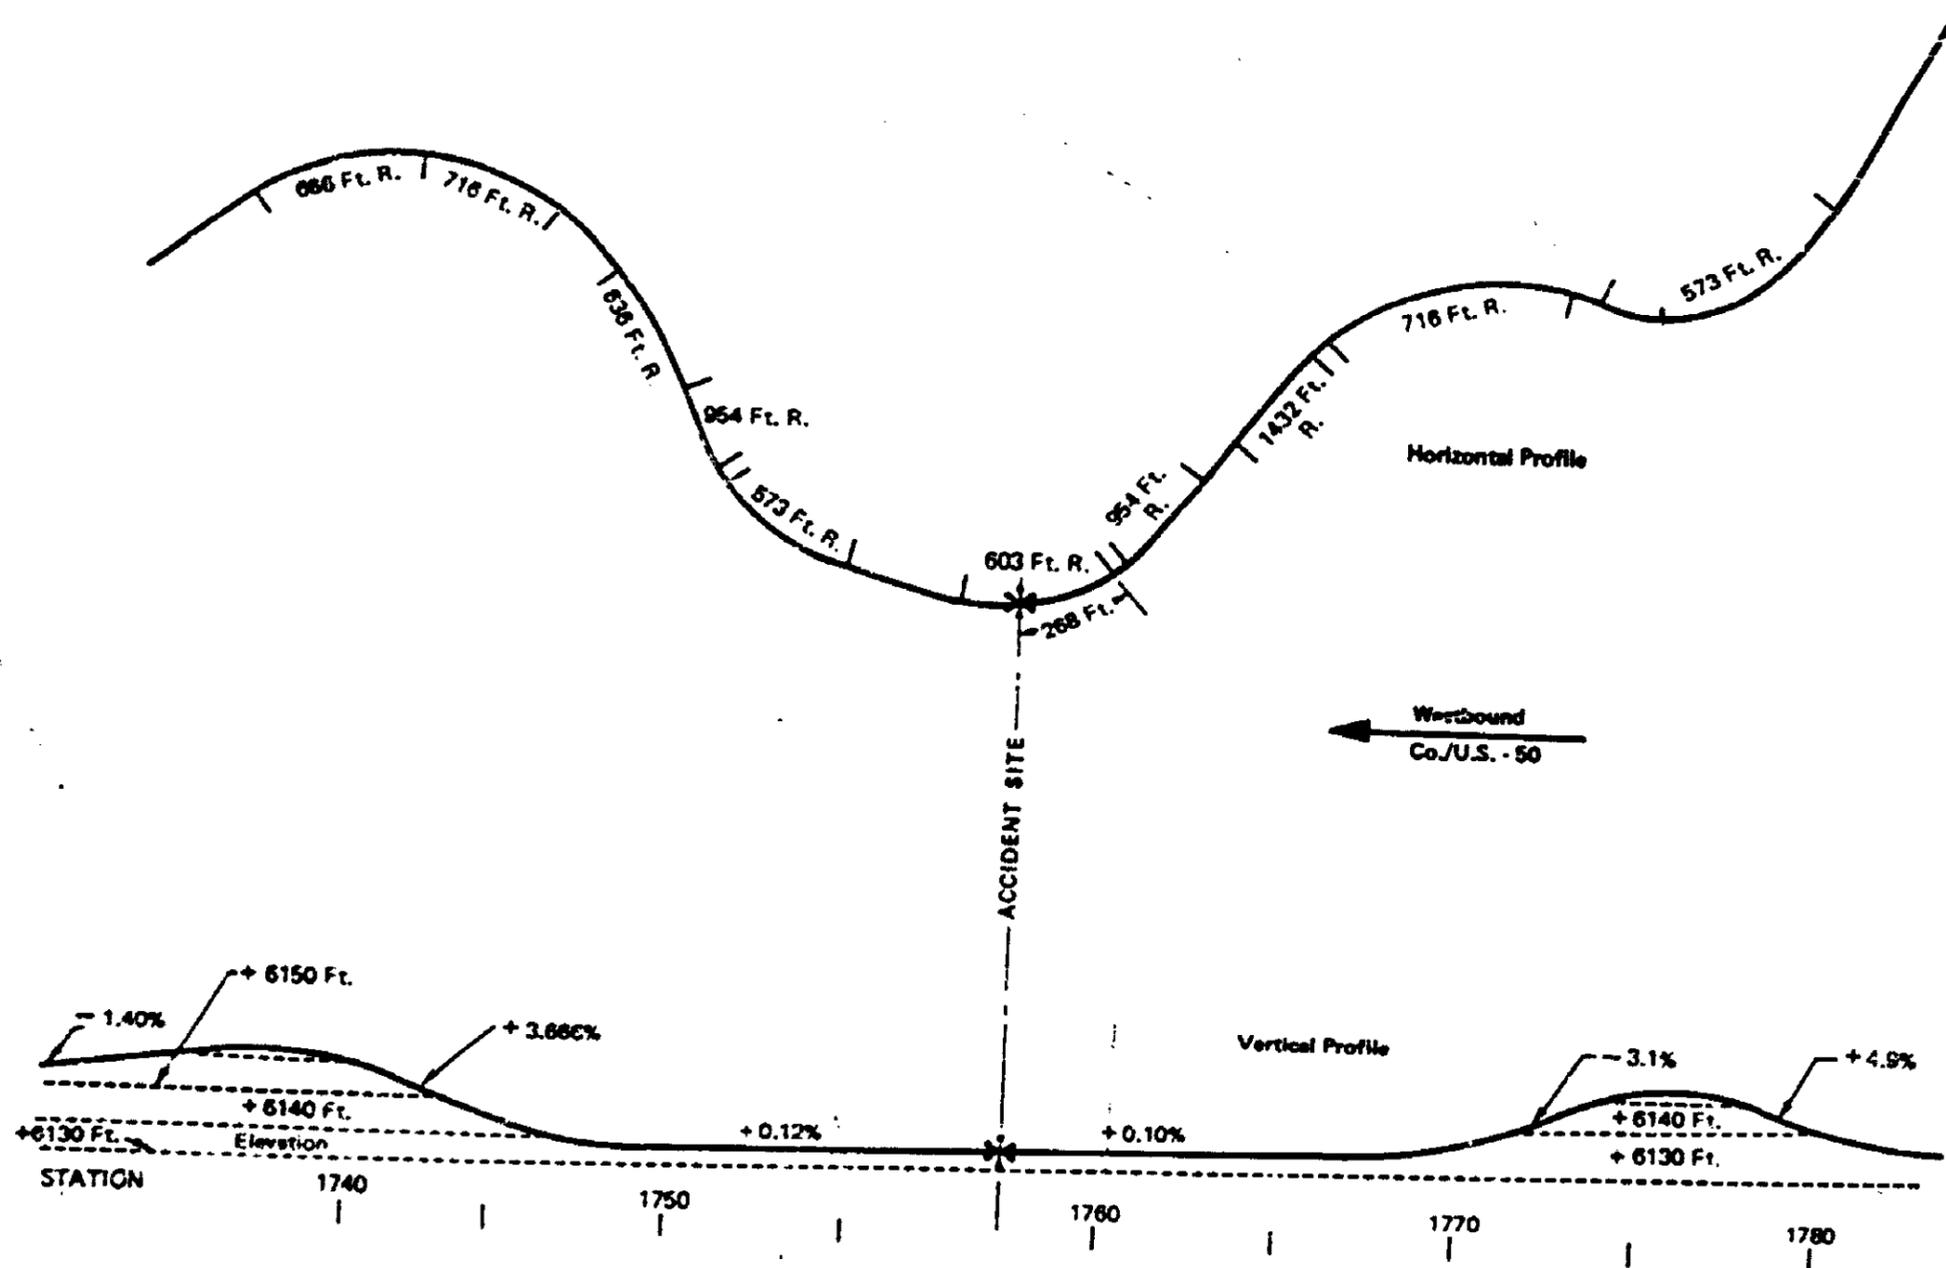
Figure 9.--Horizontal and vertical profile of U.S. Route 50.

this curve was calculated by the Colorado State Department of Highways (CSDOH) to be about 47 mph. The MUTCD states that a curve sign (W1-2R) and perhaps supplemented by an advisory speed plate (W13-1) should be posted when an engineering investigation has shown that the advisory speed on the curve is equal to or less than the speed limit. An advisory speed plate is marked in multiples of 5 mph and the maximum recommended speed posted is determined by using accepted traffic engineering procedures. The speed limit on U.S. Route 50 is 50 mph near the accident site. Speed limit signs are posted about 4 miles east of the accident site and about 2 miles west of the accident site.

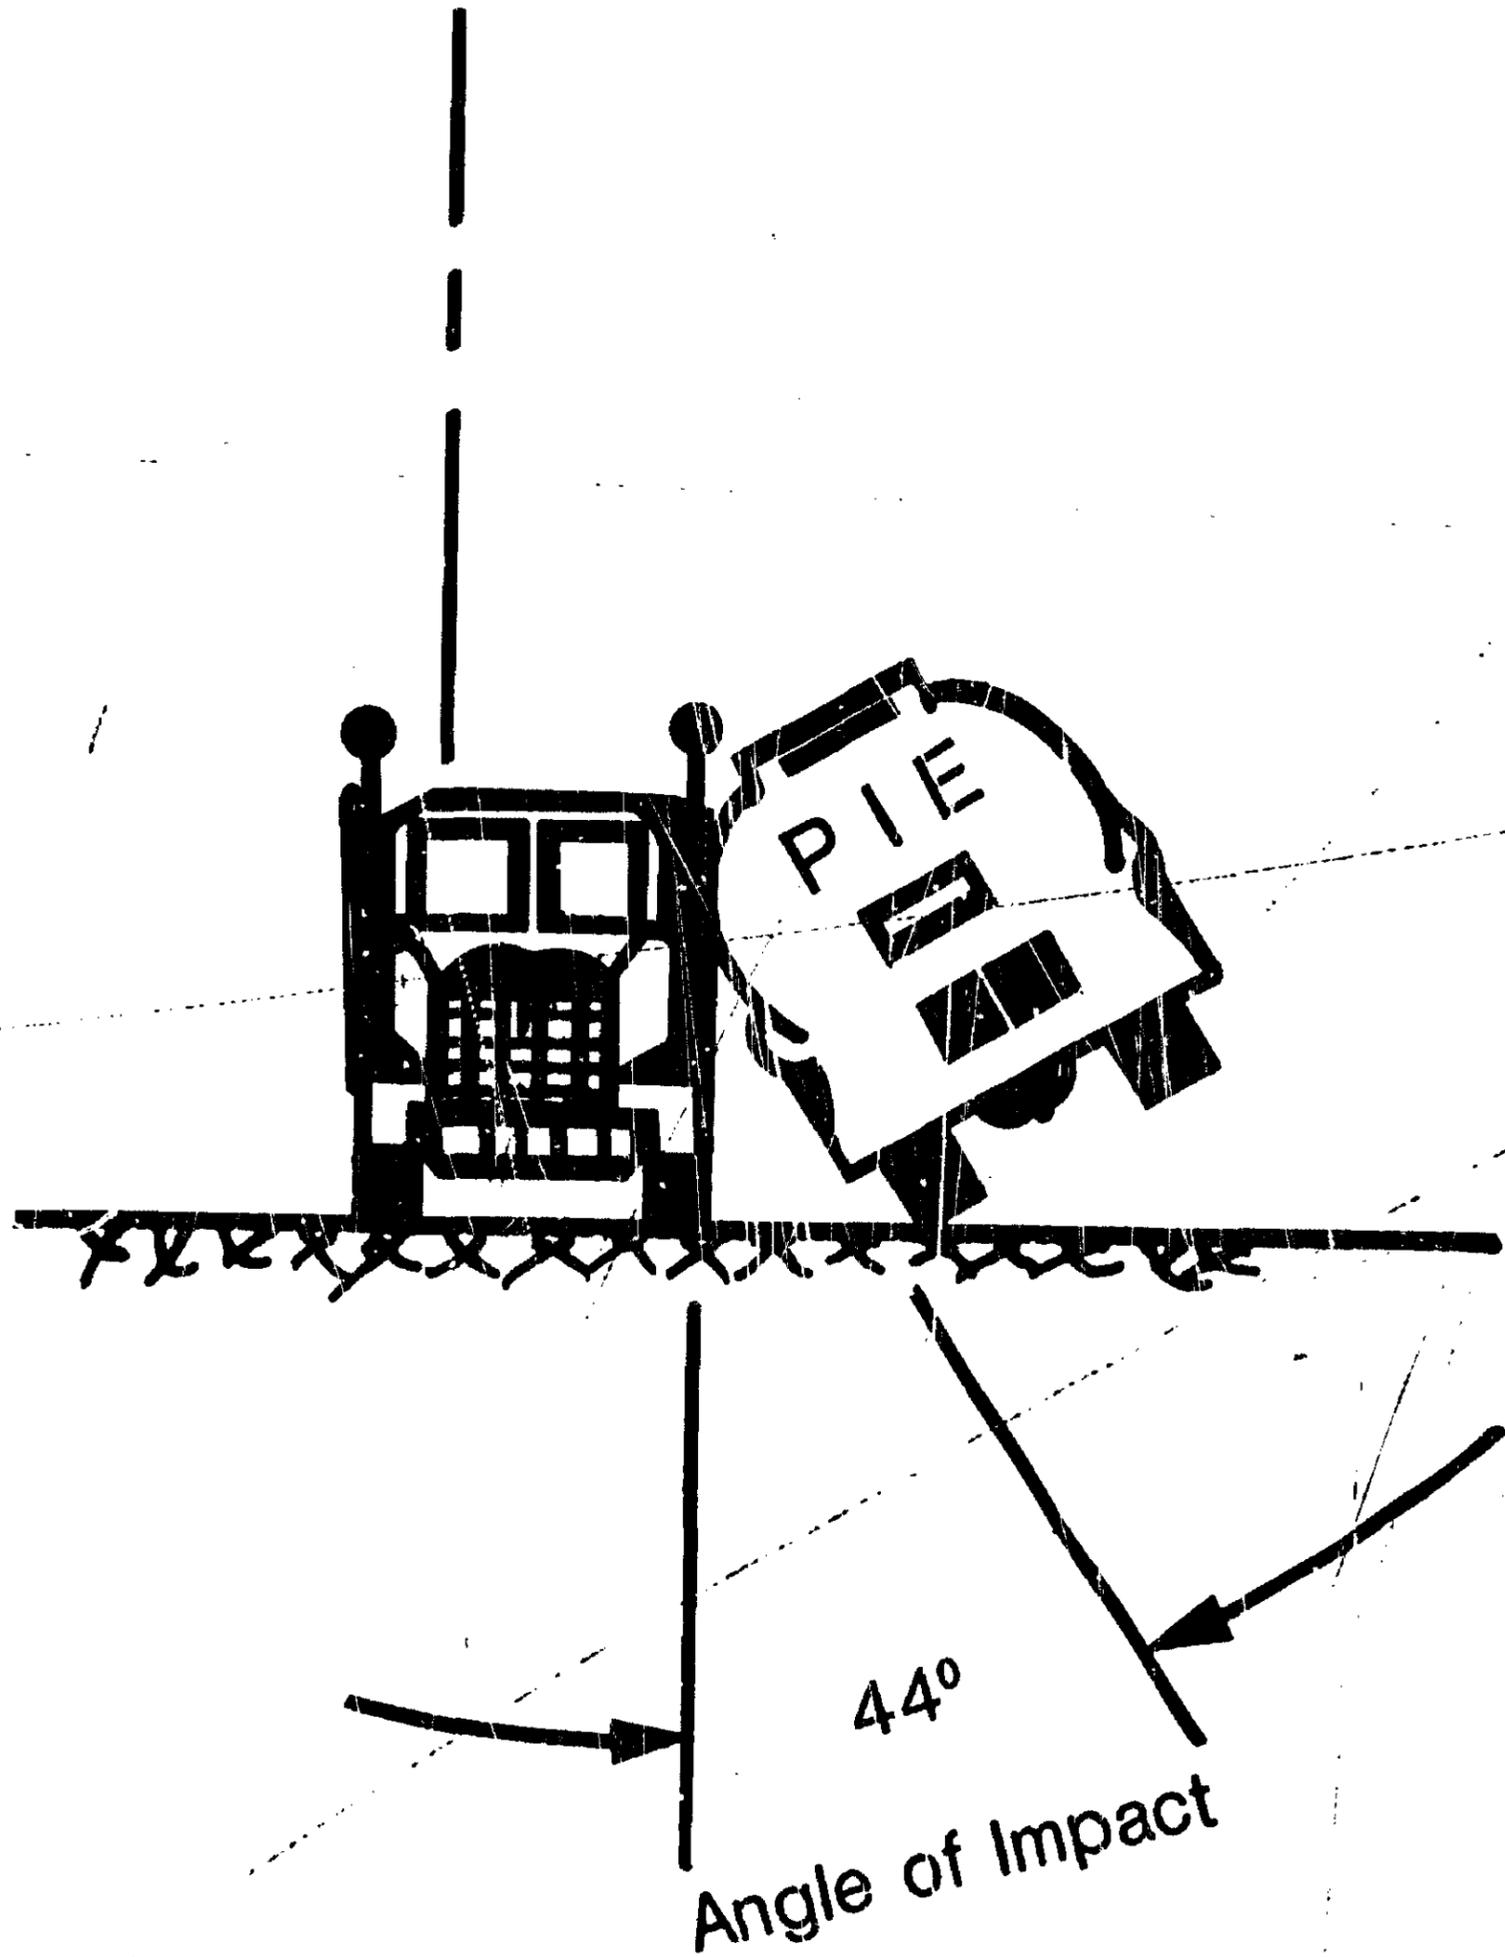
Impact probably occurred between the left front corner of the ripper blade and the overturn roof rail across the top of the cargo tank. During postimpact inspection, a large section of the overturn protection roof rail of the cargo tank was found lodged underneath the work light on the D9H tractor. In order for the ripper blade to have contacted the roof rail, the cargo tank semitrailer would have had to have been in a rollover attitude during the impact sequence. The angle of impact between the vertical centerline of the cargo tank and the left rear corner of the D9H tractor was estimated to be 44°. <sup>8/</sup> (See figure 11.)

Figure 11.--Vertical angle of impact between the PIE and Eagle combination vehicles.
