Highway Accident Report - Pattison Head Start
Center School Van Run-off Bridge and Fire Near
Hermanville, Mississippi, December 17, 1981

(U.S.) National Transportation Safety Board
Washington, DC

1. Report No. NTSB-HAR-82-5		2. Government Accession No. PB82-916205		3. Recipient's Catalog No.	
4. Title and Subtitle Highway Accident Report-- Pattison Head Start Center School Van, Run-Off Bridge and Fire, Near Hermanville, Mississippi, December 17, 1981				5. Report Date September 22, 1982

**PATTISON HEAD START CENTER SCHOOL VAN
RUN-OFF BRIDGE AND FIRE
NEAR HERMANVILLE, MISSISSIPPI
DECEMBER 17, 1981**

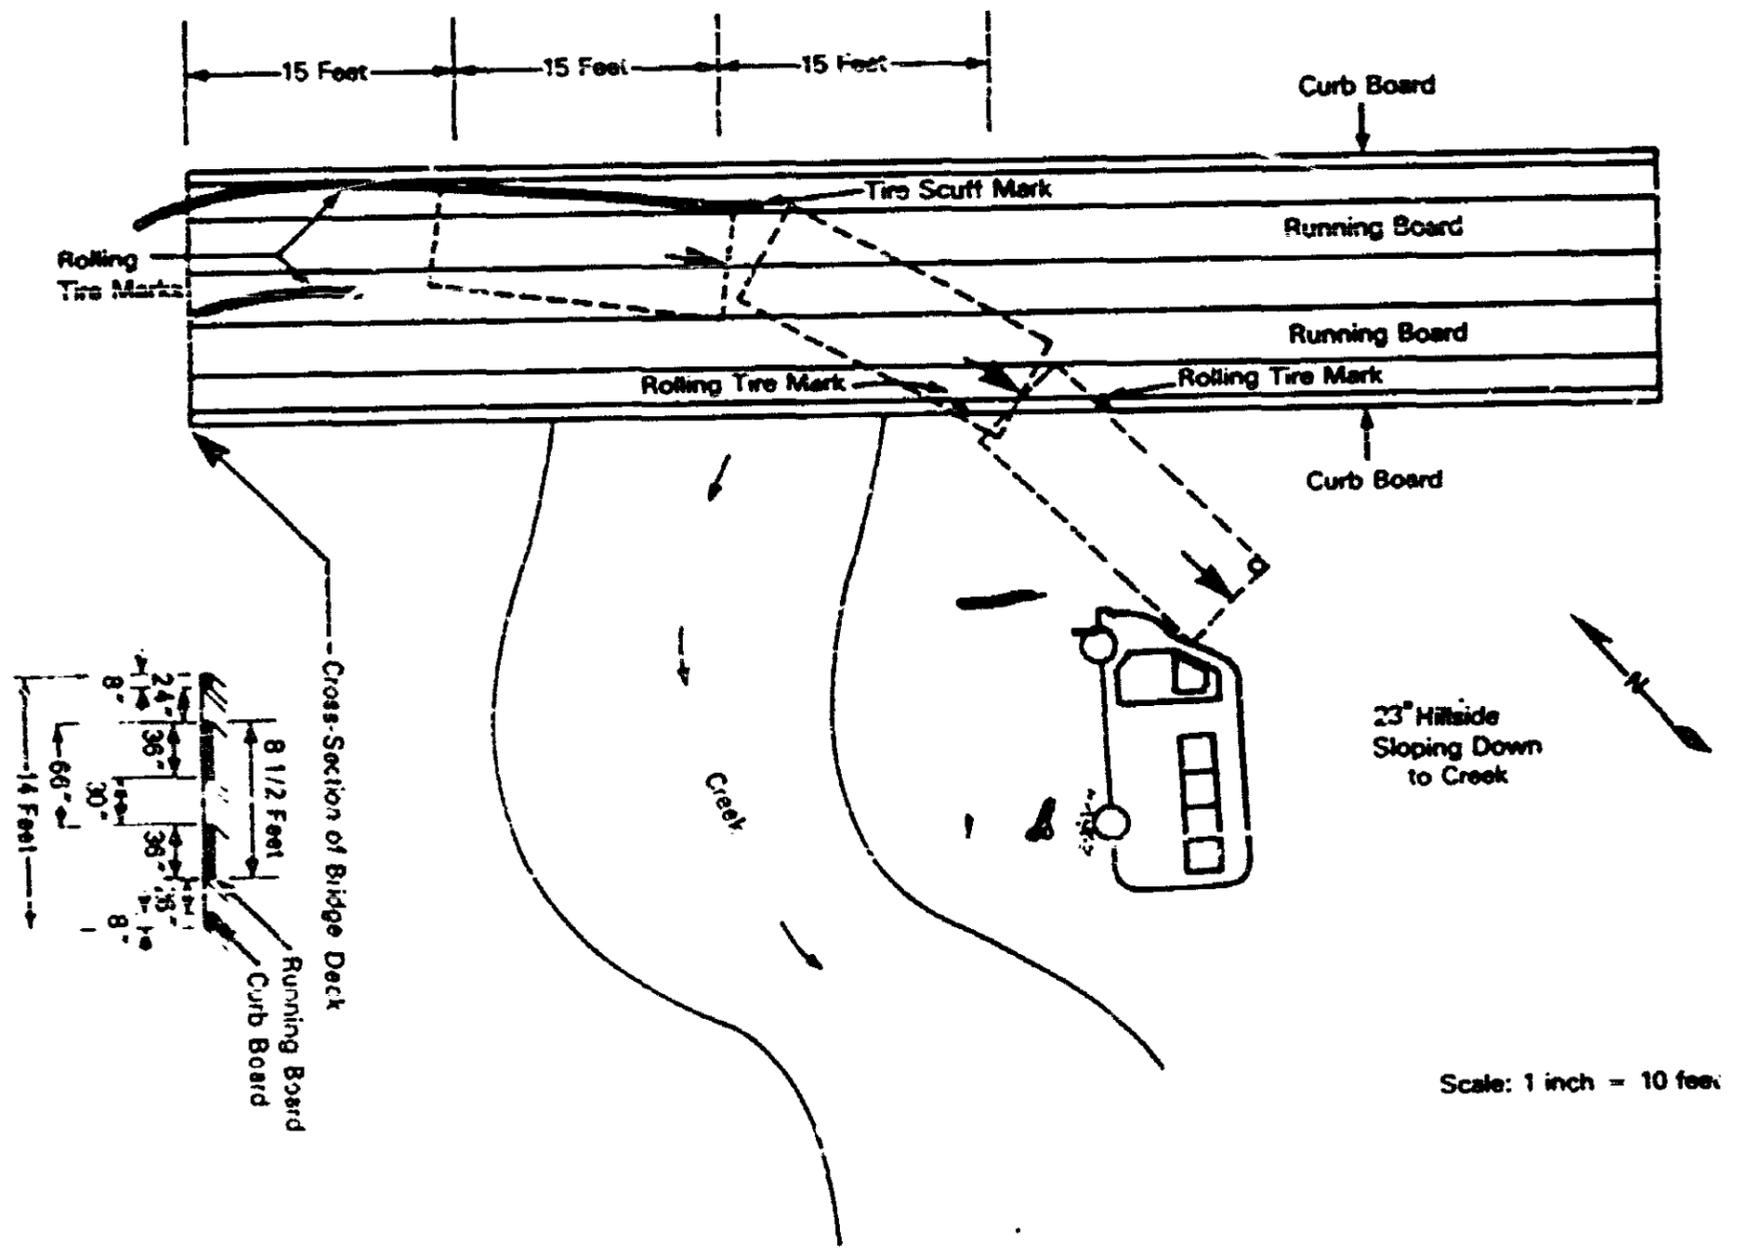
Figure 2.—Plan view of accident site.

The Claiborne County sheriff's investigating officer reported that rolling, muddy tire marks were found about 1 foot to the left of the beginning of the bridge running boards. These marks curved slightly to the left, almost contacted the left curb board, and then curved to the right. The track width of these marks was equivalent to the track width of the van. Tire scuffmarks about 3 feet long were found along the left-side edges of the running boards, about 30 feet from the beginning of the bridge. Two rolling, muddy tire prints were found across the top of the right curb board, at a 30° angle with respect to the bridge and about 43 feet and 50 feet from the beginning of the bridge. (See figure 2.)

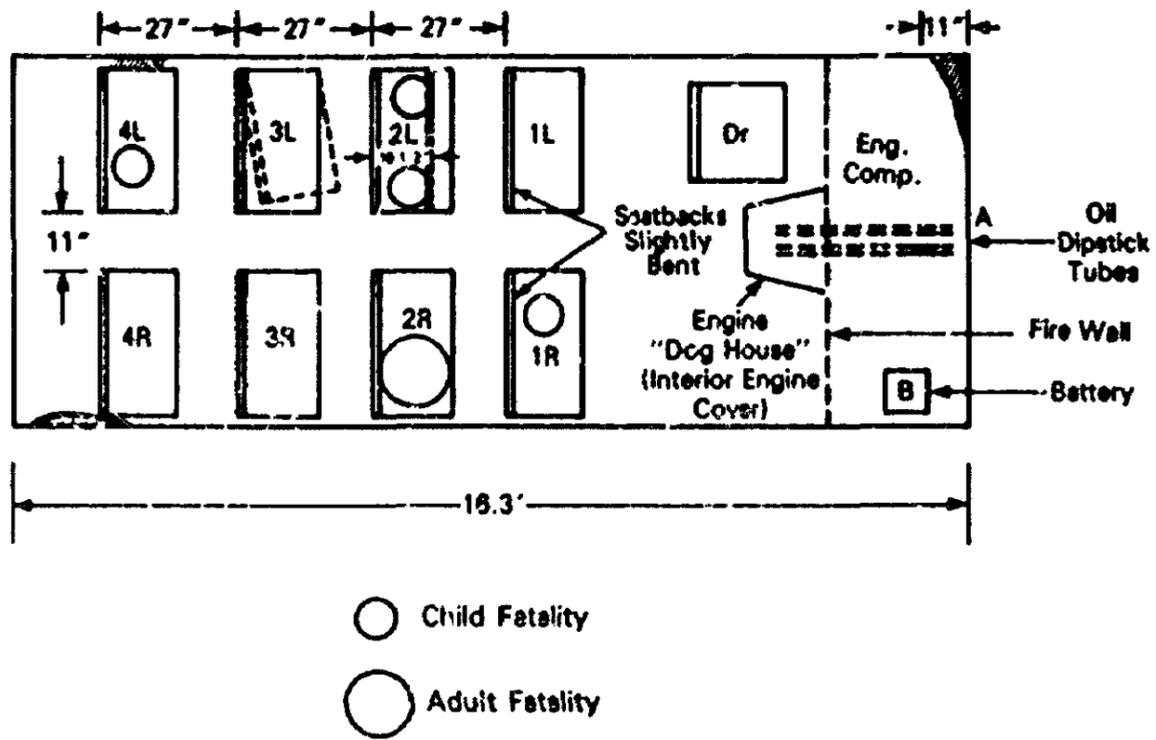
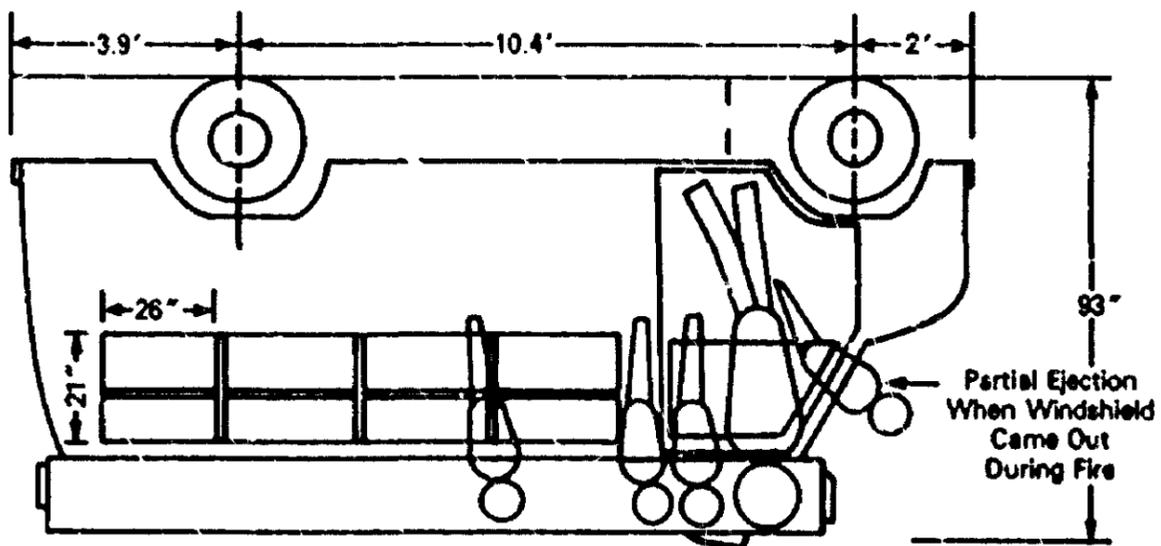
Figure 5.—Seat positions of fatalities before and after crash.

No autopsies were performed on the five accident victims. According to death certificates, cause of death was "burns, third degree." Three survivors received first-degree burns on the forehead, hands, lower leg; one received second-degree burns on the forehead; six were treated for abrasions, bruises, and small cuts; two were treated for smoke inhalation. Those killed had been seated in various seats in the front, rear, and on each side of the bus before the crash; they were found at the front of the van after the crash. (See figure 5.)
