Highway Accident Report - J. C. Sales, Inc.  
Tractor-Semitrailer, Calvary Baptist Church  
Van Collision, State Route 198 at 19th Avenue  
Near Lemoore, California, October 8, 1982

(U.S.) National Transportation Safety Board  
Washington, DC

3 May 83

1. Report No. NTSB/HAR-83/02	2. Government Accession No. PB83-916202	3. Recipient's Catalog No.	
4. Title and Subtitle Highway Accident Report— J.C. Sales, Inc., Tractor-Semitrailer, Caivary Baptist Church Van Collision, State Route 198 at 19th Avenue near Lemoore, California, October 8, 1982		5. Report Date May 3, 1983

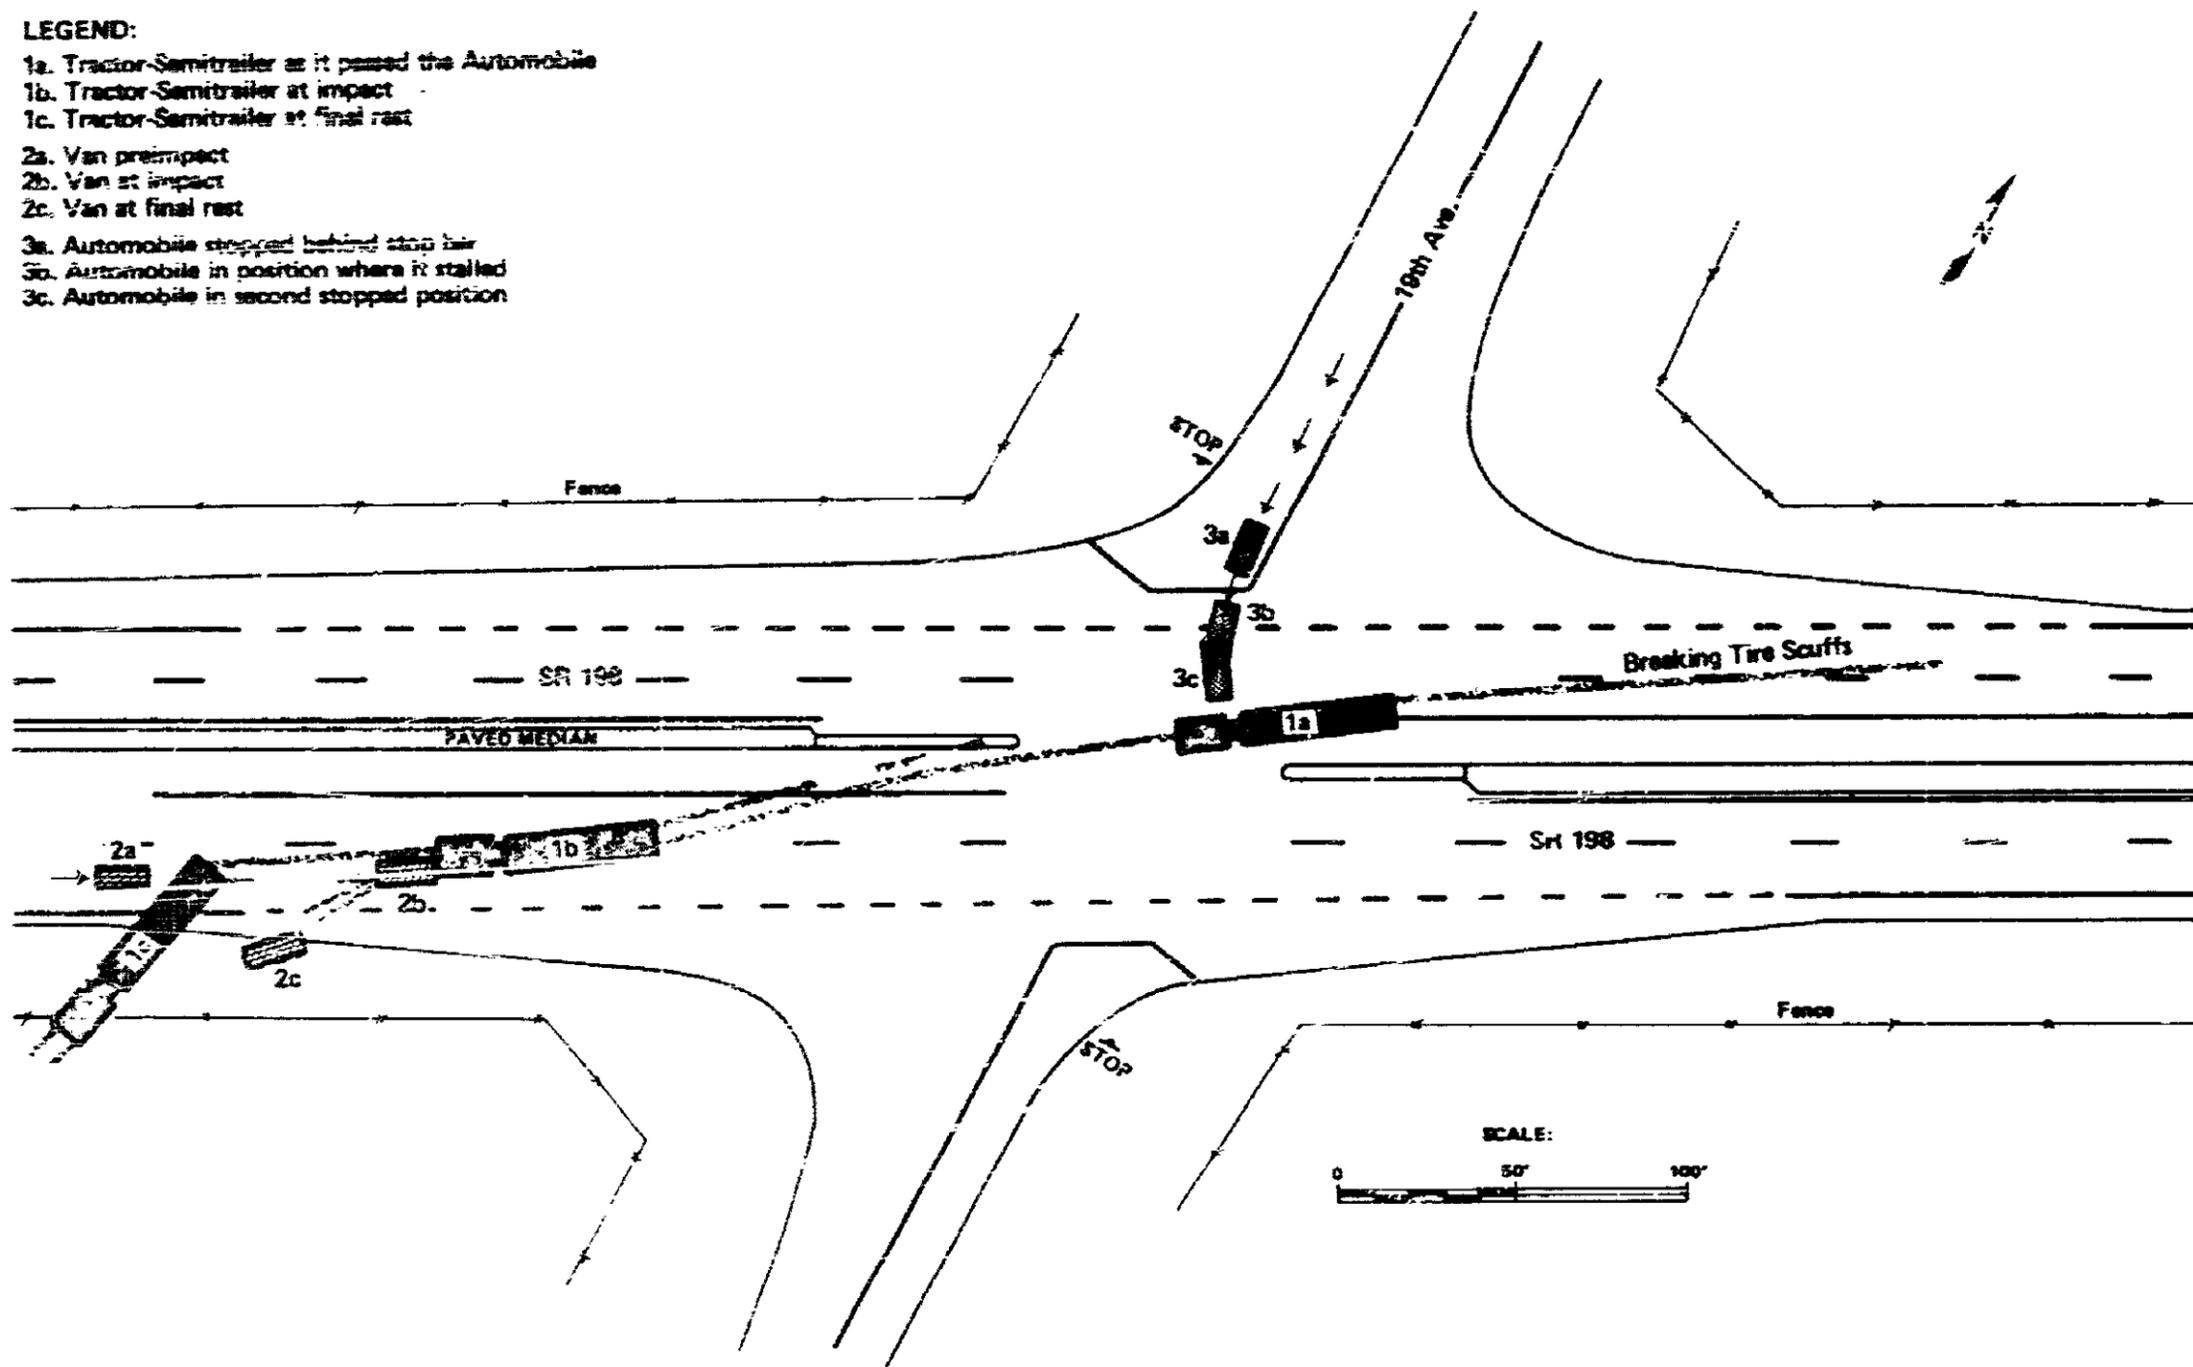
Figure 1.--Plan view of accident site.

The truckdriver successfully avoided striking the automobile in the intersection; the automobile driver estimated that the right side of the truck passed about 1 foot from the front of his vehicle. After crossing the intersection, however, the truck's right wheels overrode the east end of the 4-inch-high concrete curb in the raised median at the west side of the intersection. The truck tractor then traveled in an arc to the truckdriver's right, westward in the eastbound travel lanes, and when the truck tractor was nearly aligned with the roadway, the tractor and an eastbound van, occupied by 11 persons, traveling in the eastbound curb lane of SR 198 collided head-on. (See figure 1.)
