Highway Accident Report - Jonesboro
School District Schoolbus Run-off-Road and
Overturn, State Highway 214 at State Highway 18
Near Newport, Arkansas, March 25, 1983

(U.S.) National Transportation Safety Board
Washington, DC

20 Sep 83

| 1. Report No. NTSB/HAR-83/03 | | 2. Government Accession No. PB83-916203 | | 3. Recipient's Catalog No. | |

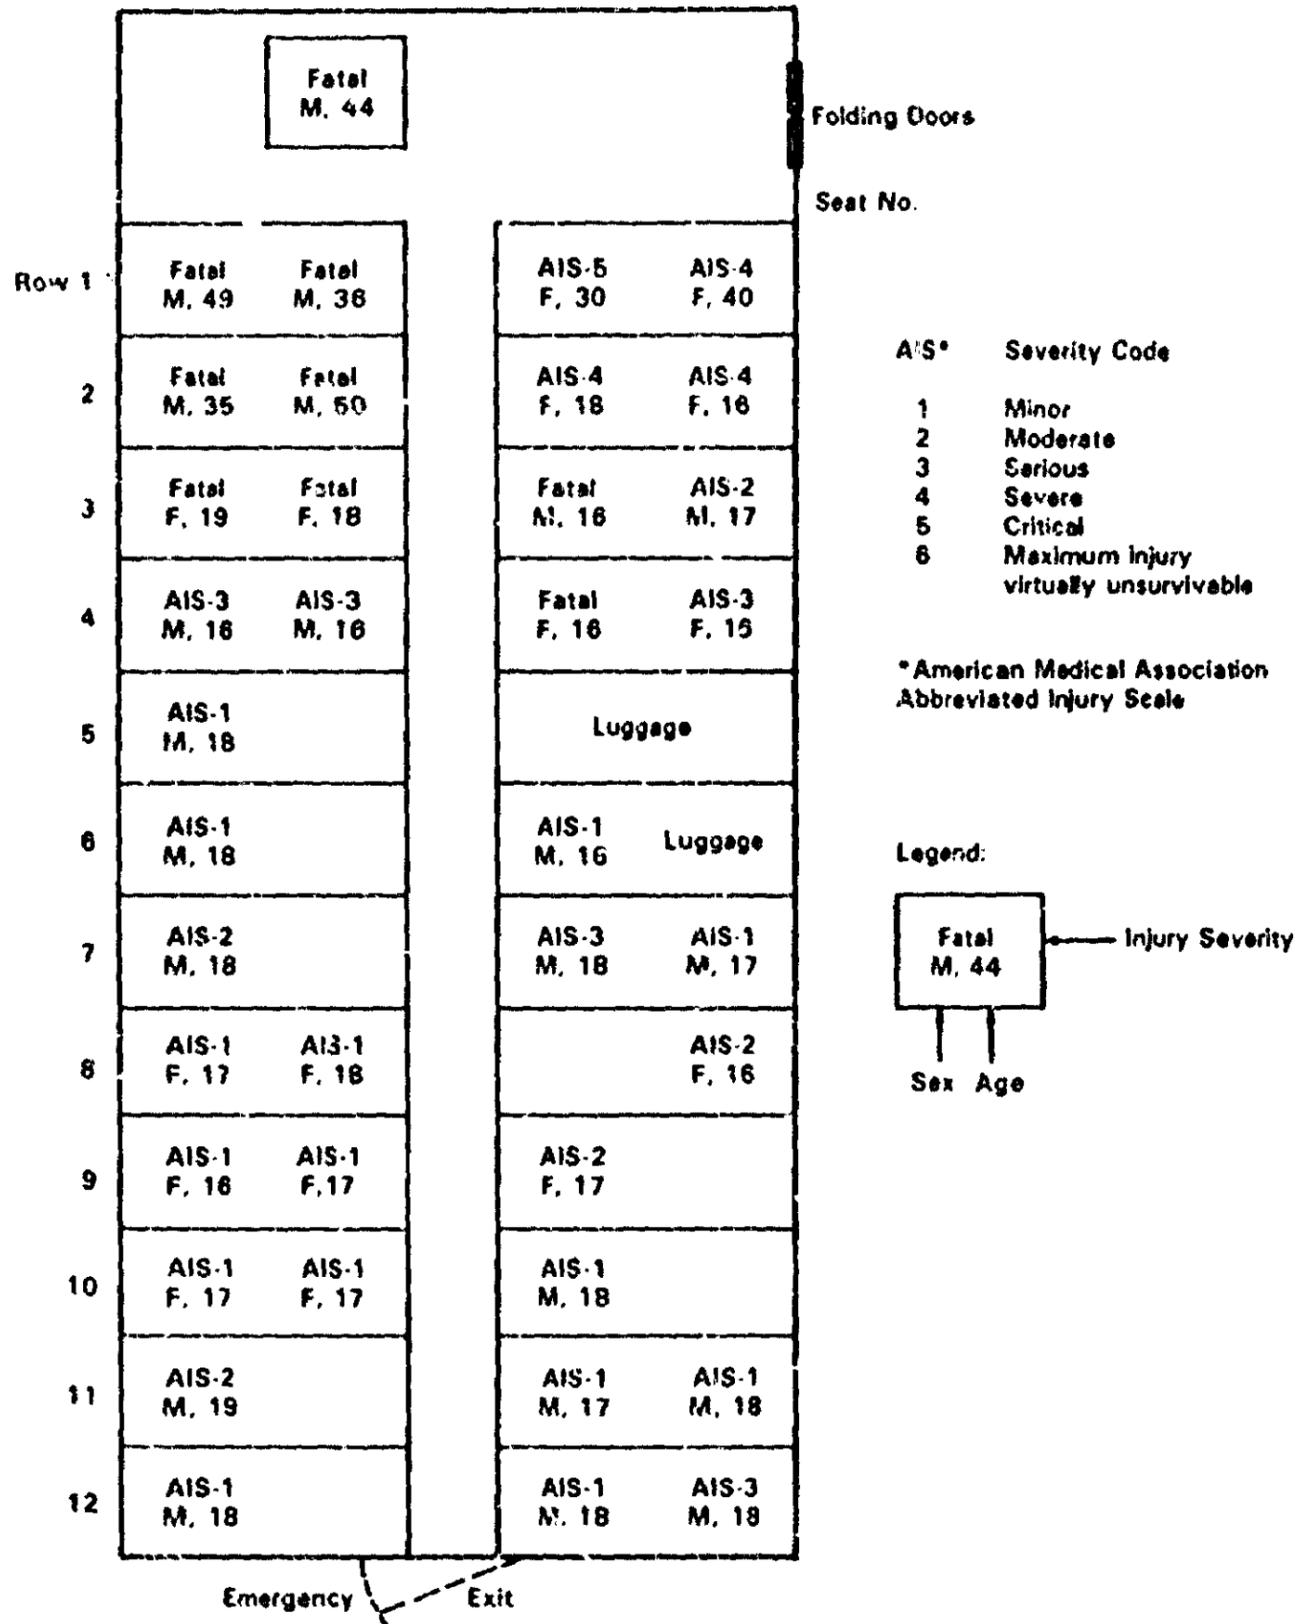
Figure 8.-- Schoolbus seating chart noting occupant age, sex, injury severity, and seat location.
